ENVIRONMENTAL INSPECTION REPORT

Permittee:	Paramount Resources Ltd., 4700 Bankers Hall West, 888 3 rd Street SW, Calgary, AB, T2P 5C5		
		Permit Expiry Date	Previous Inspection
Land Use Permit No.	MV2000P0055	January 17, 2007	April 02, 2002
Quarrying Permit No.	2002QP0012 and 19		
Contractor:	Subcontractor:

Land Use Permit MV2000P0055

June 11 and 12, 2002

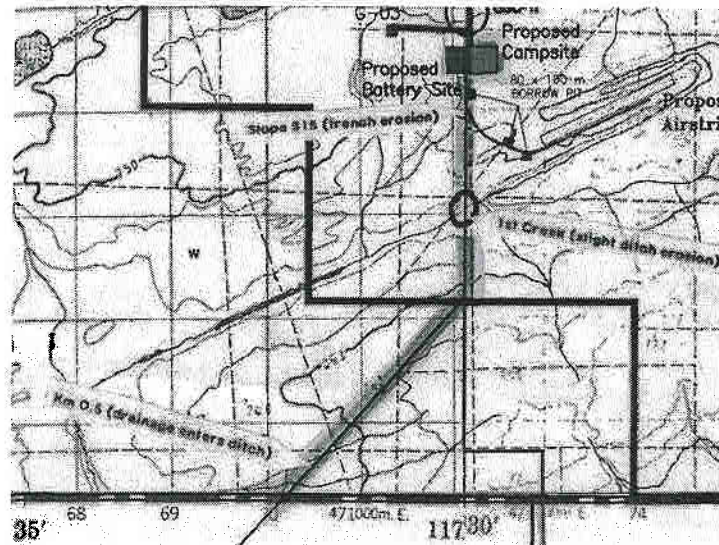
Locations shown: Km 0.5, Slope 1st Creek & Slope S15

Located approximately 0.5 km from the Alberta boarder are two drainages that flow from east to west and are situated roughly 150 meters apart. Water from the northmost drainage is entering the ditch and flowing southward under the roach and empties into the south drainage. There are several washouts on the roach between the two drainages and I observed the water steadily moving southward. This situation appears to be causing an actual diversion of the natural drainage.

The creek crossing itself appears satisfactory with no signs of erosion or siltation. However the right-of-way to the south of the creek has diverted a small intermittent drainage northward along the ditch for approximately 80 meters. The water enters the r-o-w from the east then travels north for 30 meters or so before it swings west across the roach. It then travels north against the roach for approx. 50 meters where it then swings west into the bush just south of the access/r-o-w junction. Erosion is minor at this time.

There appears to be some erosion along the ditch on the long gentle slope leading to the battery site from the south. I did not inspect this site on the ground therefore have not observed the extent of erosion but it is evident from the air.

1. Correct the drainage diversion problem so that the natural drainage pattern is permanently restored and the chances of this reoccurring are eliminated.
2. Repair the eroded ditch.

1. Restore the natural drainage and ensure that the water no longer flows against the roach.
2. Repair the erosion.

1. Take steps to permanently prevent water from moving along the roach.
2. Repair the eroded ditch.

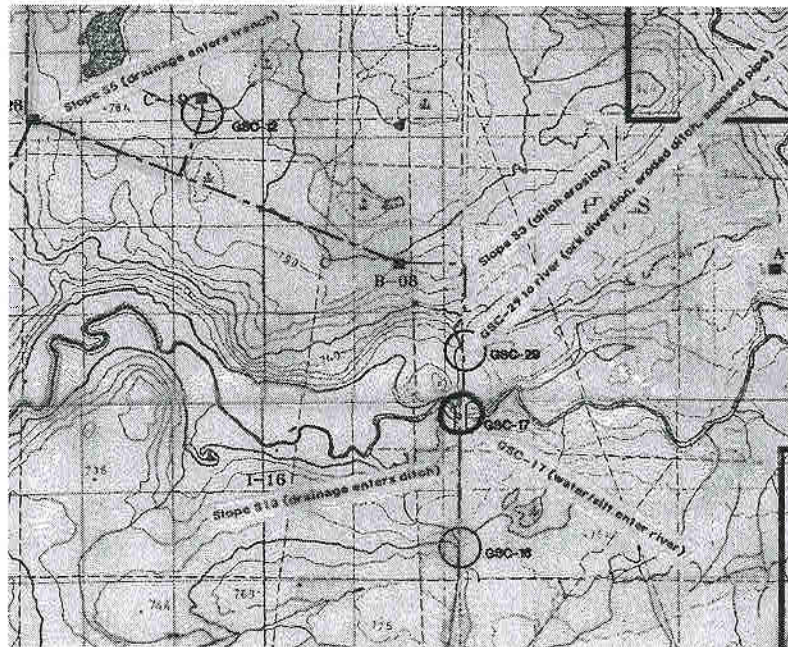
Locations shown: Slope S13 & Creek Crossing GSC-16; Cameron River Crossing GSC-17; Creek Crossing GSC-29 & the R-O-W to the Cameron River; Slope S3; Slope S5.

Near the top of the small hill located immediately south of GSC-16 a small drainage enters the r-o-w from the east, follows the east side of the r-o-w for approx 20 metres and then diverts east into the bush following what appears to be it's natural path. No erosion was observed and I could not tell if this poses a threat to the ditch or not.

The north slope of the small hill appeared stable with no significant sign of water movement. However at the base of the hill the creek GSC-16, which flows from east to west, had entered the ditch and caused extensive erosion to the north for approx. 200 meters. Paramount has installed a temporary diversion to put the creek back on course and this looks to be working. It appears that when the creek was flowing down the ditch, the majority of the water surfaced about 200 meters down slope and moved west into the bush. The 1 km of r-o-w from this point north to the Cameron River shows signs that there was water movement under the roach for part of the way and possibly all of the way. A small quantity of water is still flowing from the roach where the pipe exits the ditch to cross the GSC-17 vehicle bridge. It appears to me that in addition to the threat from GSC-16 water is entering the ditch from the muskeg to the east and may remain a problem.

It is evident that during spring runoff, water ran northward along the east side of the roach and entered directly into the Cameron River to the east side of the vehicle bridge approach causing some erosion. It also appears that water was moving through the ditch and entering the river at the same point. There is some silt deposited along the bank which suggests that some did enter the water course. Also, water had crossed the roach via a diversion ditch approximately 30 meters south of the bridge and followed the west side of the roach toward the river. There were no signs of silt near the river on the west side of the bridge.

Creek Crossing GSC-29 is located approximately 700 meters north of the Cameron River vehicle bridge. It appears that during spring runoff, water overflowed the left bank of the creek approx. 10 meters up slope of the right-of-way causing a considerable amount of water to enter and follow the west side of the r-o-w the 700 meters to the river. This does not appear to have caused any significant erosion on the north half of the r-o-w since most of the surface consists of undisturbed organics. However some of the water was diverted into the ditch approximately 30 meters from GSC-29 via an old access road diversion ditch and this has resulted in approx. 150 meters of severely eroded ditch complete with some sections of exposed pipe.

More problems were observed closer to the Cameron River. It appears that silt from the eroded ditch followed the r-o-w to within 100 meters of the bridge where it then entered the creek (GSC-29) and diverted west to the river. To complicate matters further the creek, which flows southward from the GSC-29 crossing and runs parallel to the r-o-w, overflowed its banks again approximately 200 meters from the bridge. The water entered the r-o-w joining with the water flowing down the west side of the roach and then re-entered its natural drainage and traveled to the river. A considerable amount of silt has been deposited along the 100 meters of creek drainage that runs from the r-o-w westward to the river and it appears that some silt may have entered the river. Paramount has installed several silt fences as a short term solution. This entire situation has the potential for serious ongoing problems unless a permanent solution is devised and implemented.

At the top of the slope where the r-o-w turns west toward B-08, the ditch has eroded for approx. 20 meters. At first glance this situation appears minor, however upon further observation I am not so sure. Water can be seen coming out of the roach and trickling along the bottom of the ditch for the 20 meters where it disappears and no further ditch erosion on the slope is evident. I walked the entire length of S3 looking for signs of water surfacing and leaving the ditch which I finally observed coming from a diversion ditch near the bottom of the steep portion of the slope approx. 100 meters from GSC-29. I am not sure if this is the same water that enters the ditch at the top of the slope or if it enters elsewhere from under-ground. Regardless, I suggest that the slope be treated as if there has been water movement along the bottom of the ditch for it's entire length. Paramount constructed a small hand dug temporary diversion ditch near the top of the slope to prevent water from continuing down the slope.

Approximately 50 meters east of N-28 a small intermittent drainage enters the right-of-way from the north and runs directly into the ditch. It appears that during spring runoff, a considerable amount of water flowed from the drainage into the ditch and along it to the N-28 wellsite. This movement of water has resulted in erosion to the ditch for approx. 50 meters. At the time of my inspection there was still a slight quantity of water trickling into the ditch and flowing onto the wellsite.

1. Take steps to ensure that water no longer has the opportunity to leave the creek bed at the GSC-16 creek crossing and therefore can not re-enter the ditch.
2. Repair the eroded ditch.
3. Determine whether or not water is entering the ditch from the muskeg and migrating to the river. If this is the case take permanent measures to ensure that this stops.

1. Repair the surface erosion located to the east of the vehicle bridge approach.
2. Ensure that the approach to the river and the bridge approach are well seeded and a grass catch established as soon as physically possible.
3. Take steps to permanently prevent water and silt from the ditch and right-of-way from reaching the river in the future.

1. Repair the eroded ditch.
2. Take steps to prevent the creek from overflowing its bank upstream of GSC-29.
3. Remove the old diversion ditch that helped the water to enter the ditch.

4. Take steps to prevent the creek from overflowing it's bank and entering the right-of-way approx. 200 meters from the bridge.
5. Take steps to prevent the silt, that has accumulated in the creek bed from the r-o-w to the river, from entering the river. This may include establishing vegetation as well as other erosion control measures.

1. Repair the eroded ditch.
2. Take steps to prevent the water from entering the ditch at the top end of the slope.
3. Ensure that vegetation is established as per permit conditions number 65 and 66.
4. Determine if water has been (or still is) moving along the bottom of the ditch for most of the length of the slope. If it is rectify the matter.

1. Repair the eroded ditch.
2. Take steps to permanently prevent the drainage from entering the ditch.
