Giant Mine Mill Conveyor Demolition

1.0 Rationale for Demolition

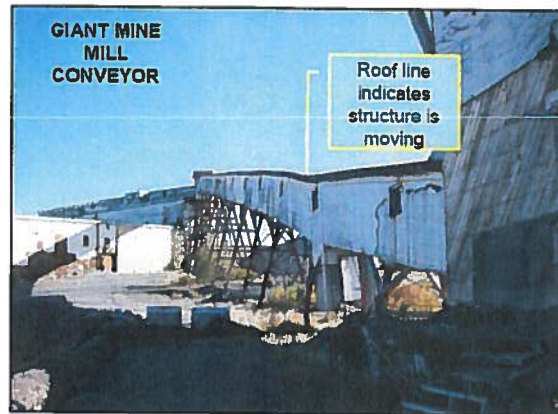
Figure 1: Roof Line of Giant Mine Mill Conveyor

- Evidence of settlement of the roof line is visible.
- Exterior tar paper siding is damaged and is being wind blown off the structure leaving the underlying bare wood structure to be exposed to the weather.
- Movement of the A-frame support legs is visible. Some of the legs have twisted or moved perpendicular to the plane of deflection.
- Several wooden grade level ties located between the A-frame legs have been damaged or have moved from their original position.
- Concrete foundation supporting legs have cracked which has decreased their ability to support a vertical load.
- There has been lateral movement of the elevated gallery. This indicates there is a lack of longitudinal stability of the overall structure.
- The supports are very close to an active service road, there are no means of traffic protection (vehicles, snowplough) for the A-frame legs.

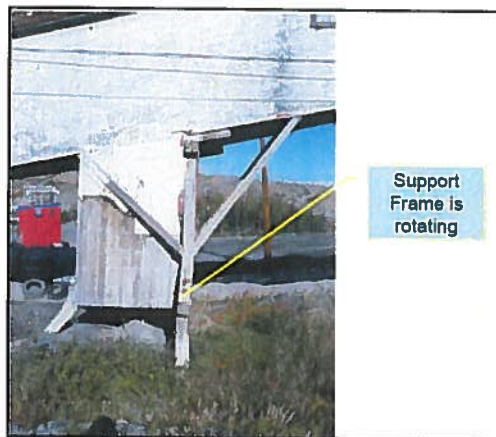
Figure 2: Rotating Support Frame

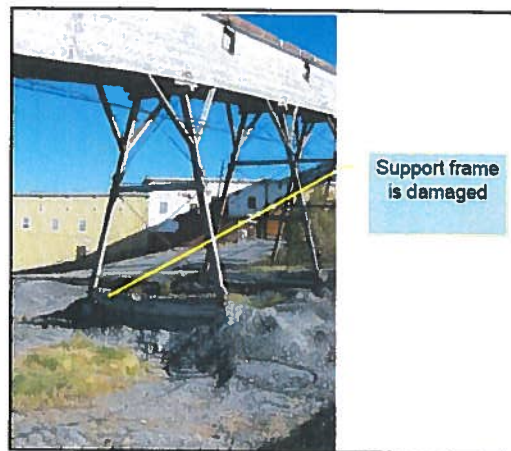
Figure 3: Damaged Support Frame

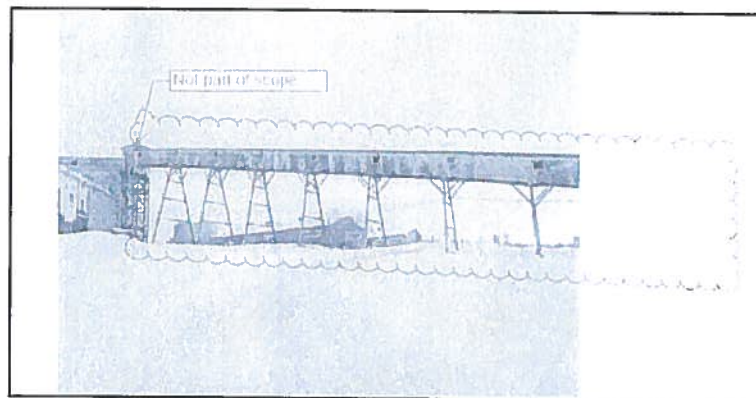
Figure 4(a): Targeted section of the mill conveyor for demolition
Courtesy of Deton'Cho/Nuna Join Venture

The work entails the complete demolition of the mill conveyor but not the adjoining structures (Figures 4a and 4b). Specifically, the work will include but not be limited to the following:

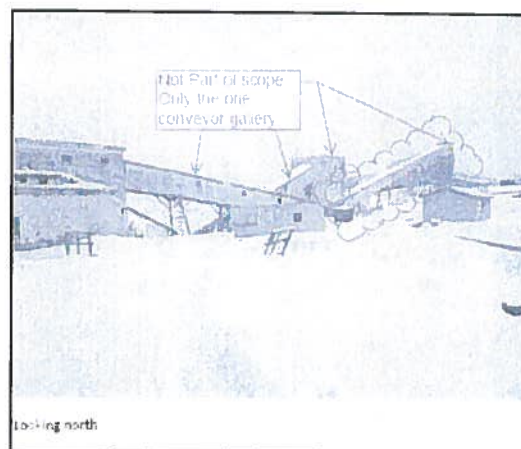
Figure 4(b): Infrastructure surrounding the mill conveyor
Target conveyor section is circled
