**DATE** February 1, 2012**PROJECT No.** 09-1427-0006/20000/20100**TO** Dave Colbourne  
DXB Projects / PWGSC**AECOM DOC. No.** 000-GEN-0-MEM-0007-Rev1\_20120201**CC** Rudy Schmidtke, AECOM**GAL DOC. No.** 156**FROM** Darren Kennard and John Hull**EMAIL** dkennard@golder.com; jhull@golder.com**PUBLIC ACCESS CONTROLS ABOVE NON-ARSENIC STOPE 2-01 COMPLEX NEAR A2 OPEN-PIT,  
GIANT MINE REMEDIATION PROJECT****1.0 NON-ARSENIC STOPE 2-01 COMPLEX CROWN PILLAR STABILITY  
ASSESSMENT**

Project title/Titre du projet  
**GIANT MINE  
REMEDATION PROJECT  
YELLOWKNIFE, N.W.T.**

Drawing title/Titre du dessin  
**POTENTIAL SURFACE SUBSIDENCE  
2-01 STOPE AREA, A2 PIT,  
RECOMMENDATION FOR FENCE  
TO ADDRESS PUBLIC HAZARD**

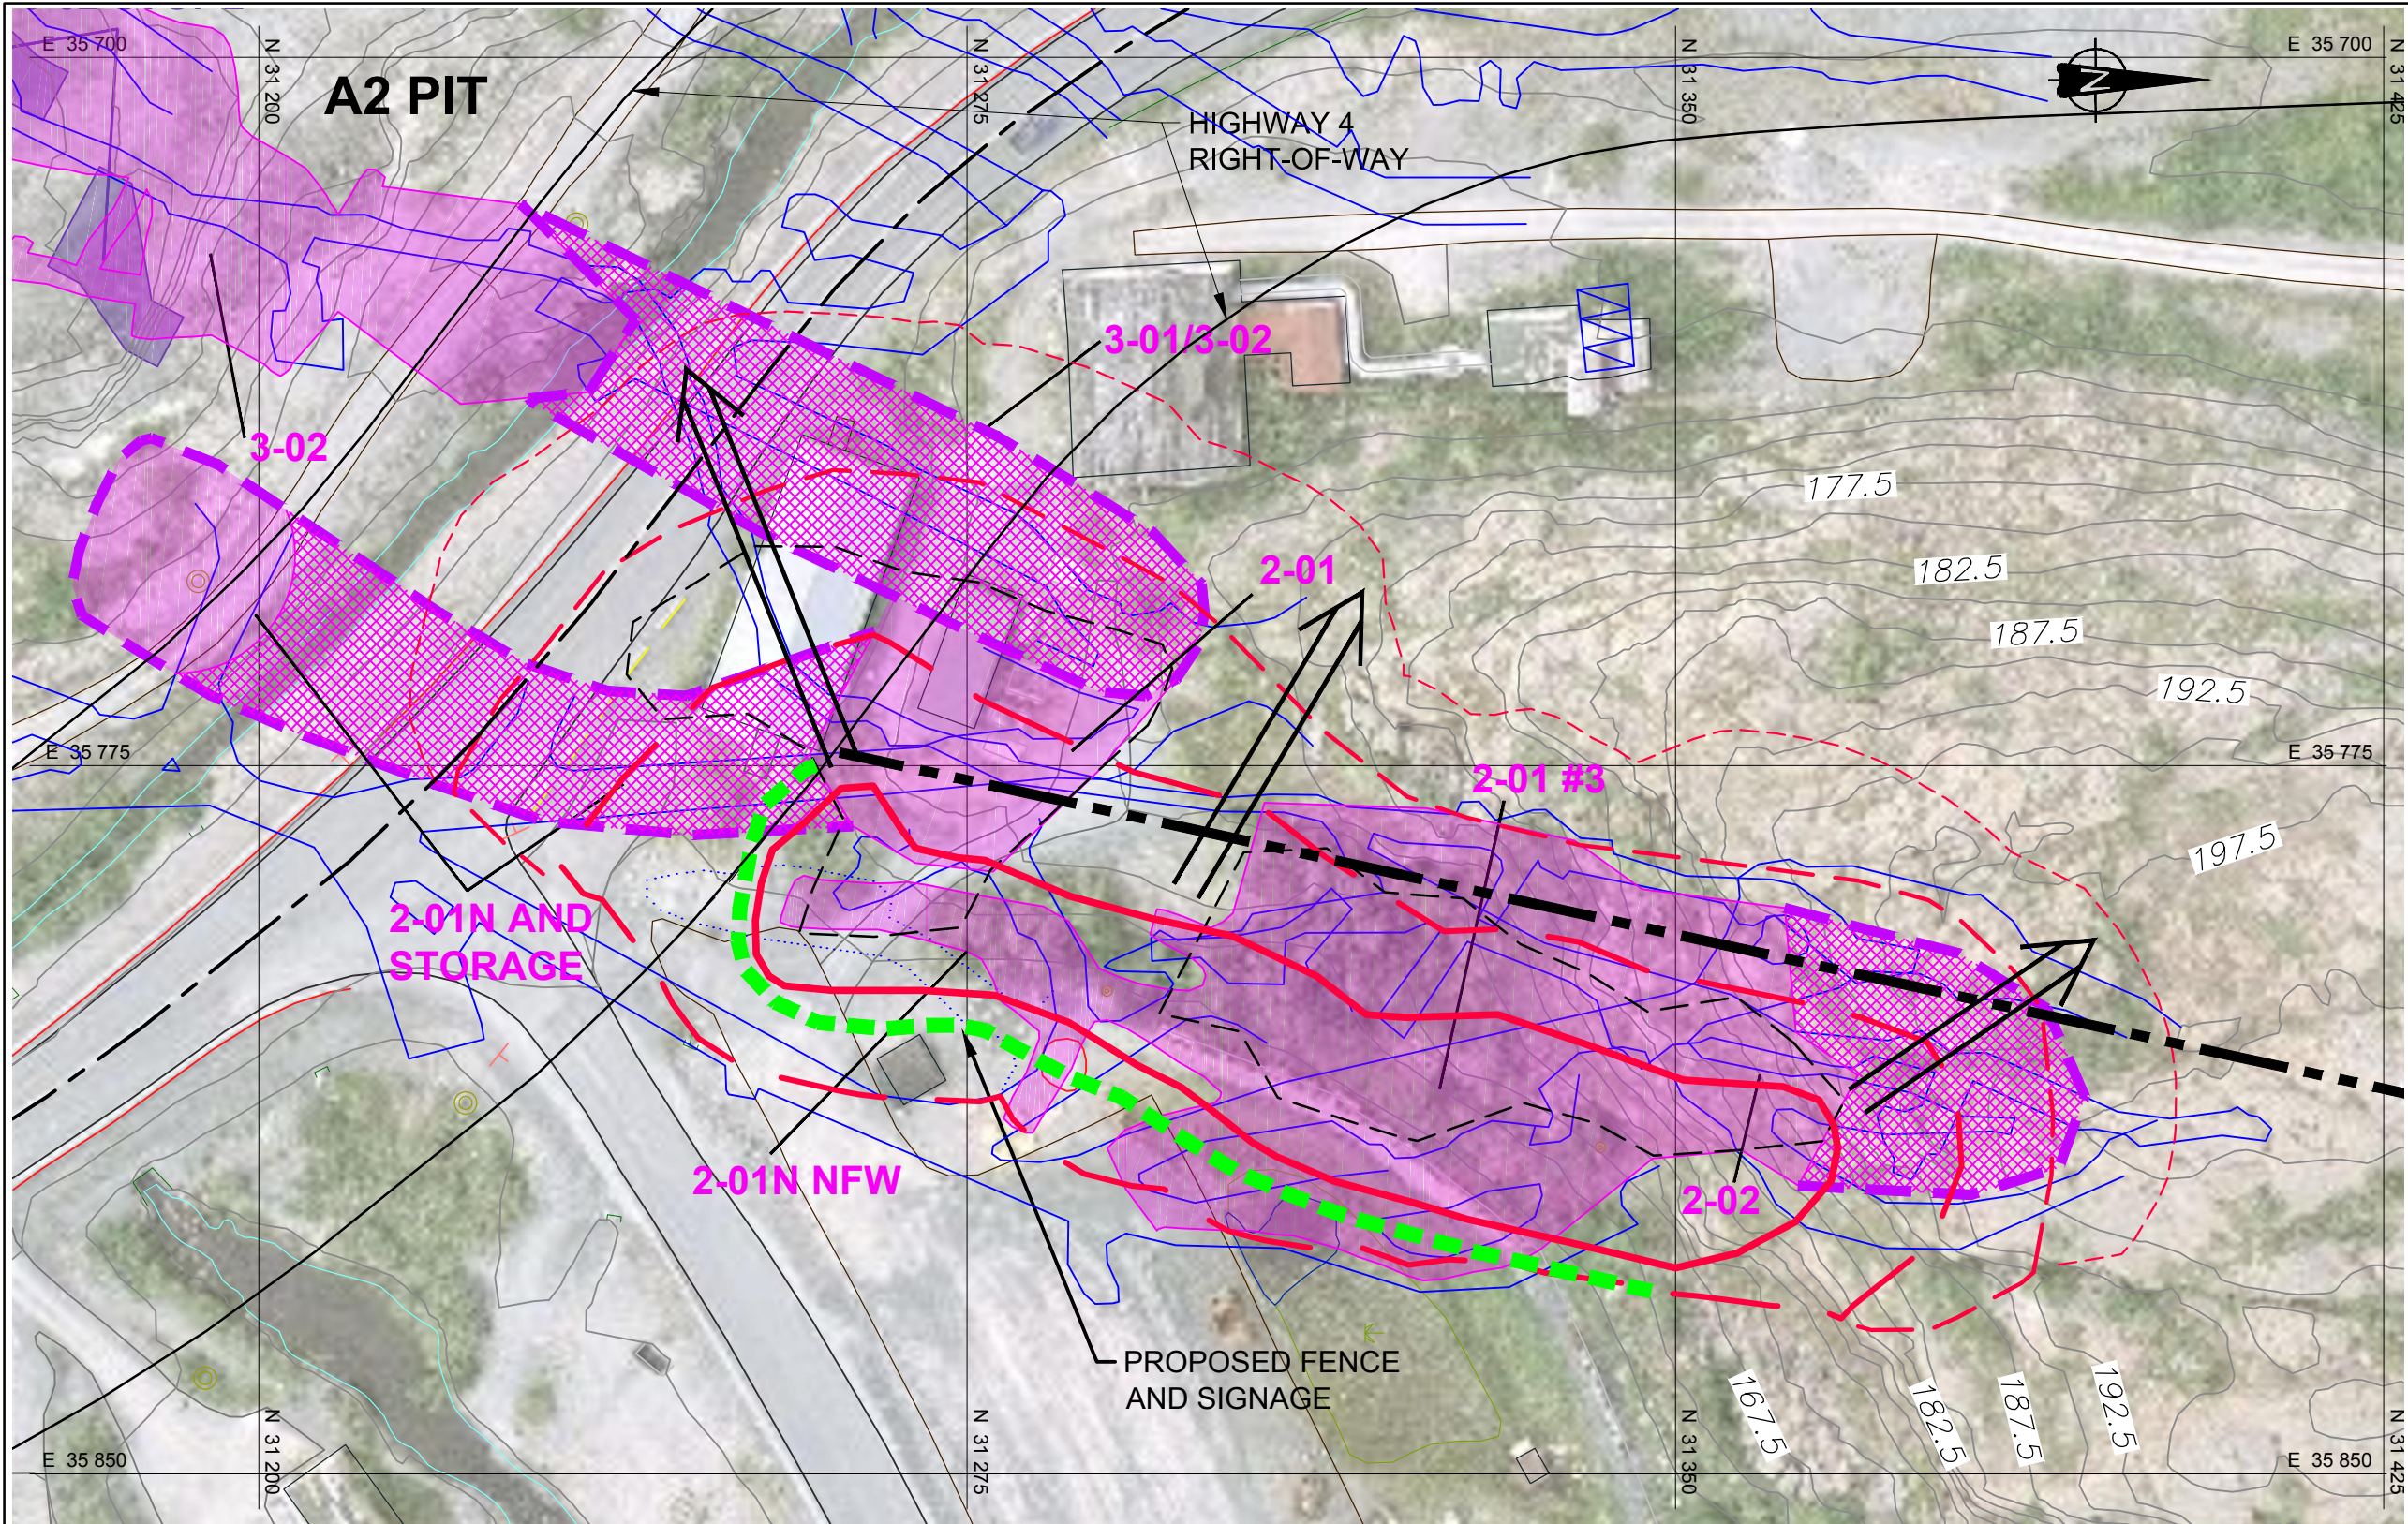
| Project No./No. du projet<br><b>R-014204-320</b> | Sheet/Feuille<br><b>FIGURE 2</b><br>OF 2 | Revision no./La Révision no.<br><b>1</b> |

Golder's work included an assessment of the probability of failure of the crown pillar(s) above a series of non-arsenic stopes commonly referred to as the '2-01 stope complex' which are situated north of the A2 open-pit, adjacent to Highway 4, and partly inside the Giant Mine town site boundary (see Figure 2). The stopes in this area underlie or are near to publicly accessible areas (e.g., parking lot) and historical mining equipment pieces associated with the NWT Mining Heritage Society.

The predicted probability of failure of the rock crown pillar over several individual stopes in the 2-01 stope complex area for anticipated typical stope geometry and rock mass quality conditions was: 1% (2-01 NFW stope), 5% (2-01 #3 stope), and 19% (2-01 stope). Worse conditions could prevail due to the inherent variability of the mechanical properties of the rock mass and the complex geometry of the crown pillar and the remnant rock pillars in the stope themselves. Further, there is a significant amount of soil overburden over the rock crowns but the geology of these materials, which may contain significant amounts of fill, is not understood.

A large bedrock knob dominates the north-western portion of the 2-01 stope complex area and any crown pillar failures under it would likely choke off quickly resulting in minimal surface impact. The area of concern is related to the flat portion of the site southeast of the main 2-01 stope complex area where the crown pillars are the thinnest. Figure 2 shows the zone with the highest potential for surface subsidence due to crown pillar failure with associated lines of decreasing probability of failure away from it. Any crown pillar failure would be expected to manifest itself initially within the highest probability of failure zone with potential gradual progression outwards.

Golder recommends that public access to the area above non-arsenic Stope 2-01, 2-01 NFW, and 2-01 #3 near the highest probability of crown pillar failure zone be restricted as soon as practical. A typical solution could include erection of a fence near the outer edge of the zone of highest probability of subsidence to buildings and natural topographic barriers.

Figure 2 shows an example fence location that would dissuade casual public access over the area of concern. The southern portion of the fence should start at the northeast corner of the Exploration Shed; then pass west or behind the Heritage Building, and east of and parallel to the tracks holding the historical mine pieces. The fence should finally cross the tracks to intersect the steep bedrock topography at the northern end of the fence indicated in Figure 2. Appropriate signage to inform the public of the undermining hazards beyond the fence should be erected.

The use of a temporary fence (e.g., orange snow fence) and appropriate signage would be considered appropriate for the winter of 2011/2012 but a permanent fence should be installed as soon as practical in the spring of 2012.
