ISSUED FOR USE
2009 GEOTECHNICAL INSPECTION OF AIRSTRIP, APRON AND ACCESS ROAD
YELLOWKNIFE GOLD PROJECT, NT

Y14101177

October 1, 2009

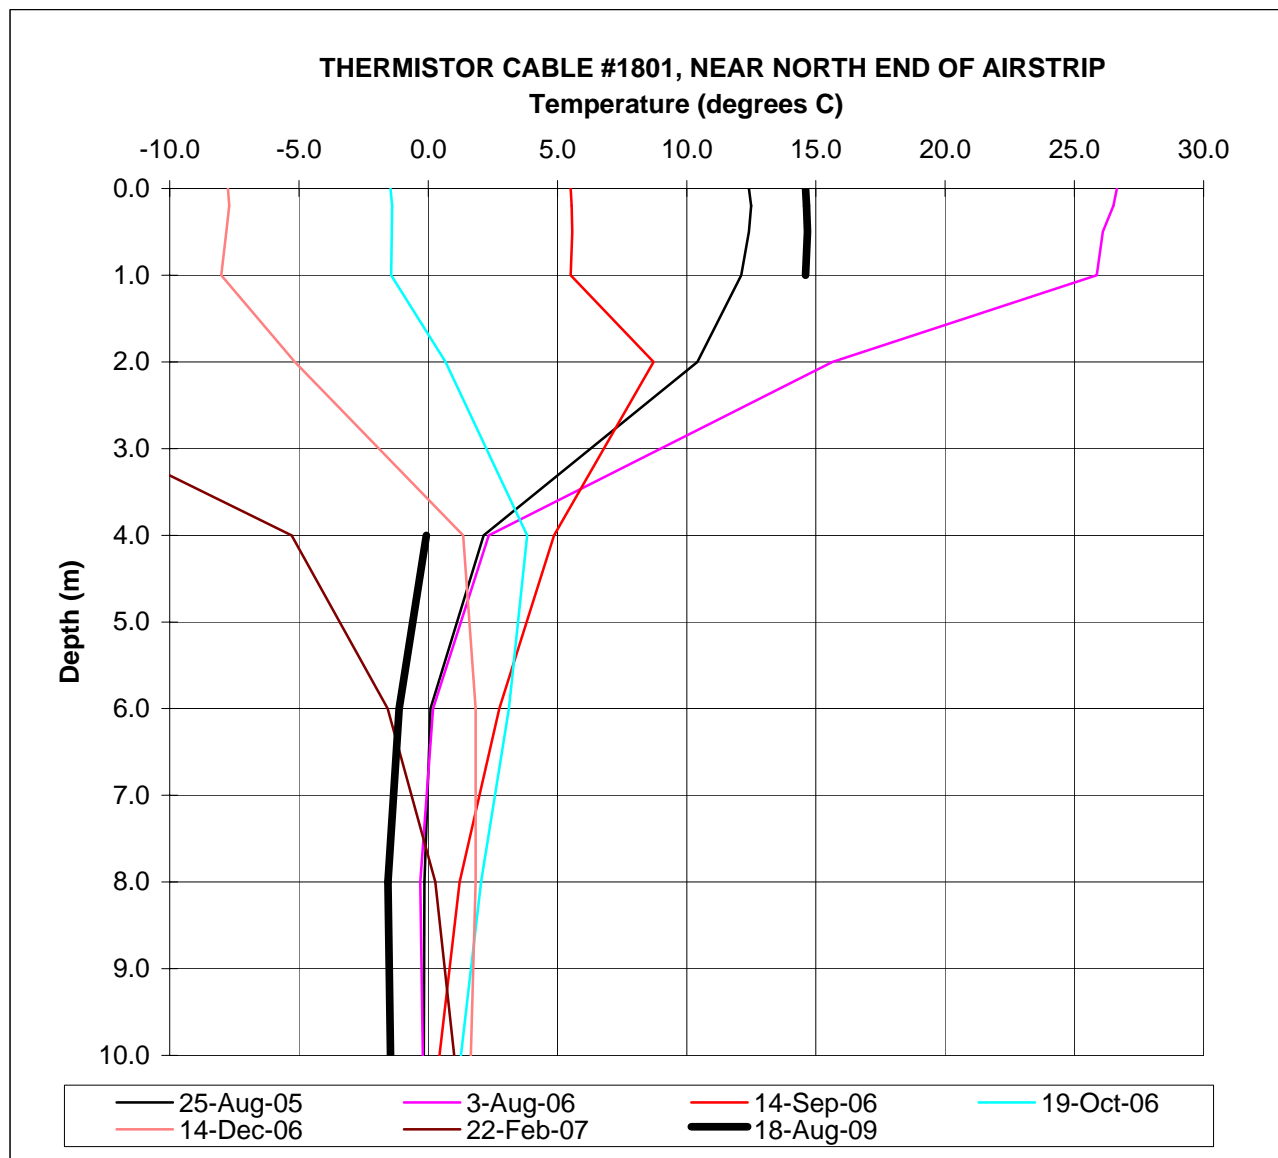
TABLE 4
TEMPERATURE MONITORING SUMMARY
THERMISTOR CABLE NEAR NORTH END OF AIRSTRIP
BOREHOLE 19; CABLE 1801
TYHEE, YELLOWKNIFE GOLD PROJECT

At the time of the August 2009 monitoring visit, the ground was frozen below a depth of about 4 m at the north end of the airstrip (Borehole 19; Table 4) and below a depth of about 3 m at the south end of the airstrip (Borehole 21; Table 6). This should not be interpreted to mean that there is permafrost at these locations. The ground at depth will continue to warm into the fall, so ground temperatures will likely rise above 0 °C.

Note: Cable destroyed by snow clearing after February 22, 2007; read wires in August 2009.

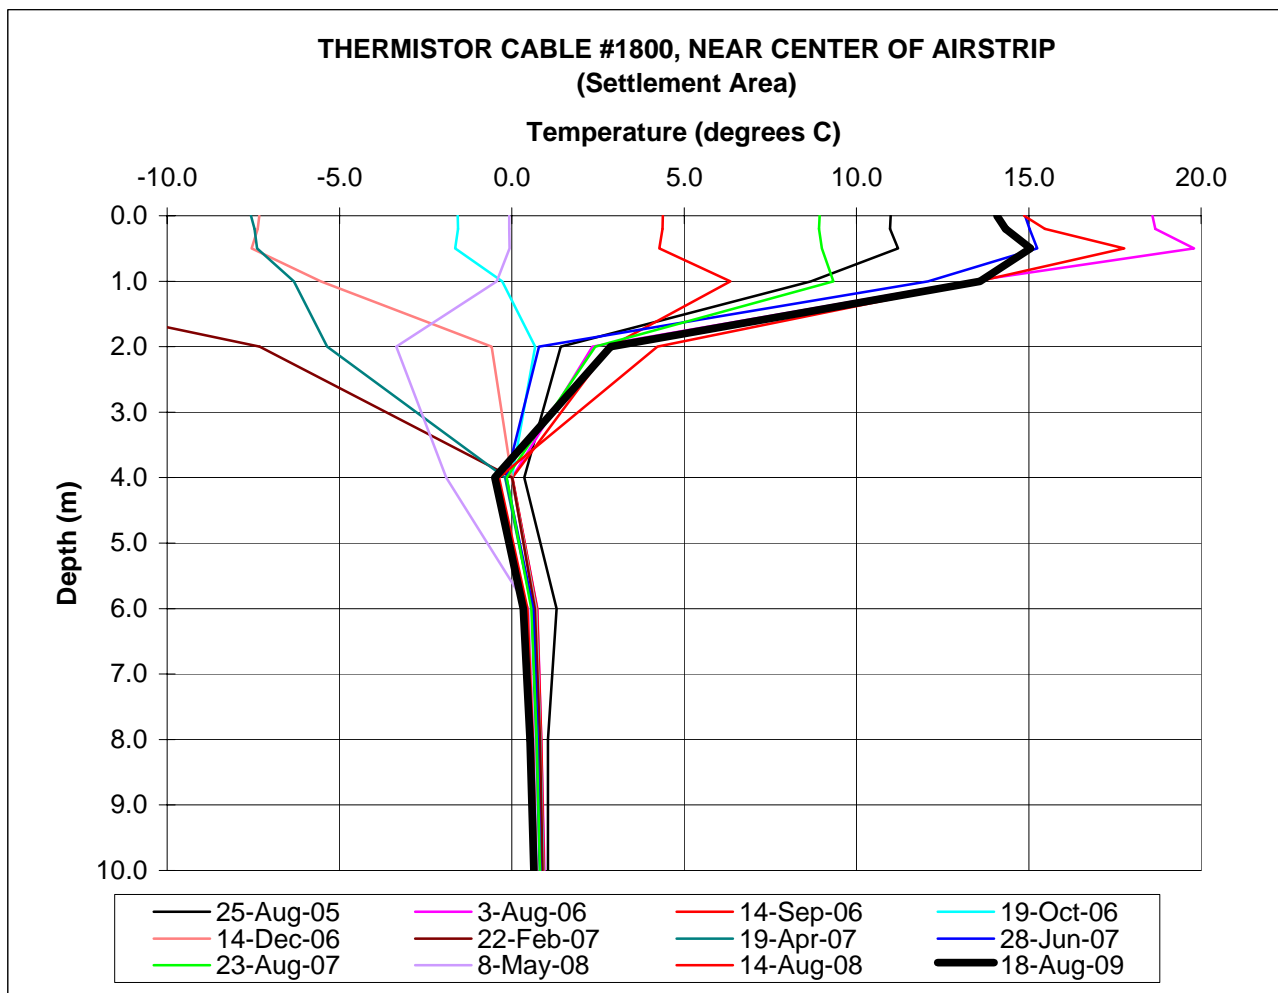
TABLE 5
TEMPERATURE MONITORING SUMMARY
THERMISTOR CABLE NEAR CENTER OF AIRSTRIP
BOREHOLE 20; CABLE 1800
TYHEE, YELLOWKNIFE GOLD PROJECT

This cooling effect is most pronounced at the location of Borehole 20 near the centre of the airstrip (Table 5). The deepest sensors at that location all indicate progressive cooling since the cable was installed. This is the area of past settlement, which was attributed to thaw of permafrost. As the ground settled, by moisture draining away, the capacity of soil moisture to buffer seasonal temperature fluctuations diminishes, permitting the ground to gradually cool.

Note: Cable destroyed by snow clearing prior to May 7, 2009; read wires in August.

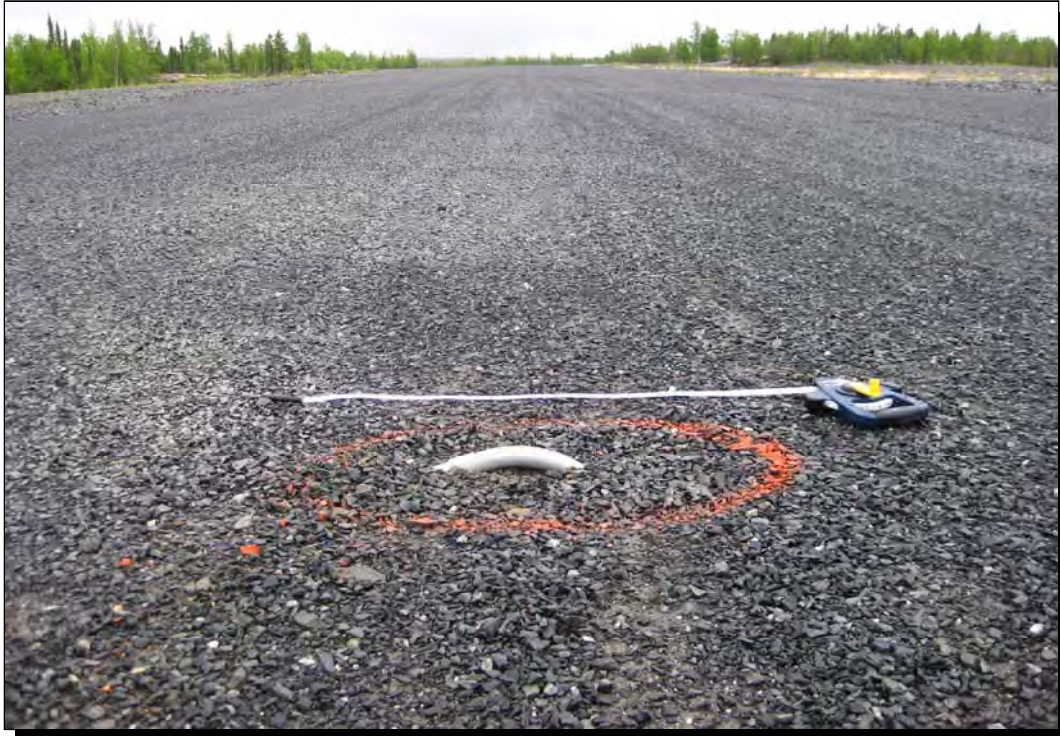
Photo 1

In early August, the thermistor casing at Borehole 20, near the centre of the airstrip, began to appear through the gravel surface (Photo 1). The area around the casing was exposed during the August monitoring visit (Photo 2), to attempt to find an explanation. The conclusion was that the upper portion of the casing was likely raised by frost-jacking, and then exposed by reworking of the surface gravel from grading and aircraft traffic.

Area of exposed thermistor casing, at the location of Borehole 20, looking south

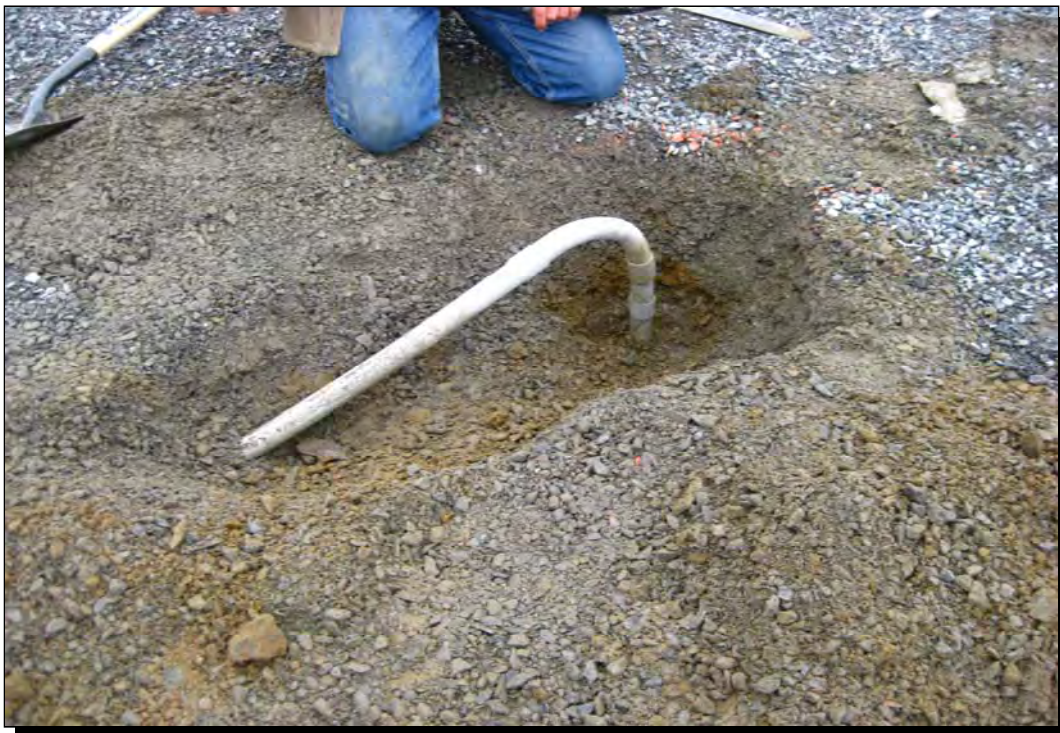
Photo 2

Area around thermistor casing at Borehole 20, dug up

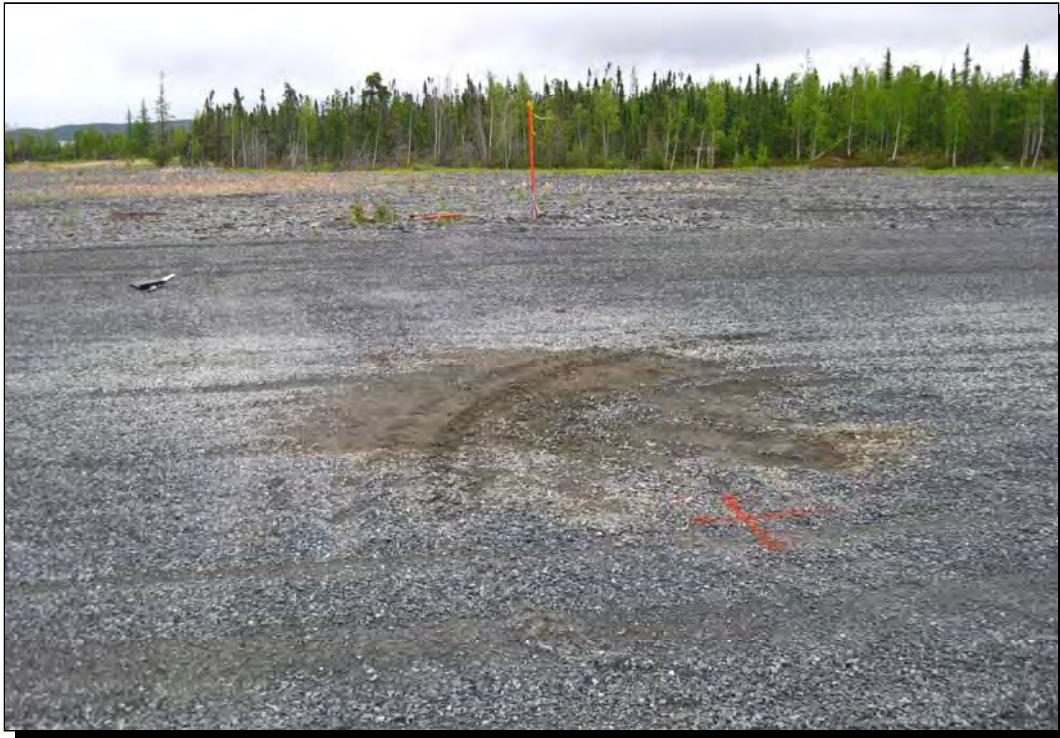
Photo 3
Location of Borehole 20, following burial of thermistor casing, looking east

The casing was heated, laid over on its side, and buried, about 0.3 m deep (Photo 3). This should not impact the operation of the thermistor cable, nor future airstrip maintenance activities.

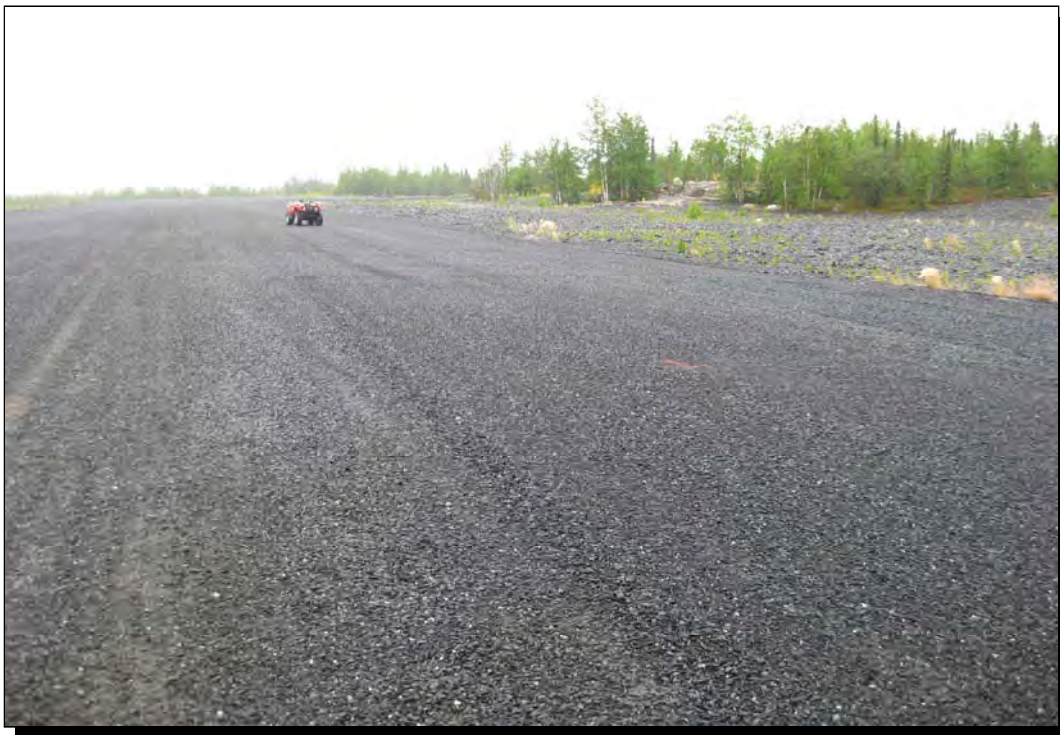
A new area of settlement developed along the west half of the airstrip, over the summer (Photo 4). It is about 290 m from the south end of the airstrip. It impacts an area about 30 m long and 10 m wide. There has been about 0.1 to 0.2 m of settlement in this area. The cause is unknown, but it could be attributed to localized permafrost thaw, perhaps in response to the generally increased groundwater levels, and associated flow, in 2008 and 2009.

Photo 4
Looking south at settlement area, about 290 m from south end of airstrip
