**Date:** September 4, 2014  
**From:** John Wilcockson  
**To:** Dave Harpley, Canadian Zinc Corp  
**Subject:** All Season Road – Review of Stream Crossings in NNPR - DRAFT

HCP Ref No.: CZN6788

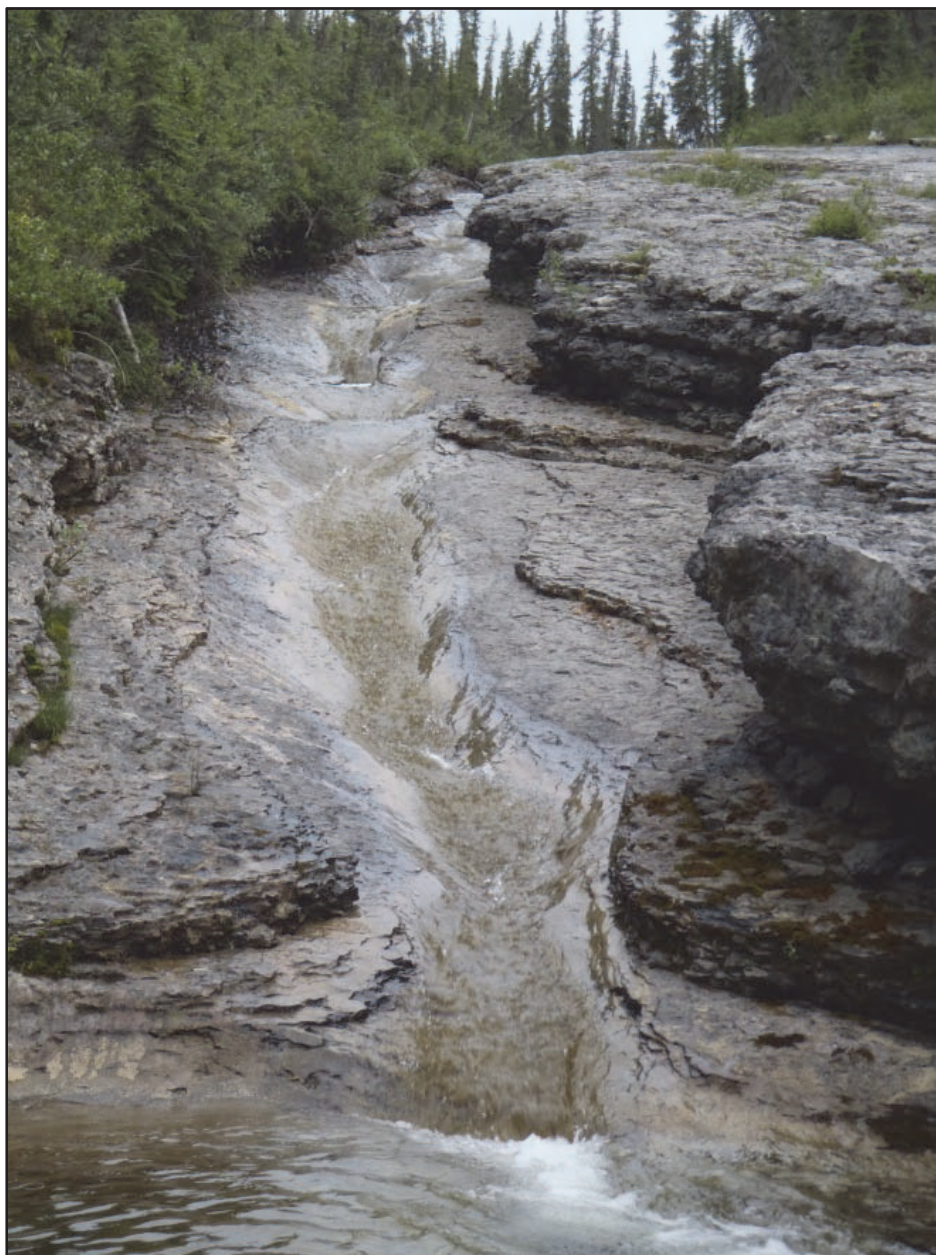
The crossing of this tributary to Sundog Creek occurs at km 43.5 of the proposed all season road (based on the LiDAR sheets reproduced by Allnorth). On July 27, CZN and Parks conducted a ground assessment of a 900 m section of the creek downstream of the crossing. There is a prolonged section of 10° to 12° slope over bedrock (Figures 1 to 4). The formation resembles a chute, with minimal back eddies or pools. While it would not be impossible for a fish to swim upstream during flood conditions, it is unlikely. Therefore, this feature is assumed to preclude

fish passage. Upstream of the chute, the habitat for fish improves, the gradient decreases and there are numerous pools, overhangs, backwaters and boulders. In this area, substrate consists primarily of bedrock, cobble and gravel. In 2005, electrofishing was conducted of a 40 m section of this reach and no fish were found (Bathurst 2005<sup>1</sup>). During the current investigation, CZN and Parks staff conducted additional electrofishing over a 300 m reach and also found no fish. These results indicate that the creek section downstream of the proposed road crossing is likely inaccessible to fish.

**Figure 1** Upper chute on tributary to Sundog looking south (upstream), July 27, 2014.

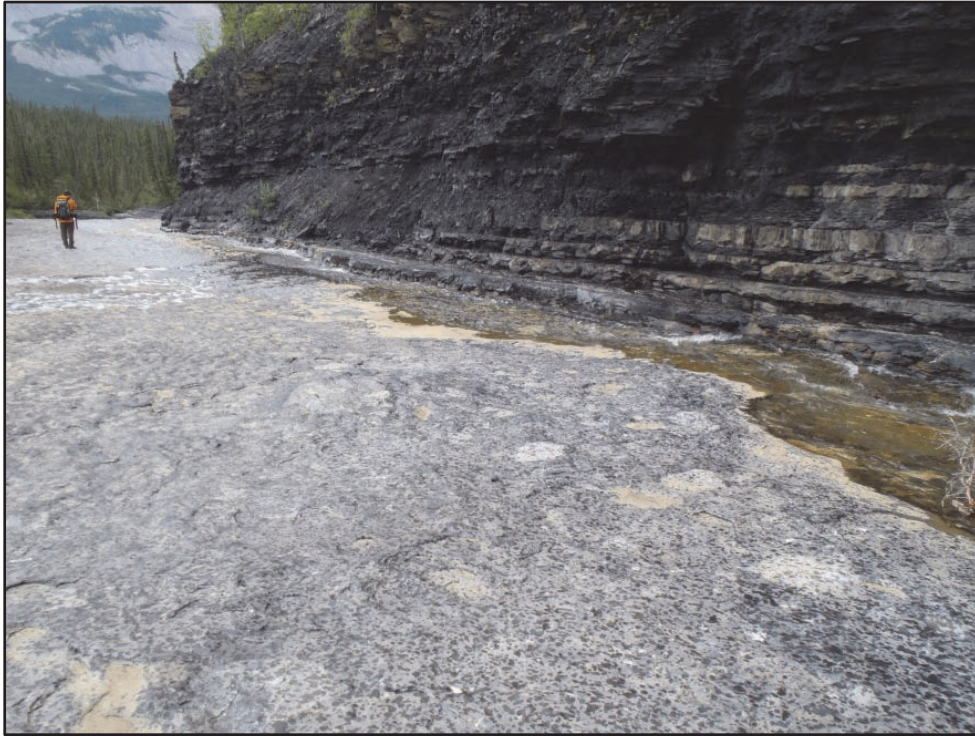
**Figure 2** Flow over bedrock against cliff on tributary to Sundog, looking north, downstream, July 27, 2014.

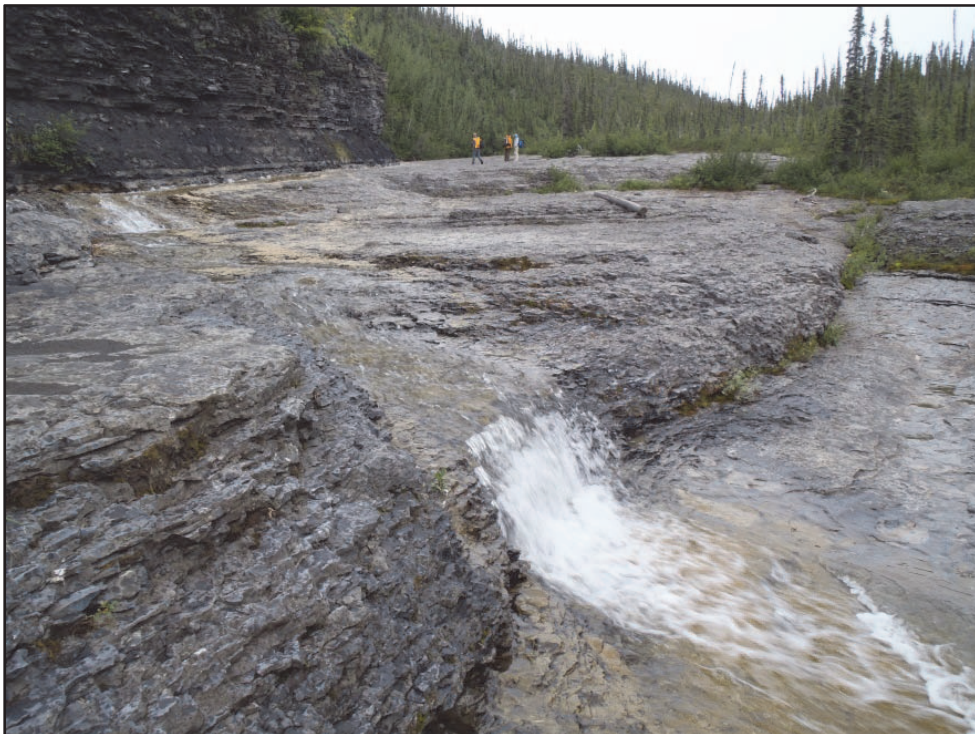
**Figure 3** Small cascade on tributary to Sundog, looking upstream, south, July 27, 2014.

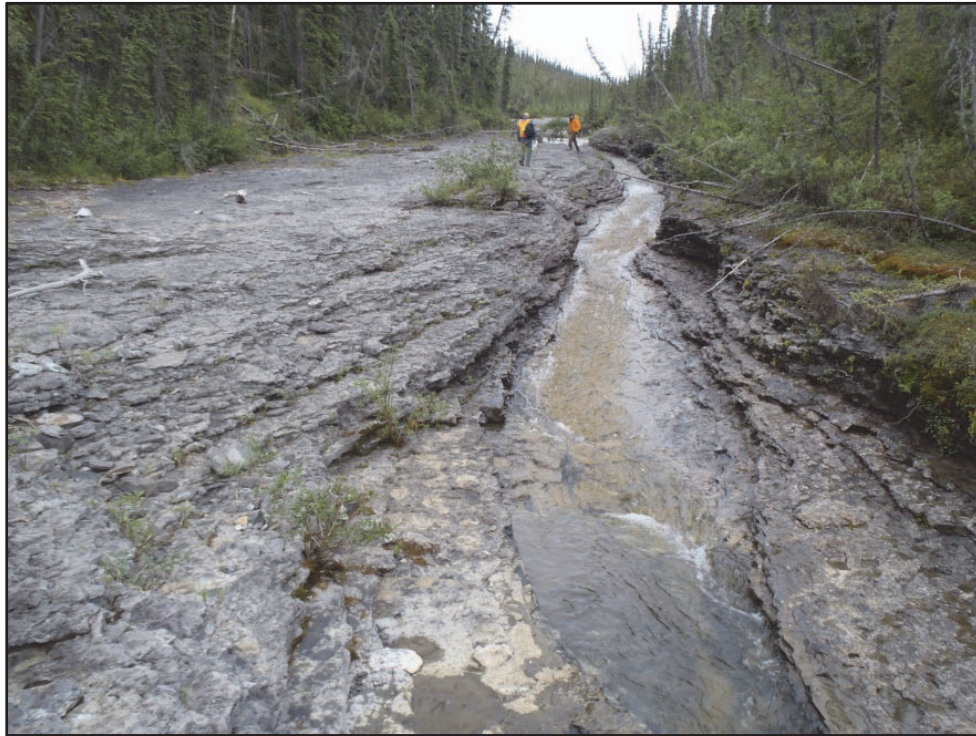
**Figure 4** Lower chute on tributary to Sundog, looking upstream, south, July 27, 2014.

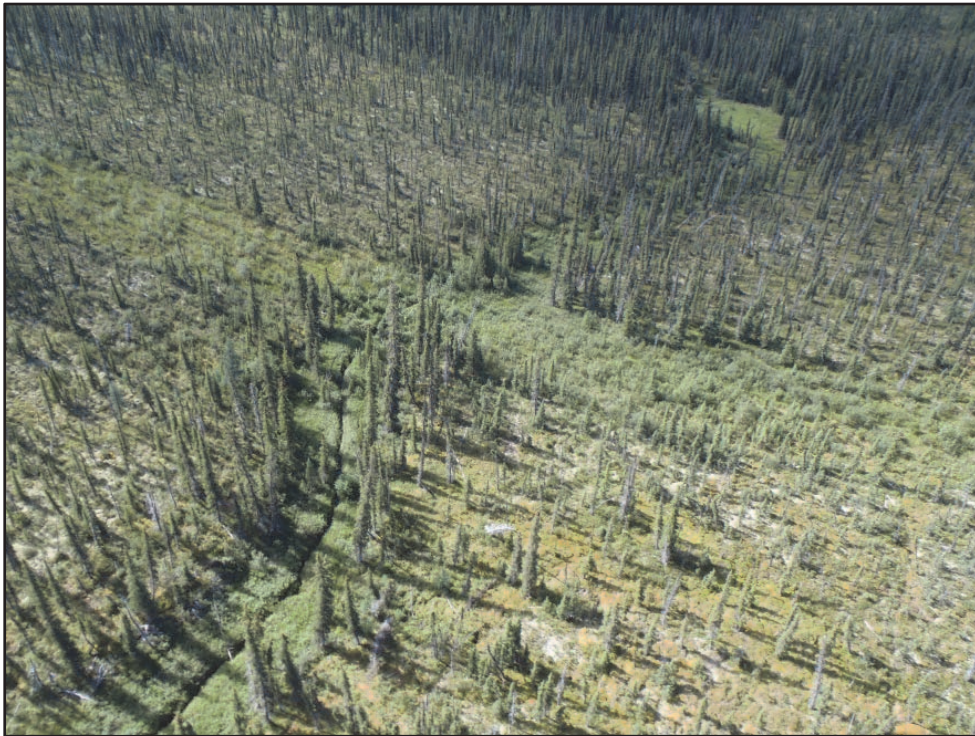
West of the Polje Creek crossing, the proposed road alignment travels along the side of a hill (km 45 to 53) and crosses several small tributaries of Polje Creek that were viewed from the air (Figure 5, 6 and 7). There were five small creeks with defined channels, and the locations of four of these are shown on the drawing provided as Attachment 1. The largest creek appeared to have a width of approximately 1.5 m. Ground-based assessments will need to be conducted on these creeks; however, observations from the air indicate that habitat upstream of the proposed crossing would be limited by flow as a result of the close proximity to the creek headwaters. The creeks with defined channels are located at km 46.7, 47, 49.3 and 54.3.

**Figure 5** Creek near km 47 (waypoint 37 on Attachment 1), tributary to Polje Creek, looking downstream, south, July 28, 2014.

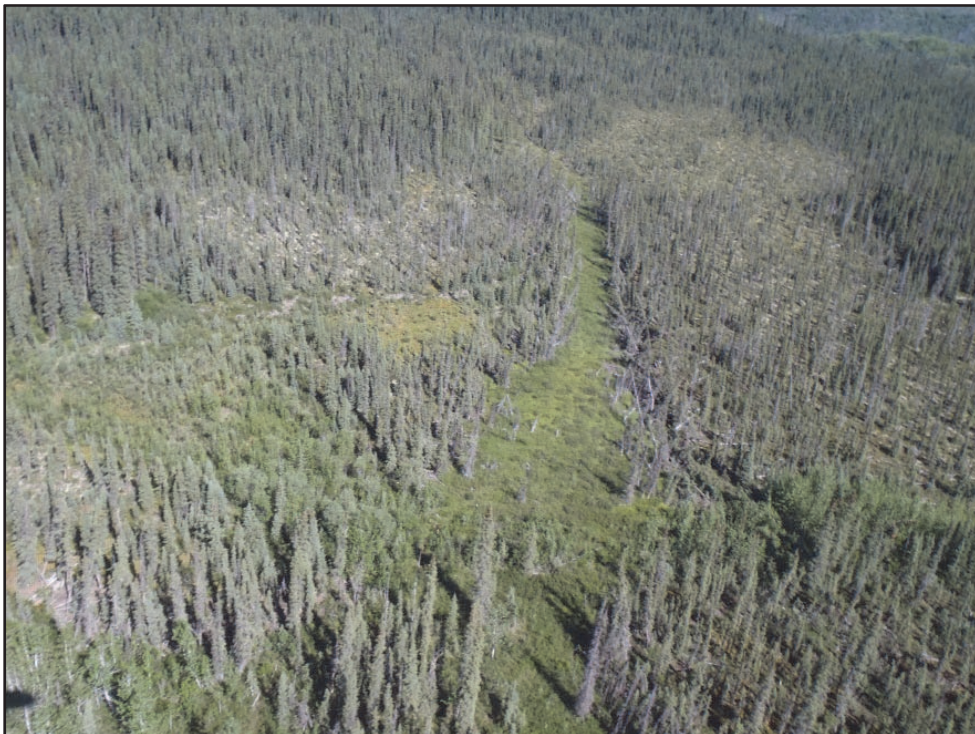
**Figure 8** Creek near km 49 (waypoint 34 on Attachment 1), tributary to Polje Creek, looking upstream, north, July 27, 2014.

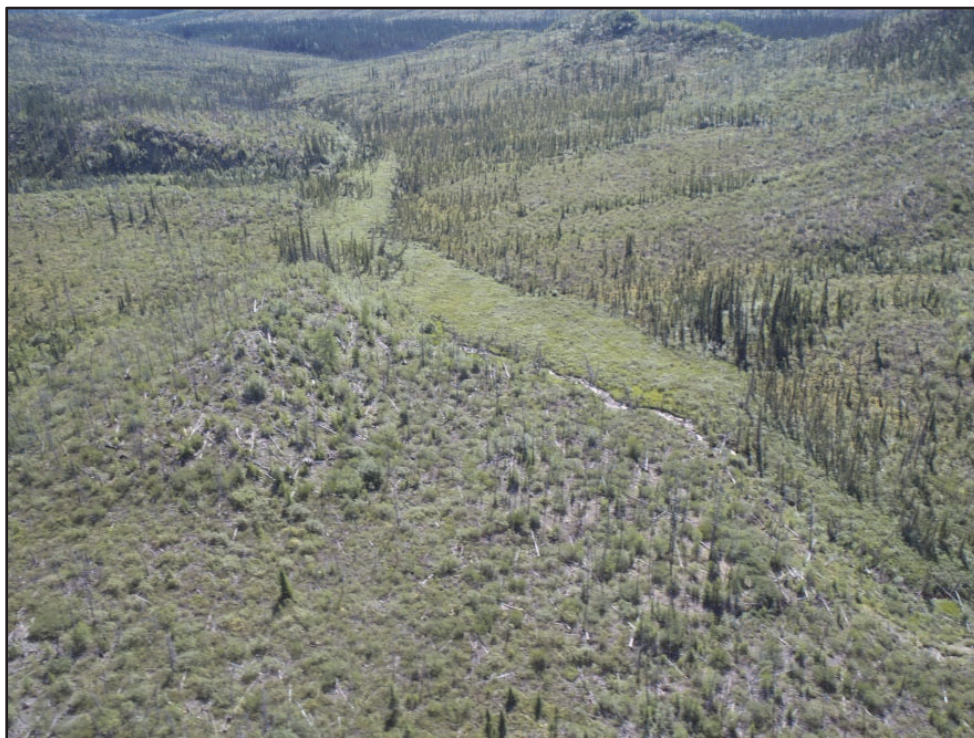
**Figure 9** Creek near km 50 (waypoint 33 on Attachment 1), tributary to Polje Creek, looking downstream, south, July 28, 2014.

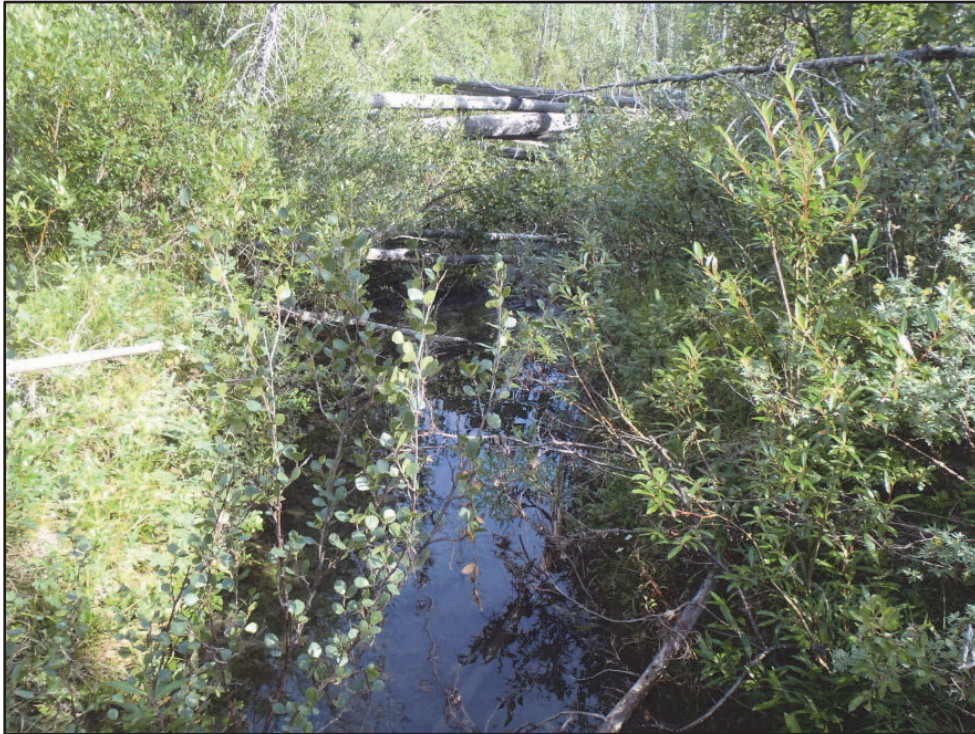
A ground-based assessment was conducted on the Polje Creek Crossing and two smaller creek crossings to the west. Both of the smaller creeks were identified as tributaries to Polje Creek. The first tributary west of Polje Creek was small, having an average wetted width of 1.5 m; however, water quality appeared to be good, and there was abundant surface cover for fish (Figure 10). The second tributary, further to the west, did not have a defined channel and flow, if present, would occur subsurface under a blanket of moss, small plants and buried, decaying logs (Figure 11). The second tributary would not provide suitable habitat for fish. Full habitat assessments were conducted on Polje Creek (Figure 12) and the first tributary to the west. Both contain good habitat for fish, including a “diversity of cover and habitat types including deep water pools, undercut banks, in-stream structure from overhanging vegetation and woody debris” (Dillon, 2009). Electrofishing was not conducted in Polje Creek as part of this reconnaissance investigation. During a previous survey, researchers were unable to capture fish and no fish were observed (Dillon, 2009<sup>2</sup>). Despite this, the investigators indicated that the creek is likely to support fish similar to those species found in Sundog Creek, and fish were found upstream previously.

**Figure 10** First Tributary to Polje Creek Crossing, looking upstream, north, July 28, 2014.

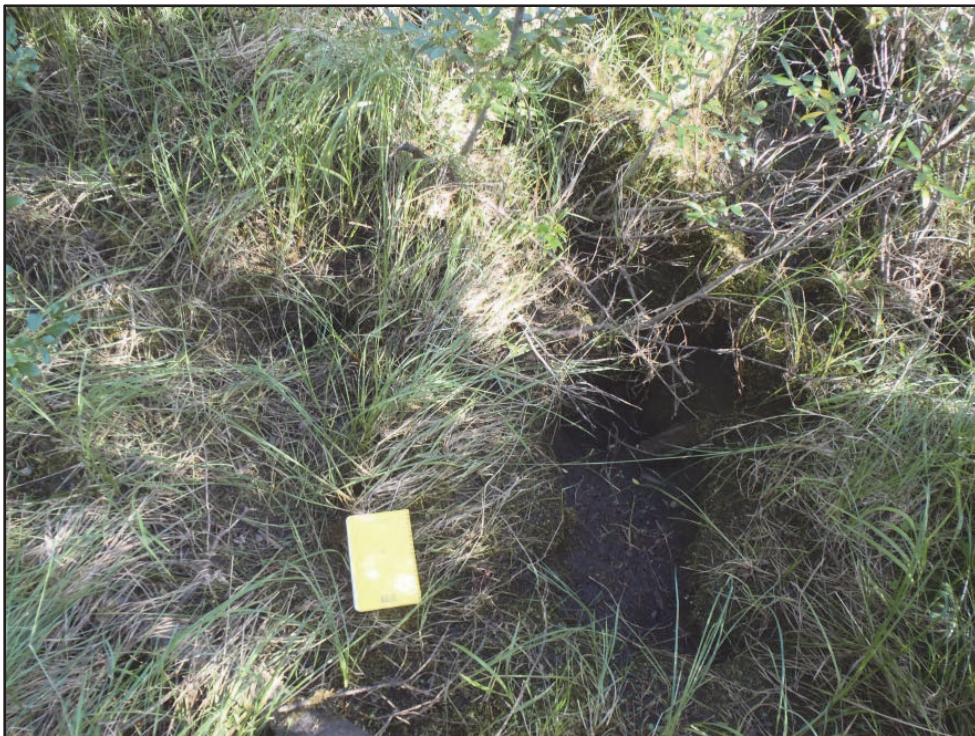
**Figure 11** Second Tributary to Polje Creek Crossing, looking south, July 28, 2014.

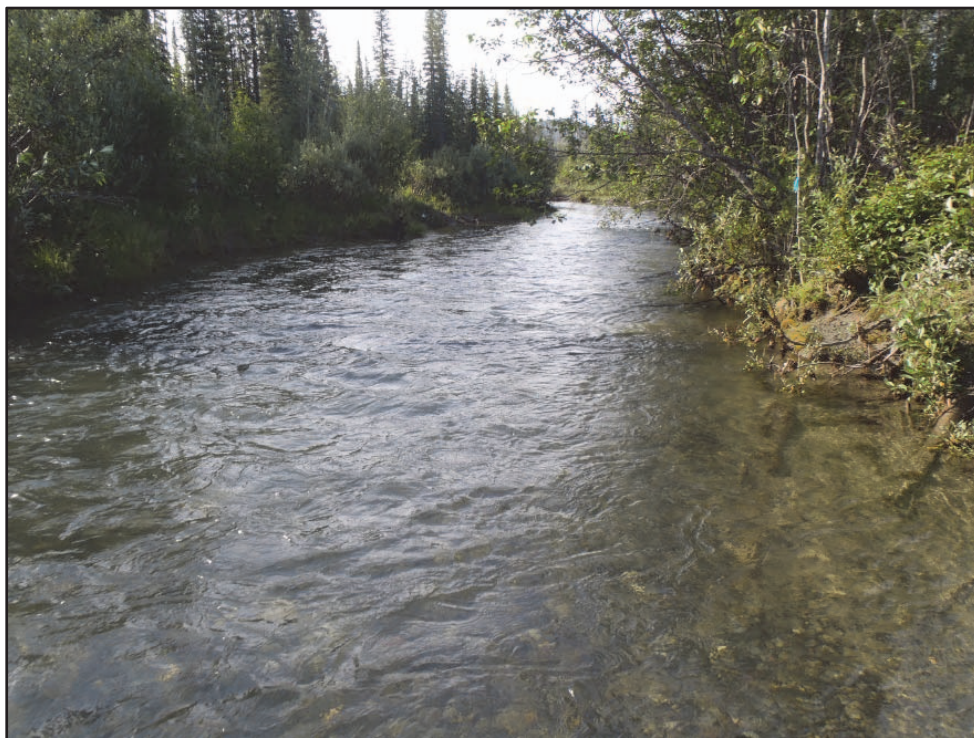
**Figure 12** Polje Creek Crossing Creek at km 49 (WP33), looking downstream, south, July 28, 2014.

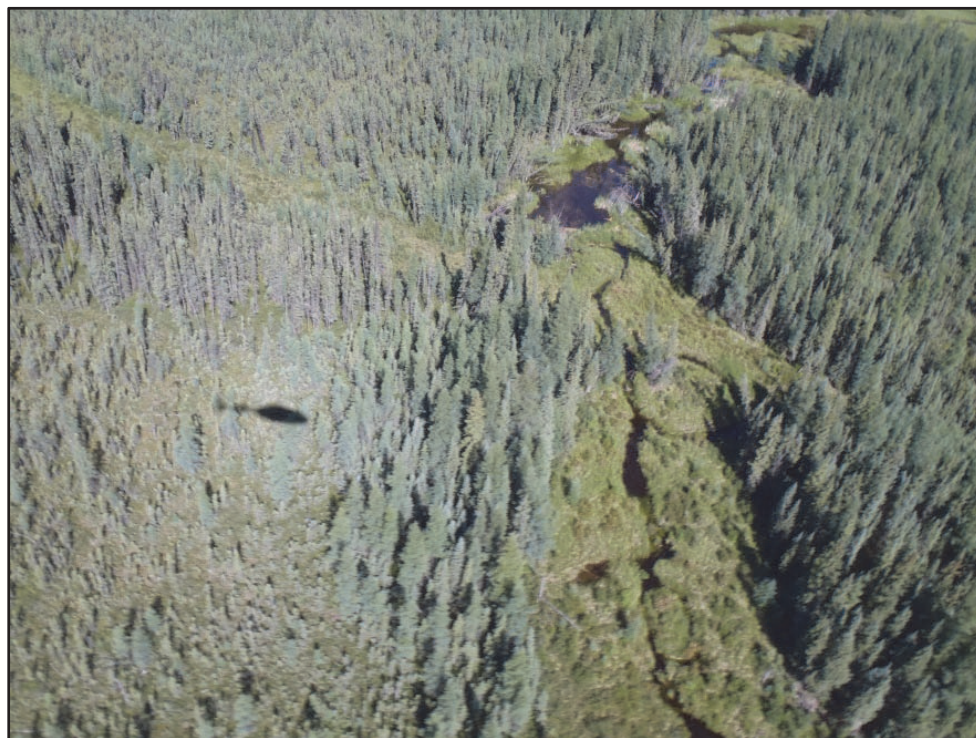
An air-based assessment was conducted of a small drainage area feeding into Mosquito Lake on July 28, 2014. Flow from Mosquito Lake is known to drain to the Poljes, which are considered to be inaccessible to fish. However, there is a possibility that Mosquito Lake hosts a resident population. From the air, the inflowing drainage appeared to enter a series of small wetlands (Figure 13). Channels were poorly defined and appeared to be low-gradient and filled with aquatic vegetation. It is considered unlikely that fish would use these inflow channels for migration. The habitat value of the wetlands appears to be similar to the littoral habitat, containing abundant aquatic vegetation. Therefore, due to the marginal, littoral-like habitat in the wetlands and channel, the inflow area is unlikely to provide any critical habitat to fish even if they are present in Mosquito Lake.

**Figure 13** Inlet of Mosquito Lake, looking downstream, north, July 28, 2014.

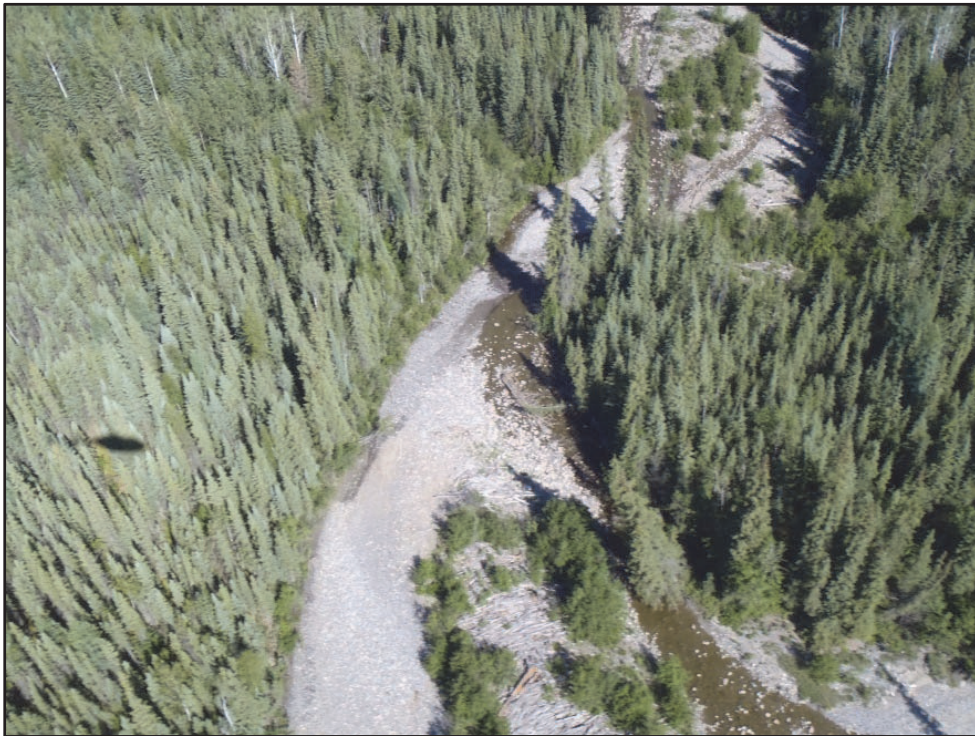
An air-based assessment was conducted on the two Tetcela River crossings. Tetcela River is a larger river: at the crossings, the river was about 15 m wide and appeared to provide relatively deep, run-type habitat (Figure 14 and 15). Water appeared to be tea stained and turbid. This river appears to provide good fish habitat. Fish surveys by Beak (1982)<sup>3</sup> and Rescan (1994)<sup>4</sup> recorded presence of Arctic grayling, whitefish, northern pike, lake chub, slimy sculpin, and longnose sucker.

**Figure 14** First Tetcela River Crossing, looking upstream, north, July 28, 2014.

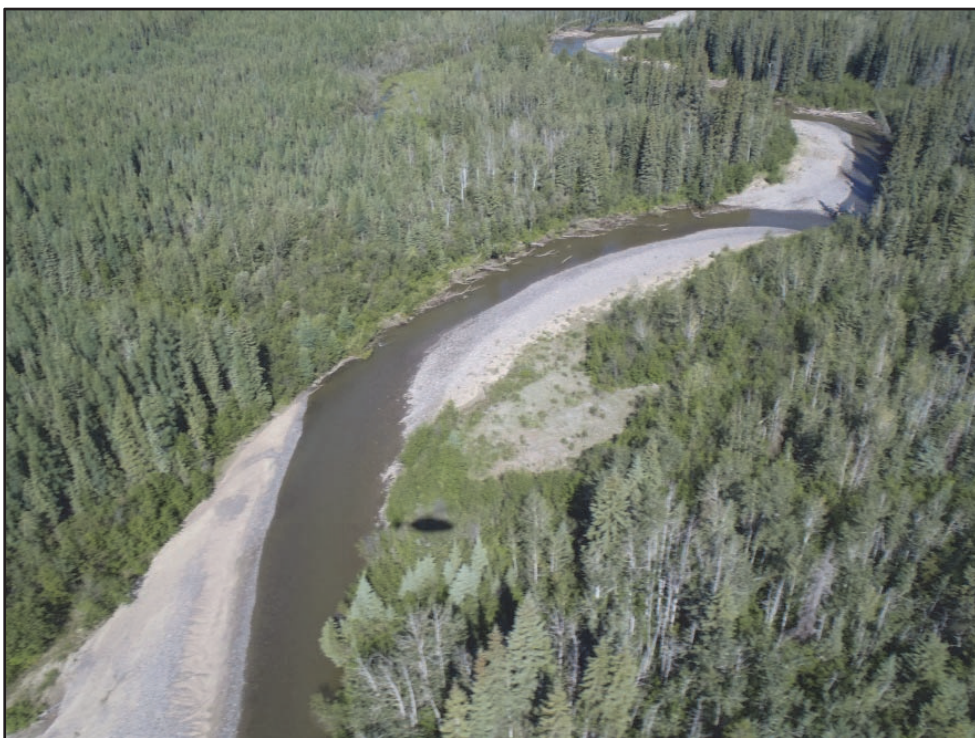
**Figure 15** Second Tetcela River Crossing, looking upstream, north, July 28, 2014.

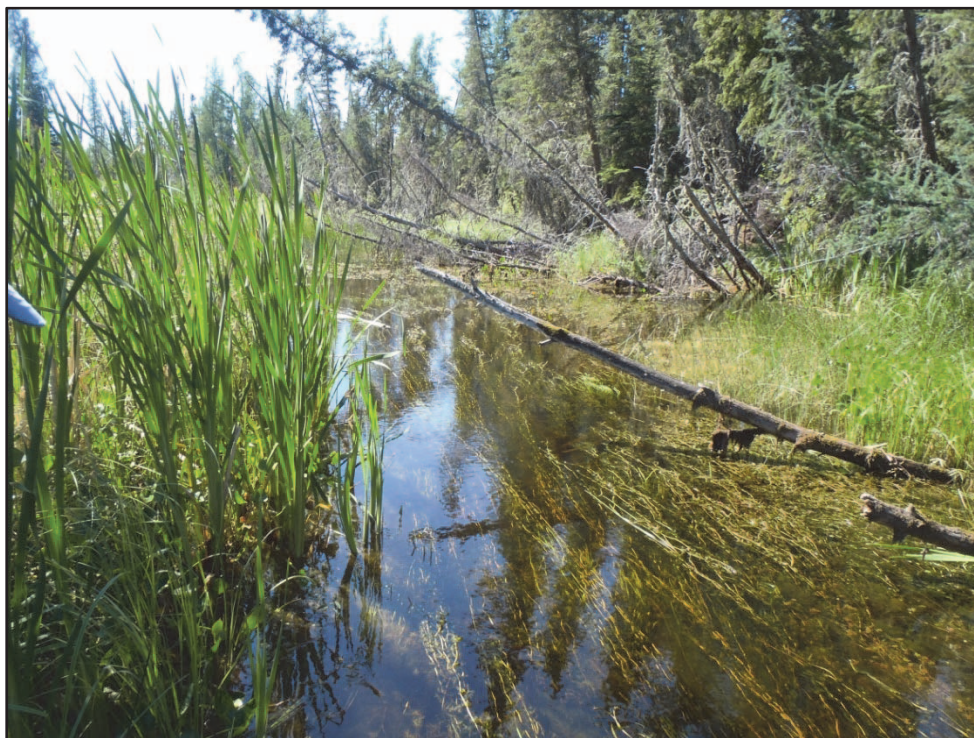
A ground-based assessment was conducted by CZN and Parks staff (Garry Scrimgeour) on July 28. Due to the boggy conditions, it was not possible to reach the crossing location from the landing site. However, a representative location, about 50 m upstream, was assessed. Fishtrap Creek in the area of the crossing consists of a series of ponds, many with beaver dams (Figure 16 and 17). Flow at the representative location was low and the channel was filled with aquatic vegetation. Water striders and aquatic snails were observed. Dissolved oxygen concentrations were adequate for fish (8.54 mg/L), but it is likely that DO levels drop significantly in this system at night when aquatic plants start removing oxygen from the water column. The high water temperature, 20° C, would also limit the types of fish that could survive at the site. Garry Scrimgeour believed the presence of water striders indicates either the absence or low abundance of fish, given these insects tend to be easy prey for fish. Observations indicate that Fishtrap Creek in the area of the all season road crossing, which is very near the upstream catchment boundary, provides poor habitat for fish. Electro-fishing by Beak (1982)<sup>5</sup> failed to locate fish. In addition, a water quality assessment under ice by Beak (1981)<sup>6</sup> observed dissolved oxygen concentrations below 1 ppm, thus likely precluding fish overwintering.

**Figure 16** Fishtrap Creek Crossing, looking downstream, south, July 28, 2014.

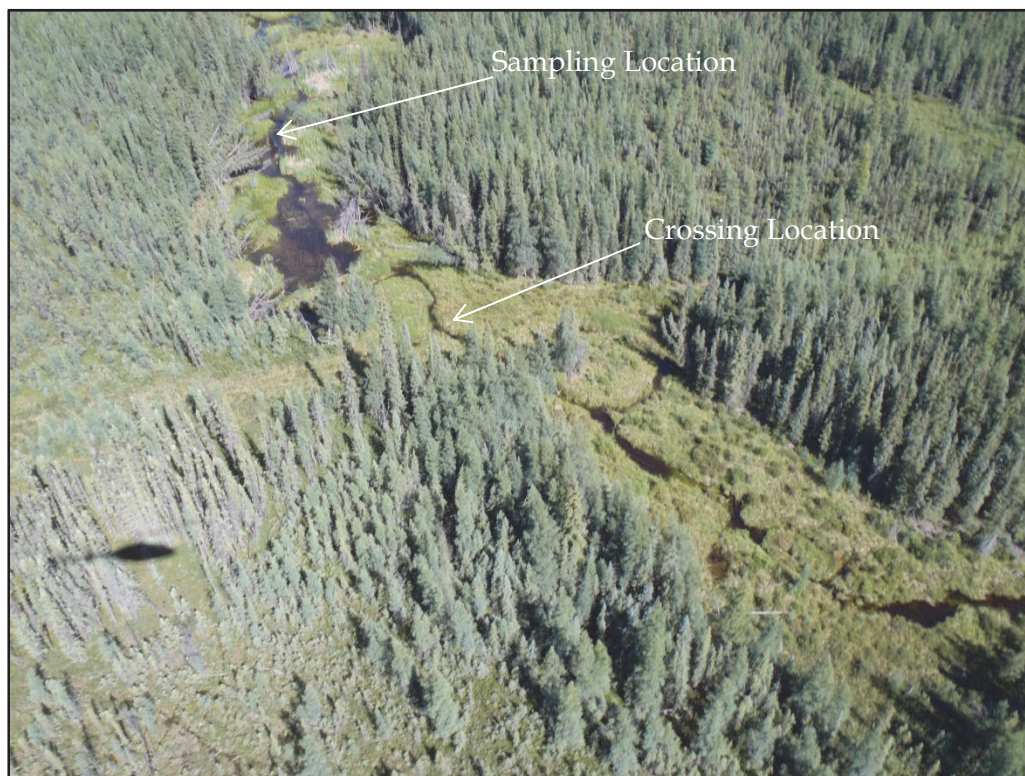
**Figure 17** Fishtrap Creek Crossing, looking upstream, north, July 28, 2014.
