From: Lorraine Seale [sealel@inac-ainc.gc.ca]
Sent: April 5, 2007 4:59 PM
To: Alan Ehrlich; Patrick Duxbury
Cc: Ginger Arnold; David Livingstone; Lionel Marcinkoski
Subject: RTL Ice Road Break-through Report

From: [Mike Beauregard](#)
To: [Brent Edmunds](#)
Cc: [Robert Paterson](#) ; [Larry Fairbairn](#) ; [Peter Lennie-Misgeld](#) ; [Kenneth Dahl](#) ; [Louie Azzolini](#)
Sent: Tuesday, March 21, 2006 11:46 PM
Subject: Ice Road Accident Report - RTL - Snowfield Mud Lake Kimberlite Sampling Program

**RTL Robinson Enterprises Ltd.
Evaluation of Recovery Options
Drybones Break-Thru
Prepared by S. Langlois
June 27, 2006**

**RTL Robinson Enterprises Ltd.
Drybones Break-thru Clean-up Report
Prepared by S. Langlois, shane_langlois@rtl.ca
RTL Incident # RY-06-81**

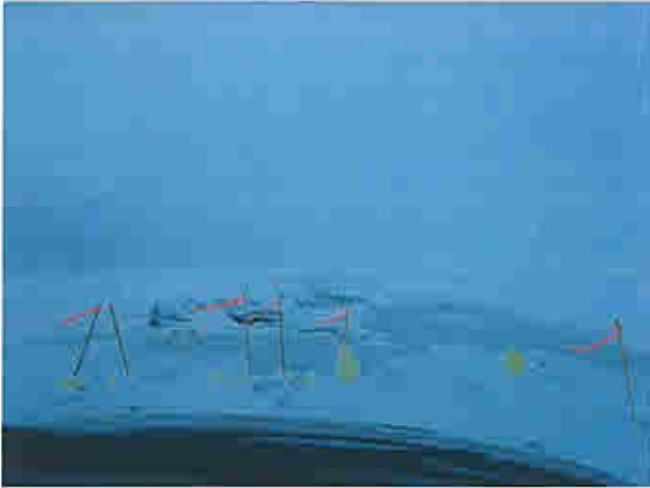
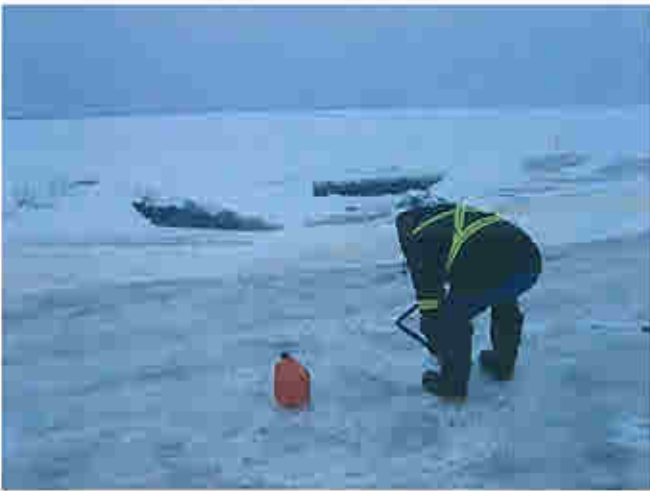
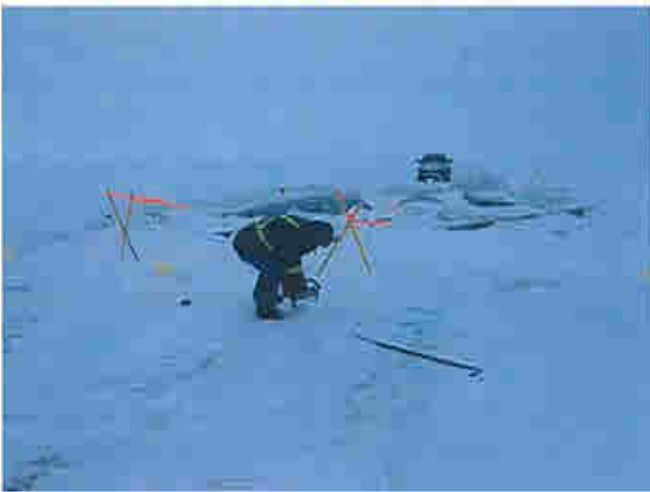
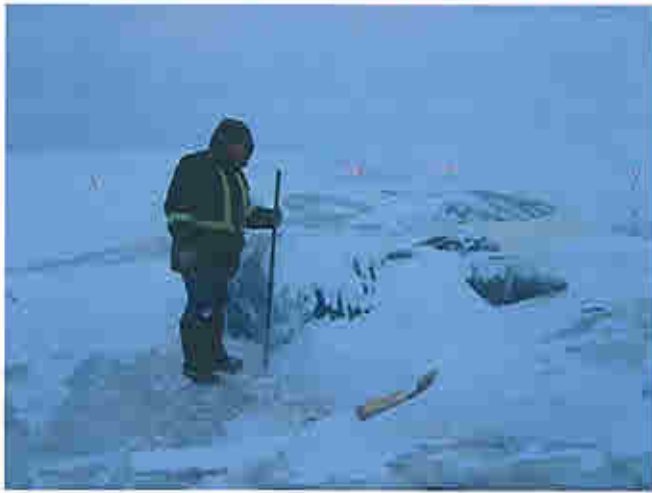
March 15, 2006 Inspection, Pictures:

- Wayne and Shane Langlois inspected the site, drilled 7 holes randomly around the perimeter of the break-thru to establish ice thickness and to check for fuel
- Measurements of the ice recorded between 94 cm and 107 cm
- No fuel was found in the test holes, some fuel was visible in the opening

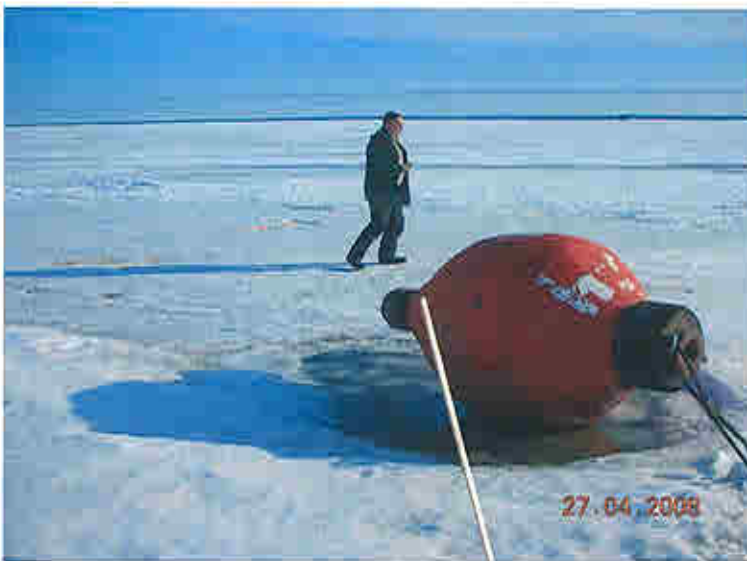
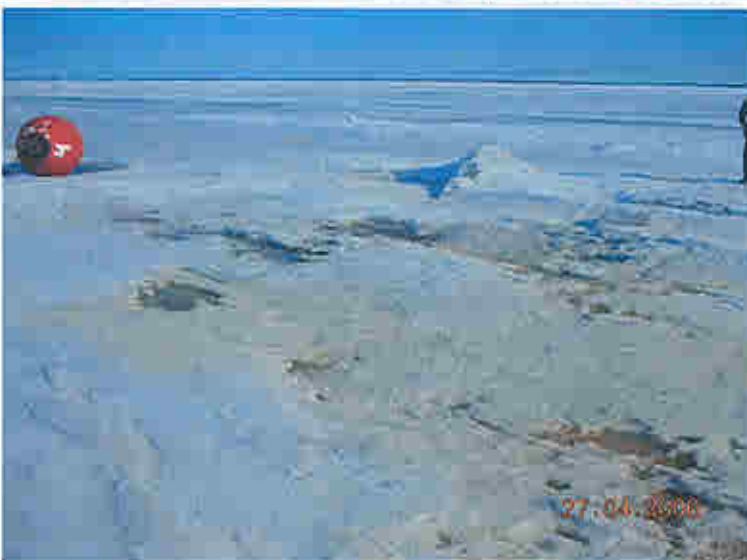
It would be a good time to go back any time now for additional cleanup. There is fuel apparent at the surface of the ice. It also appears to be coming up at the cracks. A chipper, torch and absorbents would probably go a long way. If you could drill some more holes, that would also tell us what is under the ice.

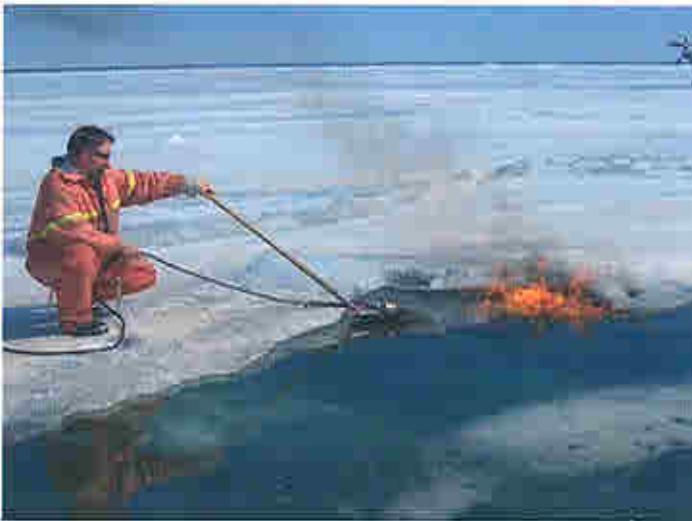
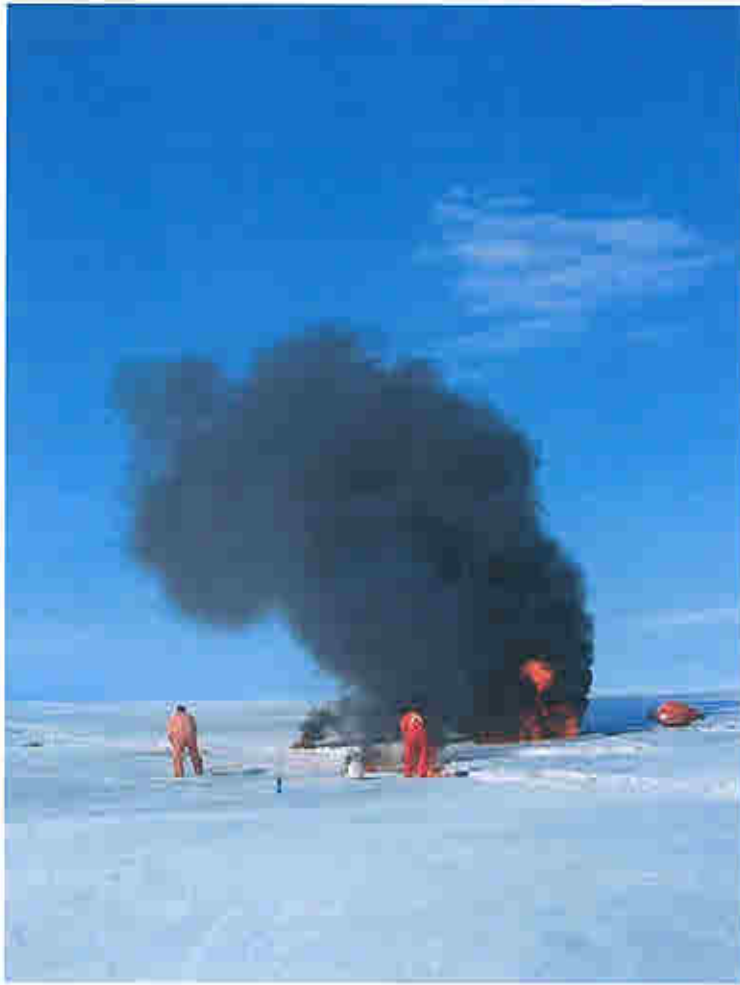
May 1, 2006 Burn Pix:

At the site we found fuel laying on the surface of the water directly over the break-thru location and where ice sheets were protruding from the surface. This fuel was burned off, the fire burned readily for approximately ten - fifteen minutes.

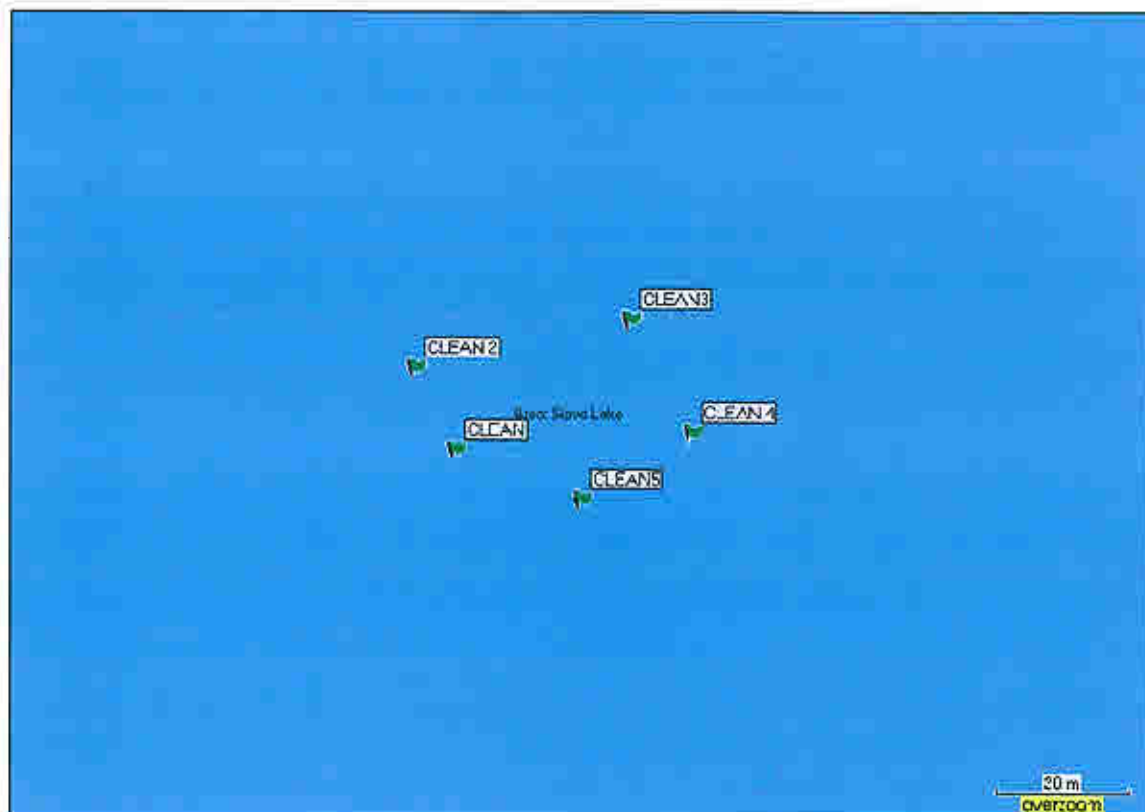
May 1, 2006 Drill Locations:

We drilled a series of holes around the site to look for pockets of fuel, none was present.

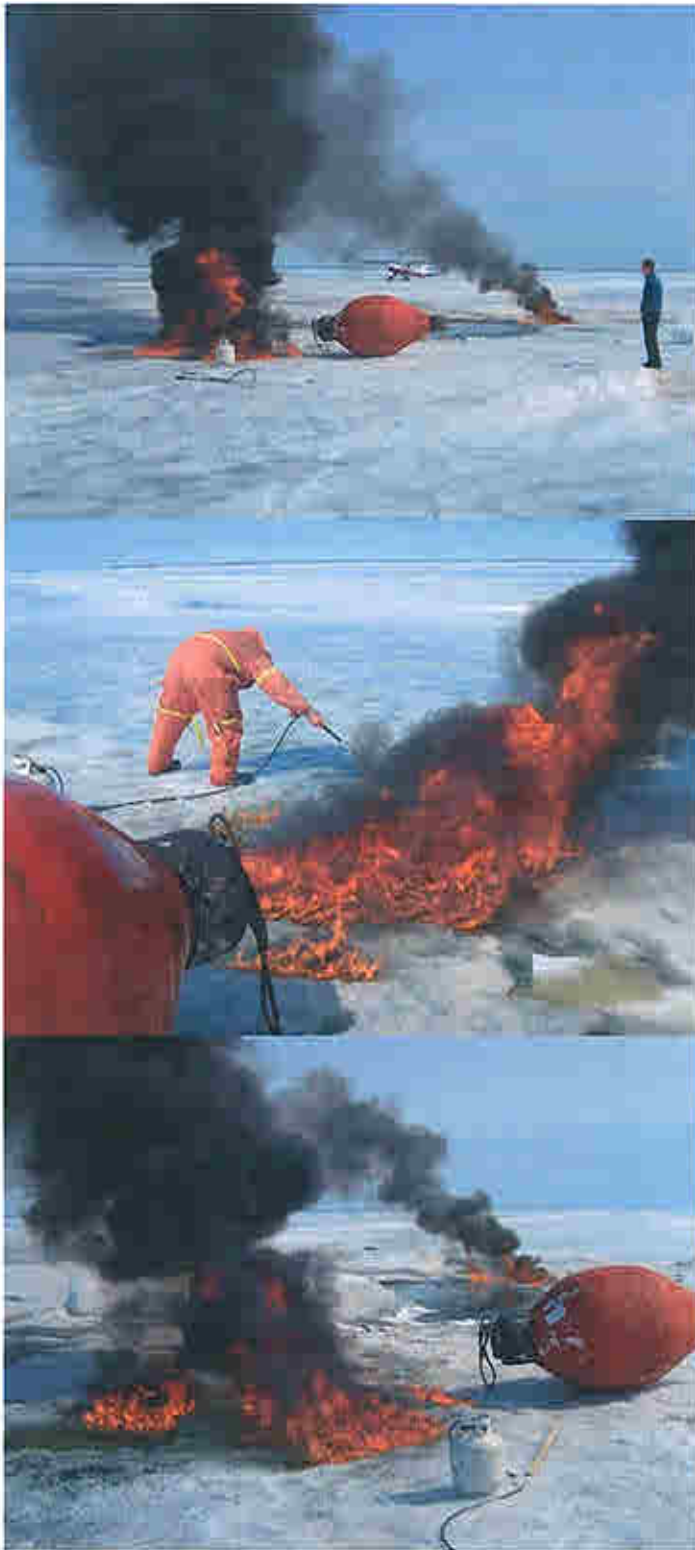
May 2, 2006 Burn Pix:

I went back to the site once again via Turbo Beaver, some fuel was present on the surface of the water, fuel appears to be trapped under ice sheets and areas that are drifted in by snow. An in-situ burn was completed and two more bundles of absorbent pads were used and taken back to YK for disposal.

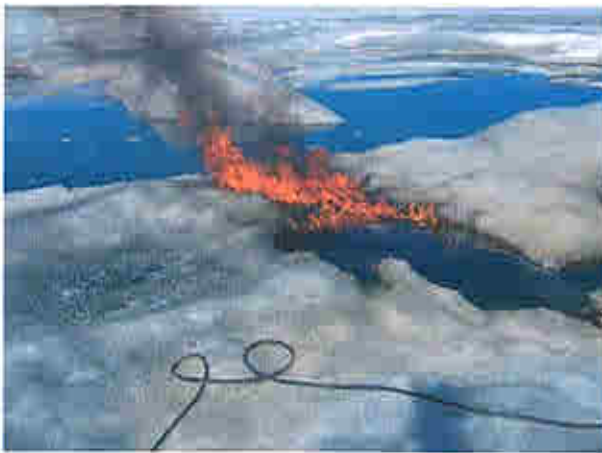
May 10, 2006 Burn Pix:

At the site we found no fuel laying on the surface of the water directly over the break-thru location. We did find one small pocket of fuel in an area that was snow covered on May 1, 2006. This fuel was burned off, the fire burned for approximately five minutes.

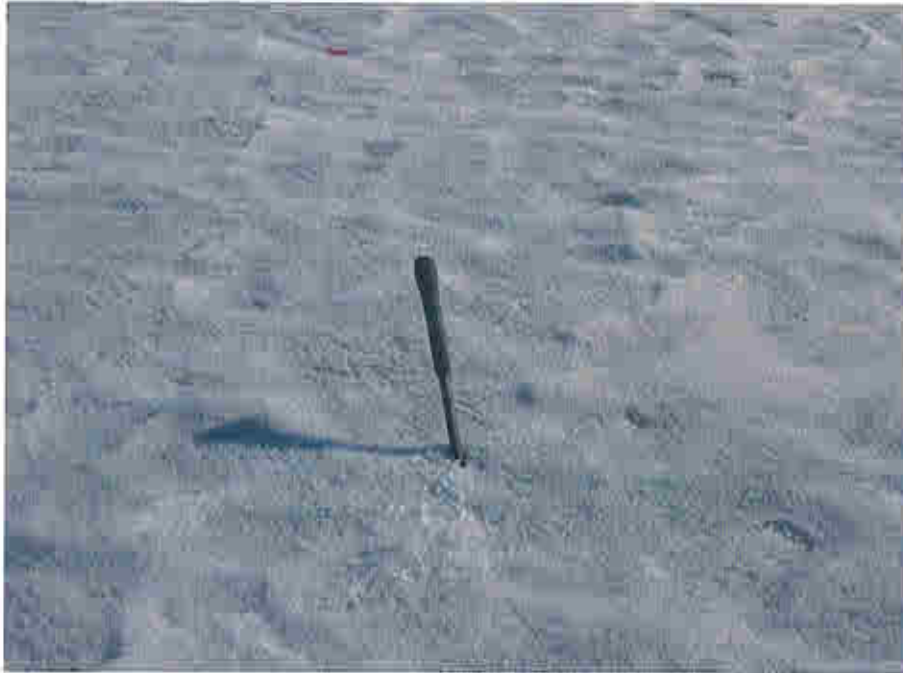
May 10, 2006 Ice Condition Pix:

The pilot felt it was unsafe to land the helicopter on the ice; we exited the machine while under power and performed the clean up while the chopper waited on shore. The ice had "candled" about 12" from the surface; water is also collecting at this point beneath the rotten ice.

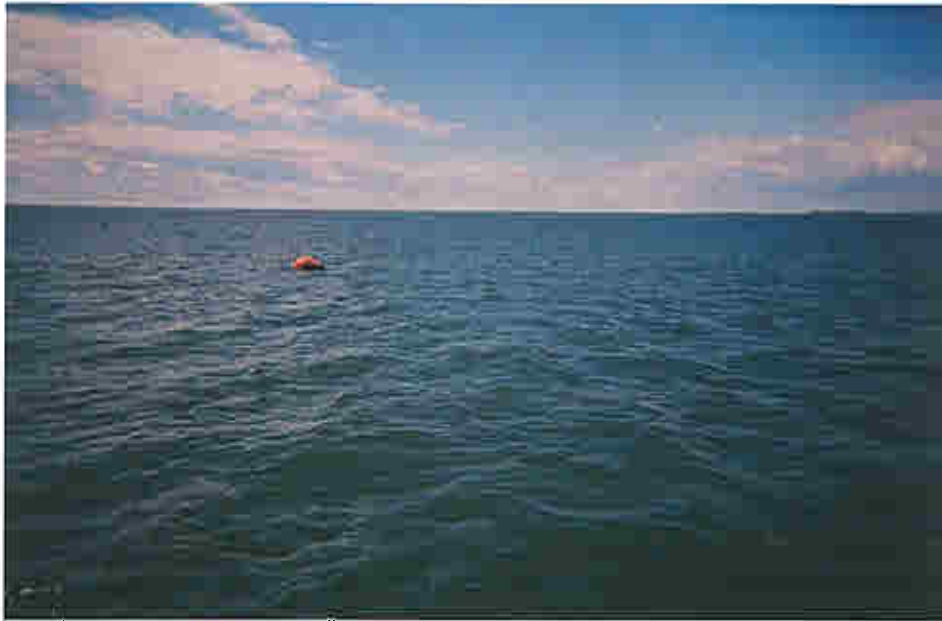
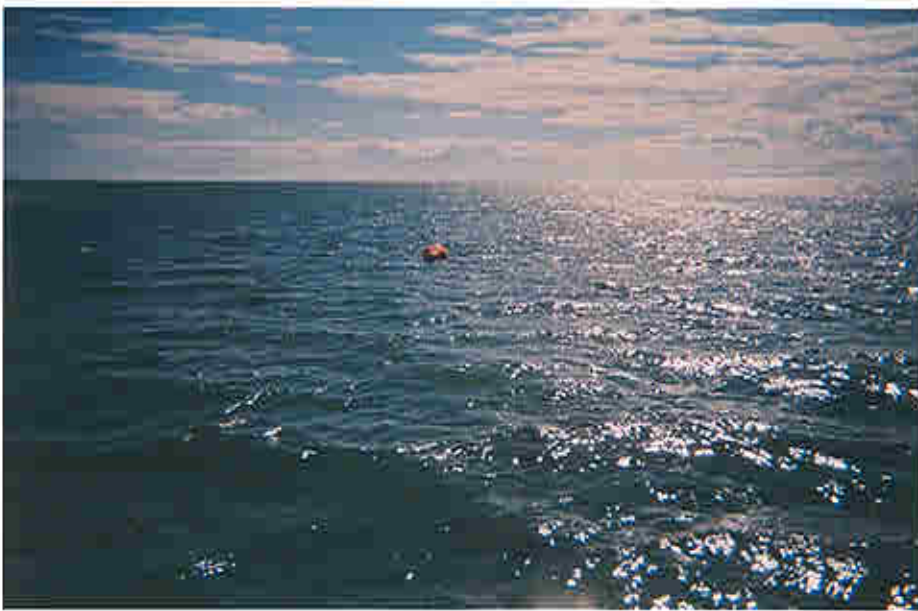
RTL inspected the incident site at Drybones Bay Sunday June 25, 2006. Waves were about 12" high; wind about 7 knots, no leakage was noted. Some pictures were taken; I will include them in tomorrows meeting.
