**RE: FLOOD EROSION PROTECTION – PRAIRIE CREEK MINE, NT**

**Condition Inspection Report Summary  
Bulk Fuel Storage Facilities  
Canadian Zinc Corporation Mine  
Prairie Creek, NT**

**BULK FUEL STORAGE FACILITIES  
CONDITION INSPECTION REPORT**

Bulk Fuel Storage Facility  
Condition Inspection  
July 21-22, 2005

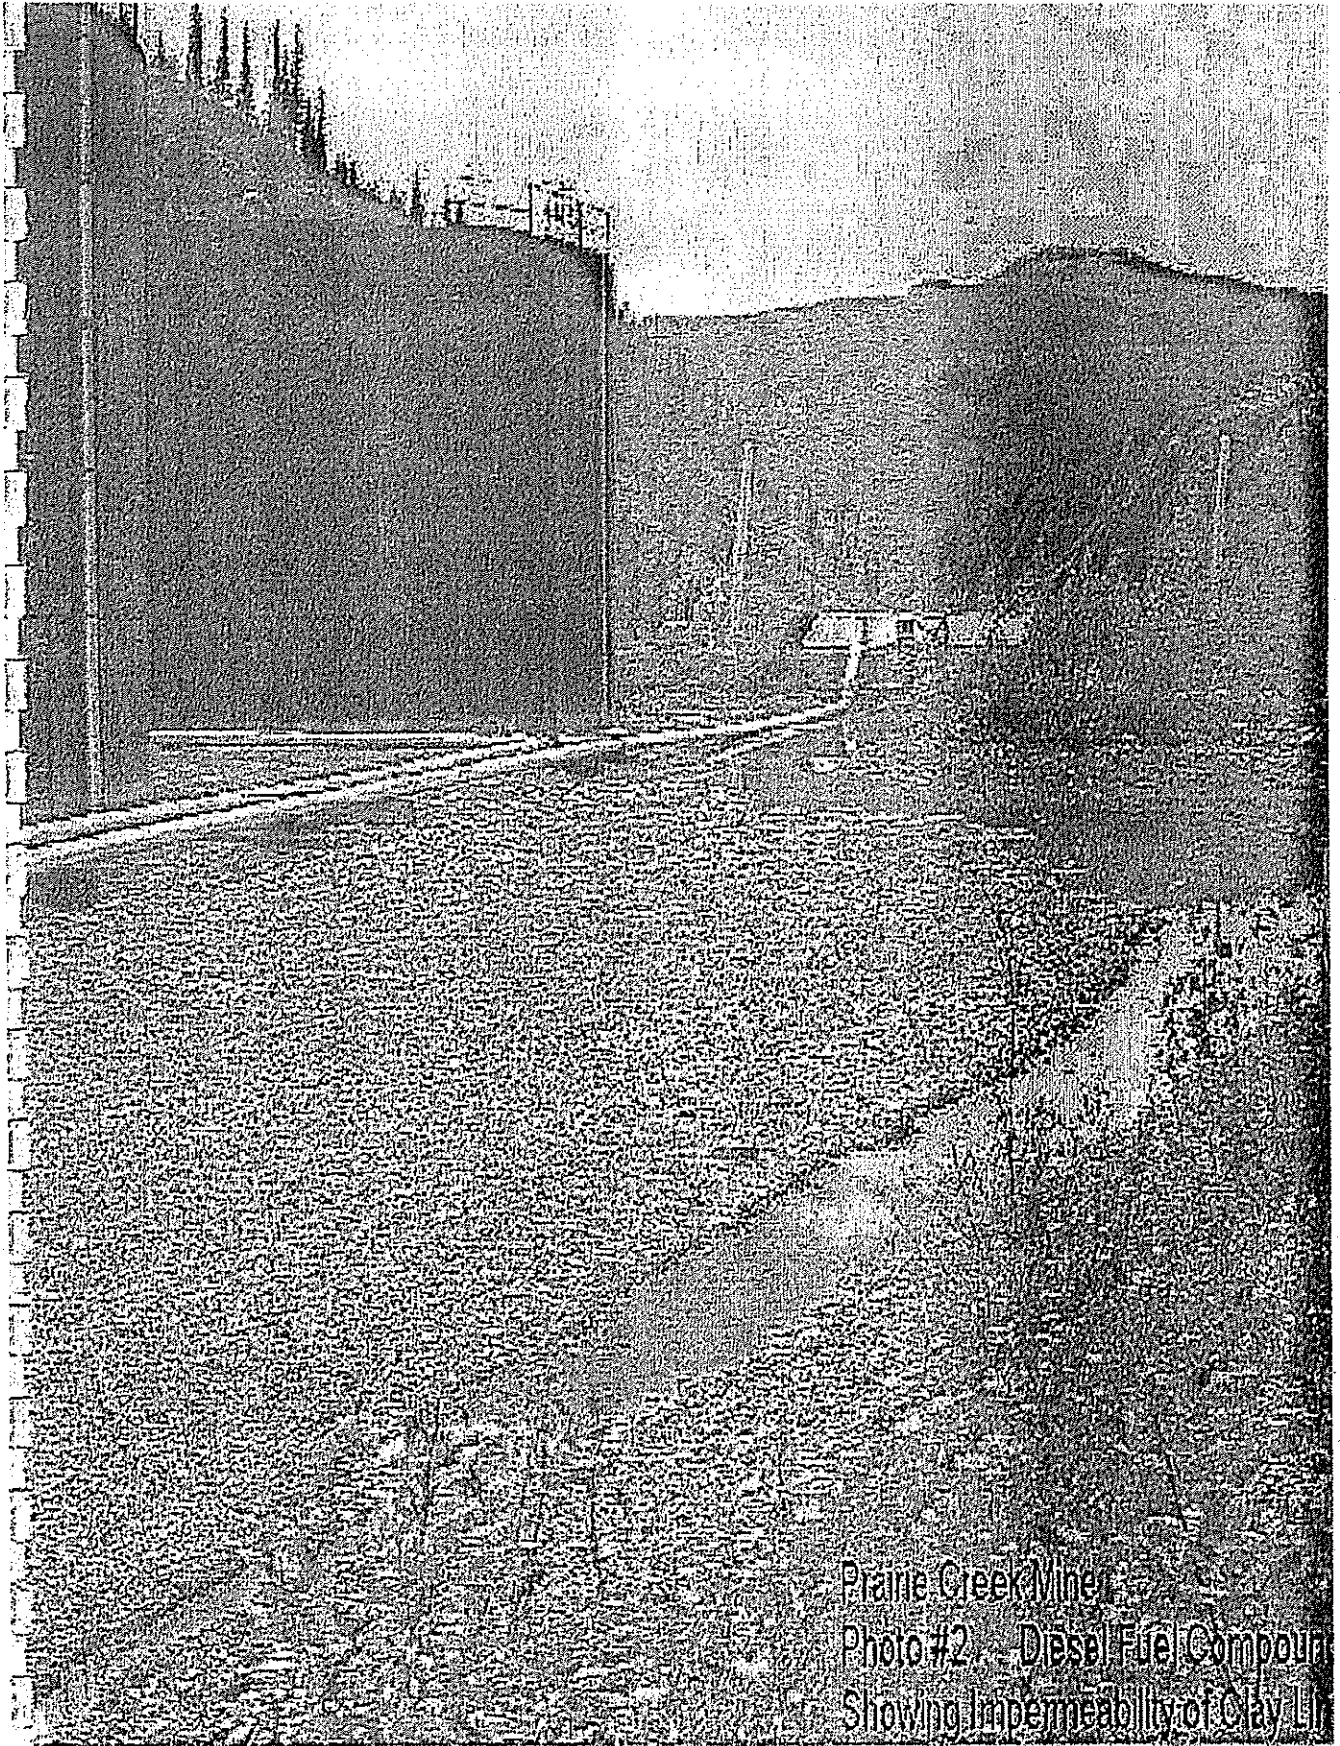
Prairie Creek Mine  
Photo #2. Diesel Fuel Compound  
Showing Impermeability of Clay Liner

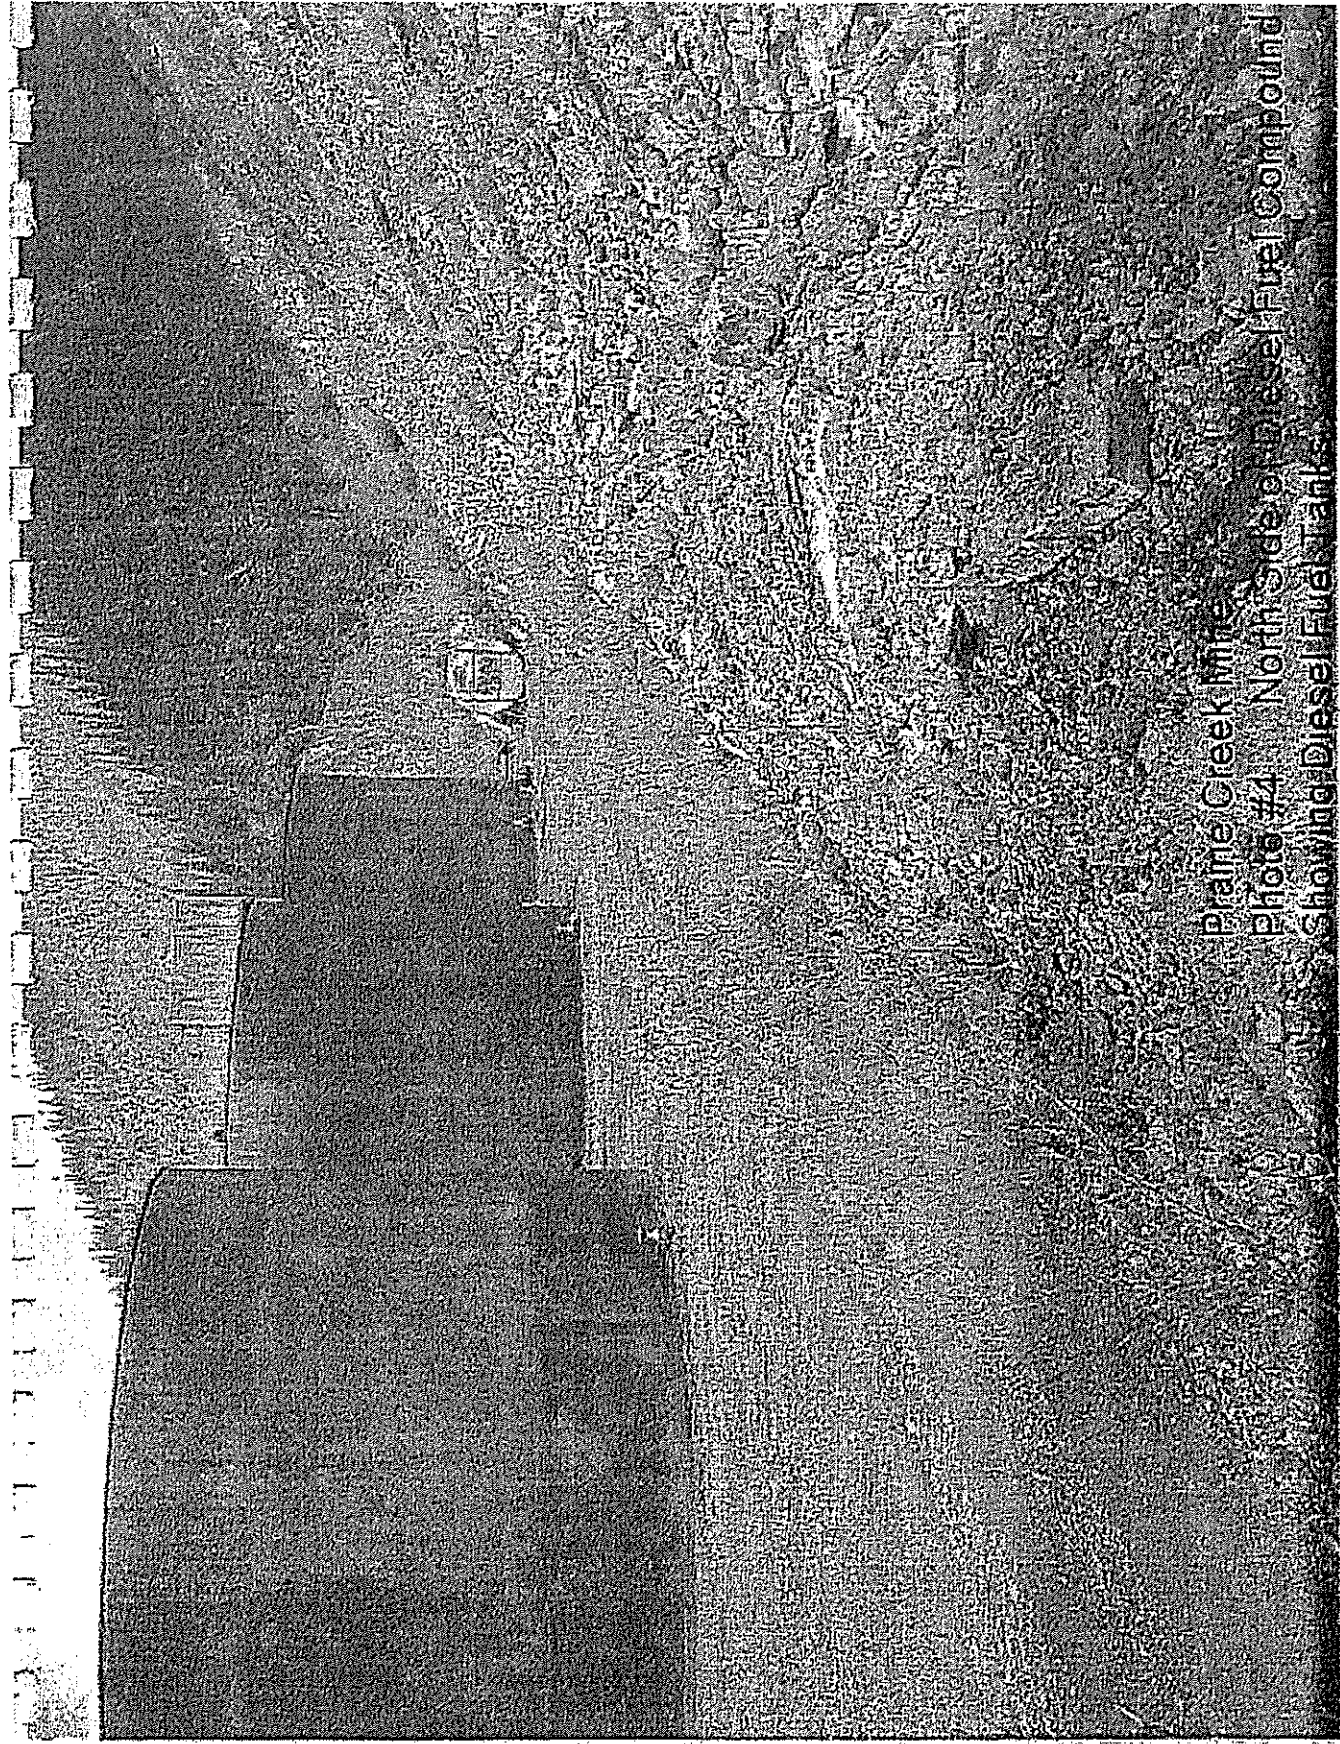
Prairie Creek Mine  
Photo #74 North Side of Diesel Fuel Compound  
Showing Diesel Fuel Tanks

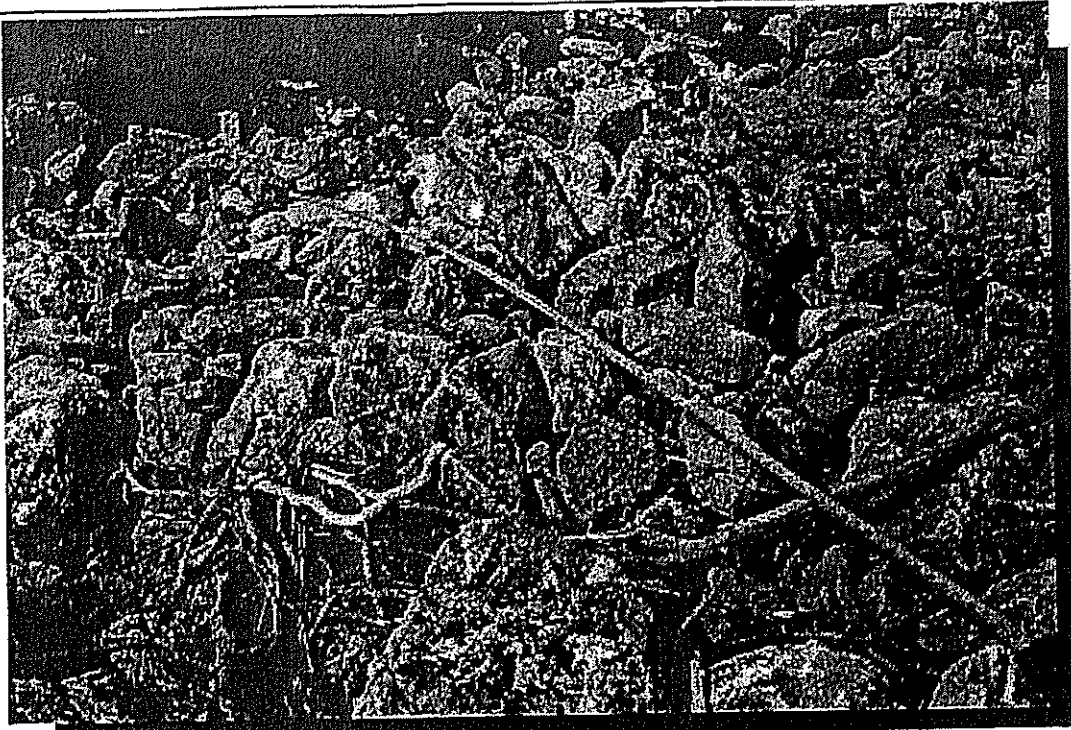
**Photo 5**  
Composition of Riprap Berm Material

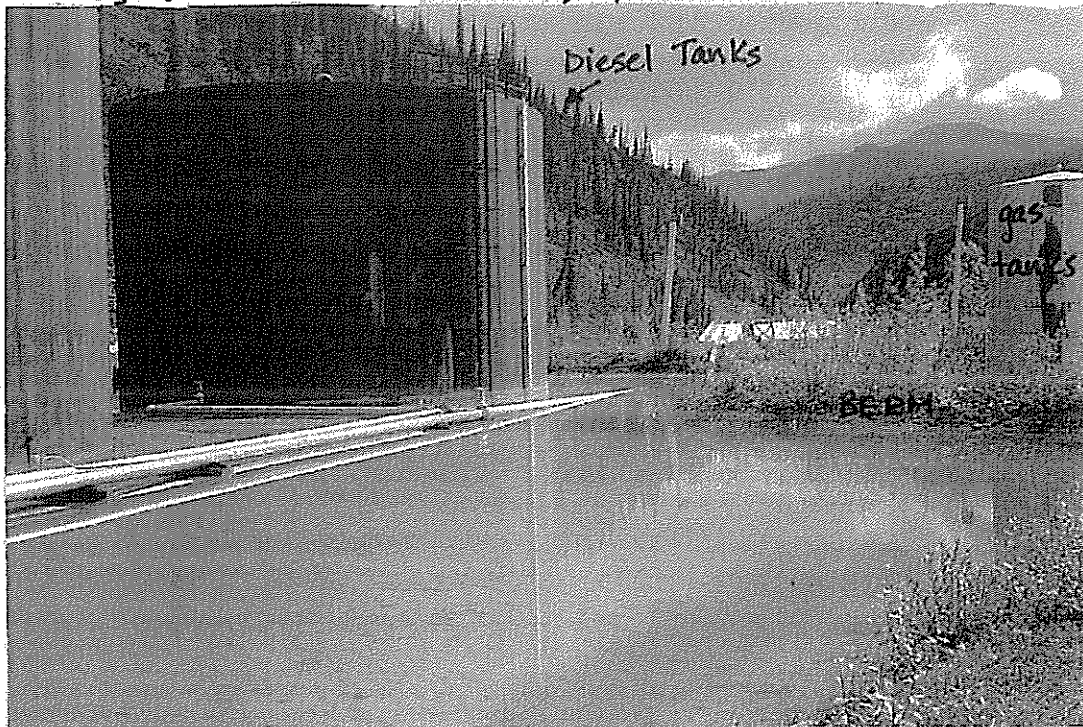
Photograph #1: Tank Farm Facility with ponded water

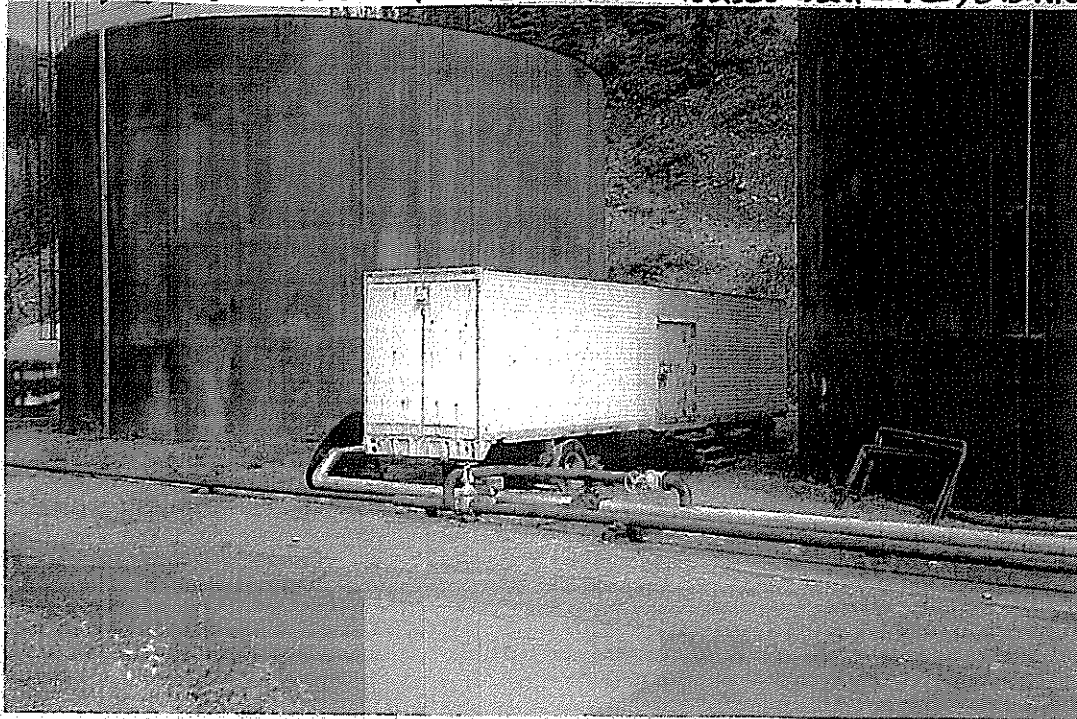
Photograph #2: Trailer inside bermed area surrounding the Tank Farm Facility. The trailer houses batteries, chemicals etc.

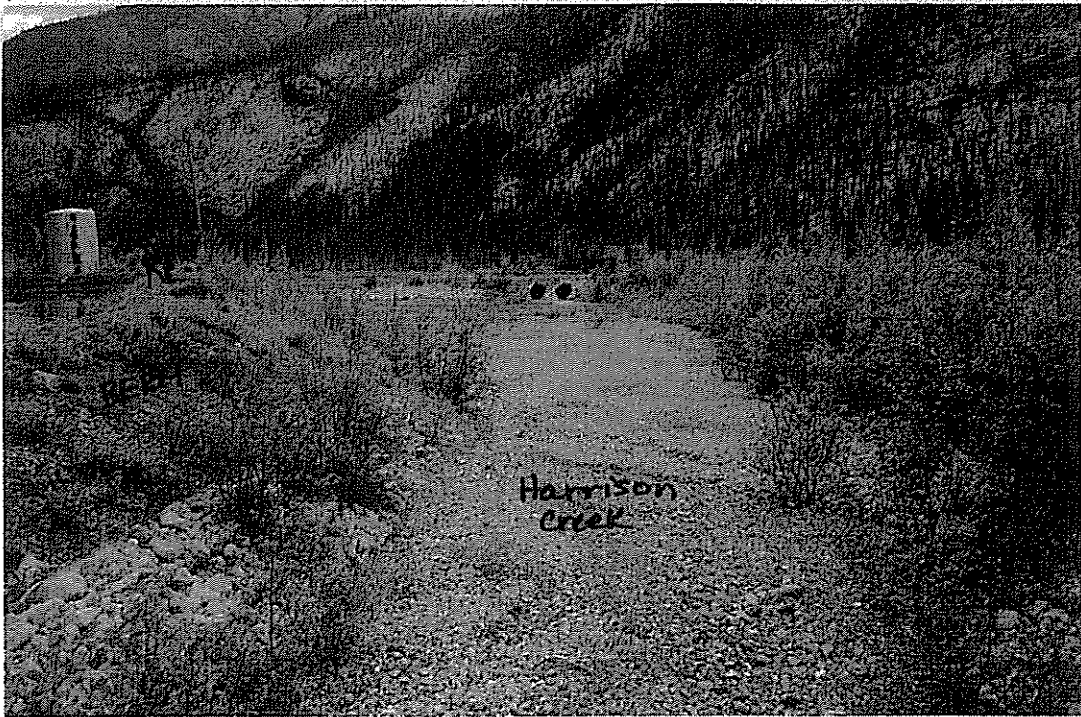
Photograph # 3: The berm between Harrison Creek and the Tank Farm Facility is on the left side of the photo.

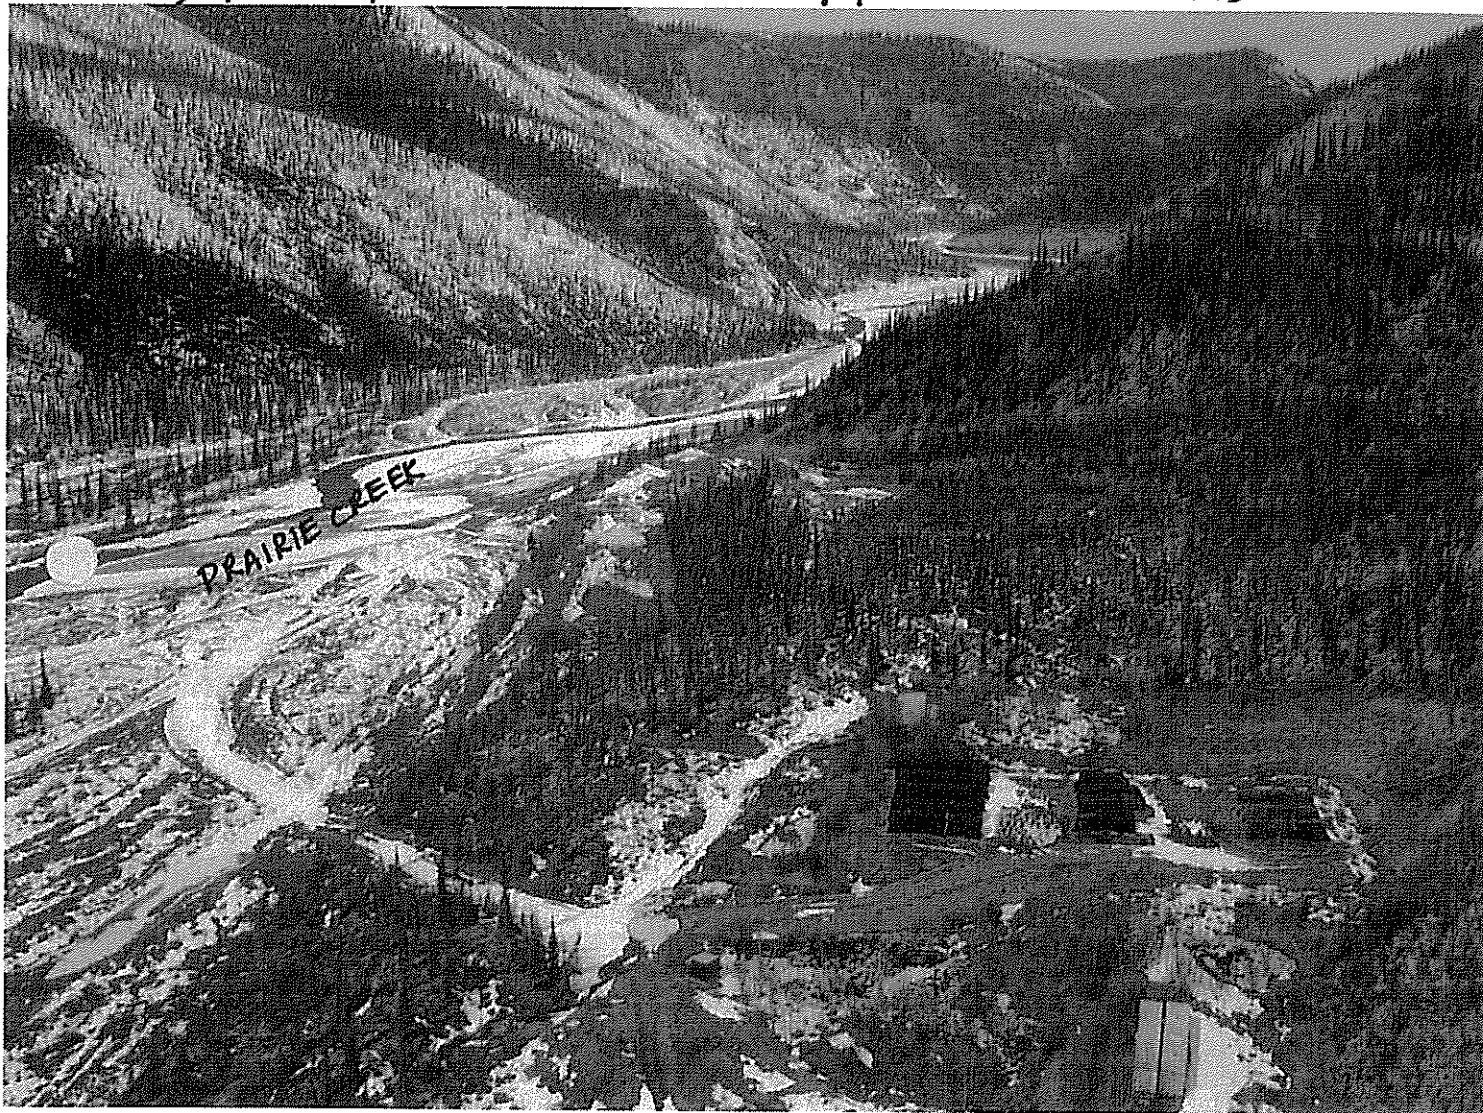
Photograph #1 of the chemical stores (cyanide circled in red)

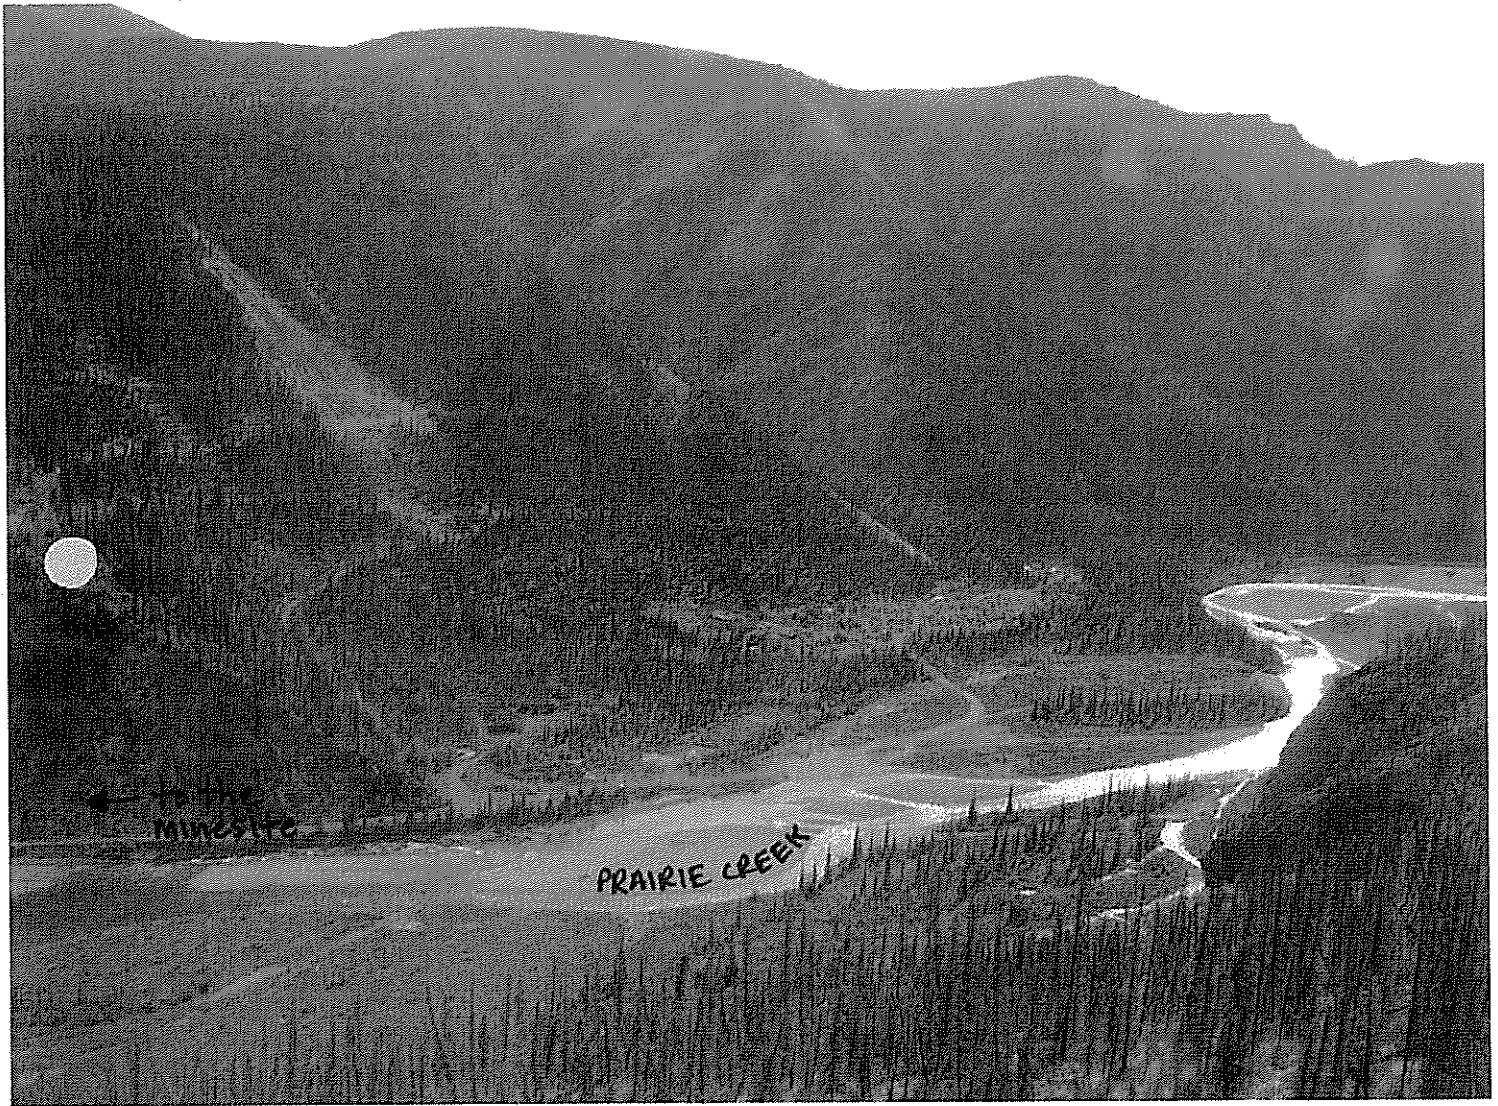
Photograph #2 of the chemical stores (cyanide circled in red)

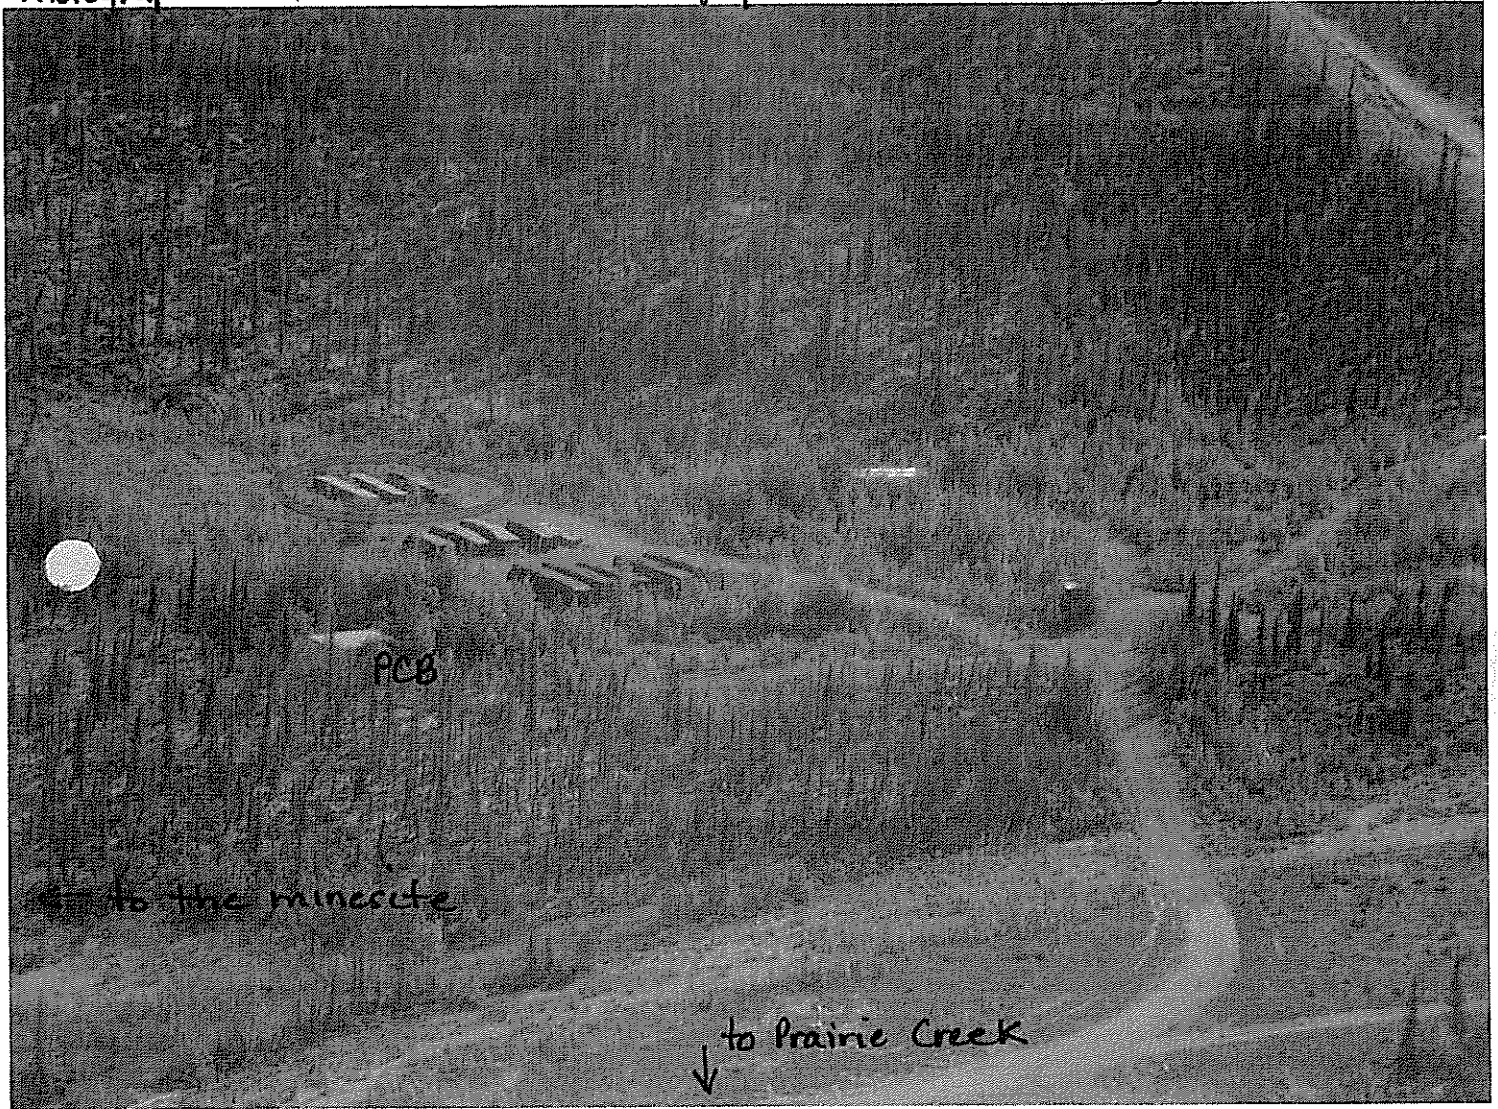
Photograph #3 of the chemical stores (cyanide circled in red)
