RE: Debogorski Public Hearing – undertaking # 3 submerged truck and excavator Great Slave Lake

**RTL Robinson Enterprises Ltd.
Drybones Break-thru Clean-up Report
Prepared by S. Langlois, shane_langlois@rtl.ca
RTL Incident # RY-06-81**

RTL Robinson Enterprises Ltd.
Pilot Islands Break-thru Inspection Report
Prepared by S. Langlois, shane_langlois@rtl.ca
RTL Incident # RY-06-81

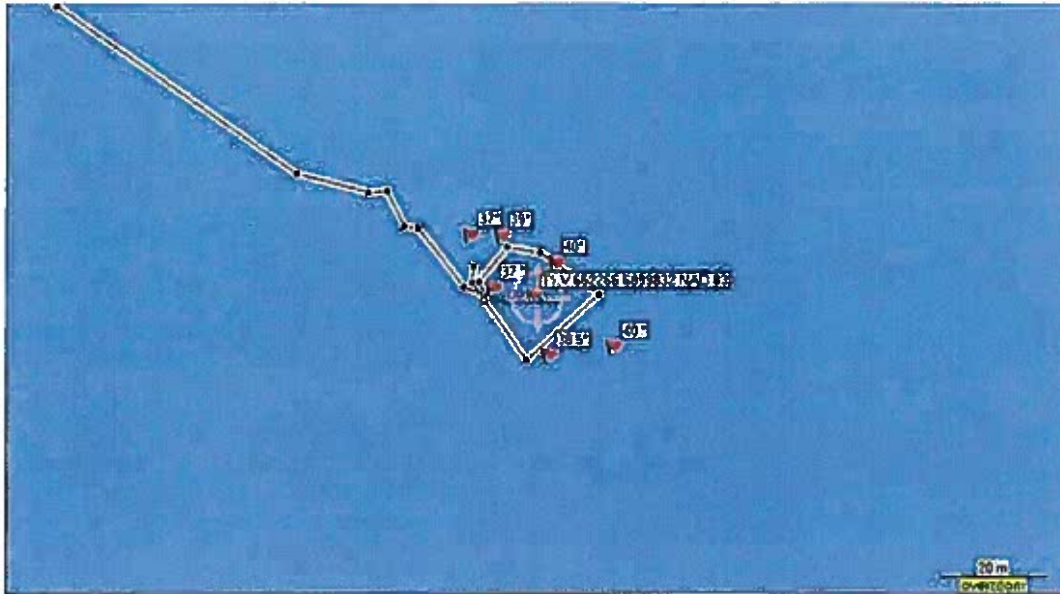
March 15, 2006 Inspection, Drill holes:

- Wayne and Shane Langlois inspected the site, drilled 7 holes randomly around the perimeter of the break-thru to establish ice thickness and to check for fuel
- Measurements of the ice recorded between 94 cm and 107 cm
- No fuel was found in the test holes, some fuel was visible in the opening

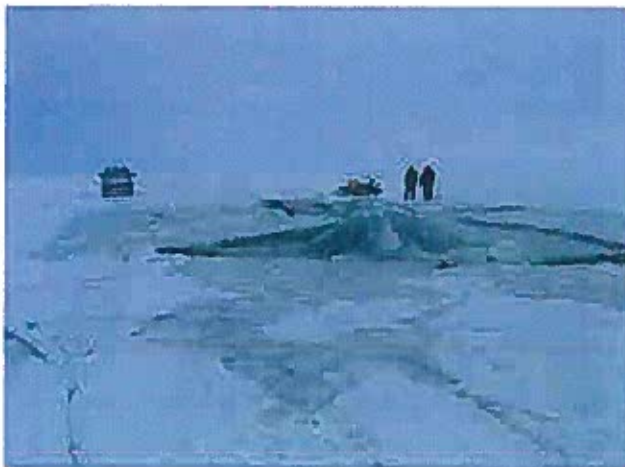
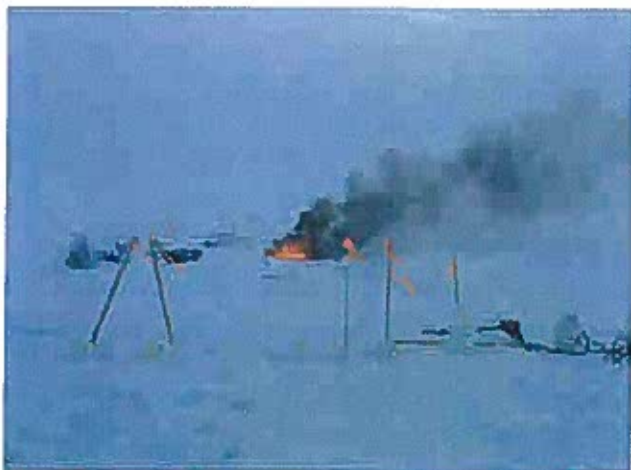
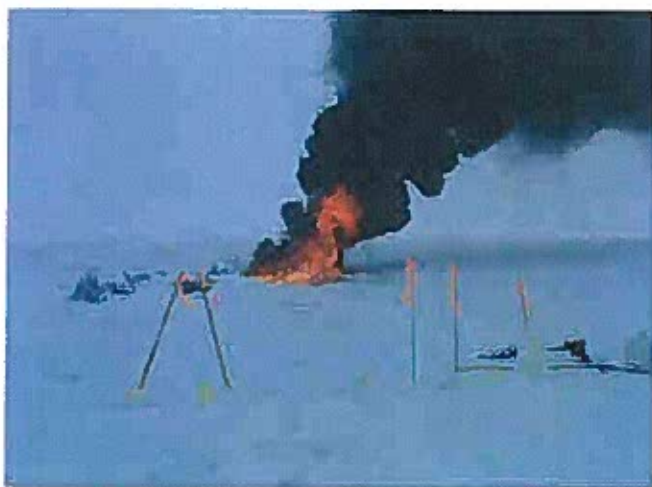
March 16, 2006 Inspection, Clean up/Burn:

- In-situ burn of the spilled fuel

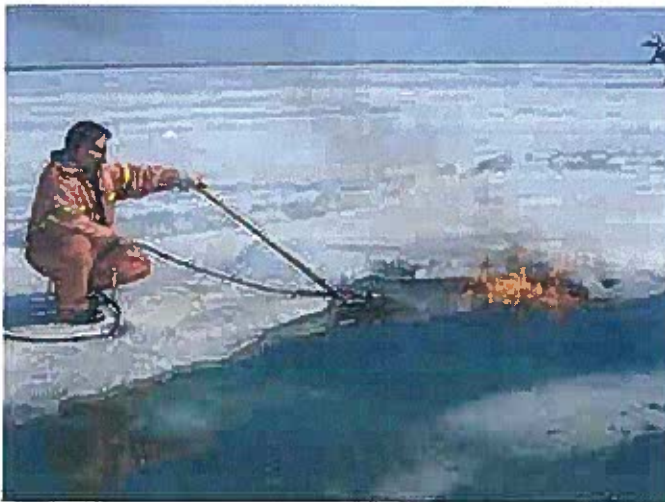
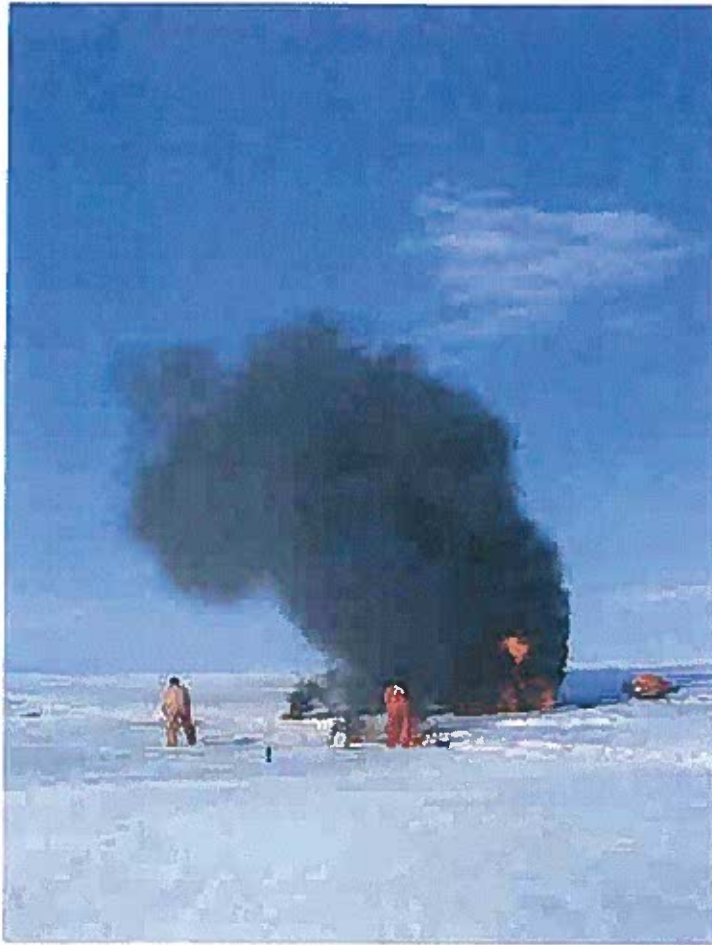
May 1, 2006 Burn Pix:

At the site we found fuel laying on the surface of the water directly over the break-thru location and where ice sheets were protruding from the surface. This fuel was burned off, the fire burned readily for approximately ten - fifteen minutes.

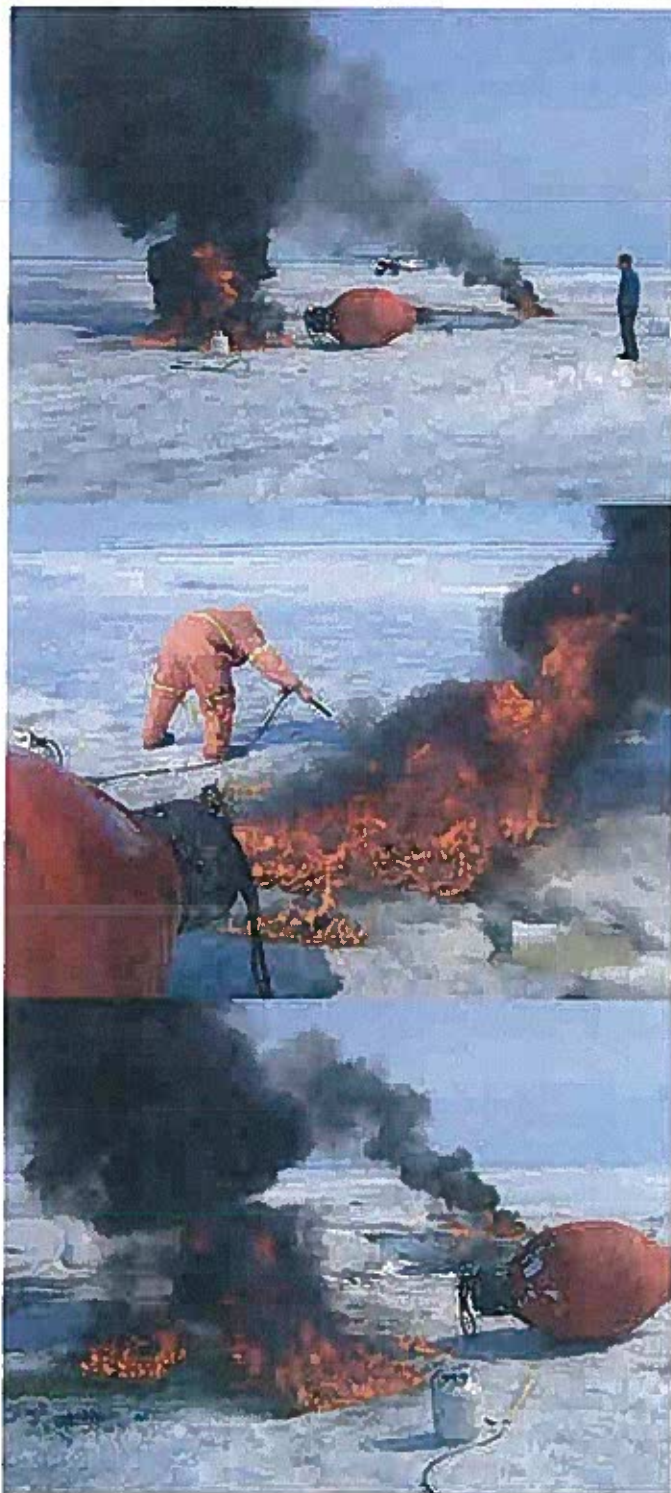
May 2, 2006 Burn Pix:

I went back to the site once again via Turbo Beaver, some fuel was present on the surface of the water, fuel appears to be trapped under ice sheets and areas that are drifted in by snow. An in-situ burn was completed and two more bundles of absorbent pads were used and taken back to YK for disposal.

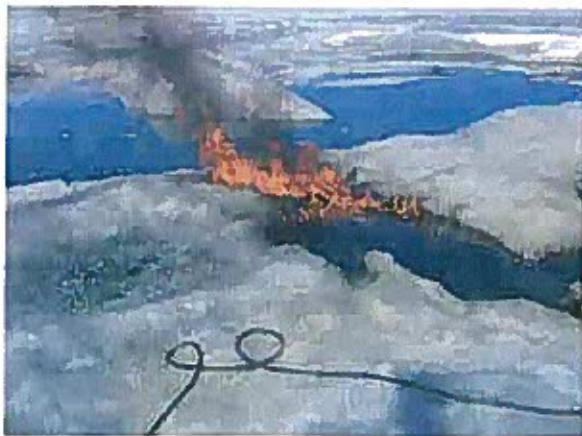
May 10, 2006 Burn Pix:

At the site we found no fuel laying on the surface of the water directly over the break-thru location. We did find one small pocket of fuel in an area that was snow covered on May 1, 2006. This fuel was burned off, the fire burned for approximately five minutes.

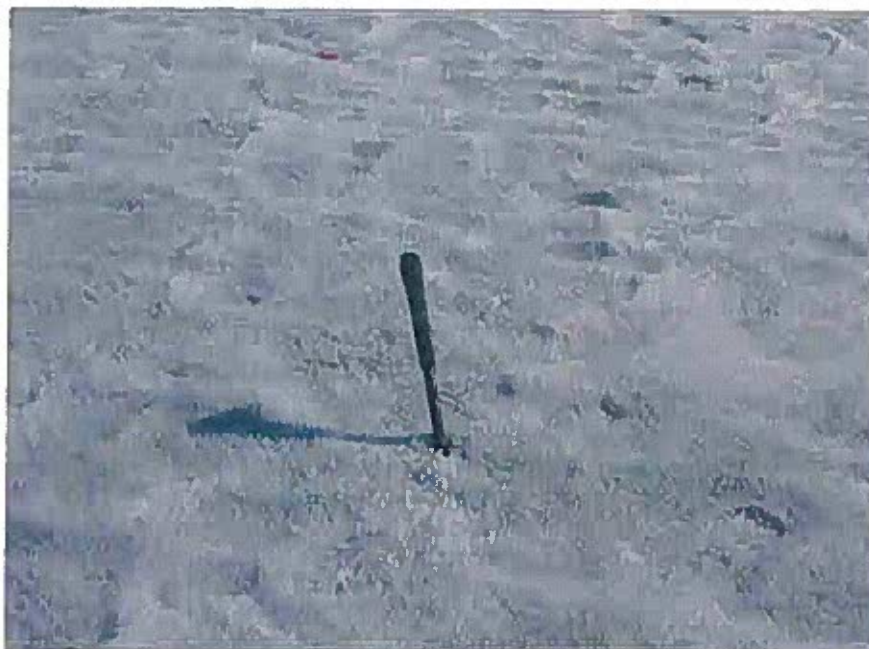
May 10, 2006 Ice Condition Pix:

The pilot felt it was unsafe to land the helicopter on the ice; we exited the machine while under power and performed the clean up while the chopper waited on shore. The ice had "candled" about 12" from the surface; water is also collecting at this point beneath the rotten ice.

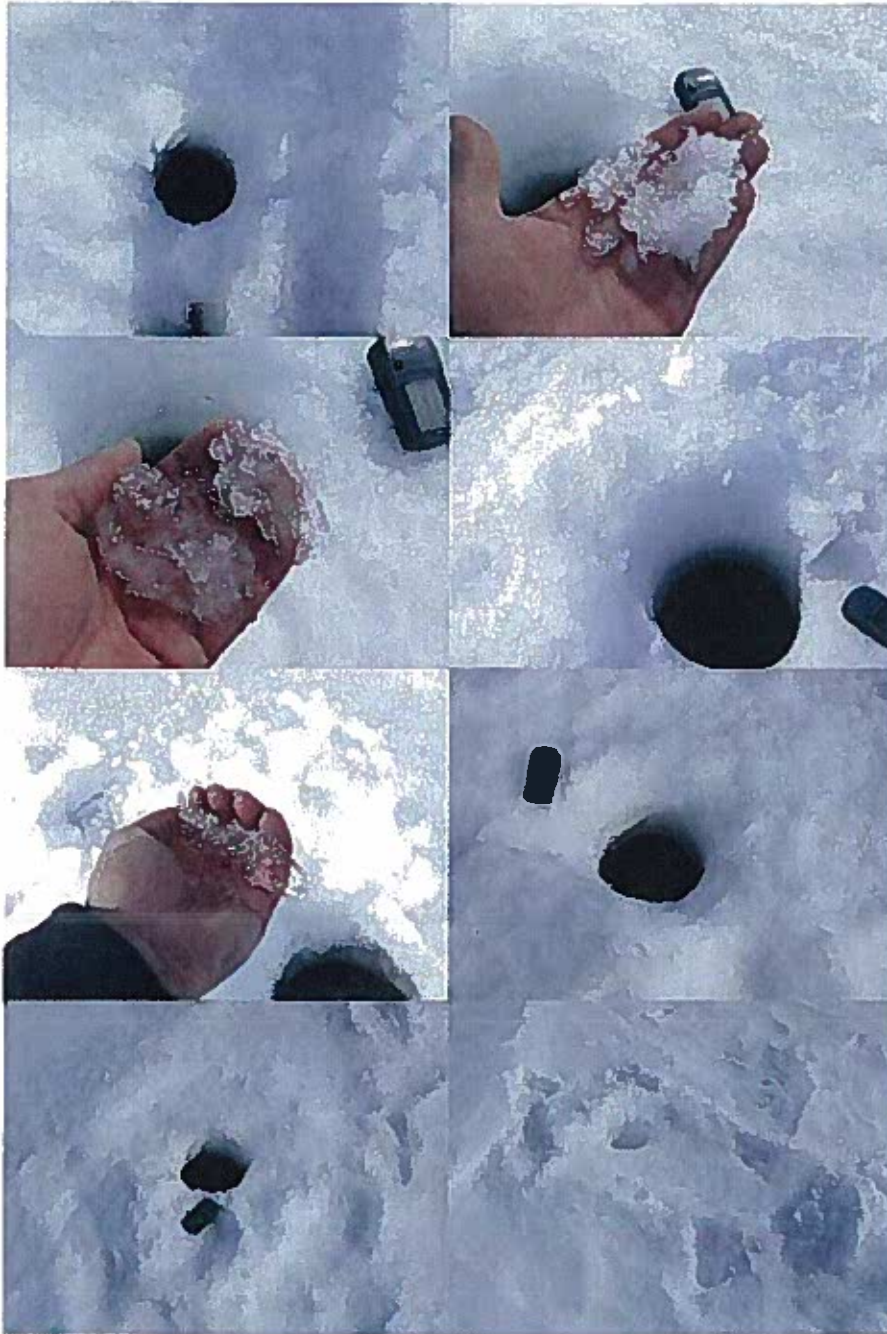
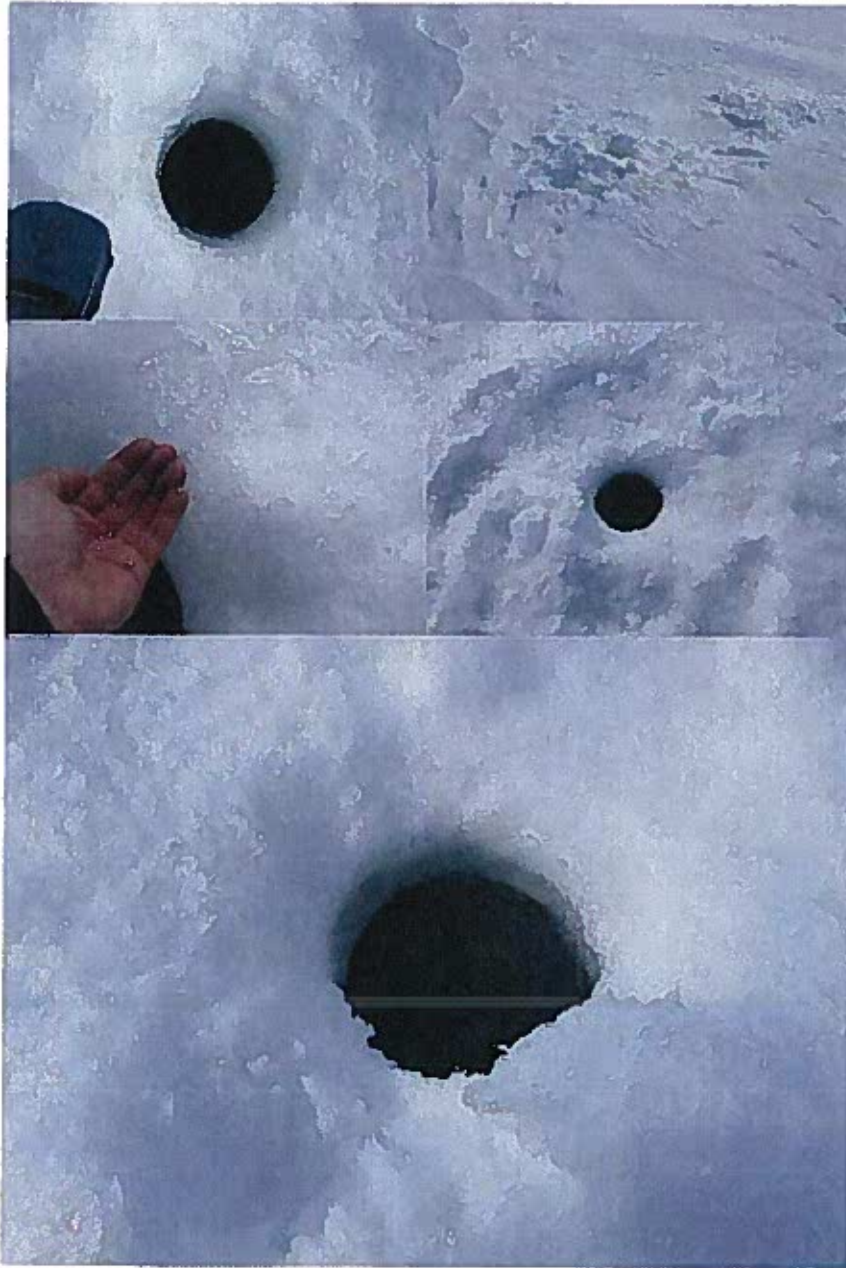
April 12, 2008 Inspection, Test Hole Pictures

On April 12, 2008 Larry Kish & I traveled to the "break thru" location 14 Km's NW of Drybones Bay to inspect for hydrocarbons. We drilled nine test holes through the ice at approximately a 50 m radius around the equipment and three more directly above. All of the ice and water samples inspected showed no visual evidence of Hydrocarbons in the water and no smell. All water was clear and cold and the snow and ice was pure with no residue. We actually drank it.

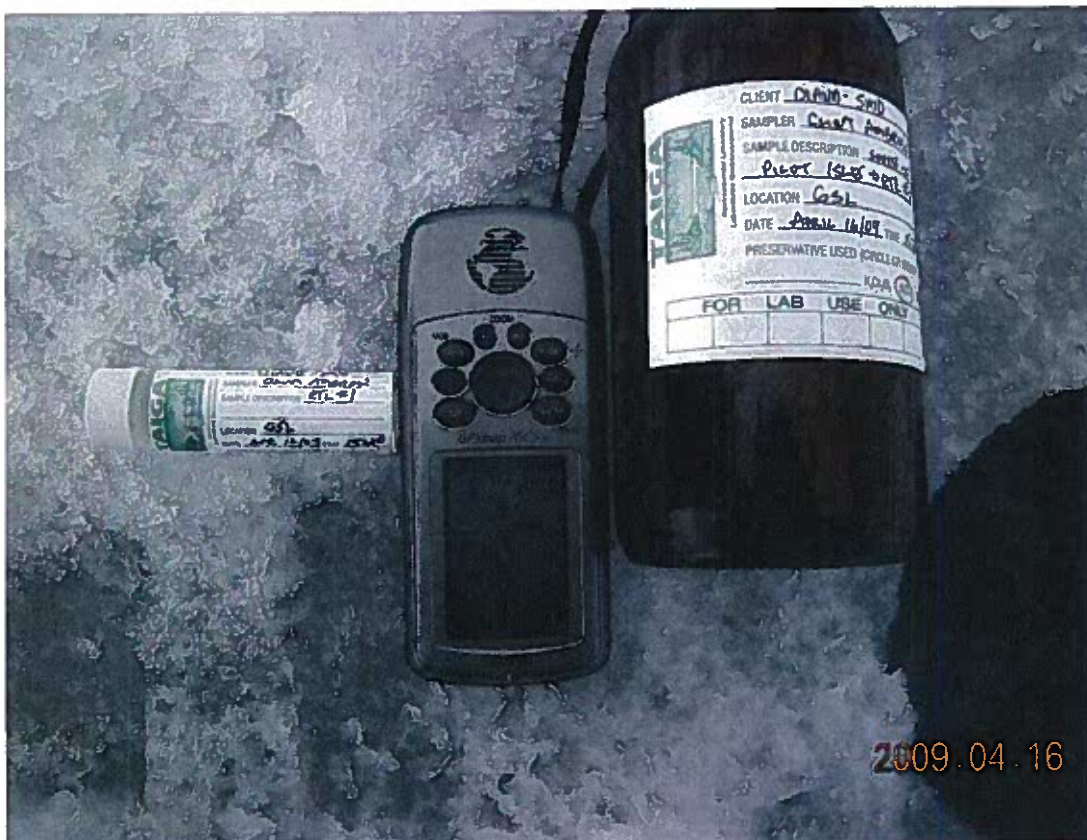
Spill site south of the Pilot Islands - RTL Robinson Enterprises Ltd.
 Water sample for hydrocarbons "RTL #1", taken from a random hole drilled through the ice.

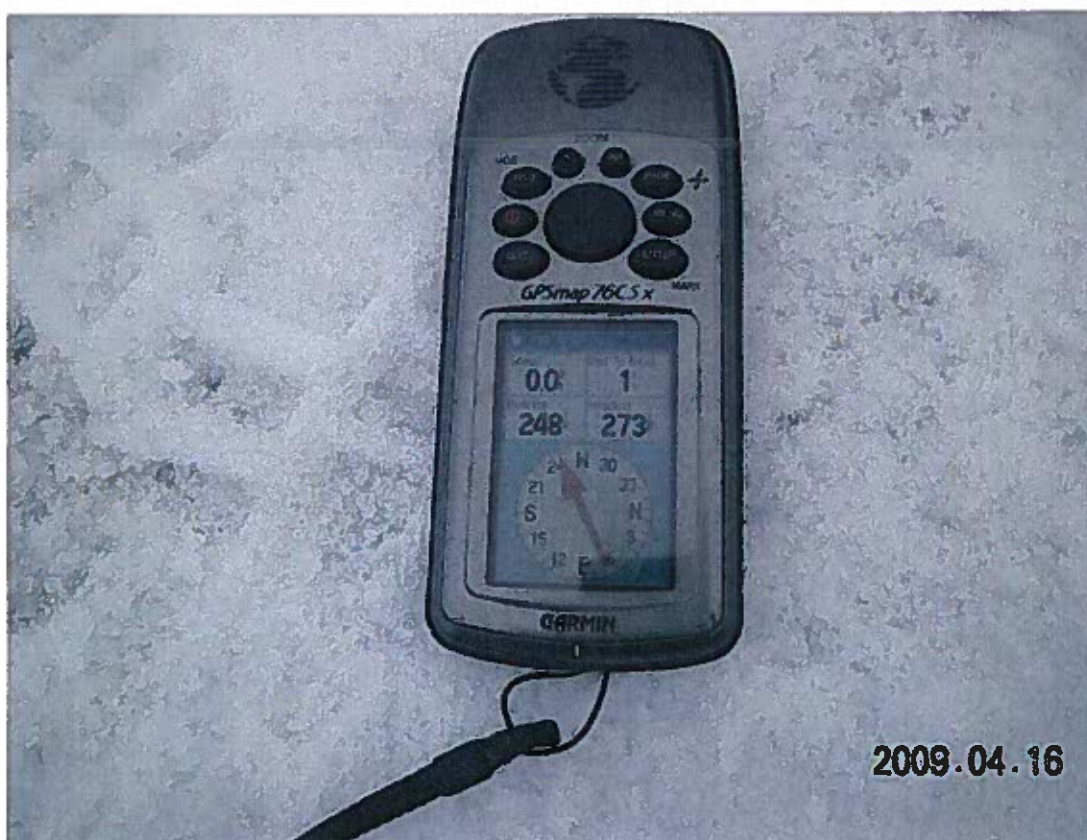
Spill site south of the Pilot Islands - RTL Robinson Enterprises Ltd.
 GPS showing hole location 1' from the location of where the equipment broke through the ice (Inspector's waypoint).

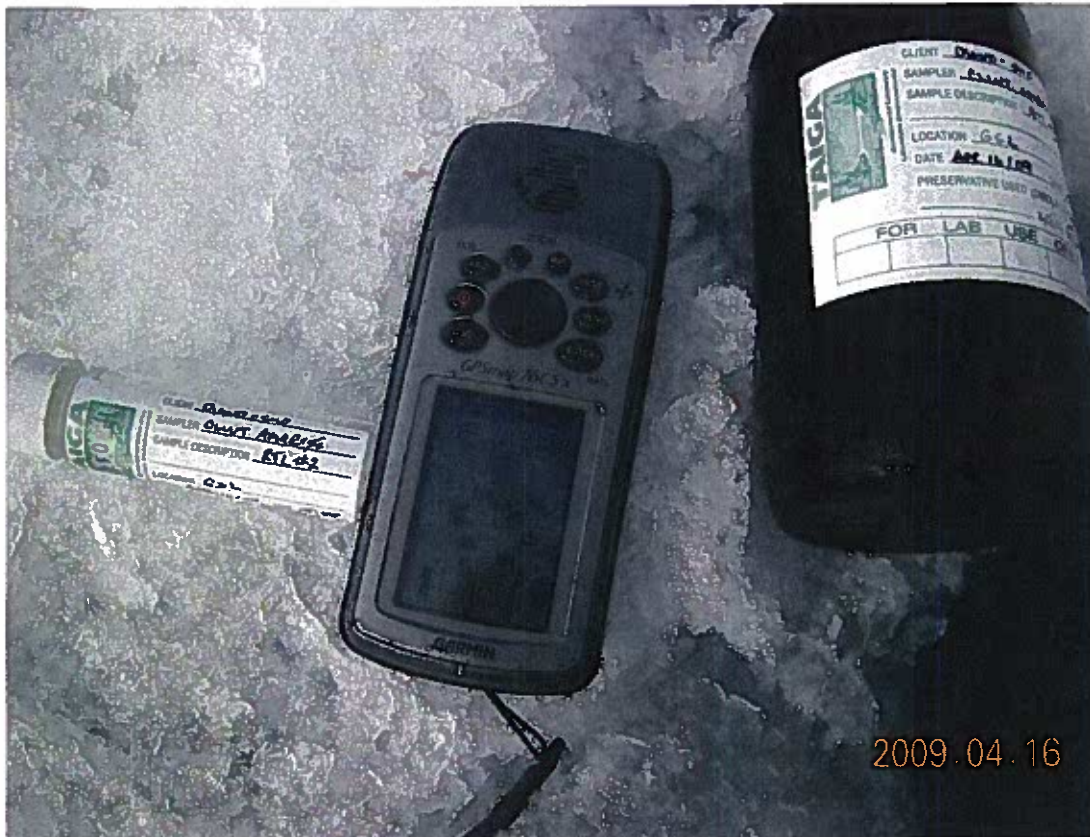
Spill site south of the Pilot Islands - RTL Robinson Enterprises Ltd.
RTL #2 water sample taken from the Inspectors waypoint.

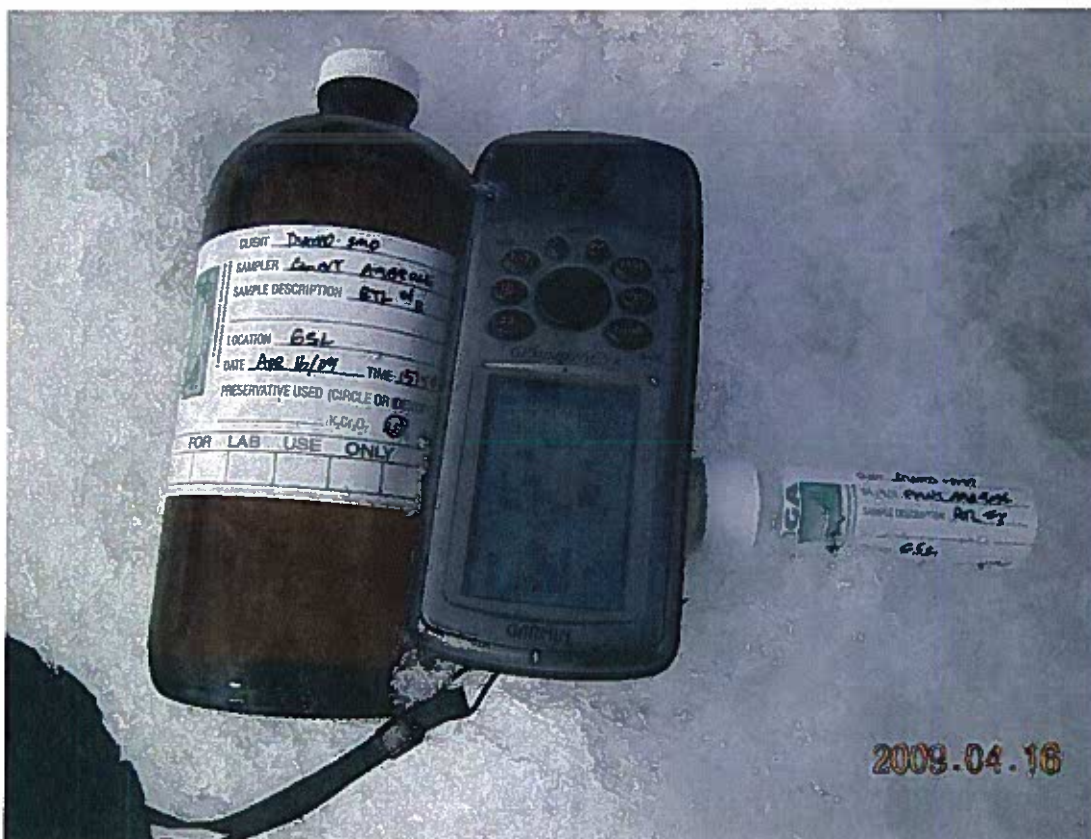
Spill site south of the Pilot Islands - RTL Robinson Enterprises Ltd.
RTL #3 water sample taken from the location where the company marked the breakthrough location.

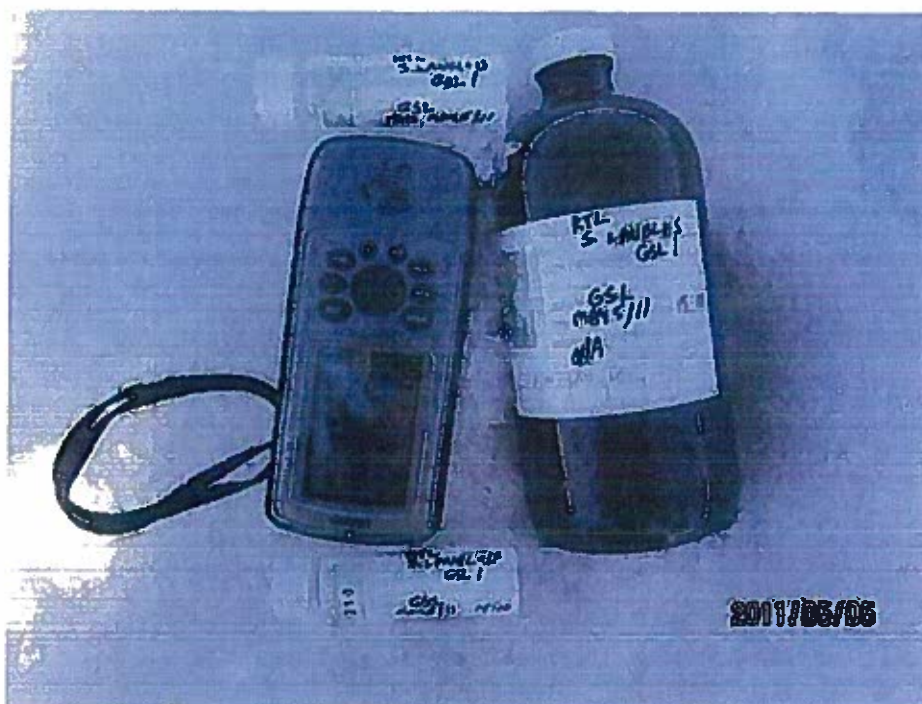
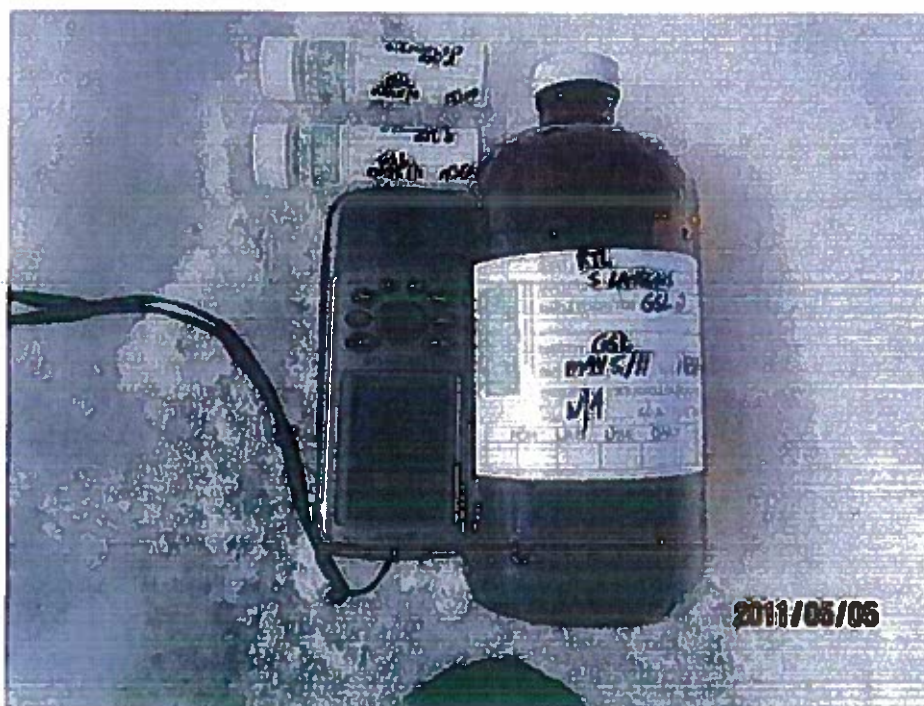
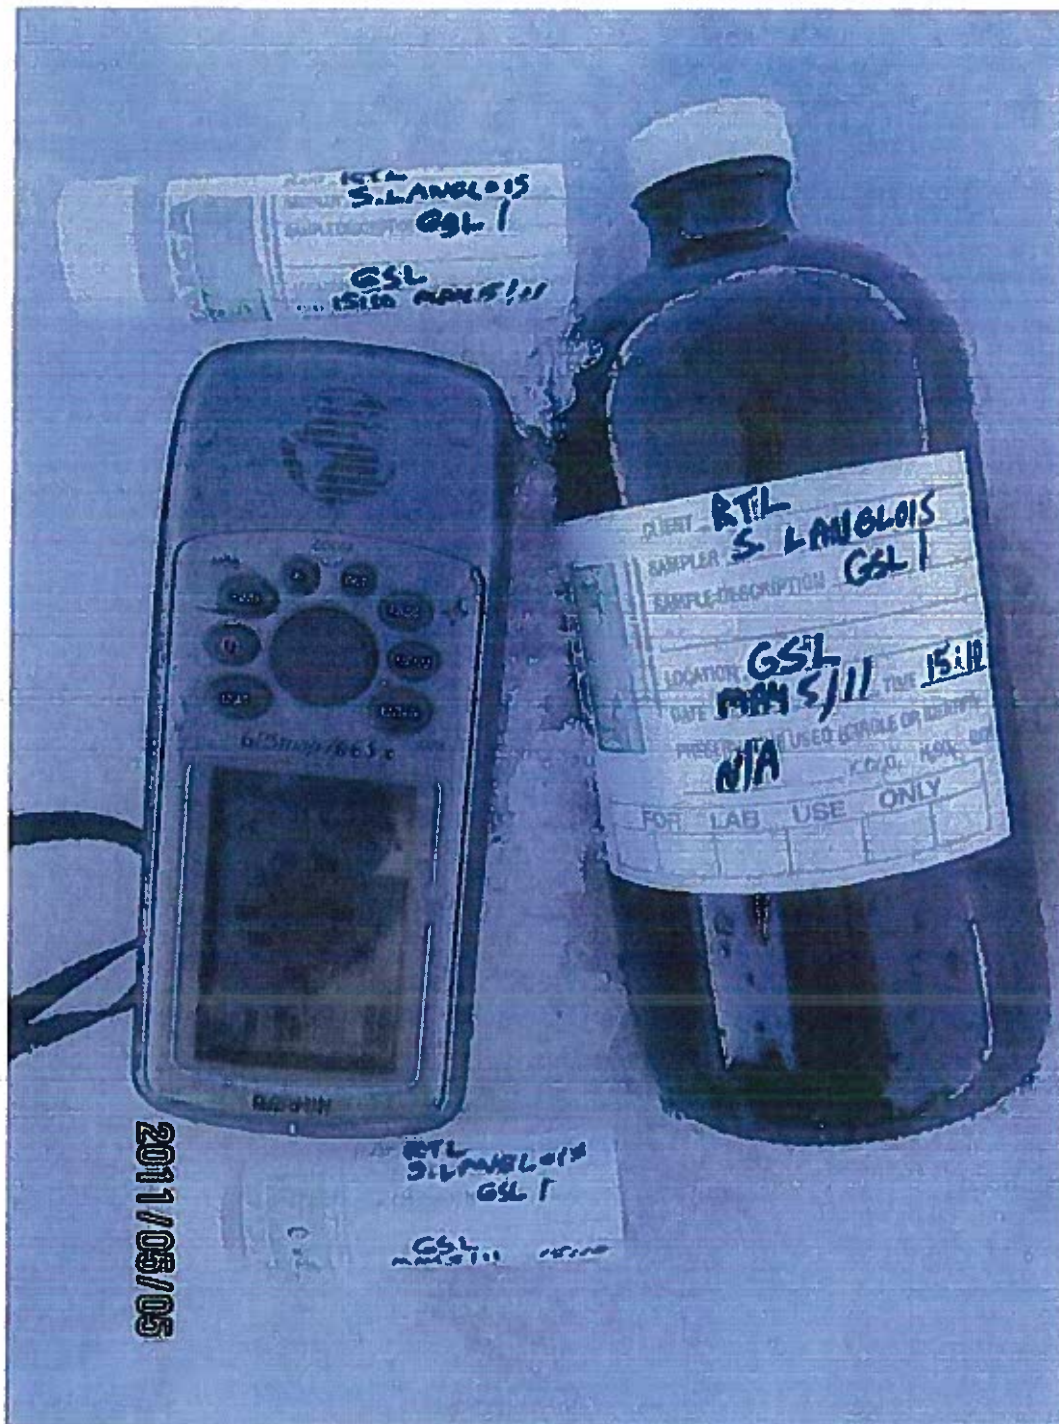
May 5, 2011 Inspection, Test Hole Pictures

On May 5, 2011 RTL traveled to the "break through" location 3.5 Km's SE of the Pilot Islands to inspect for hydrocarbons. We drilled four test holes through the ice at approximately a 25 m radius around the equipment and one more directly above. All of the ice and water samples inspected showed no evidence of Hydrocarbons in the water and no smell. All water was clear and cold. The snow and ice was clean and pure with no residue. Water Samples were taken and examined at the Taiga Water Lab for Hydrocarbons and other pollutants...NONE were found. Please see attached report.
