RE: ENVIRONMENTAL ASSESSMENT METALLURGICAL PILOT PLANT
AND UNDERGROUND DECLINE DEVELOPMENT AND EXPLORATION
DRILLING (MVEIRB FILE 01-002)

**Re: Prairie Creek Mine Tailings Impoundment Facility, NT
GNWT-RWED and DIAND Information Requests**

**Re: Prairie Creek Mine Tailings Facility
Summary of Past Work and Preliminary Recommendations for Rehabilitation**

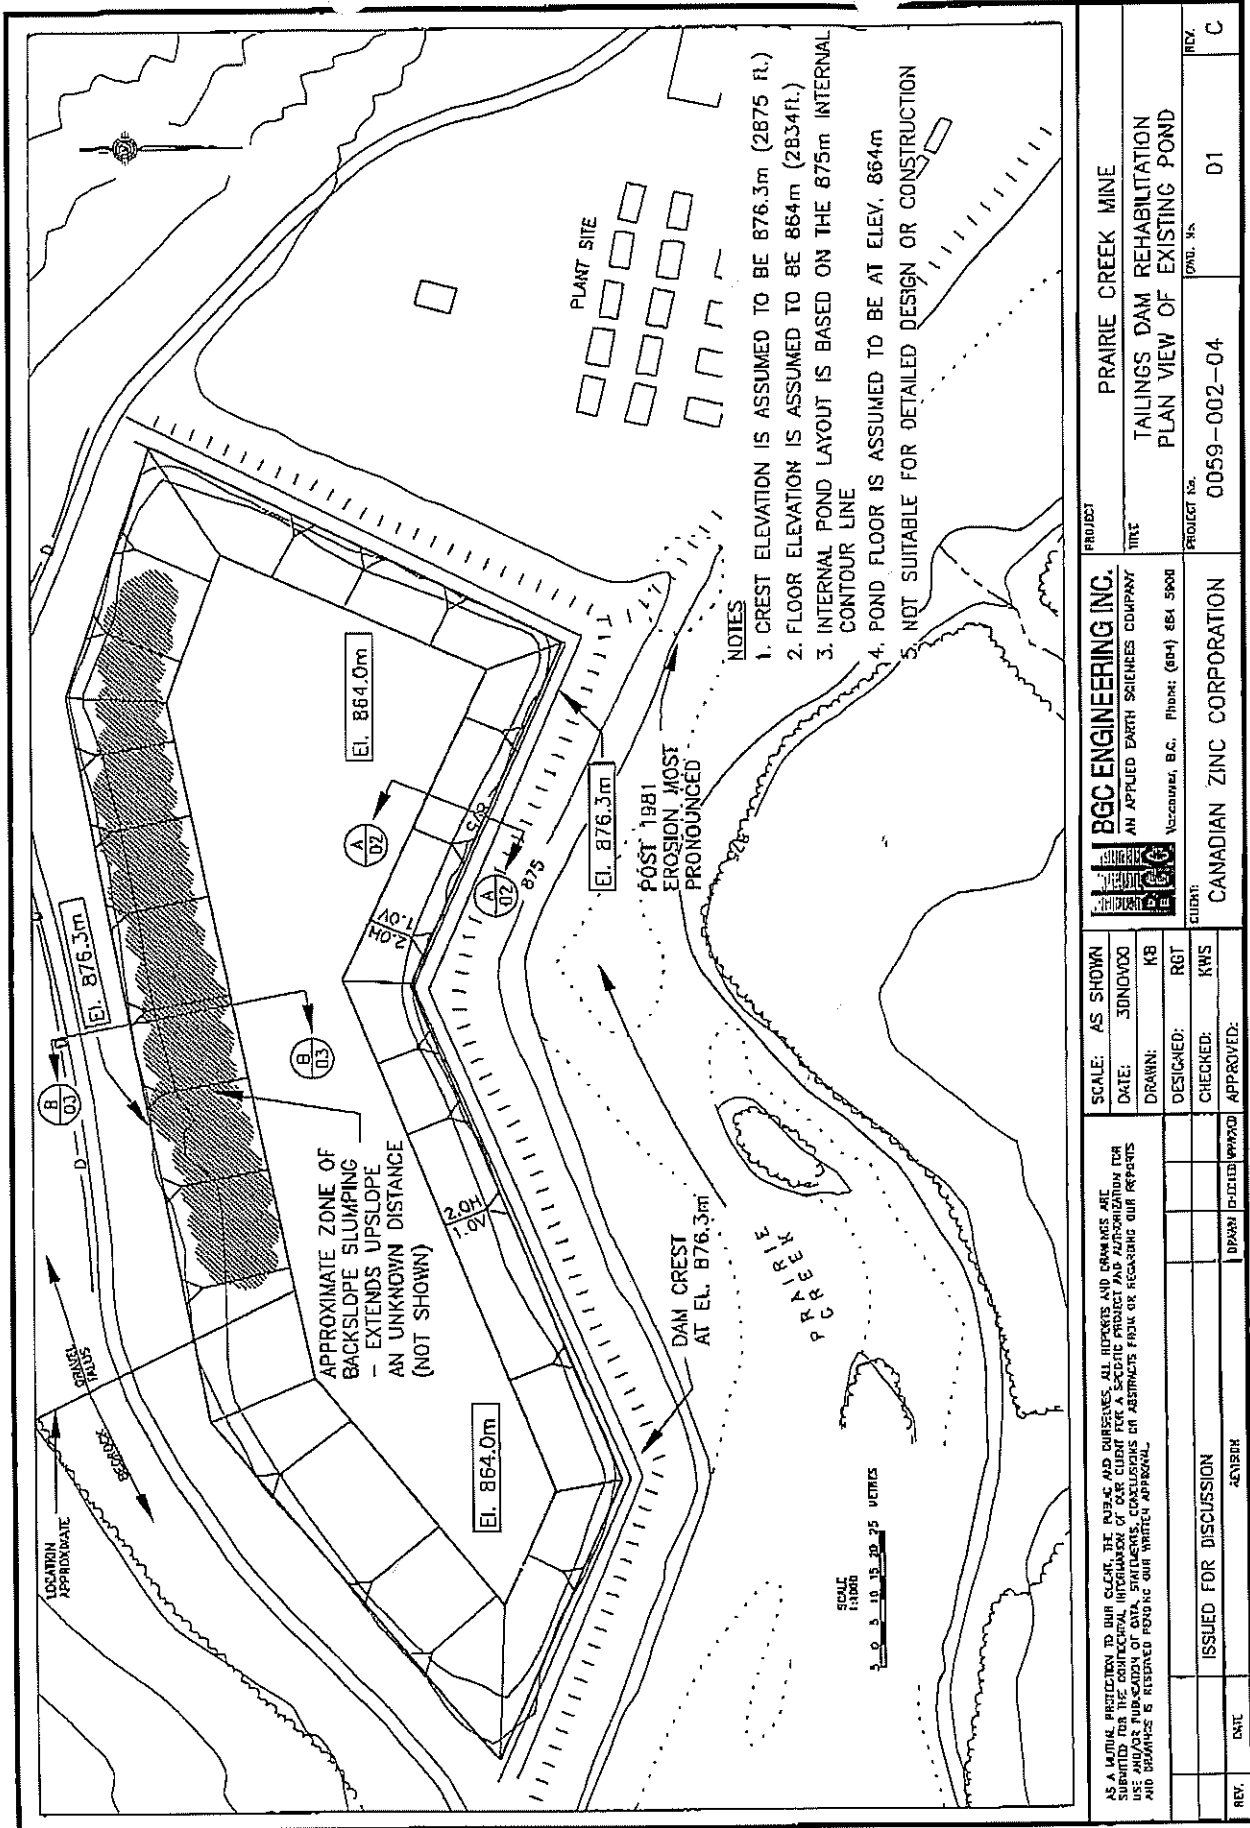
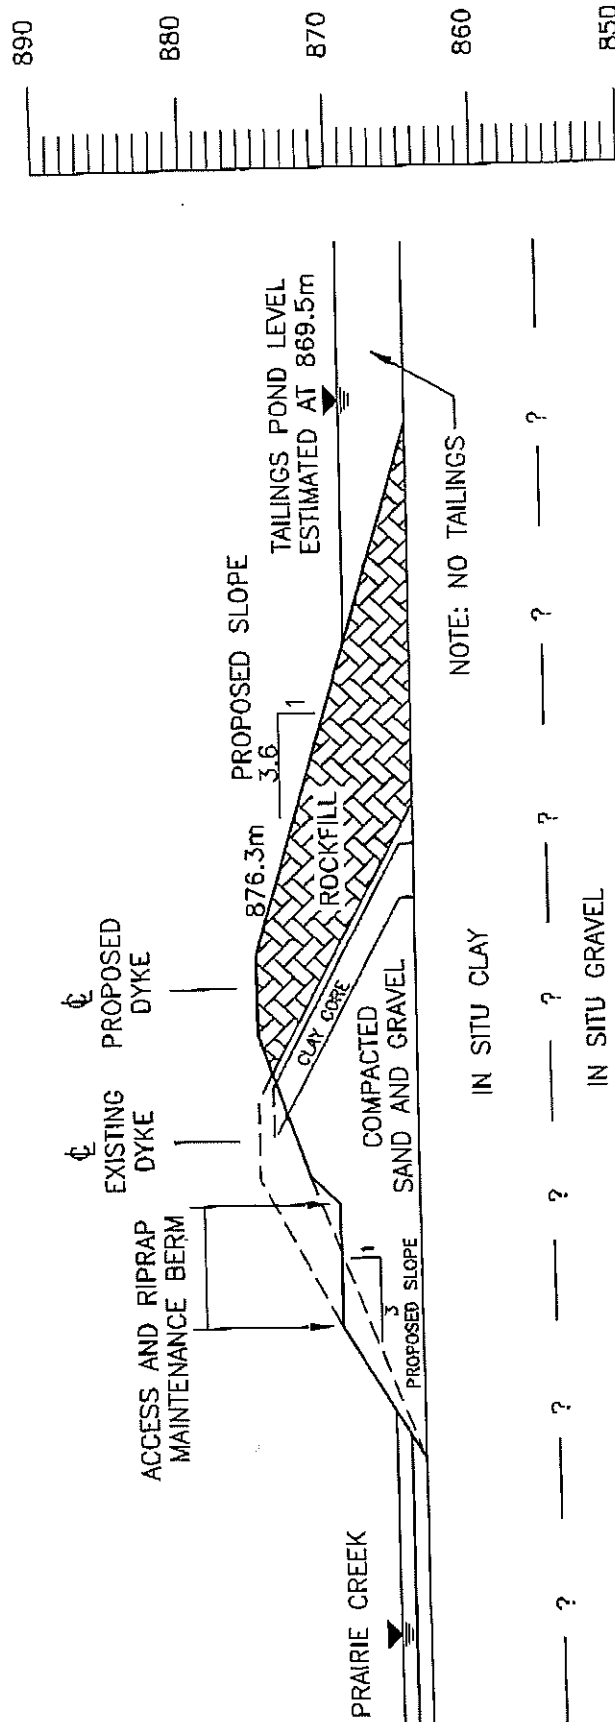
EMBANKMENT RE-CONFIGURATION WORST CASE

The "worst case" scenario adopts the very conservative assumption that residual strengths are operative across the entire embankment foundation and must be used for both the upstream and downstream slope designs. The use of residual strength gives the

We emphasize that the foregoing estimate is what we believe to be a "worst-case" or upper bound scenario for the embankment. If subsequent geotechnical investigations and/or operational monitoring indicate less than peak strengths are mobilized in the foundation clay, Drawings 06 and 07 show that further re-design flexibility is available and could be implemented, as needed. This could apply on a local basis even after the "most likely" scenario has been adopted and operations are underway.

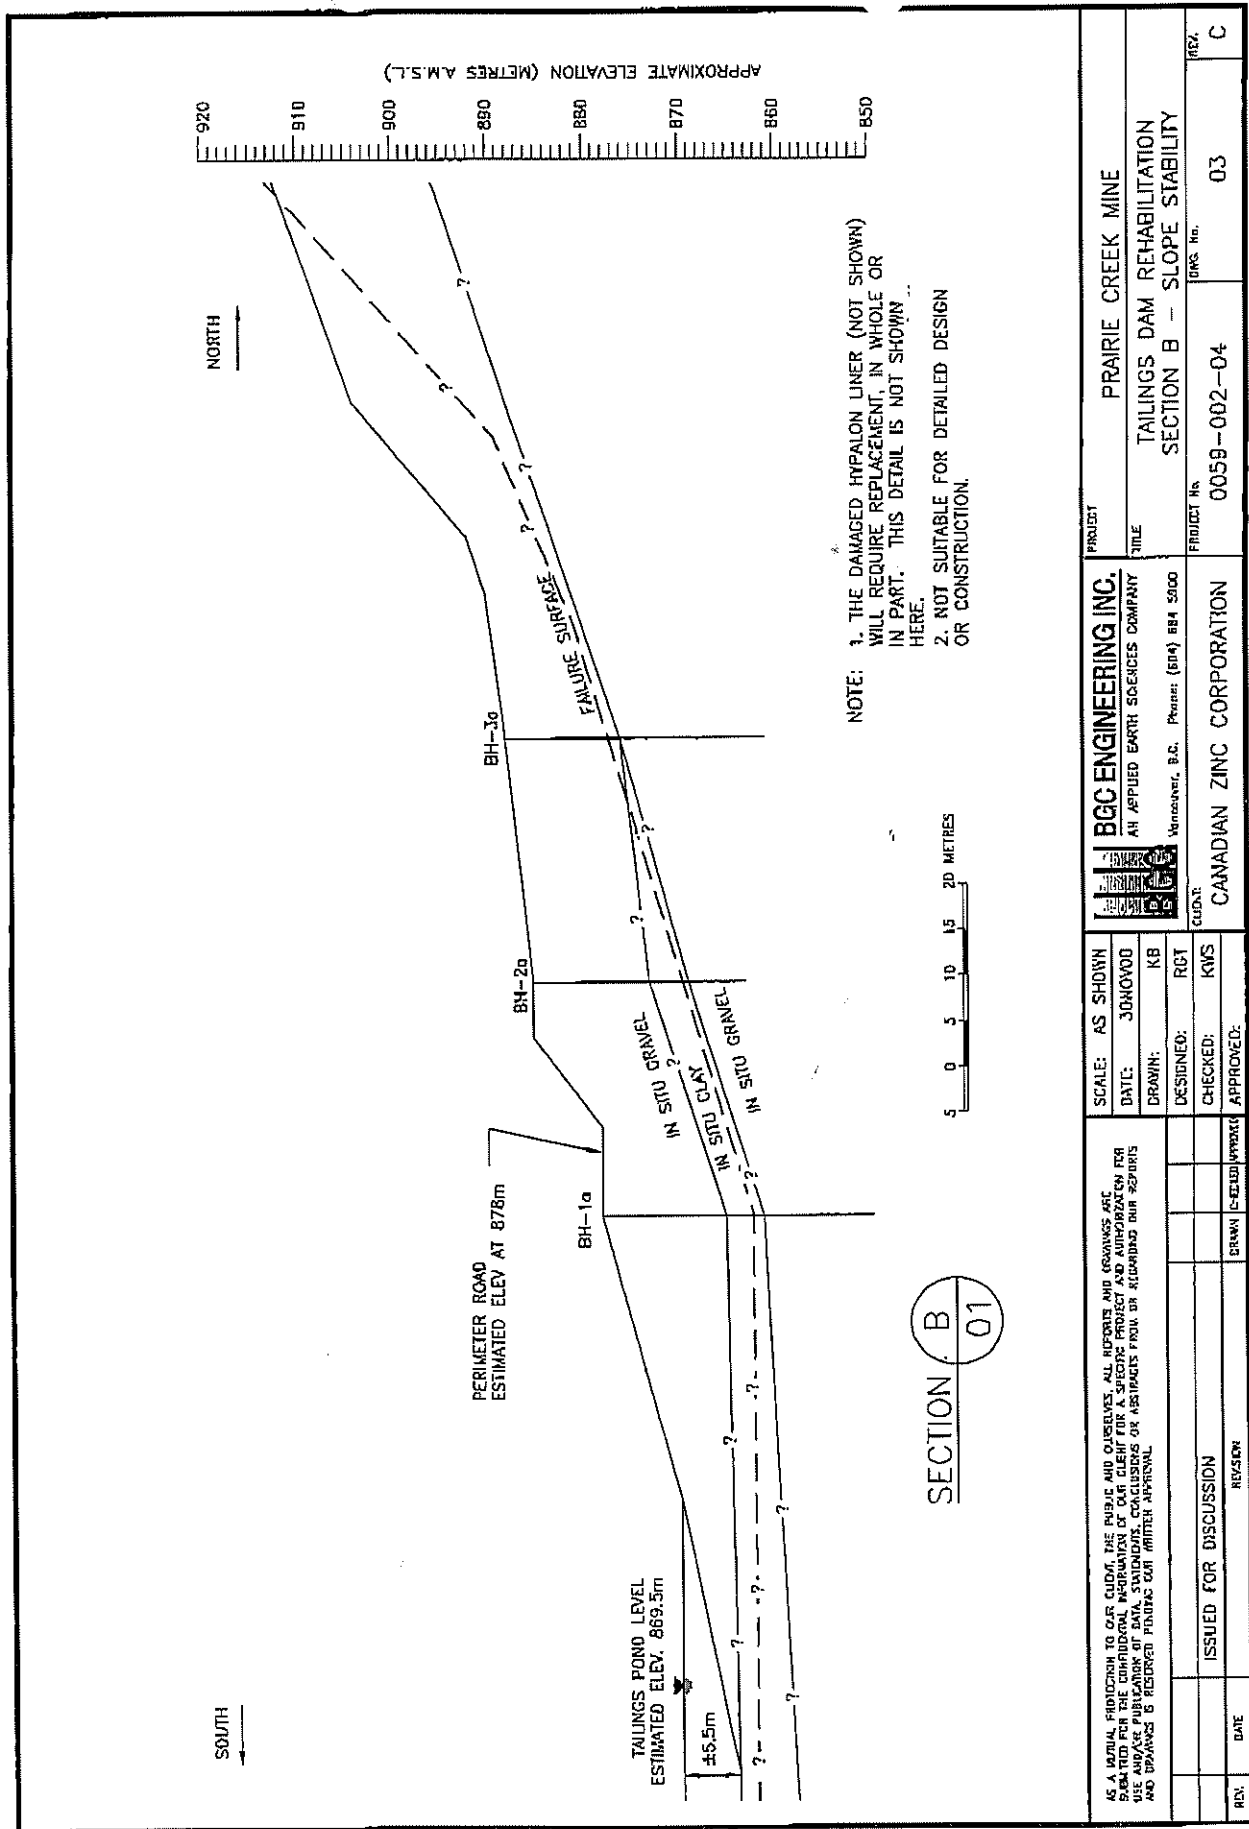
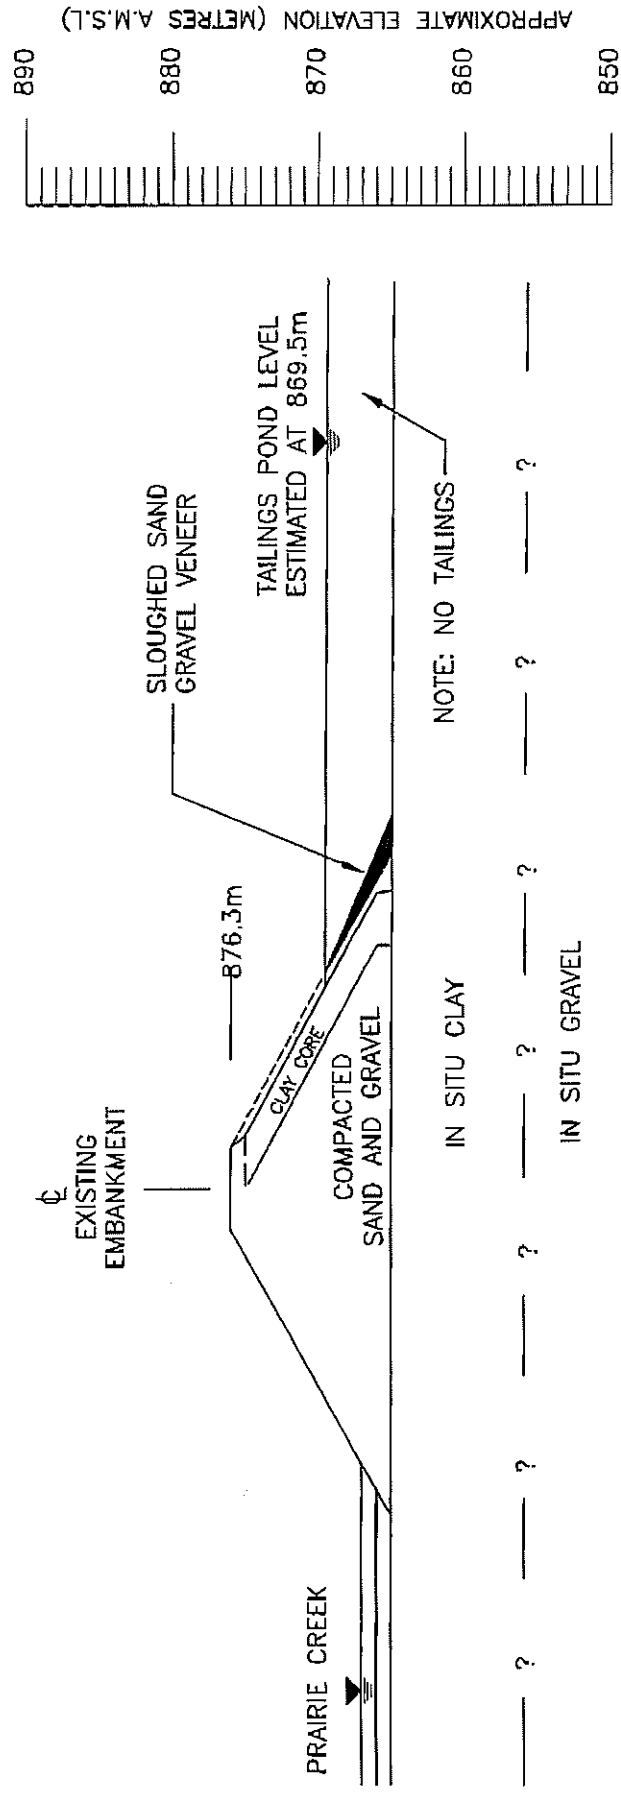
EMBANKMENT RE-CONFIGURATION
MOST LIKELY CASE

Tension cracks were noted along the crest of the embankment during construction. Shallow movements affected the upstream face in June 1982 in association with a period of heavy rain. By 1985, gravel covering the impervious clay core had almost completely sloughed into the pond (Section A, Drawing 02).

Movements affecting the upstream face of the embankment involved shallow planar slippage along the pond-side contact between the upstream high plastic core and the sand and gravel cover separating it from the tailings pond (see Drawing 02). The tension cracks observed along the top of the embankment before slippage occurred are interpreted here as the precursor to these planar movements. Visual examination of the upstream clay core in the four test pits excavated in 1994 - 1995 indicated that the core was essentially intact. Hand measurement of shear strength by field vane and pocket penetrometer indicated that the main body of the clay core fill had high strength and it appeared stable. Seasonal freeze-thaw had caused slight overconsolidation and development of a faint fissure structure.

During construction, it is considered likely that the outside edge of the clay core (about 200 to 500mm wide) received little or no compaction during placement due to physical limitations of the compaction equipment. A steel drum or rubber tire soil roller compacting in lifts cannot compact fully to the edge of the lift. This loose edge zone of poorly compacted clay is believed to have had insufficient strength to support the thin sand and gravel cover and collapsed on wetting. Substantial slumping of the sand and gravel core cover took place following heavy rain in the period prior to 1985 and left the embankment structure in its assumed present configuration (Drawing 02).

A considerable amount of sand and gravel is present at the upstream toe of the embankment as illustrated schematically in Drawing 02. Whether this needs to be added to, in whole or in part, before operations commence will depend upon how initial waste disposal operations are planned. The sequencing of sand and gravel cover replacement above the current pond elevation of approximately 869.5m, if necessary, should be considered during the next phase of study in conjunction with optimization of operational alternatives. Additionally, the thickness uniformity and integrity of the impervious clay core will also have to be investigated further during the next phase of study. For the time being, we recommend that Canadian Zinc allow for a \$150,000 up front cost to deal with these issues under the "most likely" scenario.

The next phase of geotechnical investigations should be planned to focus on the potential extent of the embankment and foundation movements and, if necessary, a means of managing the movements to achieve acceptable factors of safety over the long-term. Management should involve minimizing pre-development capital costs in favour of achieving the desired factors of safety using alternative operational means of placing materials.

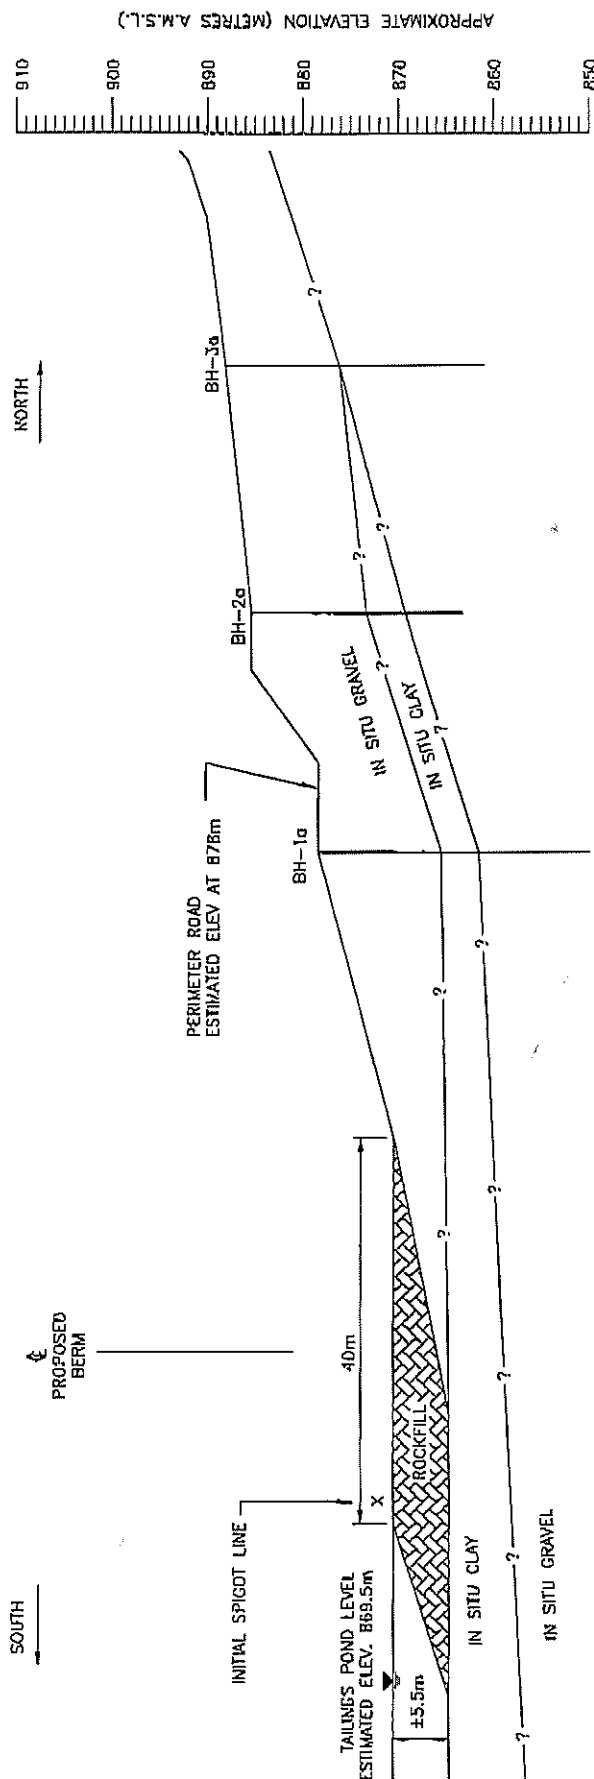
SECTION B

Movements ranging from shallow to moderately deep-seated and causing distortion and local tearing of the synthetic liner and underlying bedding and drain materials began during the late construction period and continued for several years. Permafrost degradation was believed to have been a contributing factor to these ground movements. Drawing 03 shows a profile along Section B derived from a field survey made at BGC's request in 1994.

failure surface are shown in Section B, Drawing 03. The surface is seated in a high plastic clay that may have been pre-sheared as a result of prior movements along the left valley slope of Prairie Creek. This mechanistic interpretation means that the mobilized strength of the clay beneath the backslope at the time movements began was somewhere below peak and approaching the residual value. A pervasive surface of sliding has developed, however, hence strengths used in re-design must be residual values.

The backslope movements were almost certainly exacerbated by development of excess pore pressures due to ground ice melting. Thaw-generated excess pore pressures can be expected to be significantly lower than when movements began because of deep permafrost degradation and significant attenuation in the rate of thaw in the intervening almost twenty years since backslope grading.

NOTE: THE DAMAGED HYPALON LINER MAY REQUIRE REPLACEMENT, IN WHOLE OR IN PART. THIS DETAIL IS NOT SHOWN HERE.

The backslope will require re-design, but we believe a more routine, "thawed soil mechanics" approach is appropriate. Of particular importance in the re-design is that available strengths on the deep-seated failure surface are limited to residual rather than peak values.

Drawings 03 and 08, we believe the synthetic liner does not have to be replaced under the rock berm. It may, however, still be needed at the margins of the berm. This will be a key focus of the next phase of geotechnical studies. For the time being, we recommend that Canadian Zinc allow for a \$150,000 cost related to the synthetic liner.
