## **APPENDIX 10**

**Date:** September 9, 2014  
**From:** John Wilcockson  
**To:** David Harpley, Canadian Zinc Corp  
**Subject:** Habitat Assessment of Sundog Creek Channels for Realignment- DRAFT

HCP Ref No.: CZN6788

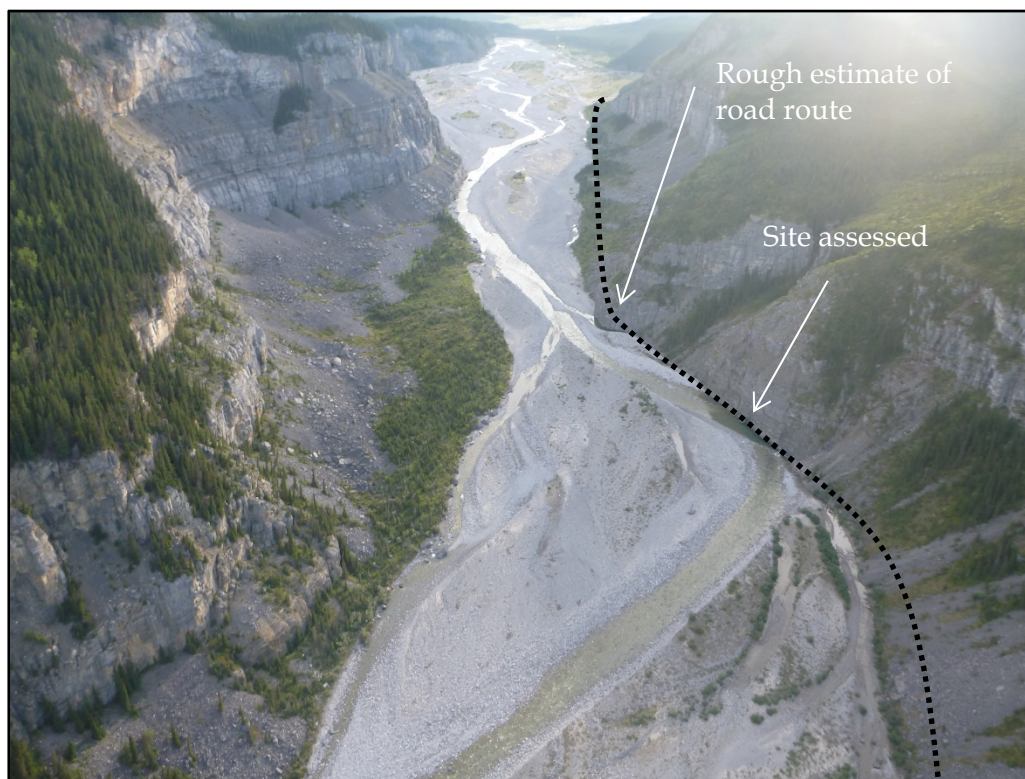
**Figure 1** Lower realignment location, site 1, facing downstream, Sundog Creek, July 27, 2014.

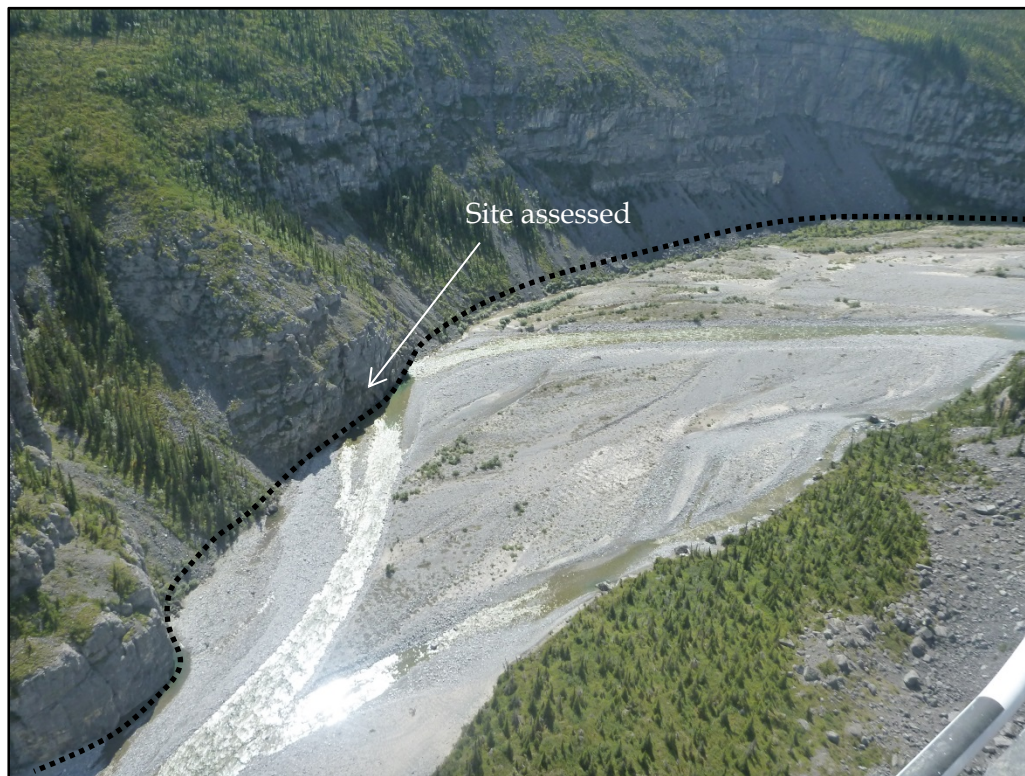
**Figure 2** Lower realignment location, site 1, facing upstream, Sundog Creek, July 27, 2014.

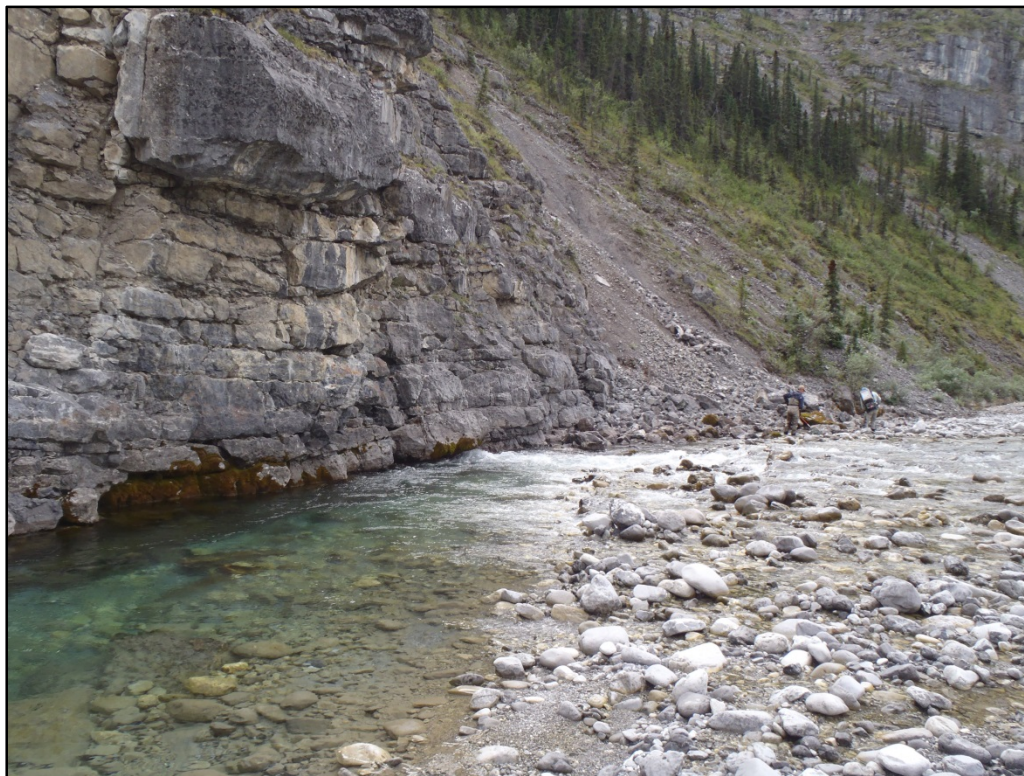
**Figure 3** Lower realignment location, site 1, facing upstream, Sundog Creek, July 27, 2014.

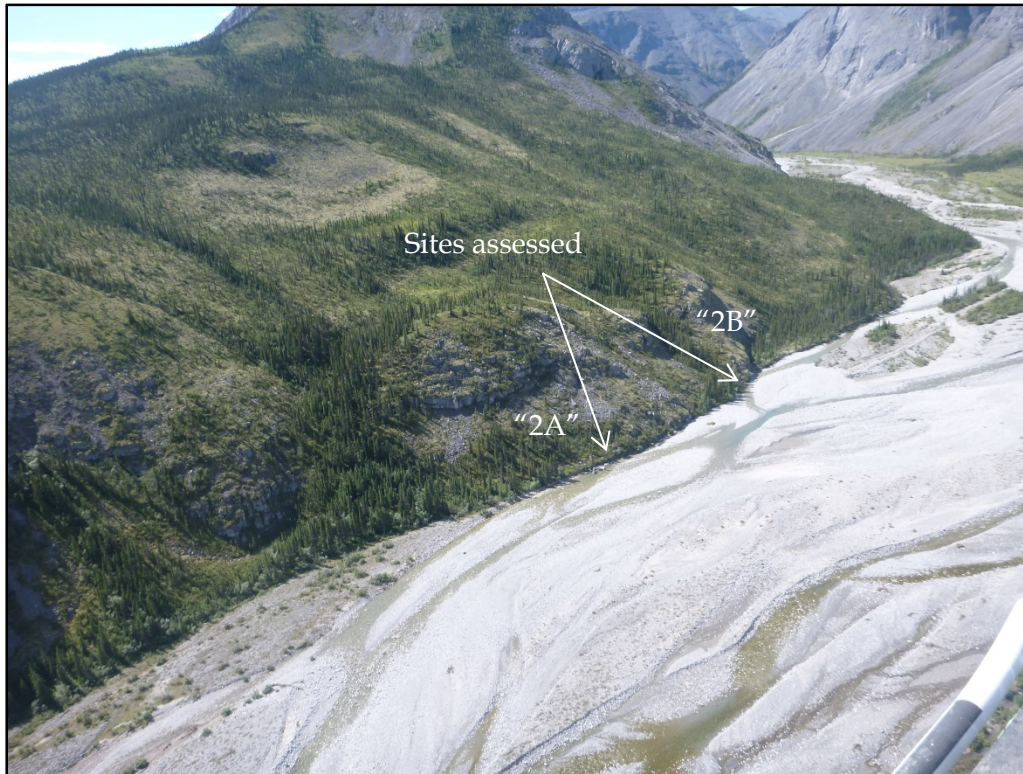
**Figure 4** Upper realignment location, sites 2A and 2B, facing upstream, Sundog Creek, July 27, 2014.

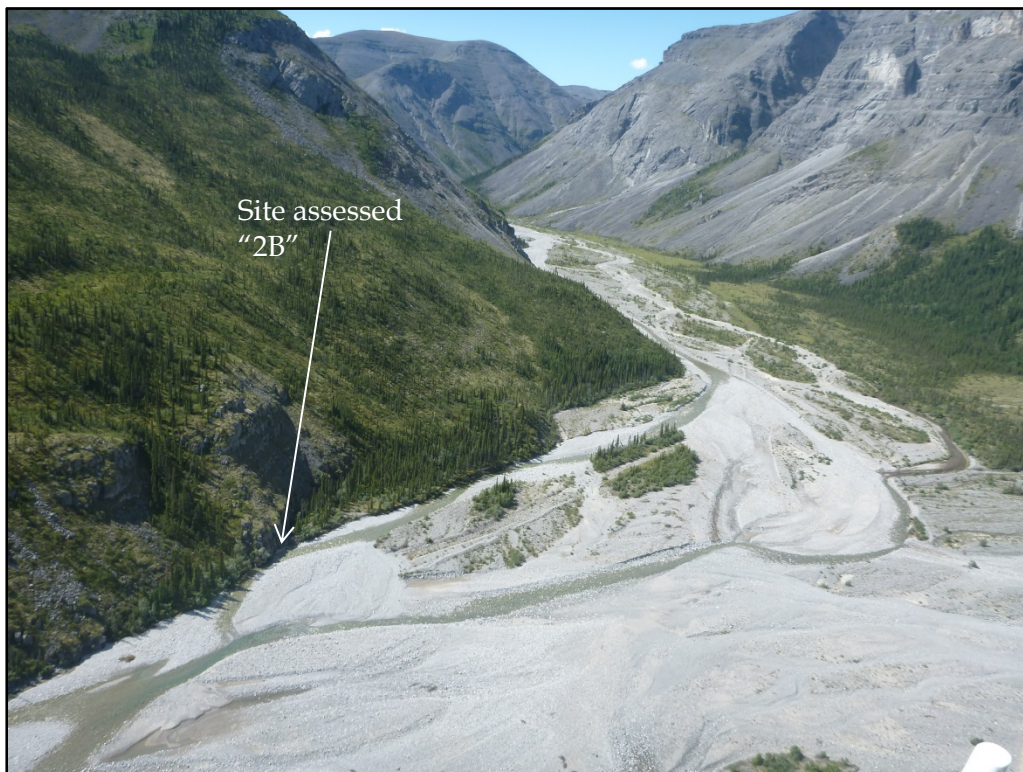
**Figure 5** Upper realignment location, site 2B, facing upstream, Sundog Creek, July 27, 2014.

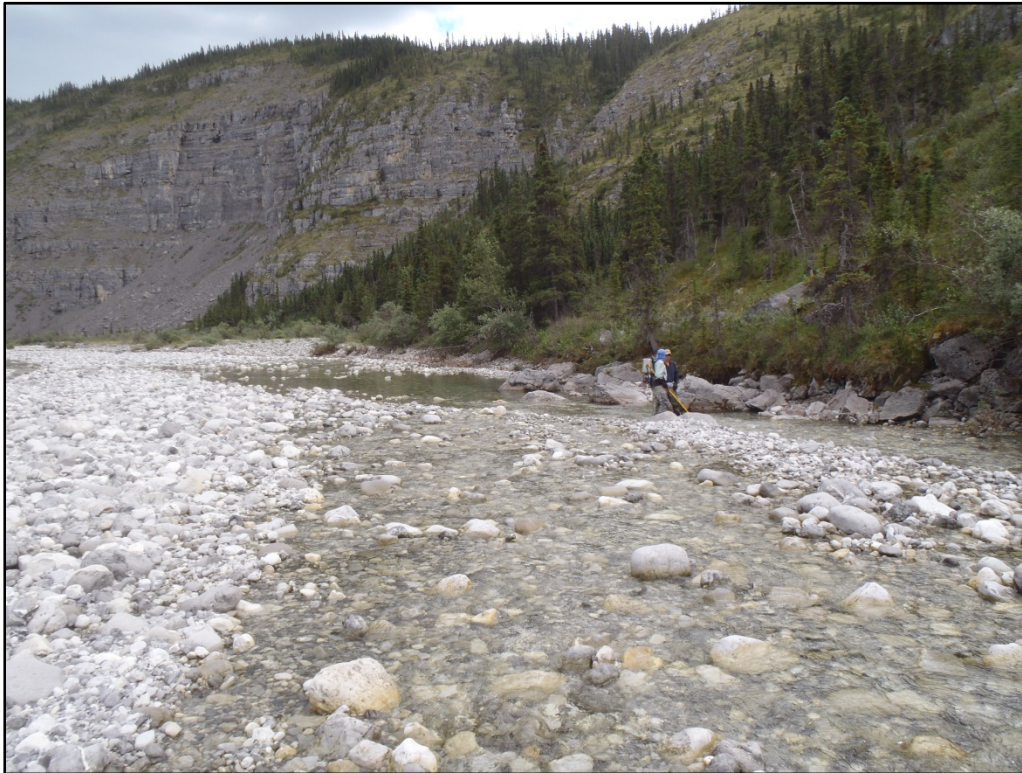
**Figure 6** Upper realignment location, site 2A, facing downstream, Sundog Creek, July 27, 2014.

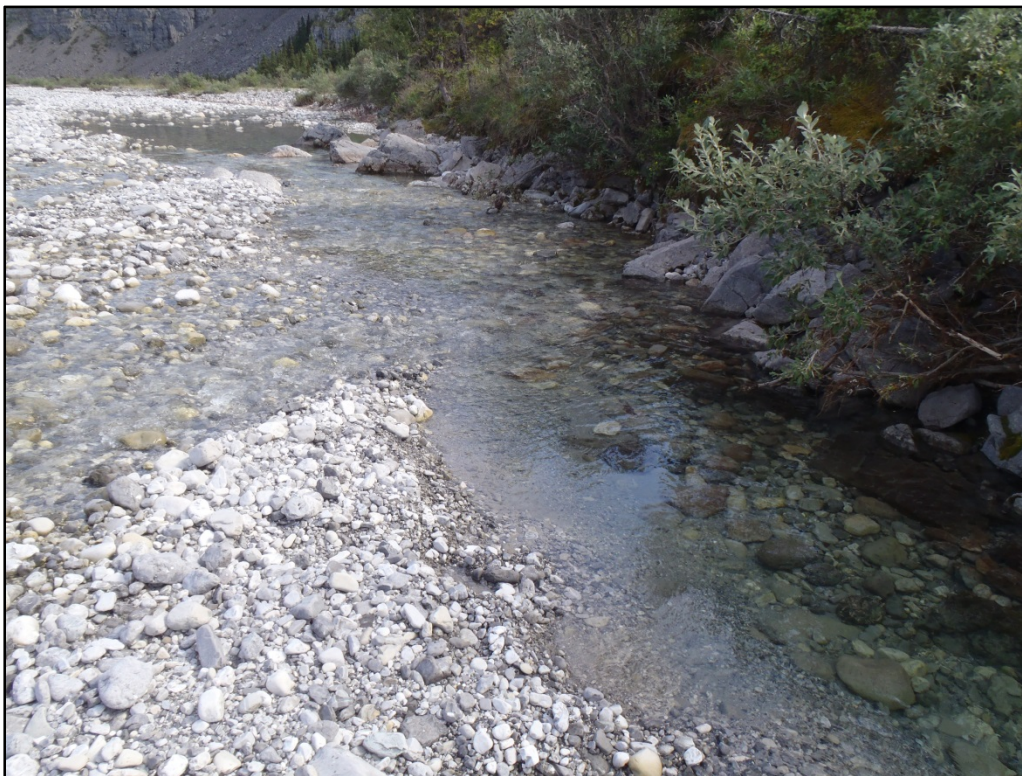
**Figure 6** Upper realignment location, site 2A, facing downstream, Sundog Creek, July 27, 2014.

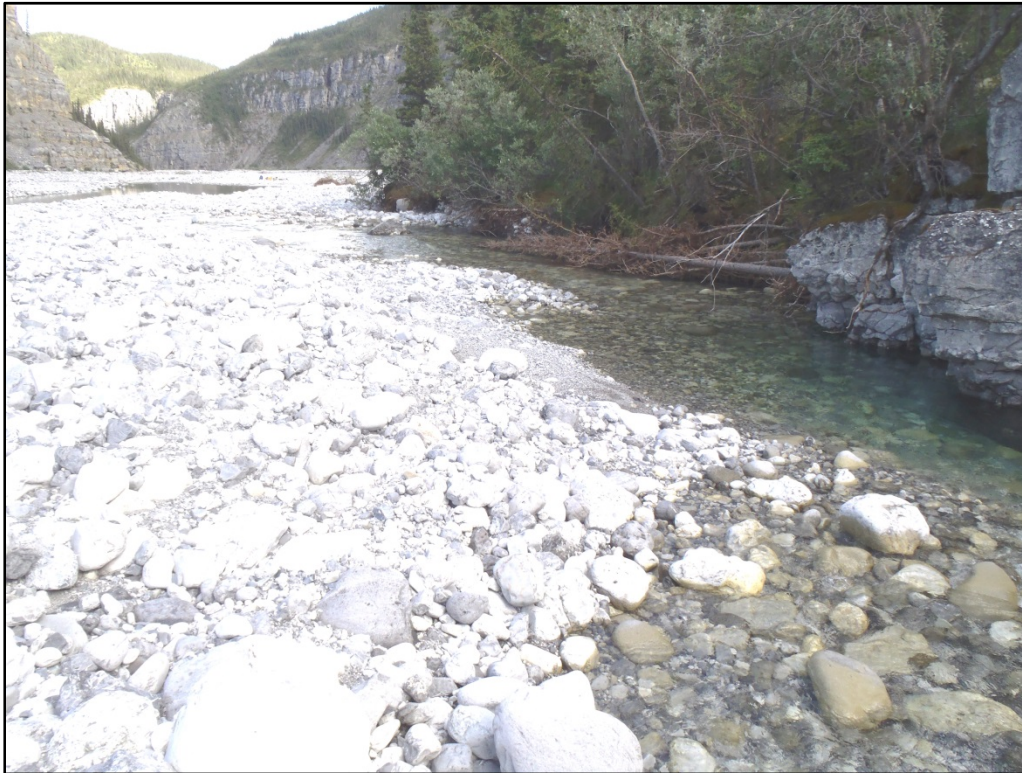
**Figure 7** Upper realignment location, site 2A, facing downstream, Sundog Creek, July 27, 2014.
