GEOTECHNICAL EVALUATION AND DEVELOPER'S ASSESSMENT REPORT SECTIONS FOR PROPOSED PRAIRIE CREEK ALL-SEASON ROAD NEAR NAHANNI BUTTE, NORTHWEST TERRITORIES

PRESENTED TO Canadian Zinc Corporation

MARCH 2015 ISSUED FOR USE - REV 01 FILE: Y14103320-01 This page intentionally left blank.

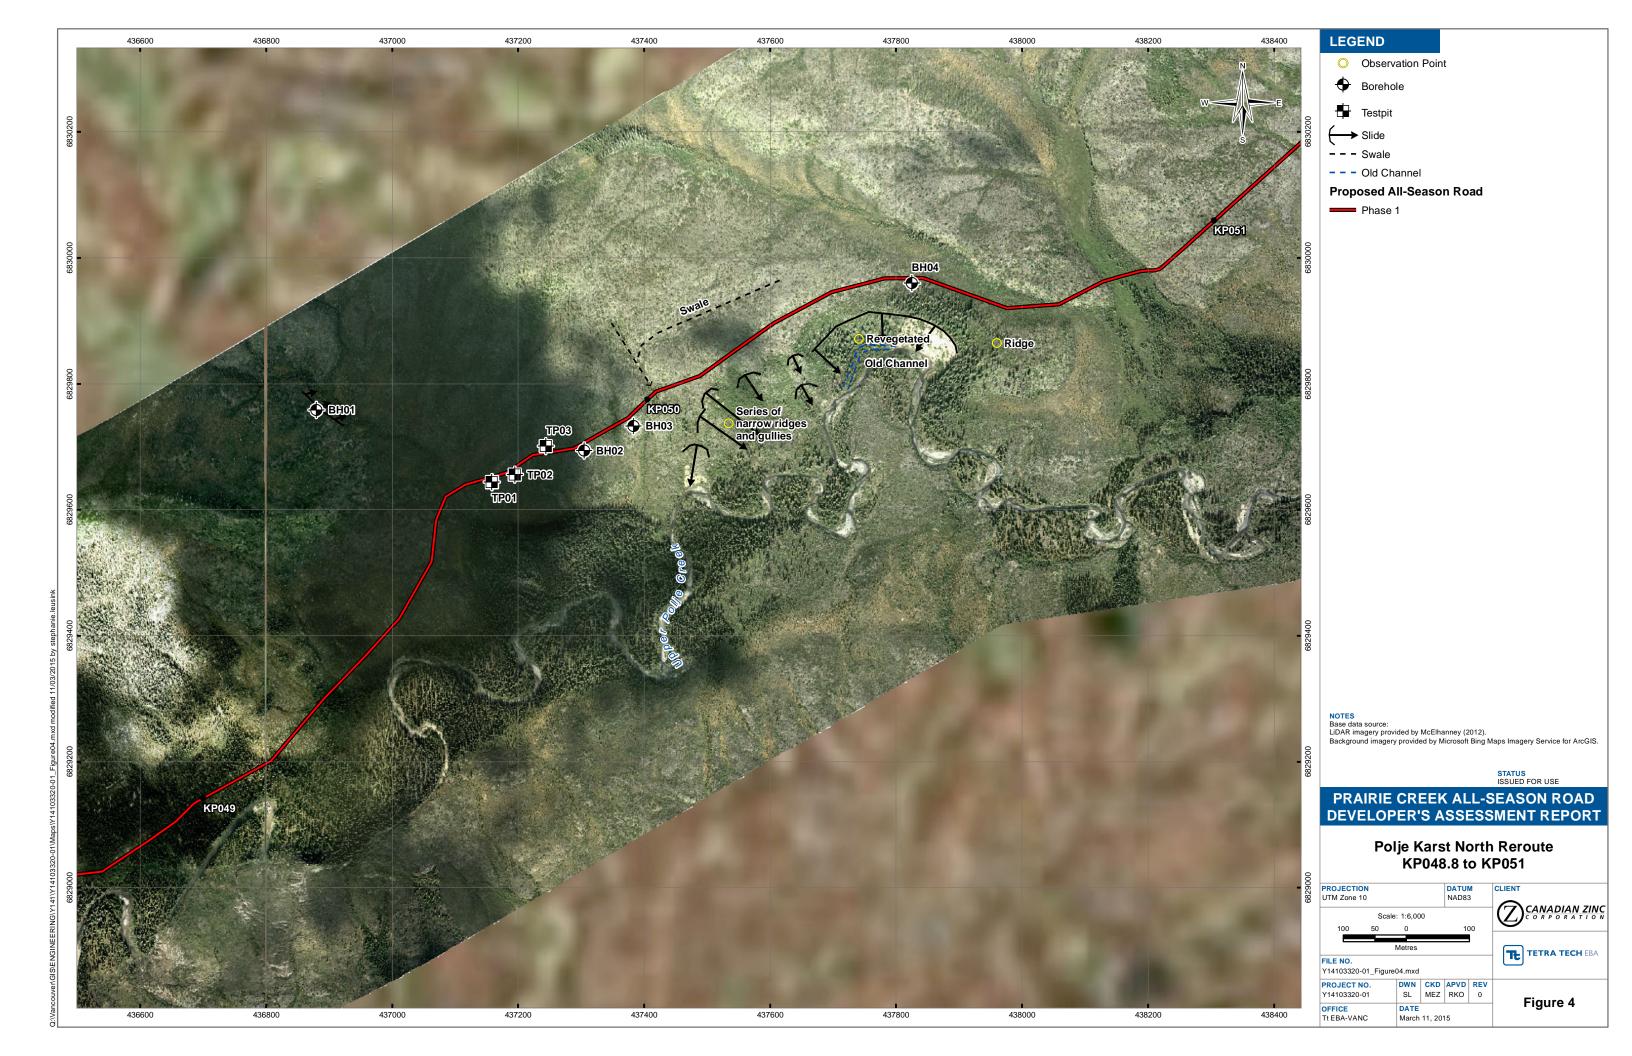
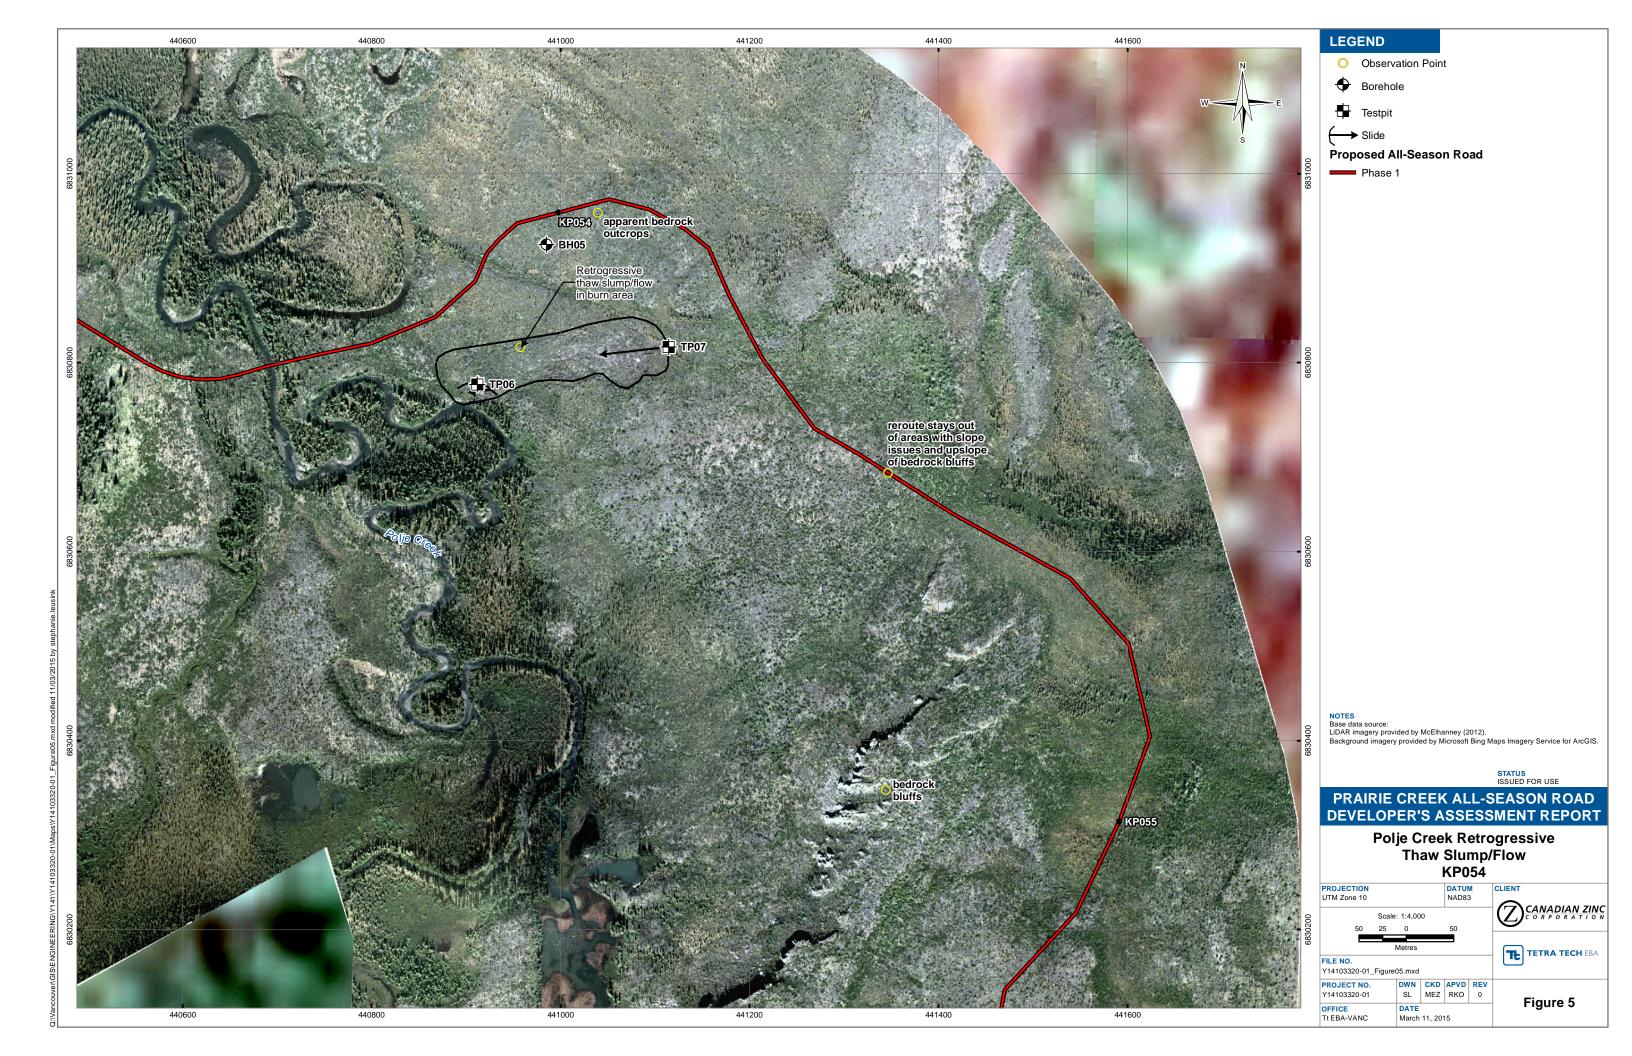
Just east of the Polje Creek crossing, a retrogressive thaw slump/flow was investigated. Here, the soils return to silt and clay with some variations noted (Figure 5, BH-05, TP-06 and TP-07). Underlying a PEAT layer of about 300 mm thickness, it appears there is a layer of colluvium, or perhaps reworked till, which shows evidence of having been modified by water, consisting of a layer of SILT, which varies from clayey to trace clay, with some sand to sandy, and trace gravel. This material is layered and sometimes varved (TP-07) with coarser particles interspersed between finer-grained layers. Also in TP-07, which was located at the headscarp of the thaw slump/flow, a layer of medium to coarse-grained sand and trace gravel, over a discontinuous layer of shale boulders was encountered. These layers were not seen downslope in TP-06, about 30 m above the toe of the thaw slump/flow. Beneath the silts, sands and/or boulders, silty clay was encountered, interpreted at TP-07 as CLAY TILL (or till-like, in any case). This material contained 61% clay, 38 to 39% silt, and up to 1% sand, and was high plastic.

Soil moistures in the clay were 29 to 32% which, although high, and above the plastic limit (29), they are but well below the liquid limit (62) for this material. It is possible that this slope failure is related to thaw of permafrost following the 1996 forest fire (see further discussion under the heading Permafrost, below).

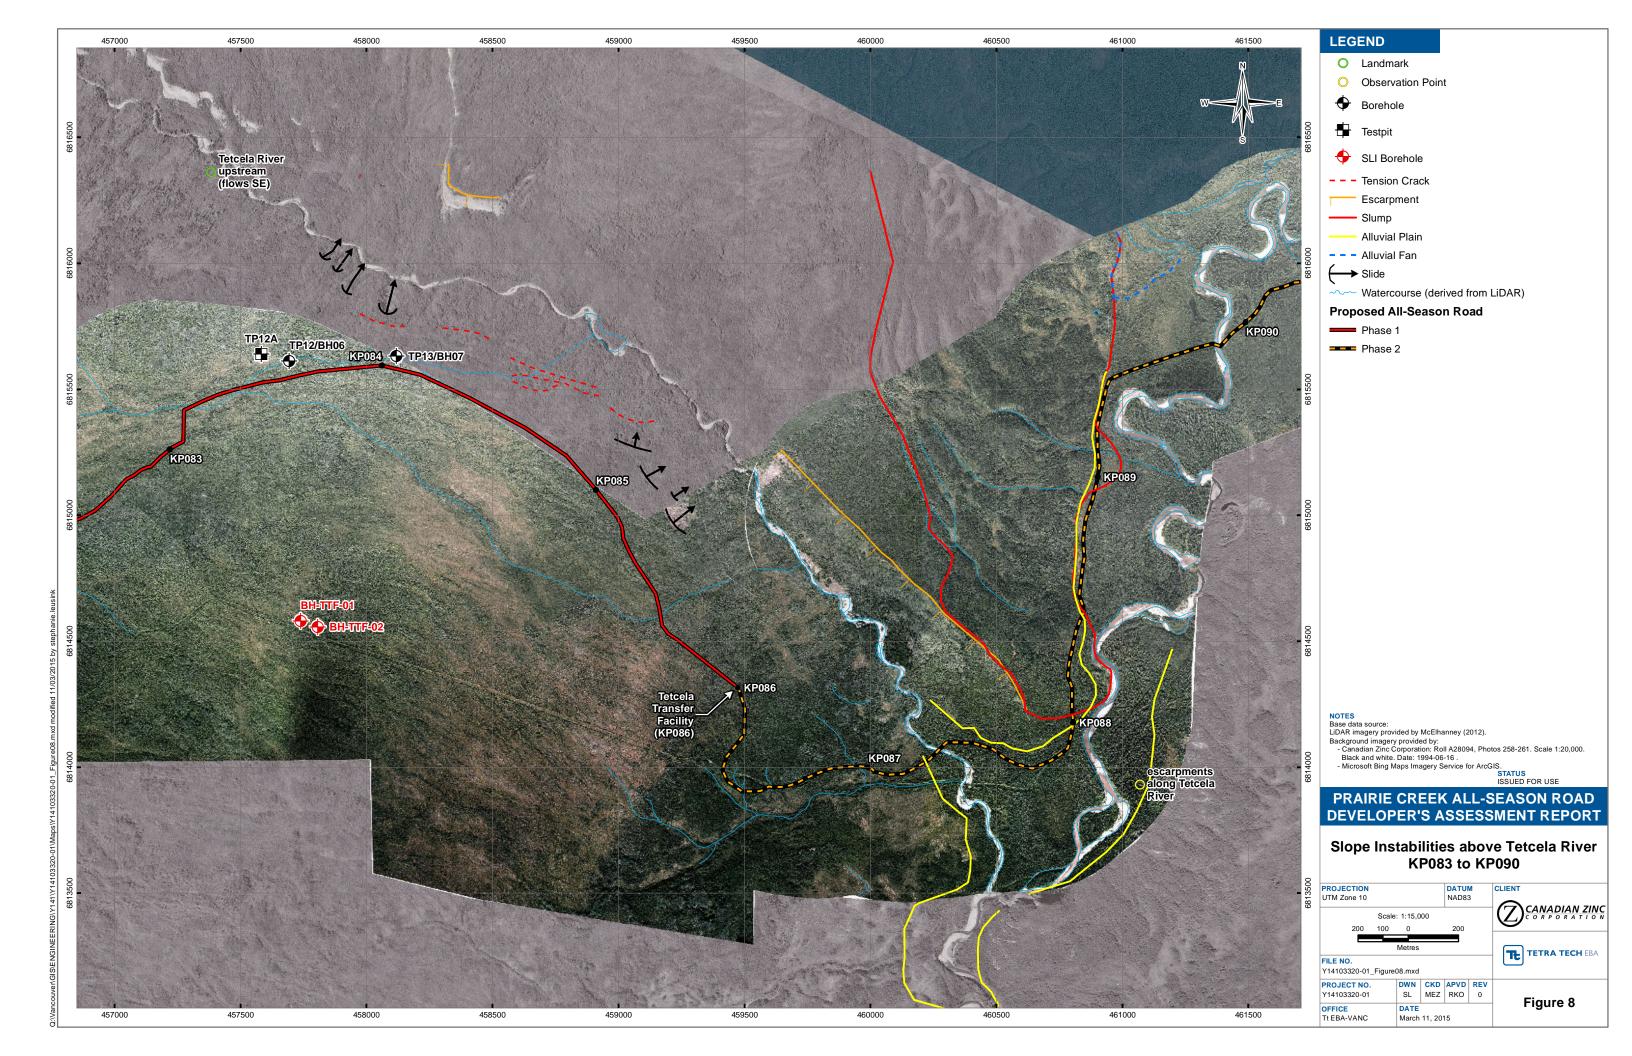
SLI's field findings suggest that permafrost is likely present on this slope. Where water potentially runs year-round (perhaps in the Tetcela River or its tributary), there is probably a talik or unfrozen zone beneath the stream. SLI's findings suggest that the permafrost may only be about 1.1 to 1.5 m thick or slightly thicker on this slope. However, no peat was recorded at the surface of their boreholes, so it is likely that in areas where peat is present, such as on undisturbed slope sections and away from streams, permafrost may appear at a much shallower depth (possibly less than 1 m, depending on the peat thickness), and that permafrost may extend much deeper. Where permafrost is present, the ground temperature is likely to be only slightly below 0°C, especially in areas where the permafrost is quite thin as was encountered by SLI, because it is likely in the process of slowly thawing.

The soils encountered probably have a low to moderate sensitivity to thaw, because these soils have moisture contents that are either at the plastic limit, or above the plastic limit but below the liquid limit. This means that the soils could still creep or possibly fail if they thaw, for example, in the form of a slope failure, but the types of failures occurring would be much more limited than failures that would occur if the soils were ice-rich and hence wetter than the liquid limit.

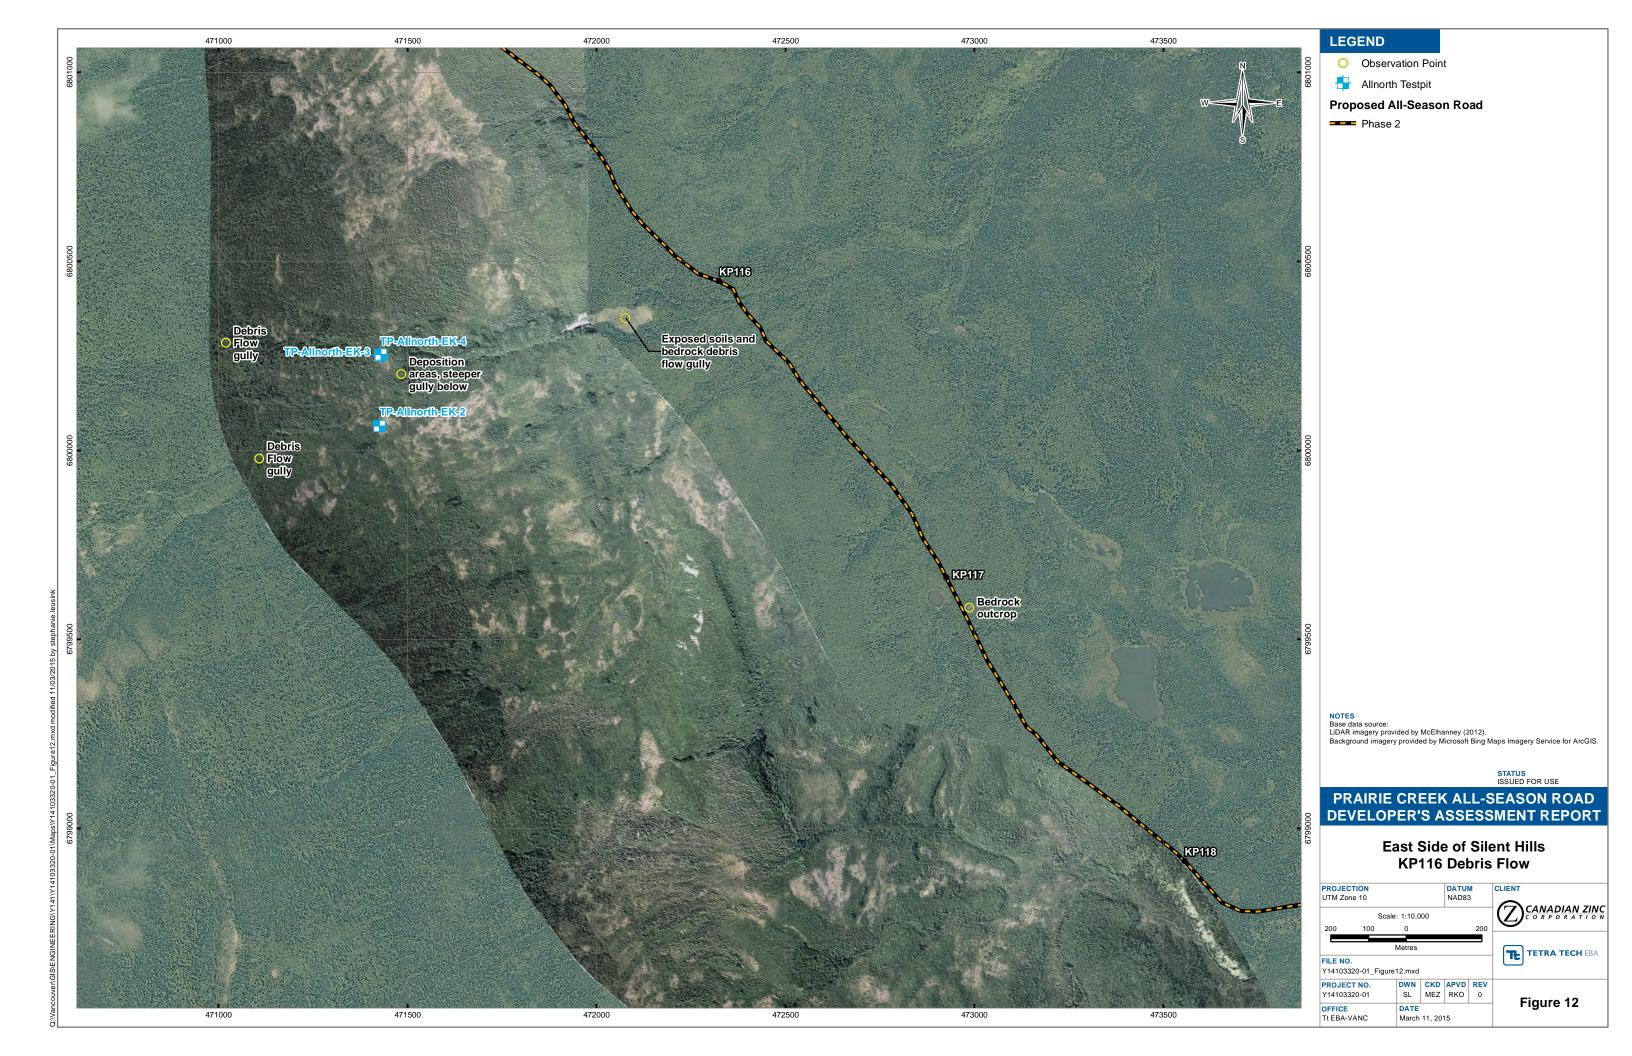
The immediate vicinity of the KP116 stream crossing and further downstream currently appears well-vegetated, but the prevalence of deciduous vegetation in this area suggests these vegetation types are likely indicators of disturbed terrain at this location (Figure 12). Therefore, the road design will need to consider suitable plans for managing a debris flow at some point during its service life, whether it is to build a bridge, or install a crossing over which debris flows can flow without either scouring out the road or having it inundated with debris, install upslope containment measures, or even to install a sacrificial crossing. The most suitable design will depend on the type of event most likely to be experienced at the crossing – scour or deposition – and whether the likelihood of scour or deposition may vary according to the size of event or according to whether successive events change the site configuration, requiring further adaptations in the future. It is noted that ortho-imagery and LiDAR are not available over the full length of the gully, and more detailed topographic data will be needed for detailed design. The route skirts the edge of the glaciofluvial floodplain between KP116 and KP117.5, where the terrain begins to moderate.

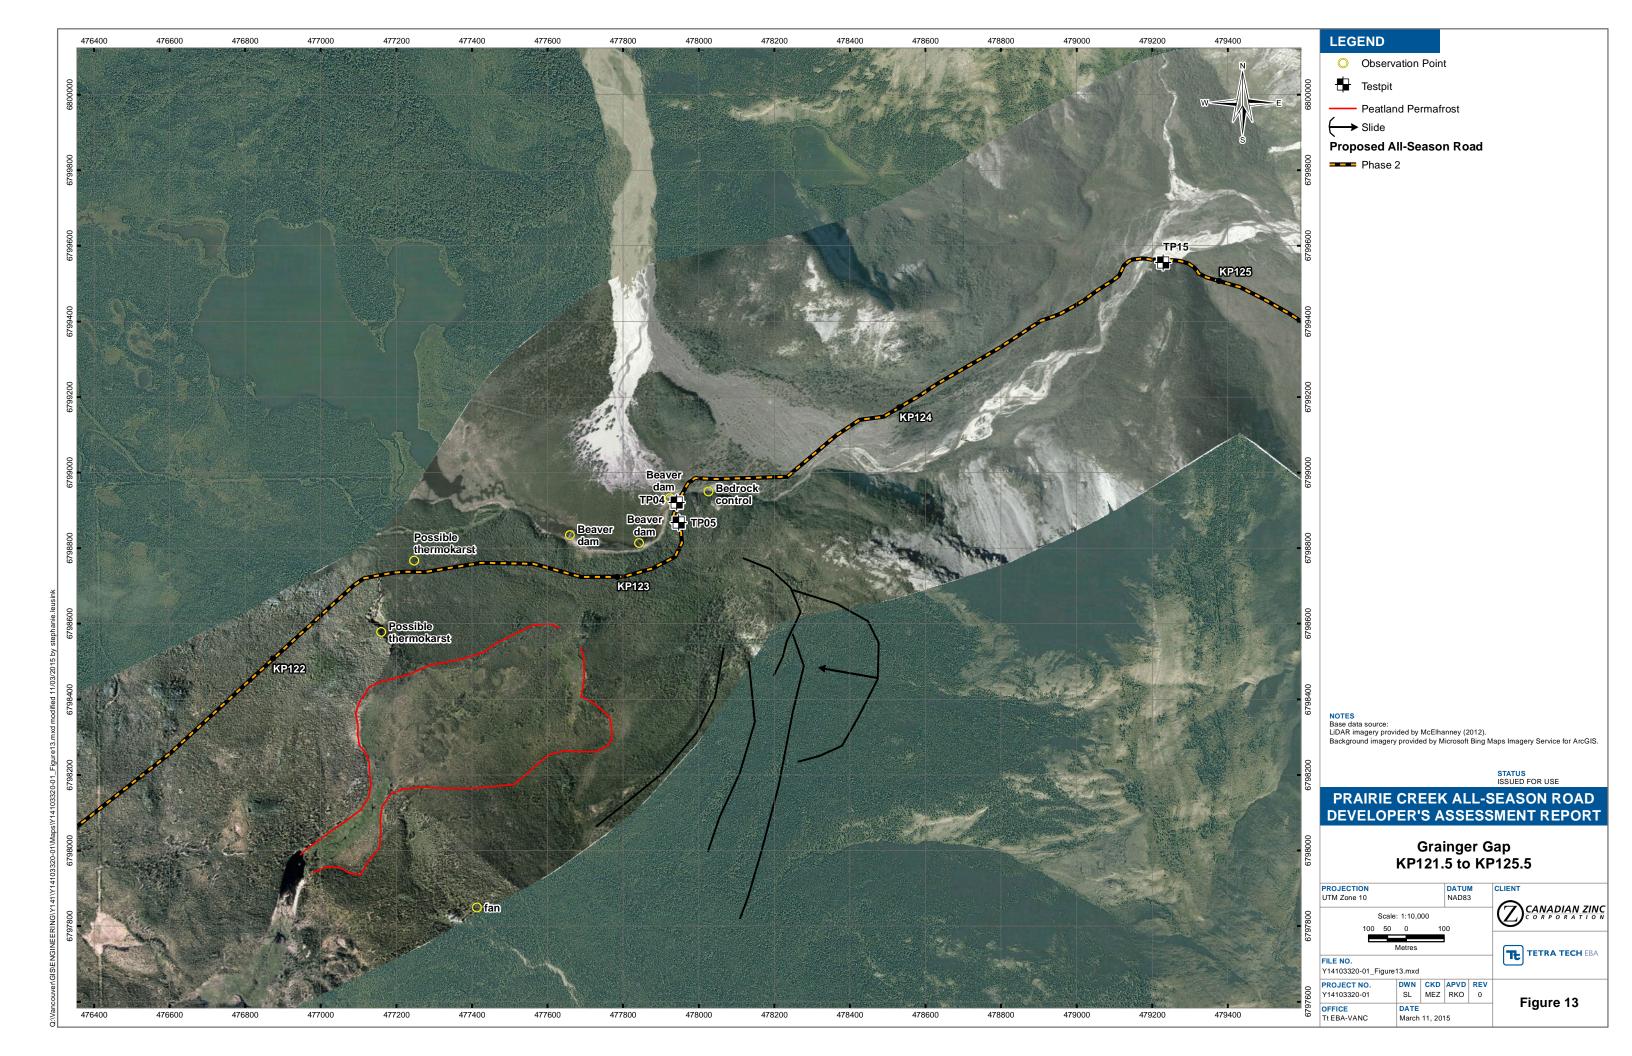
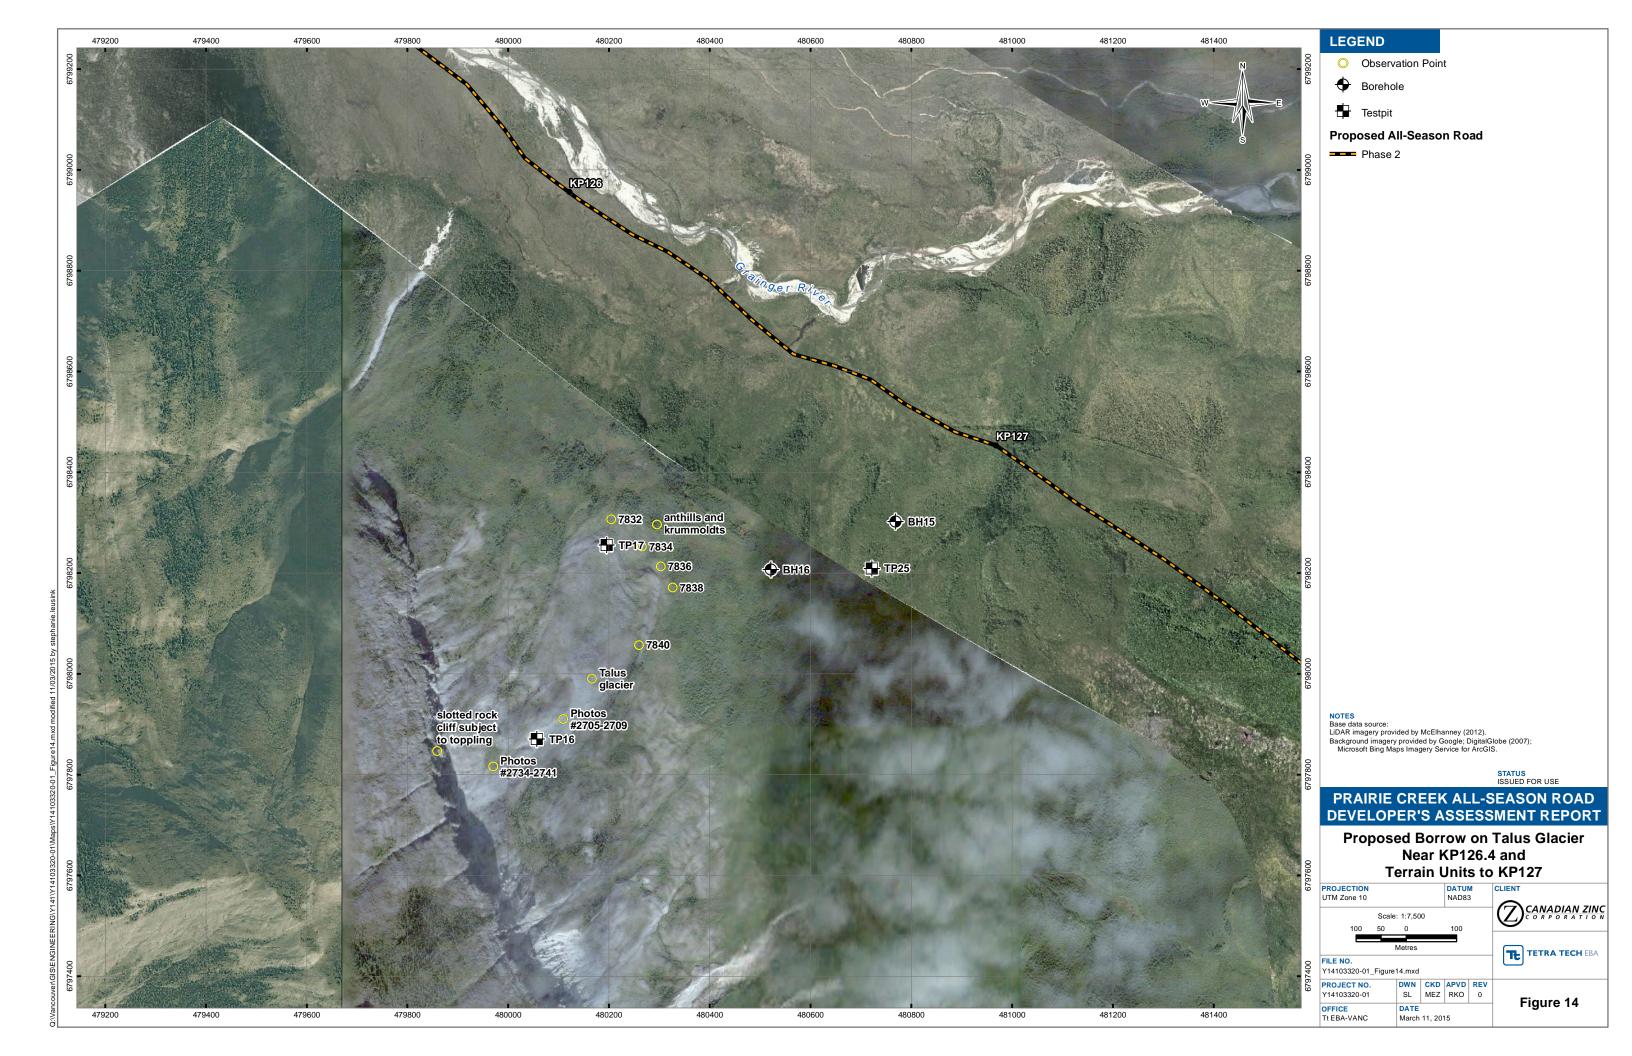
Soils upslope and west of the Grainger River floodplain are mapped as a discontinuous residual or colluvial veneer of clayey gravels, gravel-sand-silt mixtures, and poorly-graded gravels (Hawes, 1975). SAND with some gravel, to gravelly, was encountered at TP-15, in a slope failure at the toe of slope just west of about KP124.8. Layers or lenses of silty sand and cobbles/boulders were also noted. Talus and scree were noted further south along the toe of slope. Ravelling is expected from upslope, especially between about KP125.2 and KP125.6. There is potential also for larger rocks tumbling or toppling from the bedrock exposed above the scree/talus slope. Periodic debris flows are anticipated on the alluvial fan at KP125.6 to KP126.

For these reasons, it appears that the route of the winter road would be more favourable between about KP124.8 and KP126.4, in order to avoid what are likely to be ongoing upslope hazards. Allnorth has therefore made some alterations to the route in this area to avoid some problematic terrain features, both upslope and downslope, but is considering the area along the toe of slope as possible locations for granular borrow and/or a quarry (telephone correspondence, January 20 and 22, 2015; E.Kragt, R.Kors-Olthof). Since these slopes are already ravelling, extraction of borrow might mean additional ravelling or outright slope failures in talus/scree, as well as failures in bedrock. If the sources are proposed for use, detailed plans would be needed to extract materials safely.
