NORTHWEST
TERRITORIES
WATER BOARD

WATER REGISTER NO. N1L3-0035

Re: Revised Restoration and Abandonment Plan - Pine Point Operation

RESTORATION AND ABANDONMENT PLAN
MILLSITE AND TAILINGS CONTAINMENT AREAS
COMINCO LTD. - PINE POINT OPERATIONS
DECEMBER, 1991

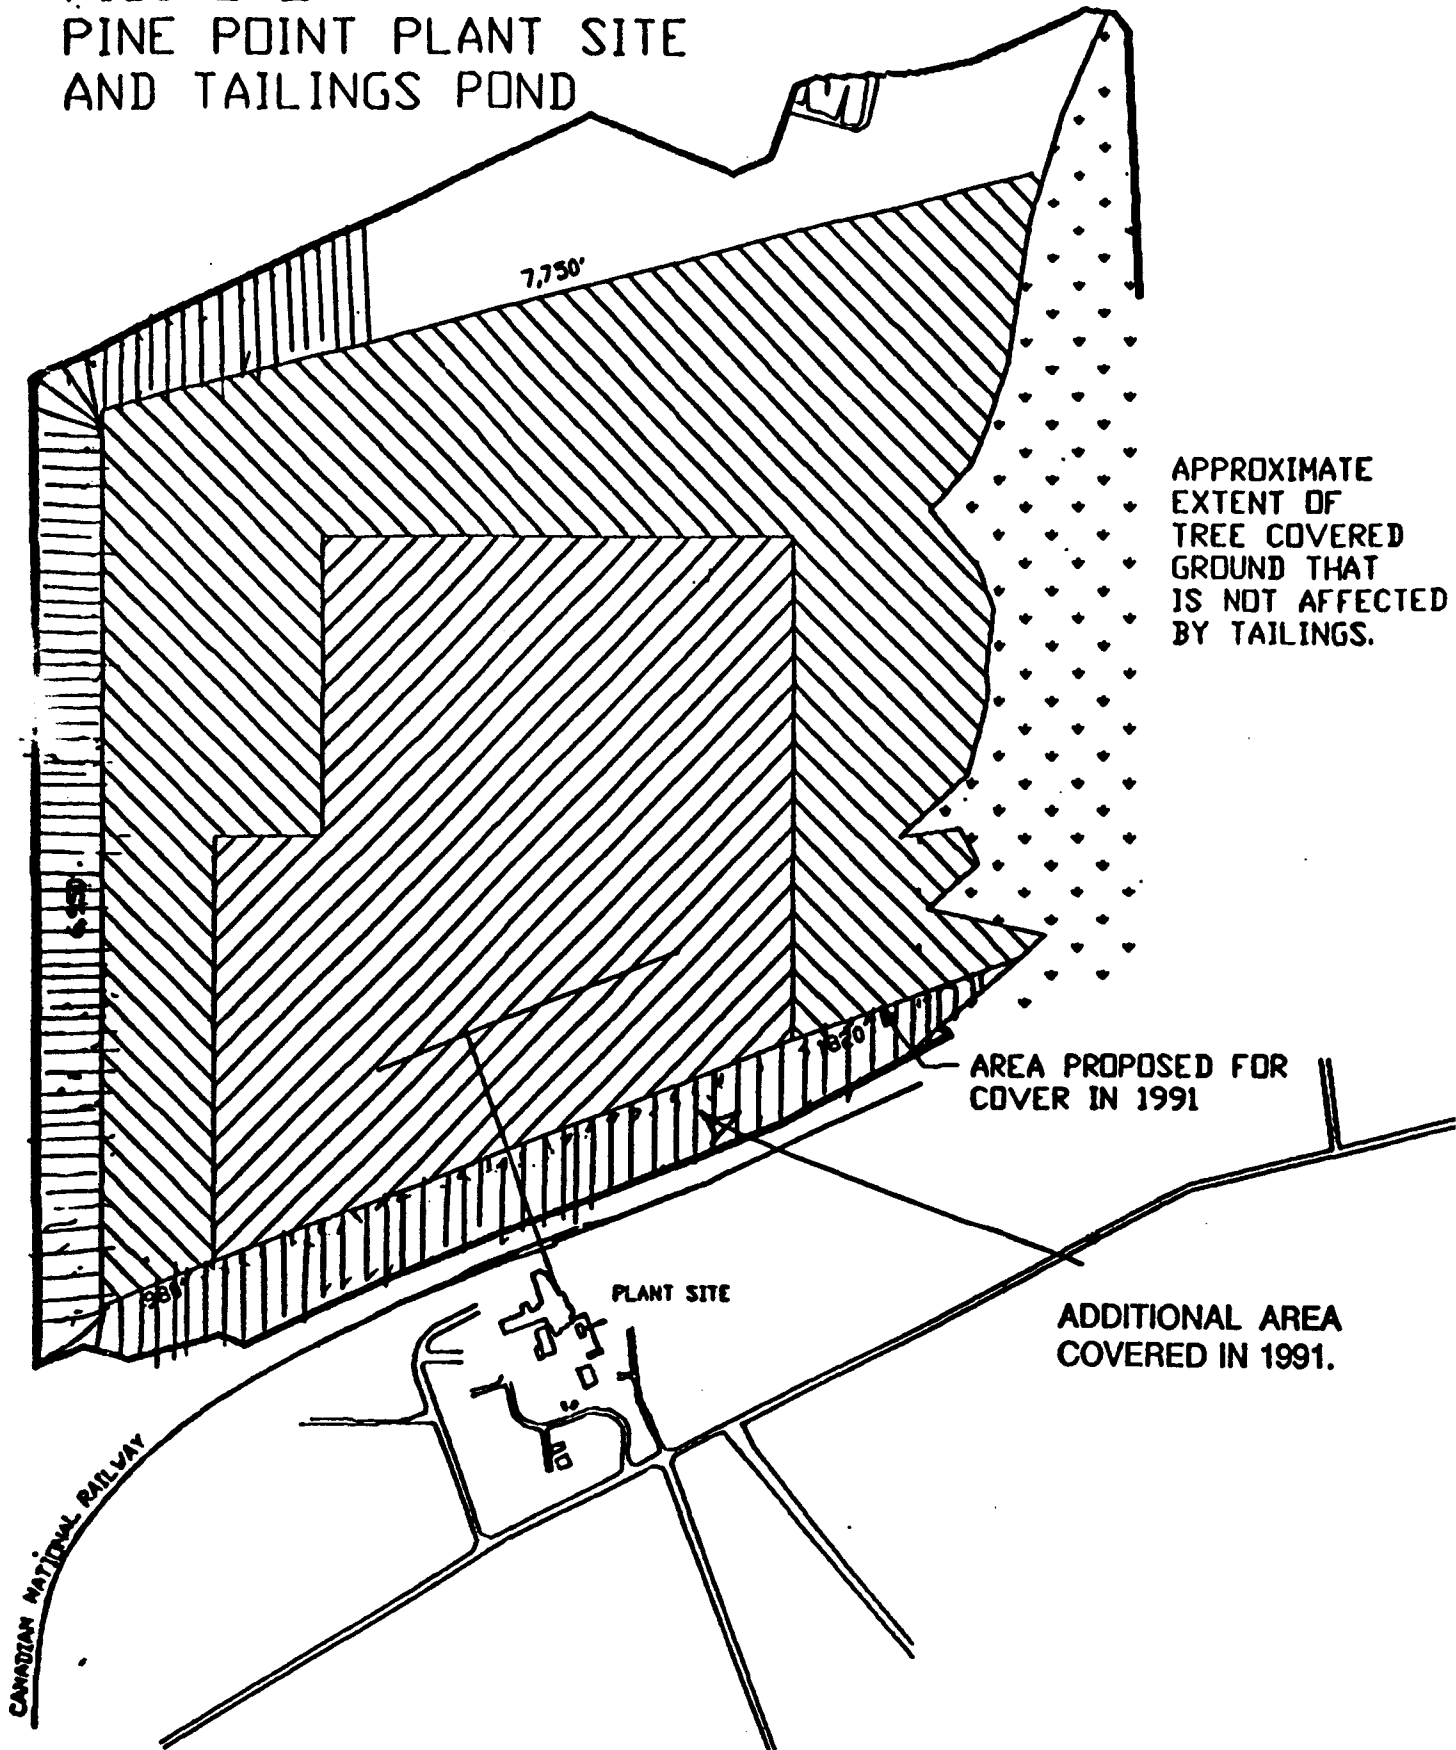
FIGURE 2
PINE POINT PLANT SITE
AND TAILINGS POND

Upon completion of final abandonment, all buildings and fixtures at the site will have been removed. All basements or disturbances at the mill site will be filled and graded. (See Figure 2.)

During the summers of 1990 and 1991 a total of 1250 acres, or approximately 86 percent of the pond, was covered with a layer of coarse gravel. The main pond area has been covered, and the cover has been effective in stabilizing the surface and preventing dust pluming, see Figure 2 and Figure 4.

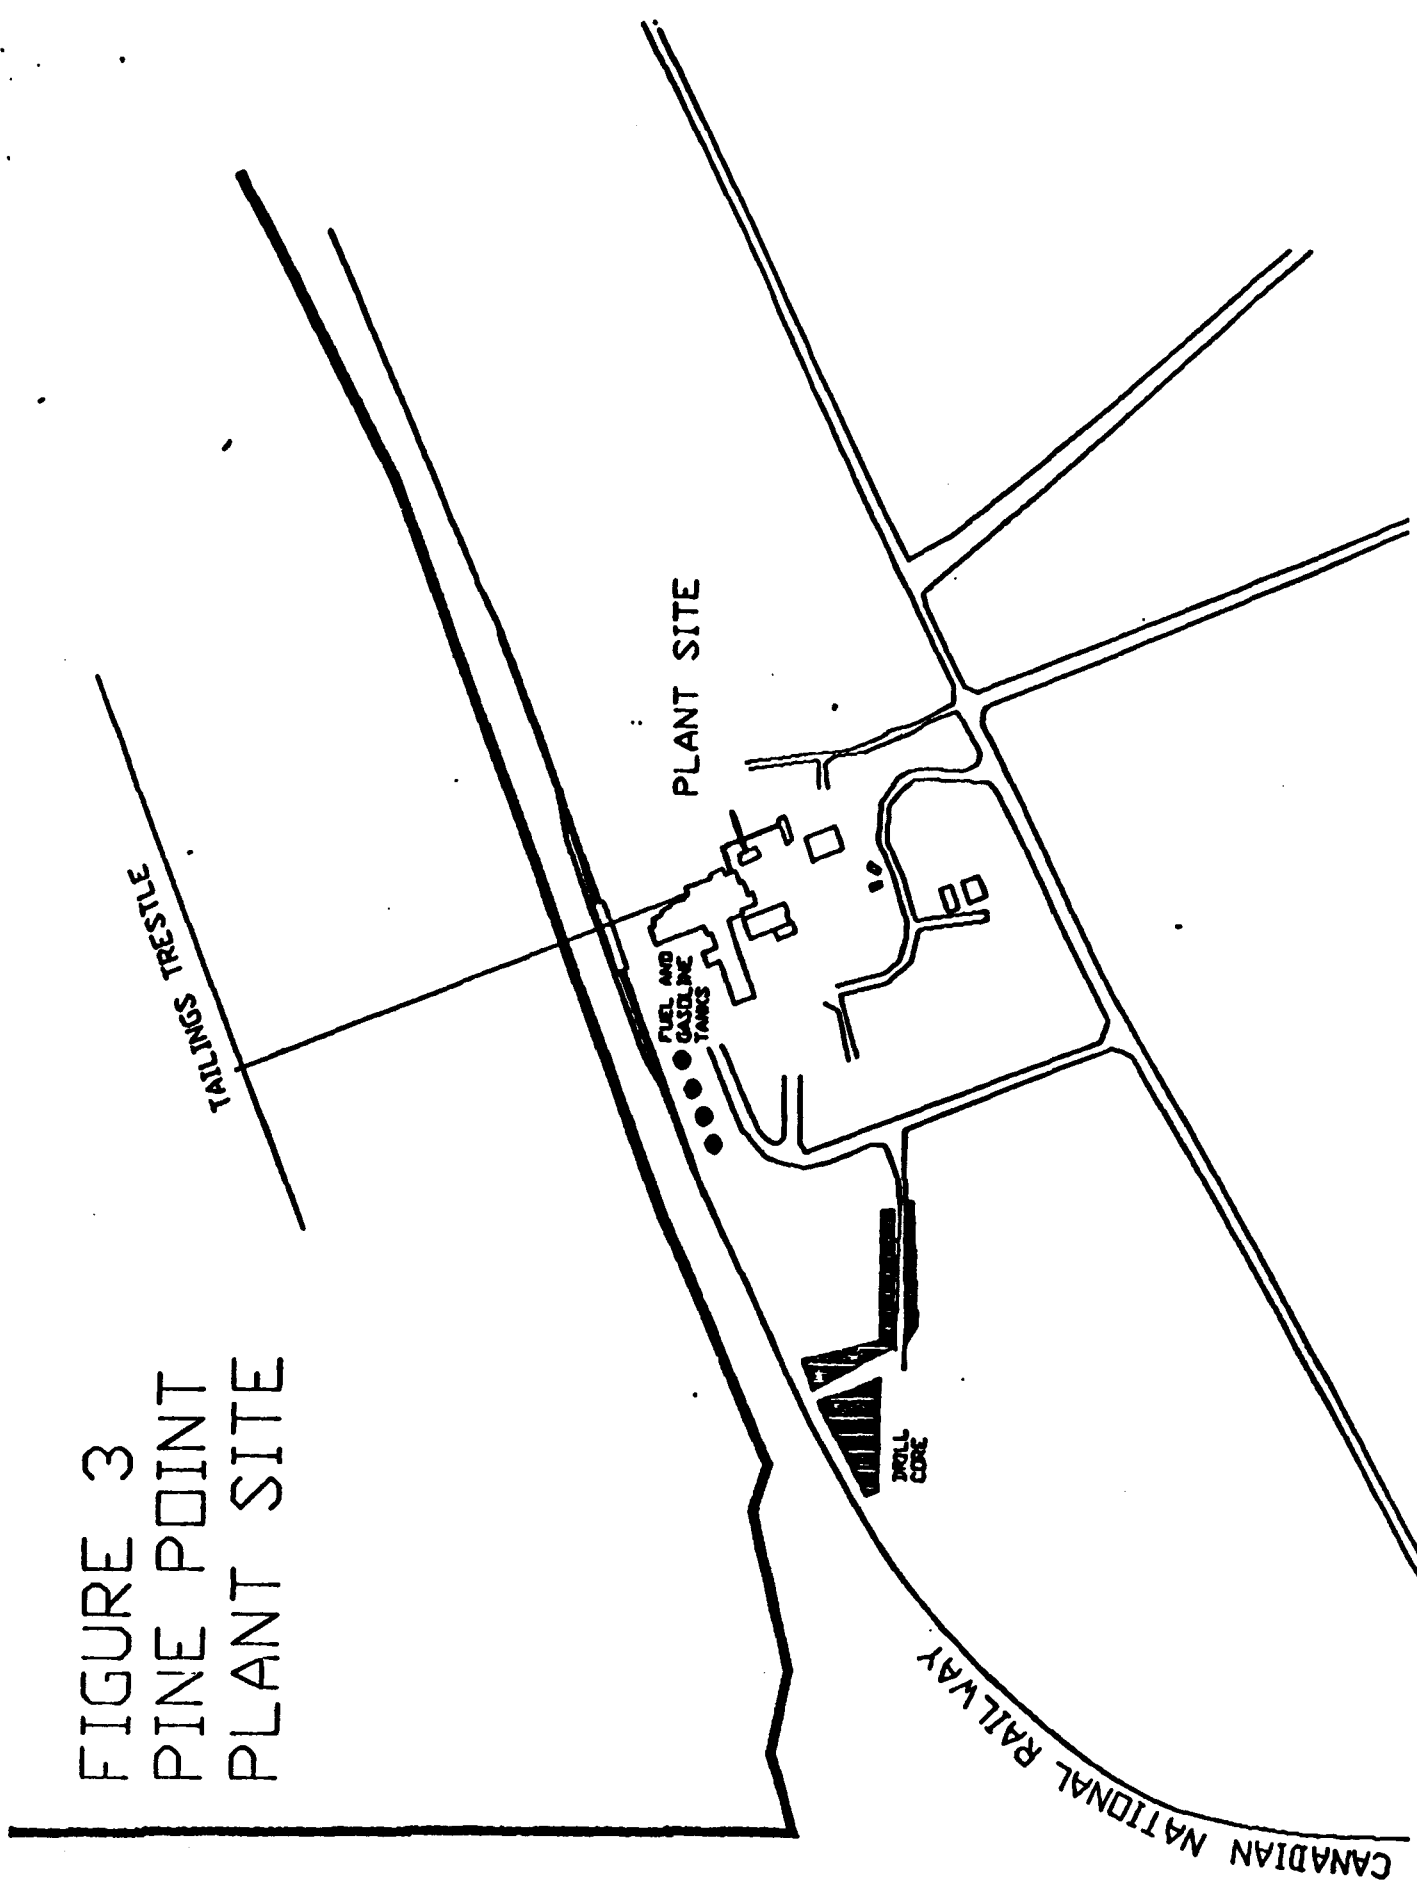
FIGURE 3
PINE POINT
PLANT SITE

Drill core produced during exploration drilling is stored in three locations to the west of the mill site, see Figure 3. Territorial Mining Regulations require that the core be left in place.
