Site Investigation and Characterization of Fuel Cache Location near Cadillac Mine, NWT

Prepared for: Indian and Northern Affairs Canada
Operations Directorate
Yellowknife

Prepared by: Environmental Services, Western Region
Public Works and Government Services Canada

February 2000

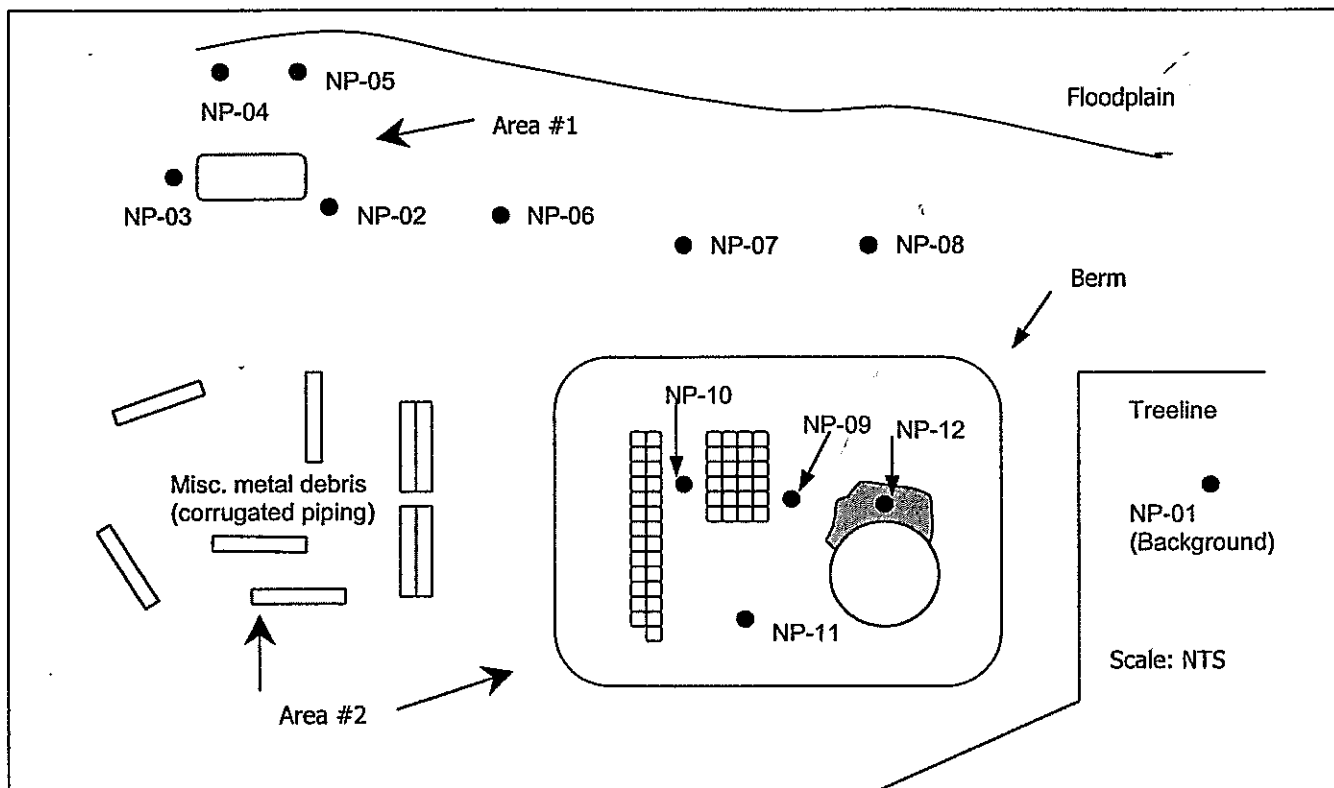
Figure 2: Sample Locations at Areas #1 and #2.

Soil samples were taken from all three areas. These locations are indicated in Figures 2 and 3.

No levels of hydrocarbons were detected in any of the samples taken outside of the berm areas, which demonstrates that there has been no horizontal migration of contamination at shallow depths. This result would not be entirely unexpected in this situation given the geology of the site.

Due to the heavy cobble content of the berm floor in Area #2, a test pit was hand dug in the stained location in order to determine a possible depth of the visible plume. Physical restrictions of hand shoveling through large rocks resulted in an inability to determine the maximum depth of the spillage movement. There was no way of determining if the plume bottom extended much further, or if it may have reached a groundwater flow depth and was transported off site, or simply had pooled up on a bedrock source.

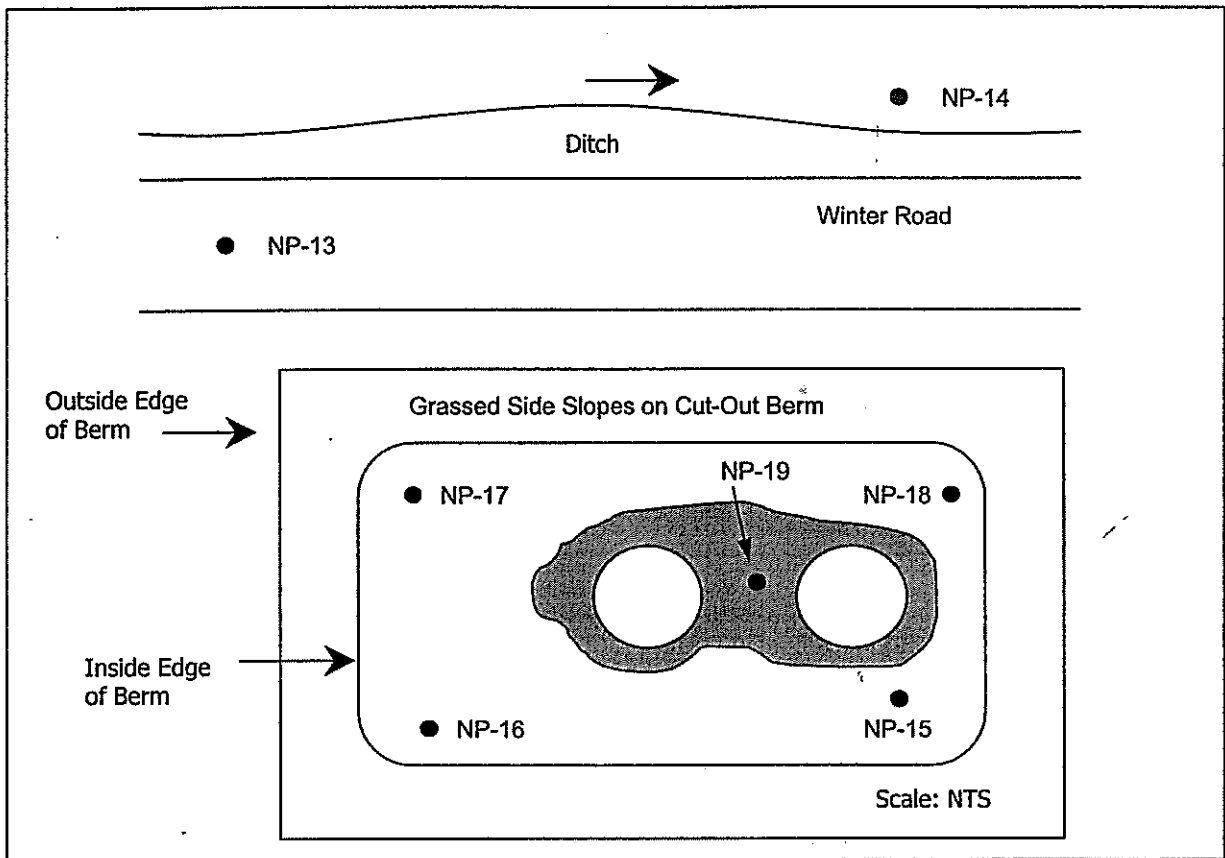
Figure 3: Sample Locations at AST Area #3

The material covering the floor of the berm for Area #3 was comprised mainly of a fine silt, however refusal of the hand auger was also reached at a shallow depth due to heavy cobble. It should be noted that the surface stain at this location was much larger than that in Area #2 and the only sample found on site to contain some measurable level of hydrocarbon (NP-15) outside of the immediate vicinity of the tanks was taken beyond the edge of the visible surface plume.

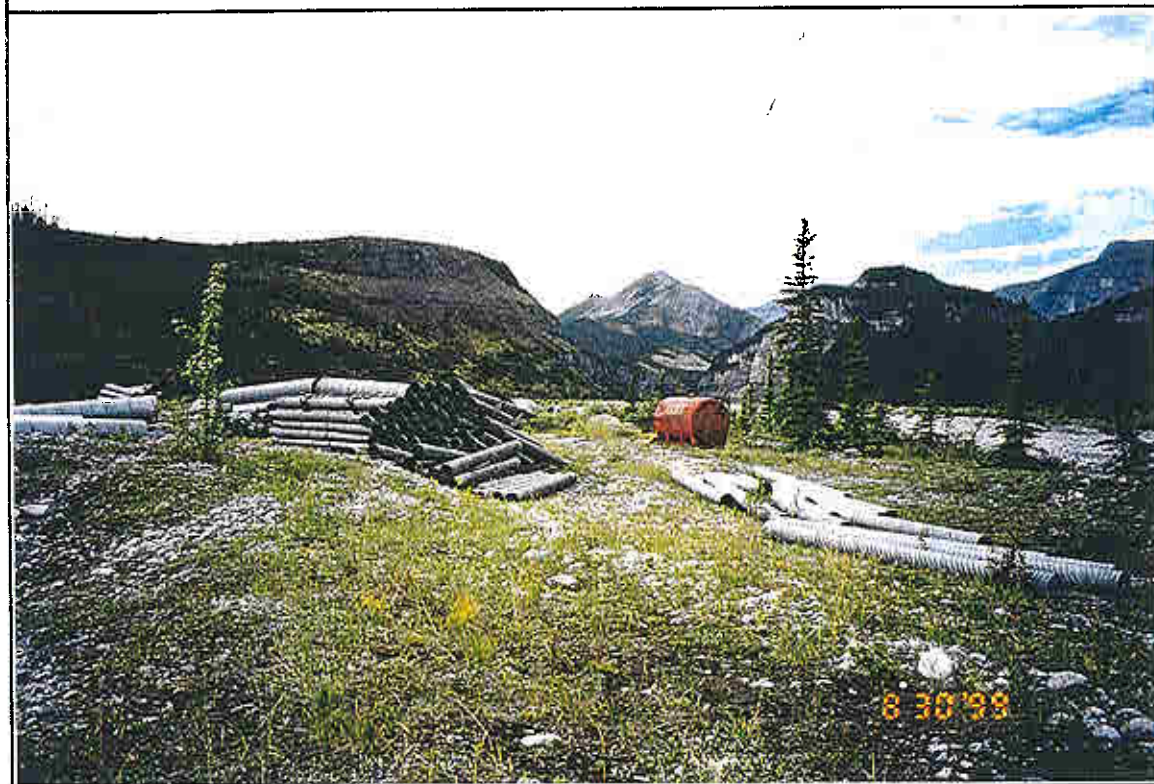
The bulk of the debris found on site was in Area #1. Numerous stacks of corrugated metal piping were strewn about and were noted as far as 500 m south of the AST in Area #1. Several barrels were also observed however all were empty or cut open.

The total volume of debris present in Area #1 was estimated to be 1000 m³.

Photo # 4 - Miscellaneous debris and AST in Area 1

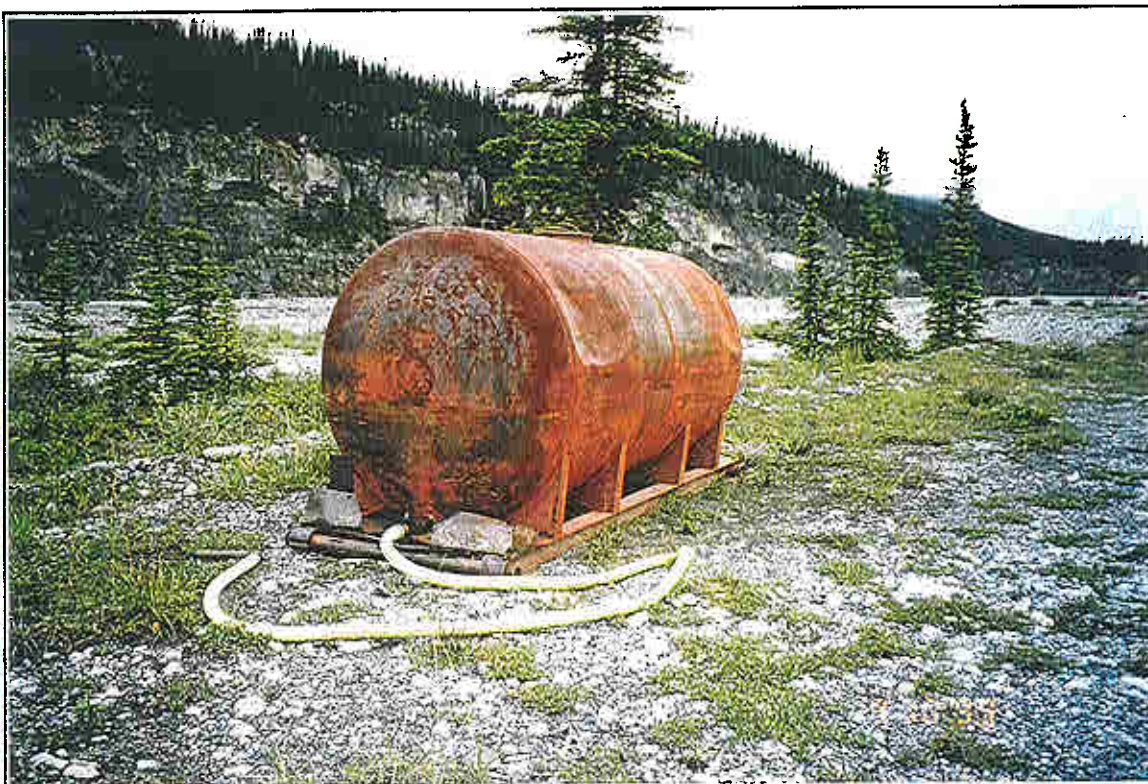
A horizontal AST of approximately 9000 L in volume dominates Area #1. It is 3.4 m long with a diameter of 1.84 m (circumference = 5.76 m). An information plate on one side indicated it was manufactured by Jasper Tank & Manufacturing (Edmonton, AB) on March 16, 1970. The tank sits on a skid pad and has no berm surrounding it. A hose leads out of one end and minor staining was observed near the outlet of the hose. While the access valve on top of the unit could not be opened, it appeared, from soundings, that the tank was nearly empty.

Photo # 5 - Horizontal AST with hose attachment in Area 1.

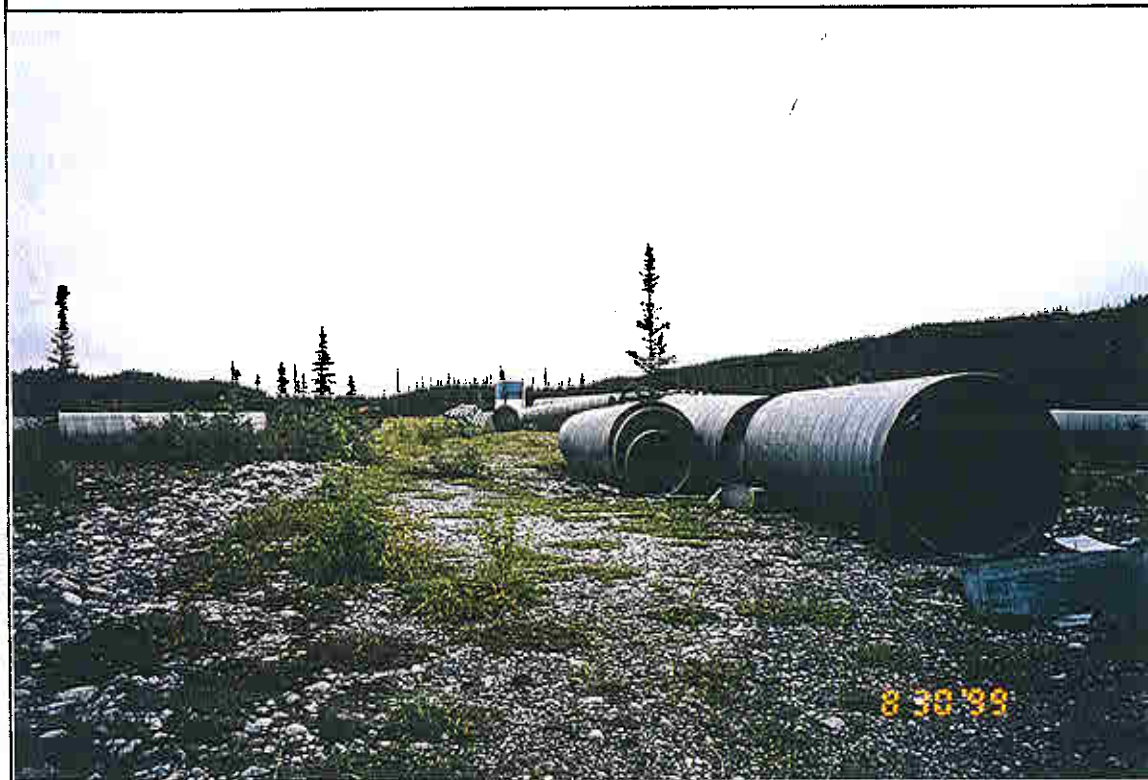
Photo # 6 - Typical view of waste metal debris, Area 1.

A landfill can serve as a disposal method for all non-hazardous waste. Buildings could be demolished and placed with collected metal debris from across the site. There is much open space surrounding the fuel cache, suitable for a landfill location providing adequate cover material can be gathered in order to deal with aesthetic issues.

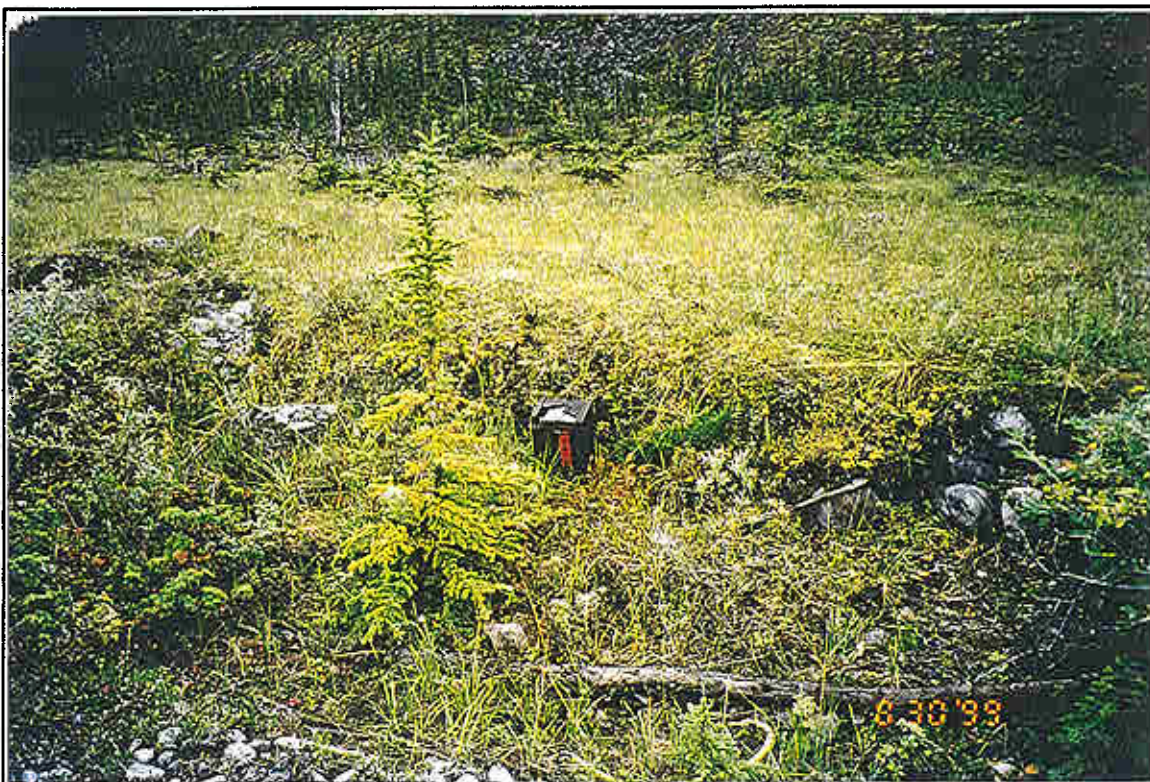
Also in Area #1, a discarded vehicle battery was found in the deposit of miscellaneous garbage, near the edge of the debris field.

Photo # 7 - Discarded battery, east edge of Area 1.

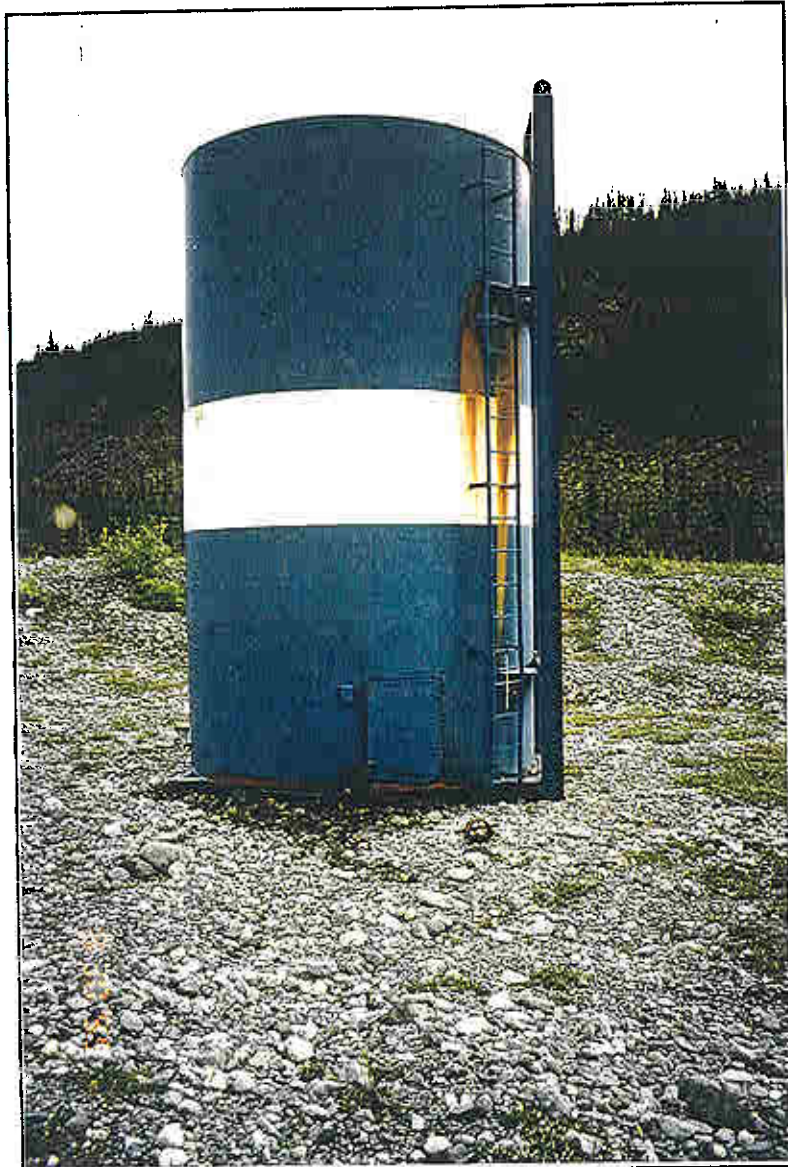
In Area #2, a large vertical AST dominates the berm area and is relatively new in appearance. It is 6.09 m high, with a diameter of approximately 3.72 m (circumference = 11.5 m). The 67 000 L tank was visually inspected and determined to be virtually full. A stain extending several metres in all directions was observed beneath the outlet valve for the tank. The stain appeared wet on the surface, indicating that the outlet may drip. However, since the tank was virtually full, the drip is likely quite slow. The date of the last filling was unknown.

Photo # 9 - Vertical AST in Area 2.
(Note stain beneath valve.)

If it is possible to mobilize a backhoe or excavator to the property over the winter road either from Fort Simpson or the Cadillac Mine, then test pits should be excavated beneath the valves on tanks in Areas #2 and #3. This would allow determination of the likelihood of subsurface migration of hydrocarbons and clarify the current lack of information regarding fuel volumes at the site. It is recommended that the test pits be dug to a depth at which an impermeable layer is encountered or to groundwater. Due to the type of soil at the site with high void content, excavation during the winter should be possible. If groundwater is discovered and it appears likely that the contamination has

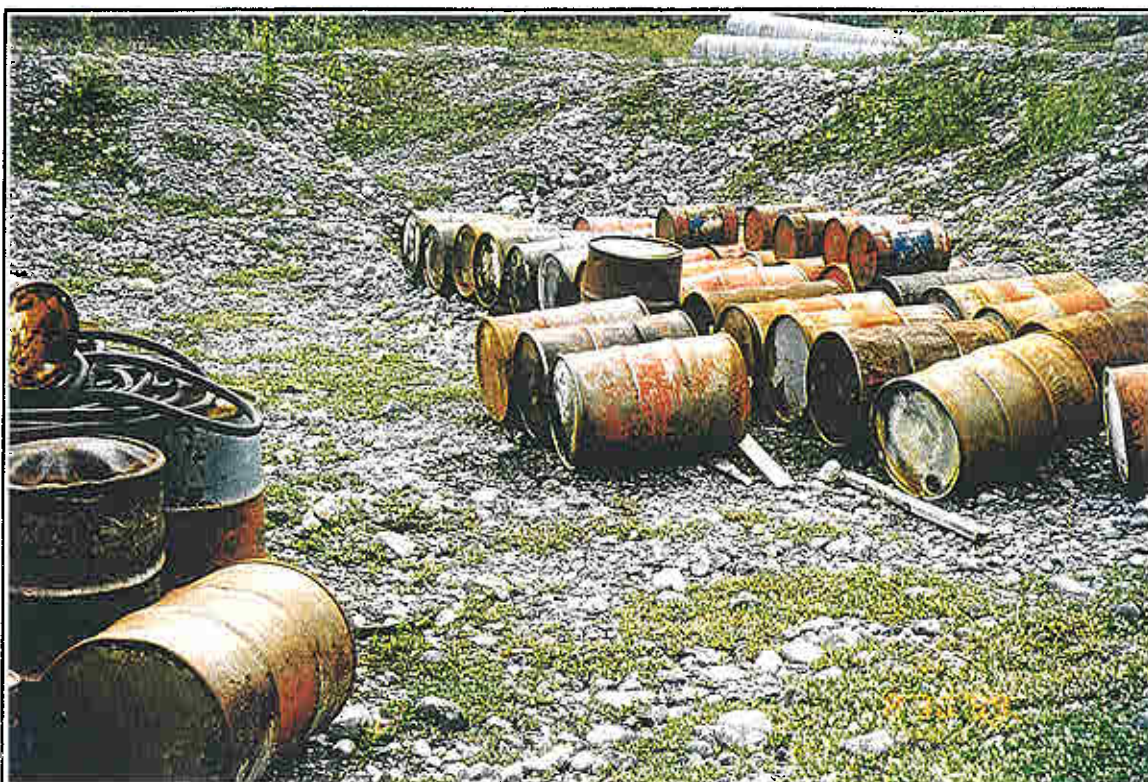
A total of 63 – 205 L barrels and 20 – 100 L drums were also stored within the berm in Area #2. The majority of them contain some product. Many of the drums are in poor condition and have been badly weathered. They remain sealed. Any markings on the barrels are either not present, or too weathered to be legible.

Photo # 10 - Stockpiled barrels and drums within berm.

Flaring of the remaining fuel appears to be a viable disposal method. Several contractors in the Yellowknife area possess flare units capable of processing the volume of fuel present on site in accordance with territorial requirements.

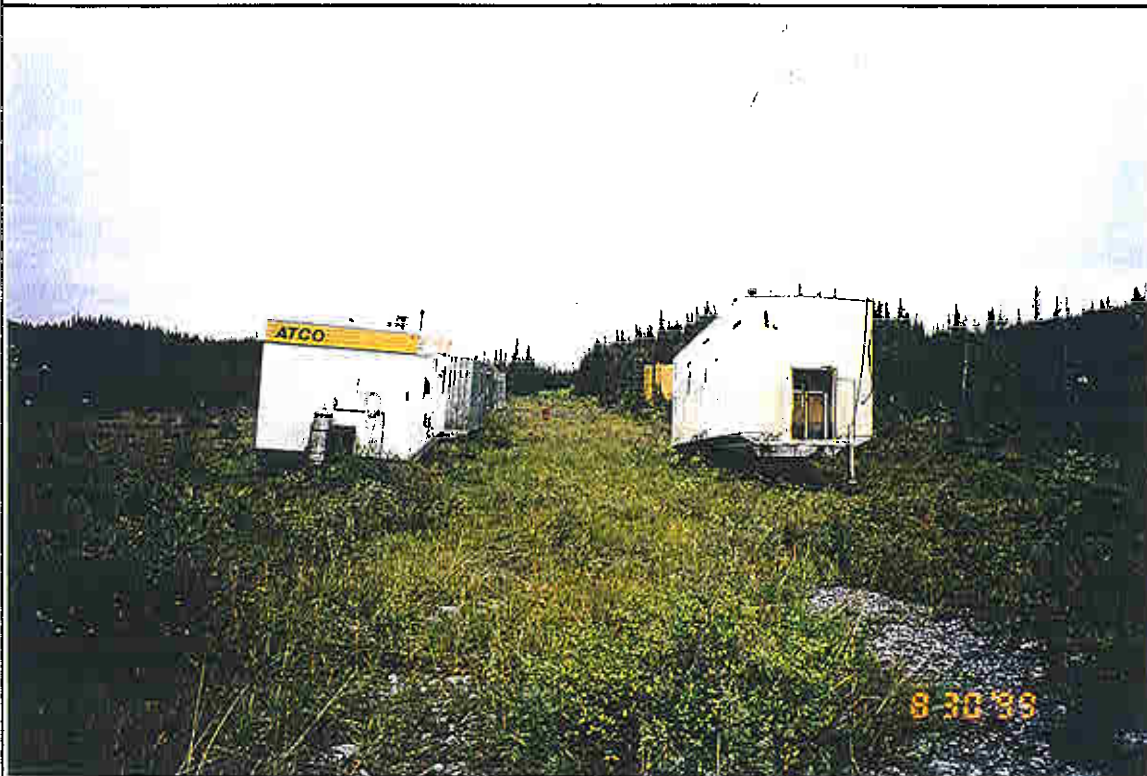
In Area #3, a total of 4 ATCO-style trailers have been left along the edge of the winter road trail. All four units can be considered to be in poor condition and several show evidence of bear damage. In addition, a 20 m long by 13 m wide dug-out earthen berm sits immediately adjacent to the winter road.

The 4 trailers were visually inspected and the presence of asbestos was not suspected. No fluorescent lights were present in the trailers. Paint samples were not taken so lead and PCB content is unknown, although from previous experience at sites with similar units, the presence of either lead or PCB containing paint is unlikely.

Photo # 11 - Trailer units situated along winter road.

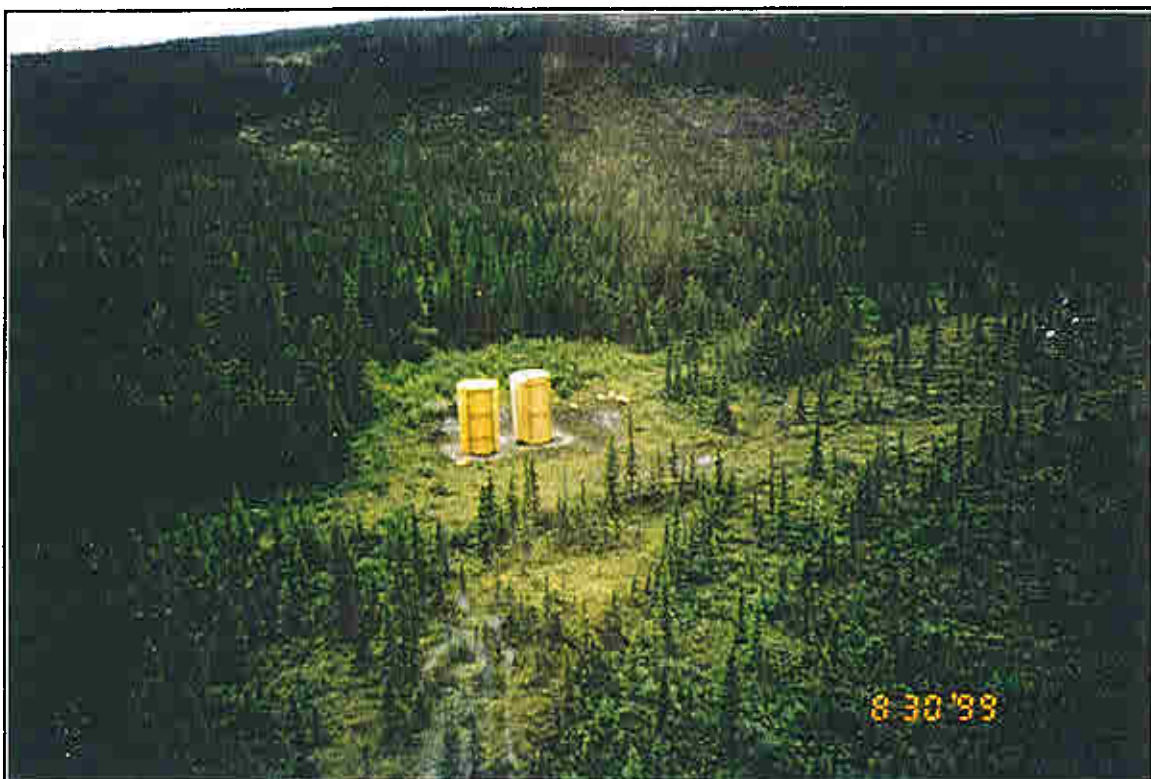
The final two AST's on site were located in Area #3 and placed in a 20 m long by 13 m wide dug-out earthen berm immediately adjacent to the winter road. The two vertical 64,000 L tanks (nominal height = 20 ', nominal diameter = 12 ') were constructed in 1980, according to side plates and were in good condition, with the exception of peeling paint. A gauge on the sides of one of the tanks indicated that it was approximately ¾ full. The gauge on the side of the second tank was broken, but from soundings, the tank was approximately ¾ full as well.

Photo # 12 - Aerial overview of berm and tanks, Area 3.

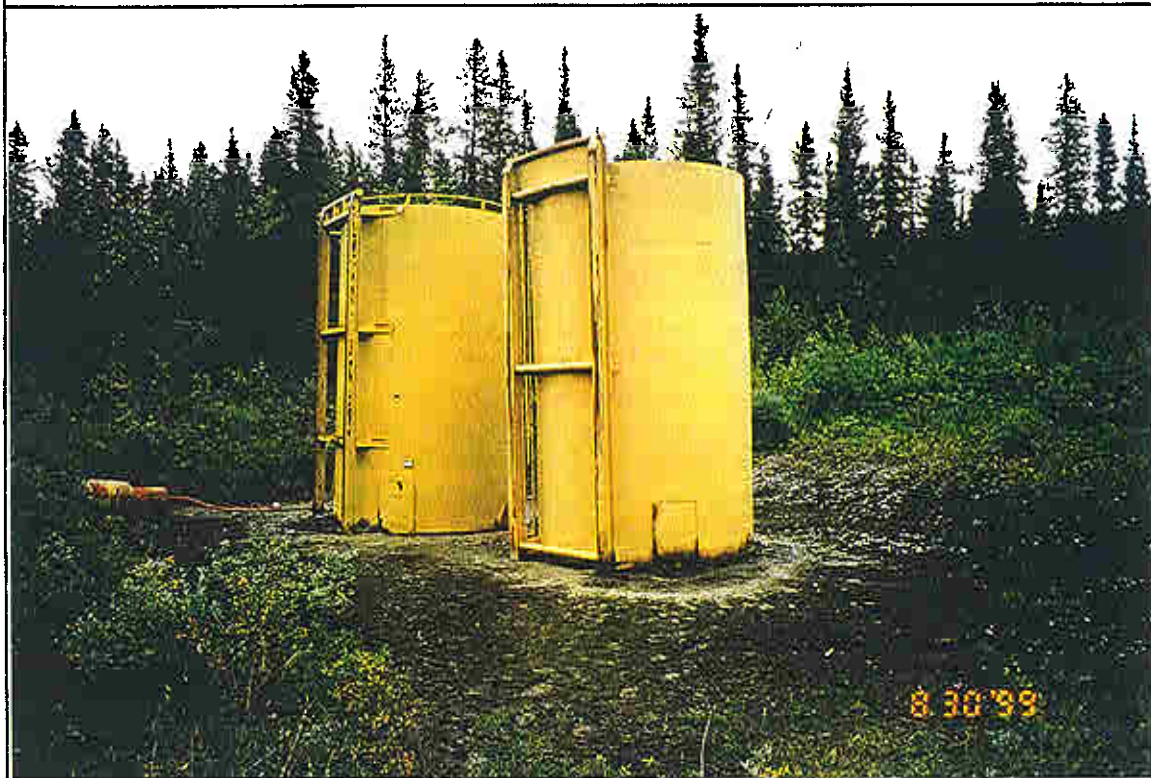
Seven 205 L barrels were also observed in Area #3, five of which were partially full. There was no vegetation on the bottom of the berm, however considerable variety was noted immediately outside of the area. Significant hydrocarbon staining was evident beneath both tanks and again, there was no evidence of a liner having been installed at this location.

Photo # 13 - Vertical AST's, Area 3.
(Note staining of berm floor.)
