**FISH HABITAT INFORMATION AND LOSS
ACCOUNTING FOR WATERBODIES SITUATED
ON THE NORTHWEST PENINSULA OF
SNAP LAKE**

Department of Fisheries and Oceans
Mackenzie Valley Environmental Review Board
as supplemental information to the Snap Lake
Diamond Project Environmental Assessment

February 2003
022-6659/5300

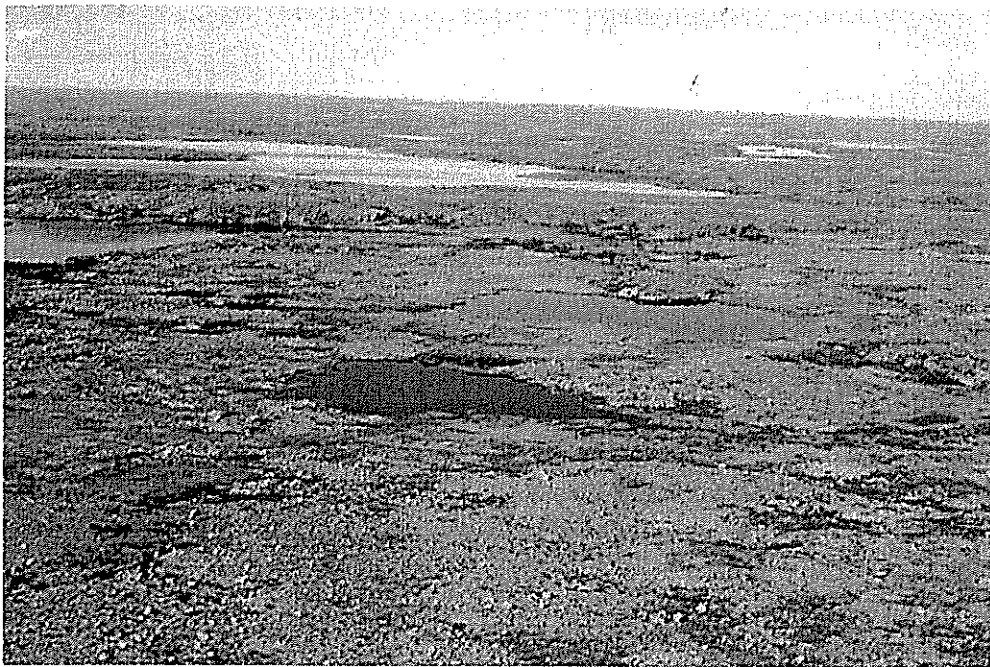
Photo 2: Aerial view of IL4 (in foreground) and IL3 (right behind IL4).

IL3 is a small (1.15 ha), isolated waterbody with a maximum depth of 1.9 m (Photos 2 and 3; Figures 7 and 8). No defined channels connect IL3 to another waterbody. The lake substrate is organic/detritus with boulder cobble along the shorelines. In 1999, ten minnow traps were set in IL3 for a total of 42 hours (Table 4). One gillnet that was 30.4 m long was set in the lake for 1 h 43 min (Table 5). No fish were captured or observed. A loon was observed on the lake but was not nesting nor observed feeding at this location. Results from water quality samples collected from IL3 are shown in Appendix I.

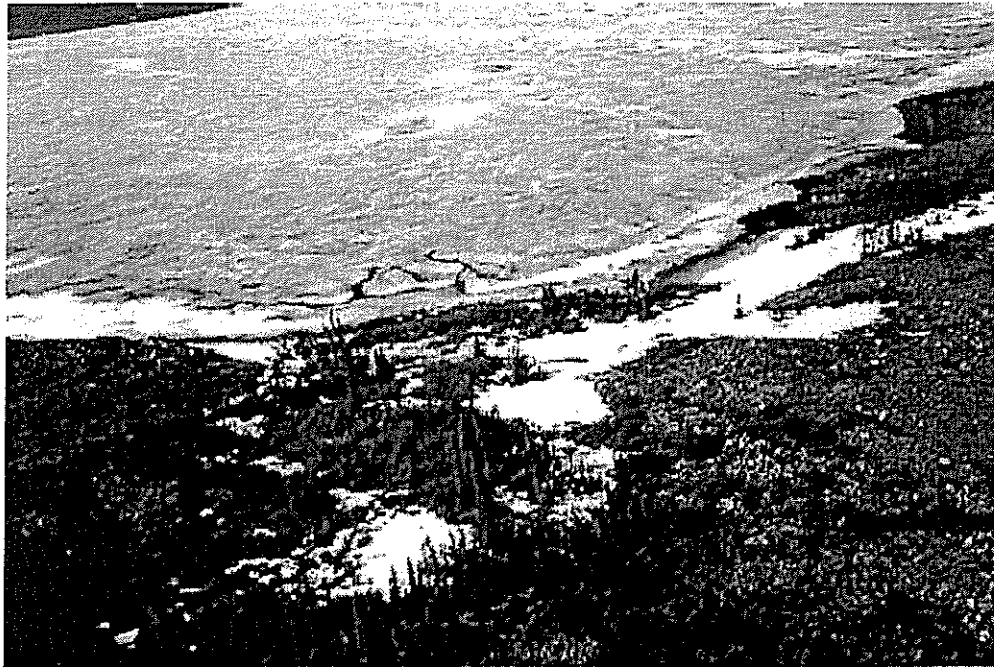
Photo 5: Aerial view of IL5 facing due east.

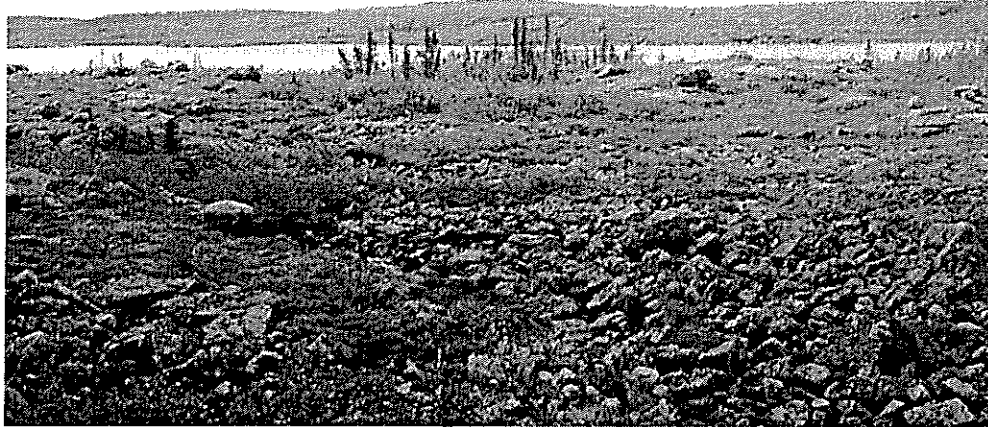
Photo 7: Rocky area between IL5, IL4, & IL3. Note lack of any distinct channels.

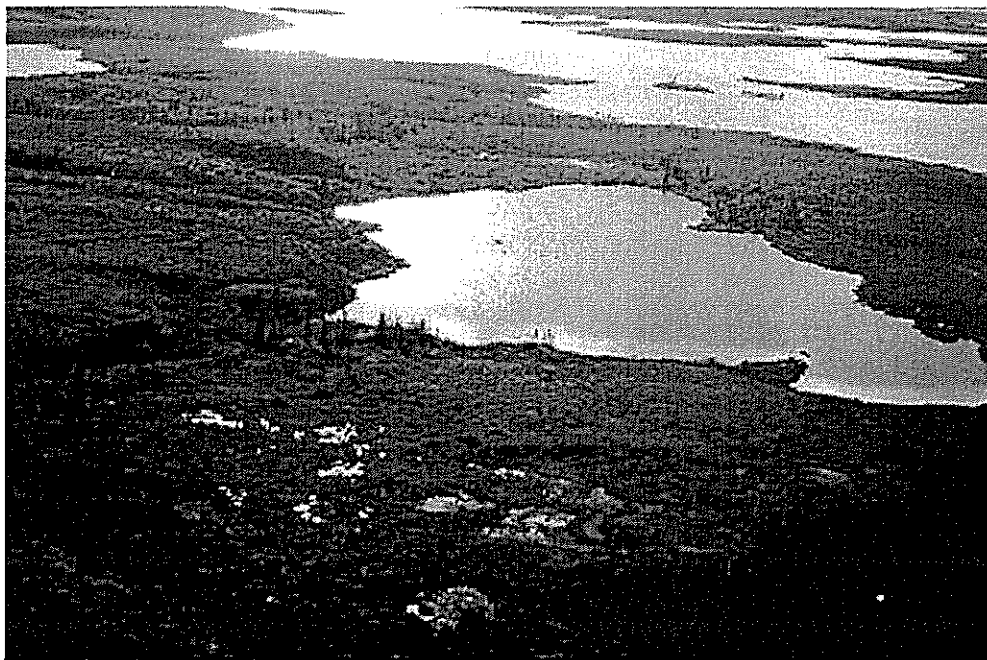
Photo 8: Aerial view of IL6 looking WNW with Snap Lake in background. Note steep cliff along south shore and (exposed) rocks in middle of lake.

IL6 is located approximately 70 m from Snap Lake and has an area of 2.88 ha (Figure 11; Photos 8 and 9). The maximum depth measured in the lake was 2.5 m (Figure 12). An ephemeral, sedge wetland area (wetland B) exists to the west of IL6 but no defined channel exists through the wetland. The topography information for the area also suggests there is no connection through this area to IL7. Wetland A connects with IL6 to the east. Although IL6 is only 130 m from Snap Lake, the area between the lakes is

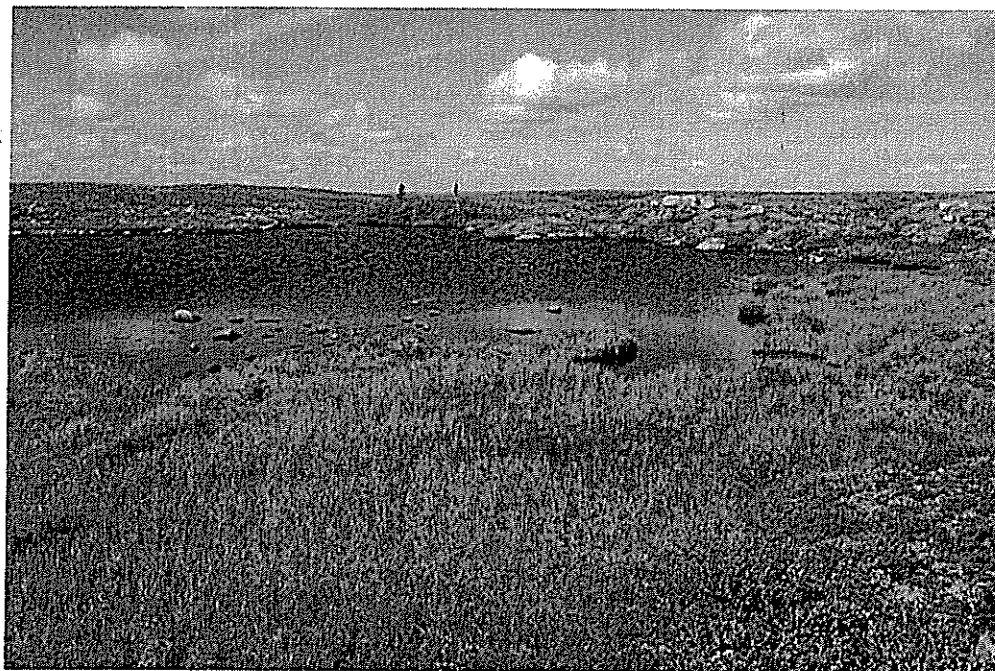
Photo 13: Looking northwest from mid-way along the east shore at IL9.

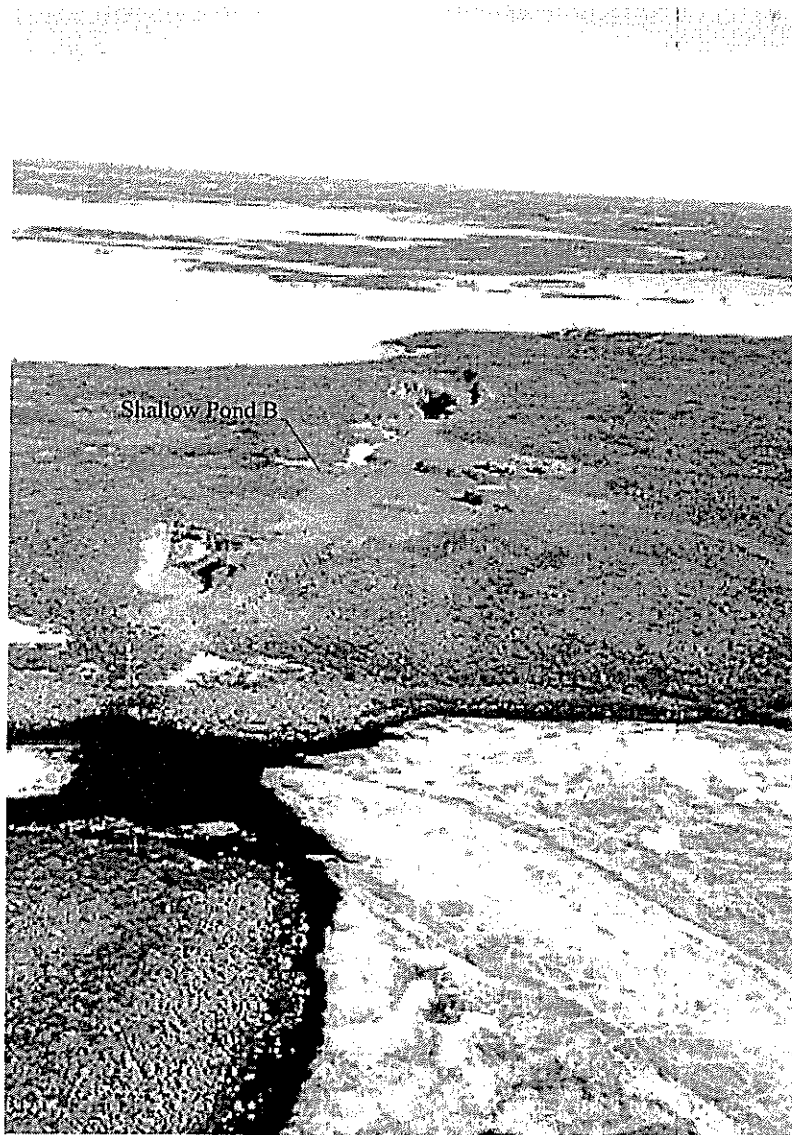
Photo 15: Aerial view of Shallow Pond "B"

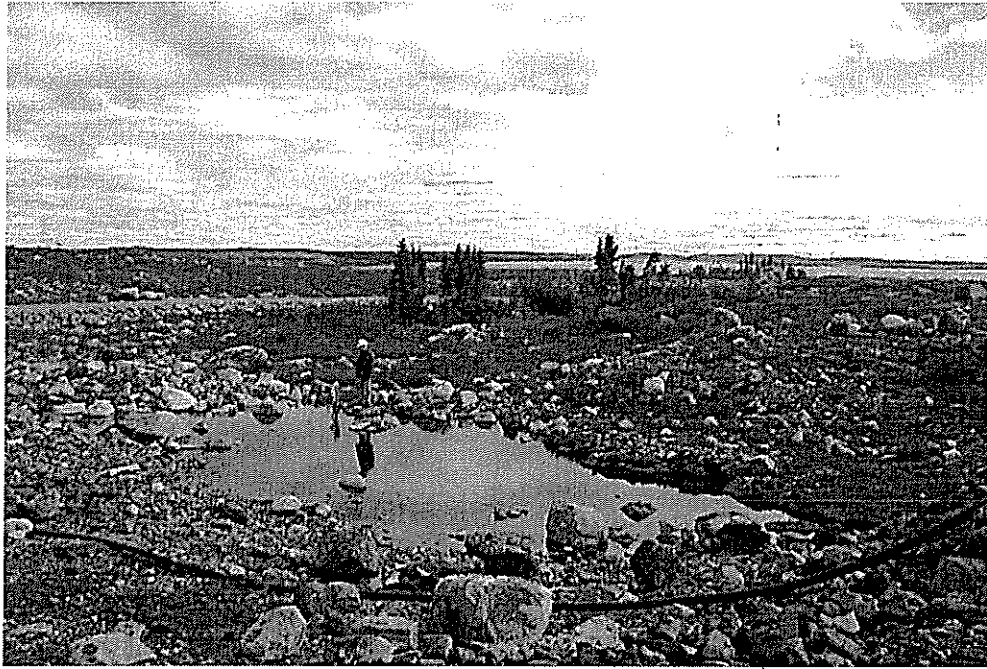
Photo 16: Shallow Pond "B"

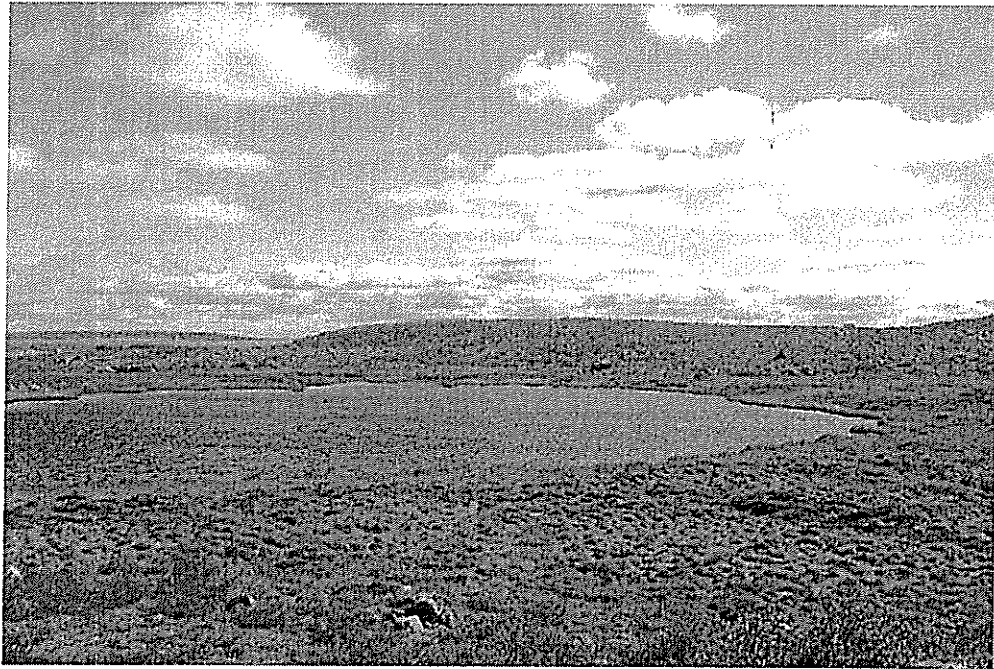
Photo 18: Looking northwest across Shallow Pond "C" from east side of lake.

Shallow Pond C has a surface area of 0.8 ha and has a maximum depth of 1.6 m (Figures 12 and 15; Photos 17 and 18). Ephemeral flow is present between this pond and a wetland to the east. No flow was detected in the channel in July 2001. The shoreline of the pond consists of muskeg and sedges. Some macrophytes were present along the shore and areas of fine organic sediments were noted. In July 2001, ten minnow traps were set for a total of 29 h 10 min and two gillnets totalling 100 m were set for five hours (Tables 4 and 5). No fish were captured. Field water quality parameters measured are shown in Appendix I.

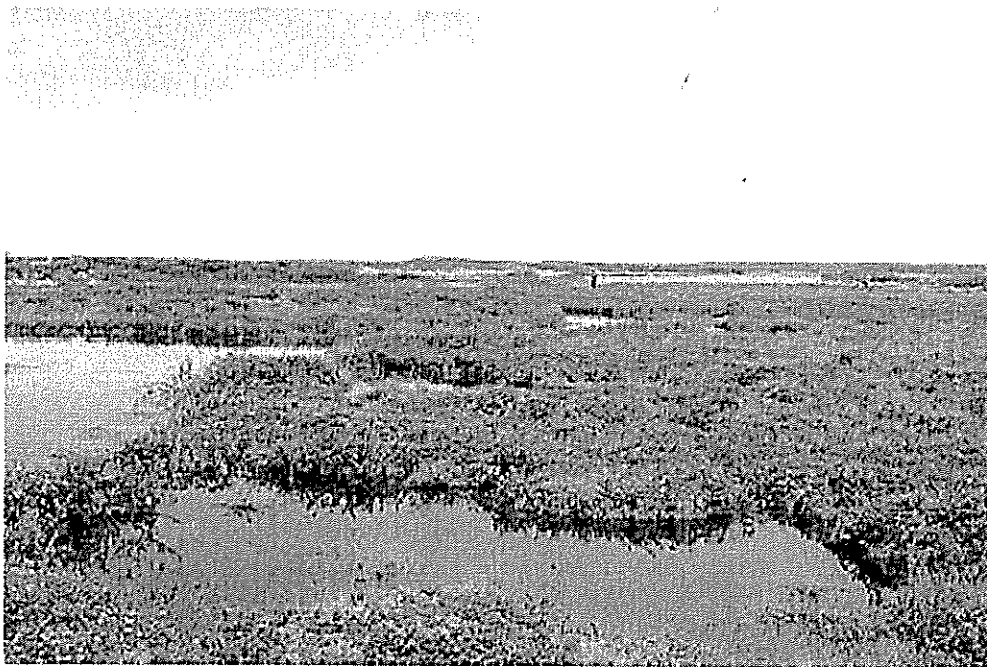
Photo 19: Looking at low gradient meander in stream S1 (H4)

S1 flows into Snap Lake from sub-basin S, south of the proposed mine site and was surveyed in June 1999 (Photo 19, Figure 16). This stream drains the IL5 sub-basin. This stream has been repeatedly monitored for water discharge as part of the hydrology monitoring program and it is the second largest sub-basin flowing to Snap Lake. S1 is approximately 100 m long with an average width of 1.9 m (full bank width) and an average depth of 0.4 m. The water stage was high at the time of the survey. Maximum pool depth was 1.0 m and maximum riffle depth was 0.4 m. The stream gradient was 2% for most of the length of the stream but was 10% near the creek mouth. The stream contained alternating pool, riffle, and run habitat (see Appendix IX.8 of the EAR for definitions). The substrate was primarily cobble-boulder with silt in some slower flowing areas. Velocity ranged from 0.0 to 0.24 metres per second (m/sec). Boulder and overhanging vegetation were the main type of cover. Results from water quality samples collected from S1 are shown in Appendix I.

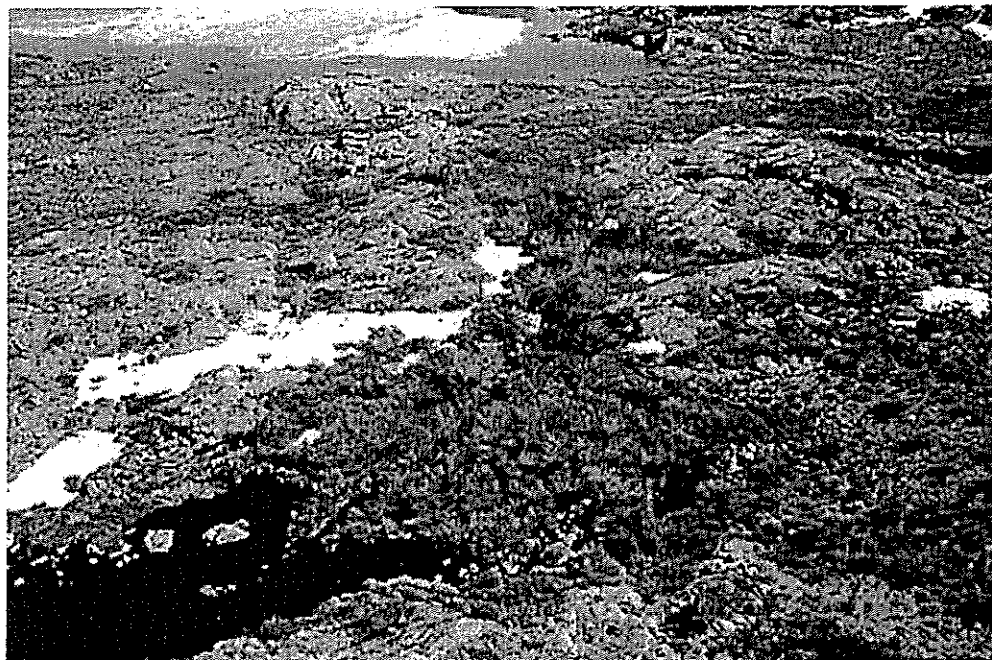
Photo 20: Aerial view looking upstream of stream S27

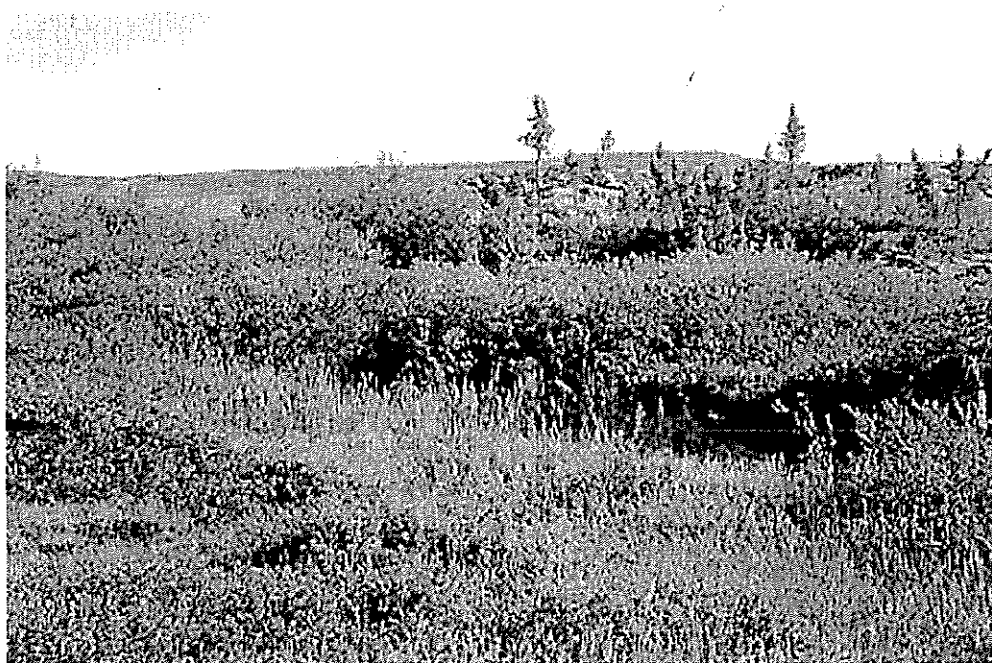
Photo 21: Looking at mid reach of stream S27 between Inland Lake and Snap Lake

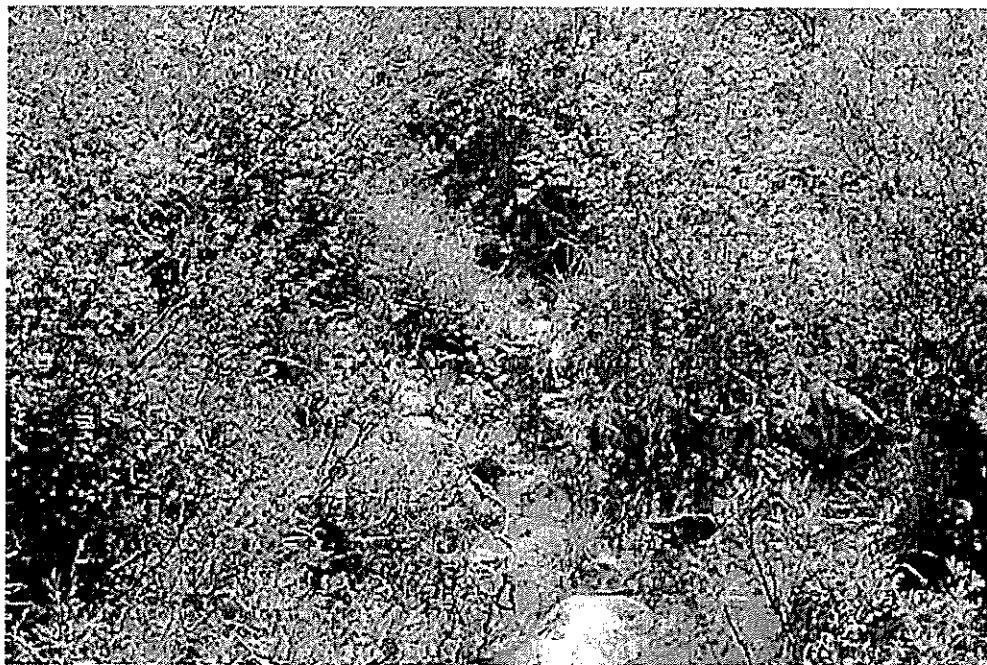
Photo 23: Looking at dense bush and trickle of water in ephemeral stream S29

S29 is approximately 130 m long and lies between IL6 and Snap Lake (Figure 18, Photos 22 and 23). The area is heavily vegetated with a gradient of 3 %. No defined channel was observed during an aerial survey on June 7, 1999 (fresnet). During the field visit on June 26, 1999, much of the area was observed to be dry. Some small areas of ponded water were observed at the downstream end of the stream as well as areas of subsurface flow. No further sampling was conducted in 1999 due to a lack of water.

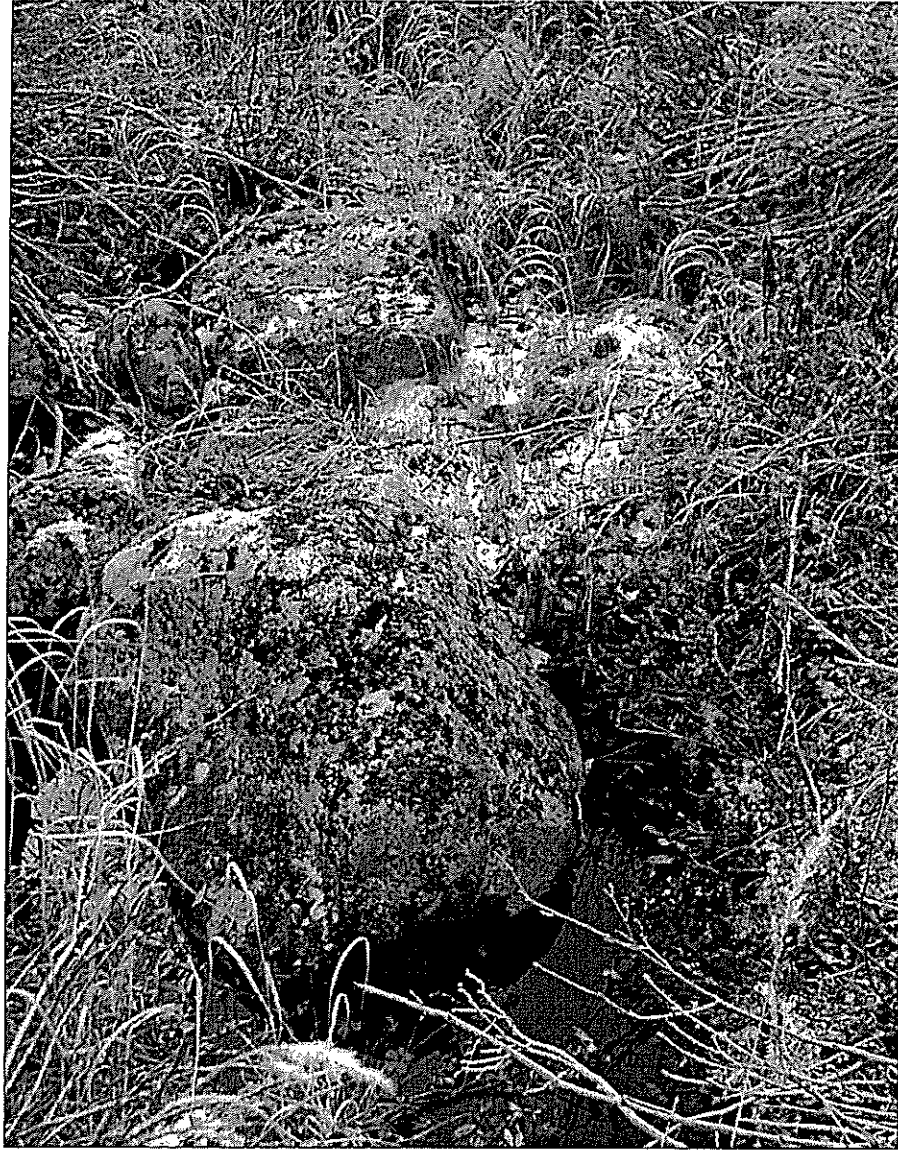
Photo 24: Channel of S29 disappears subsurface approximately 30m upstream of Snap Lake.
