Forest Deterioration Survey:

Pine Point, Mackenzie District

Northwest Territories

Drake Hocking

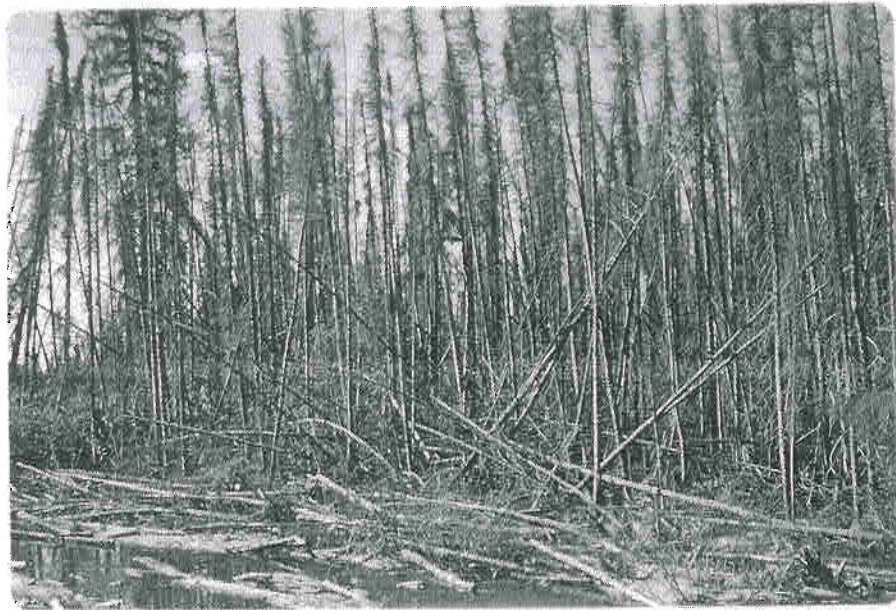
Figure 3. Drowned trees below tailings decant flume.

An additional 15,800 m³ (3.5 million gallons) of water per day are used in the ore milling and concentrating processes carried out at Pine Point. Liquid and sludge wastes (tailings) are retained in a 460 ha (1100 acres) tailings area enclosed by a recently-improved dyke. Stein and Miller (1972) reported on the effects of shortcomings in the initial dyke and overflow (decant) arrangements, many of which have now been overcome. Evidence of earlier overflows is still apparent as dead trees below the decant flumes (Fig. 3) and well above the potholed marsh beyond (Fig. 4).

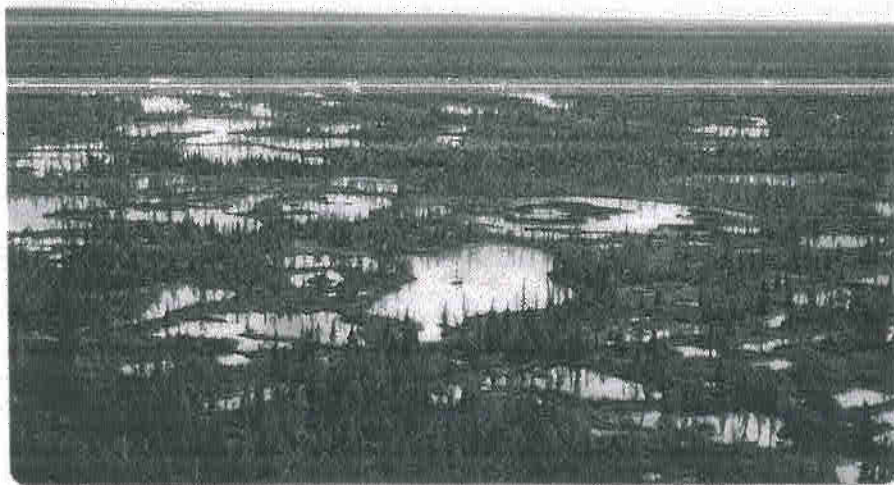
Figure 4. Potholed marsh between tailings pond and Great Slave Lake.

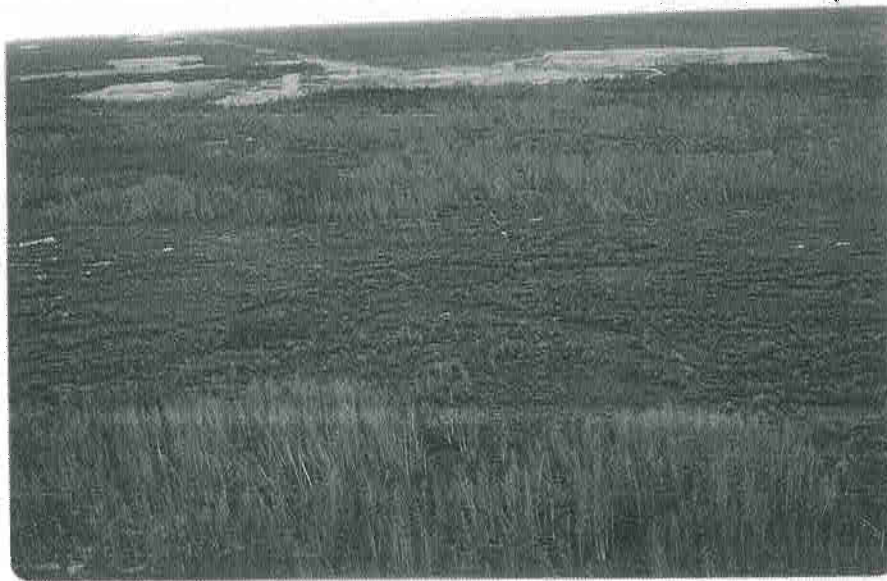
Figure 7. Flood killed area to SE of pit X-15, leading to muskeg.

Besides the 460 ha tailings pond, pit water has been allowed at times to spill into the forest, killing trees and other vegetation in its passage to natural low-lying swampy or muskeg areas (Figs. 6, 7 & 8). Analysis of chemical constituents of that water did not reveal presence of substances in sufficient amounts to be toxic to trees. Hence, mortality was attributed entirely to flooding.

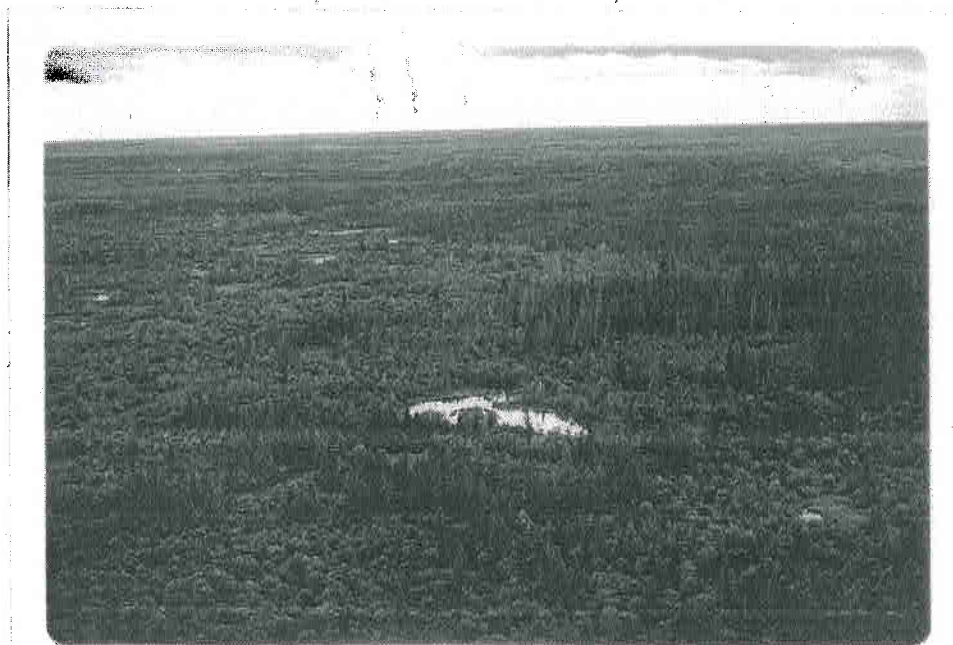
Figure 9. Drowned trees on the margins of muskeg receiving pit water.

areas sufficiently to kill trees along peripheries and along margins of natural drainage channels (Figs. 9 & 10). Beaver activity has also contributed (Fig. 11) in some localities. Reports from the Fort Smith office of the Northwest Territories Forest Service show 3 recent forest fires near Pine Point (Fig. 6), one extending over 15,000 hectares (30,622 acres) (Figs. 12 & 13).

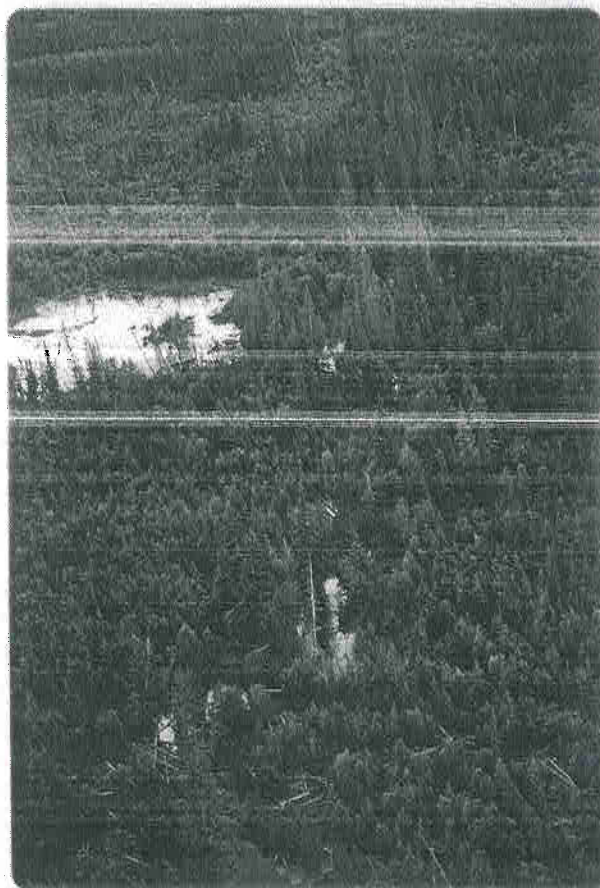
Figure 10. Drowned trees along the margins of drainage channel through muskeg.

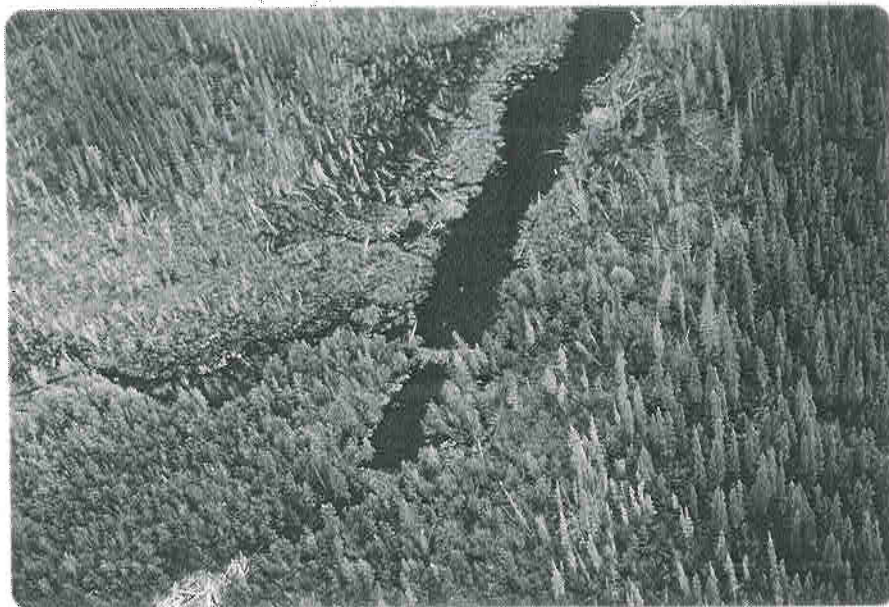
Figure 11. Beaver dams causing local flooding.

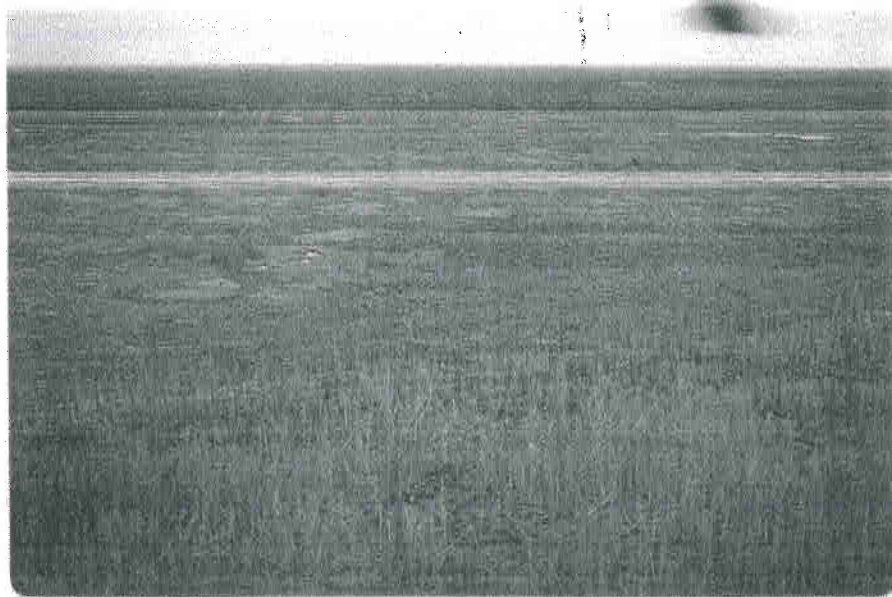
Figure 12. Fire area northeast of Pine Point

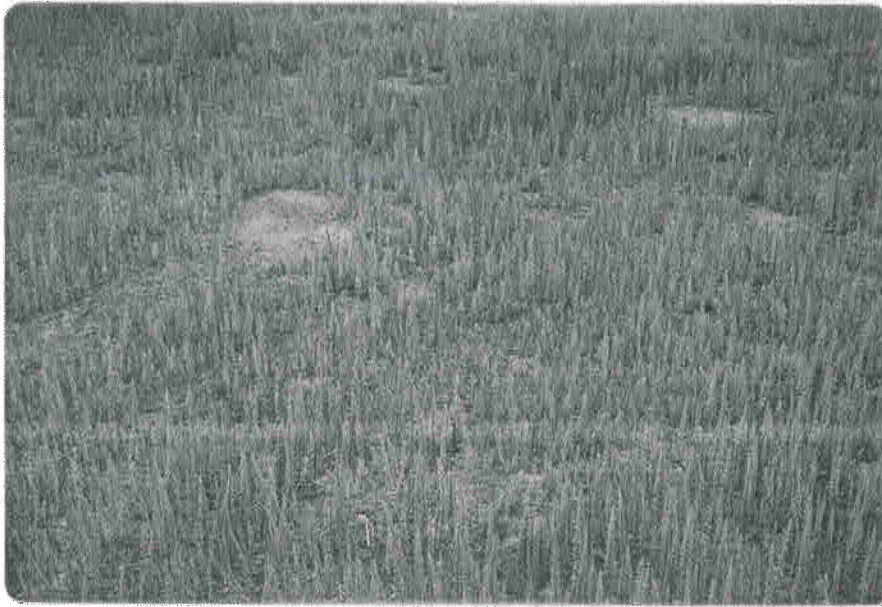
Figure 13. Fire-killed jack pine stand, same area.

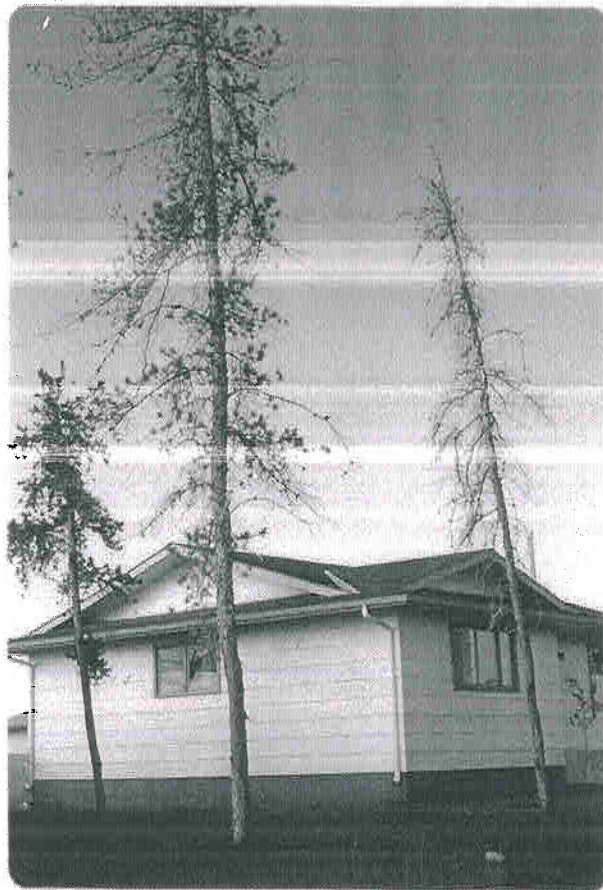
Figure 14. Residual forest jack pines within Pine Point town, showing decline and death from "people pressure disease".

Forest clearing for various reasons, forest fires, and drowning of trees are all clear and distinct forest impacts. Another impact less easily delineated but that should be mentioned is general "people pressure disease". Trees near recreation areas, settlements and residences, and other developments die from a variety of indirect causes that include windthrow, soil compaction, soil level changes, root disturbances, changes in surface water drainage patterns, and miscellaneous mechanical injuries. This is most easily observed within the town of Pine Point, where native vegetation left for landscape or park purposes is in poor condition or dead, especially when in small plots or isolated trees (Fig. 14). It is less evident but detectable as an "edge effect" along strips and around openings in the natural forest.

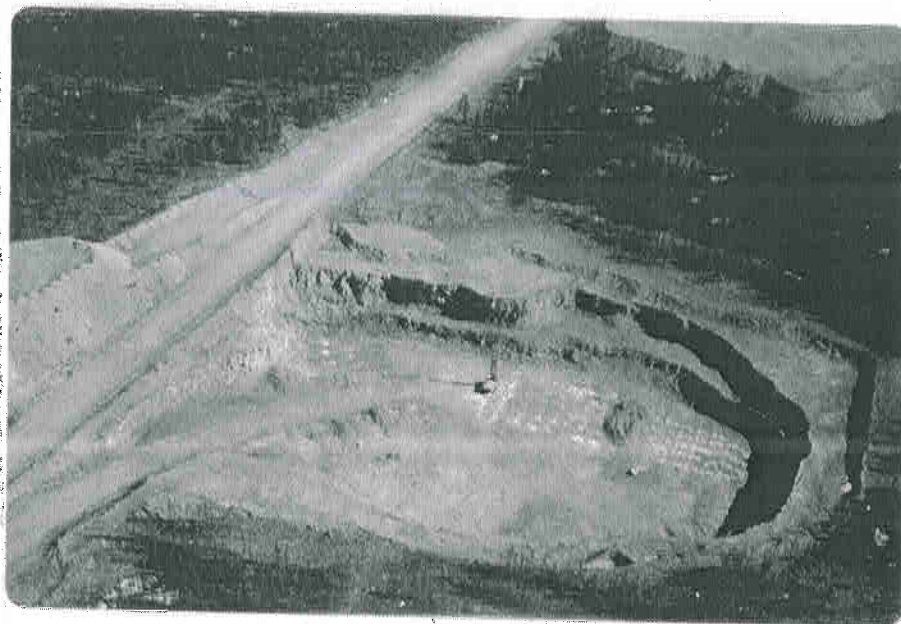
Figure 15. Mine Pit, spoil dump and haul road, Pine Point

Mining of ore deposits is by the open pit method. Rich ore pockets are lens-shaped and extremely variable in size, e.g. 50-100 m in depth and 5-150 ha in area. Mining began in 1965 and now averages 11,000 tons of ore per day. Over twelve major pits have been opened and about six are actively worked at any one time (Fig. 2).

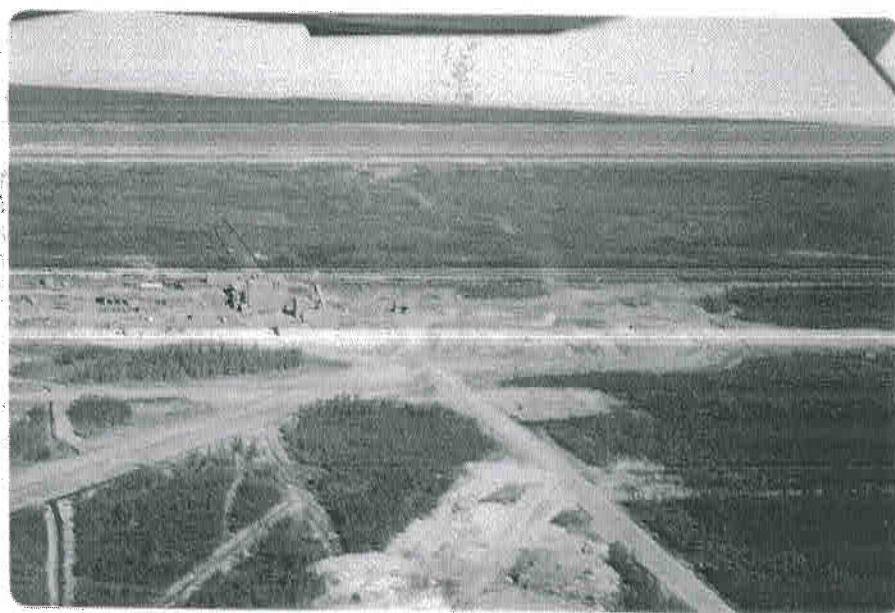
Figure 16. Milling and concentrating complex, tailings pond in background, Pine Point.
