# Giant Mine Tailings Cover Trials 2010 Data Summary

SRK Project No. 1CS019.016

**December 2010**

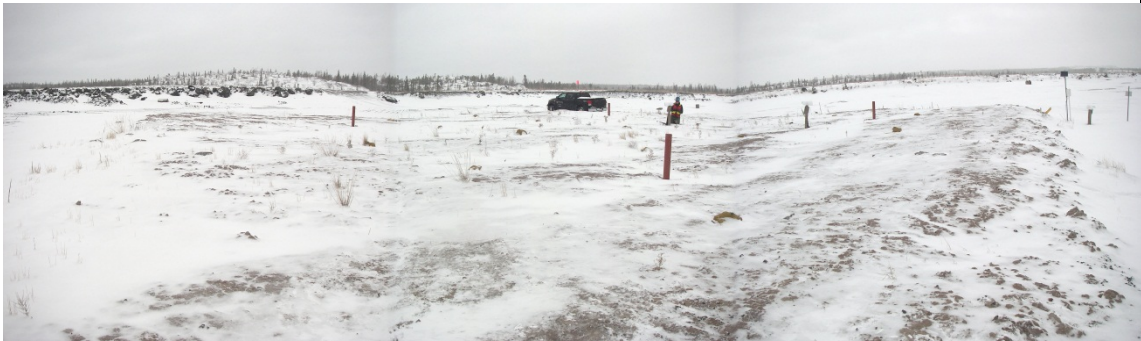
Photo 1: Beach A Plot – panoramic stitched photograph from South-East corner. The optical distortion of the photo stitching technique causes the East and South edges to be almost parallel.

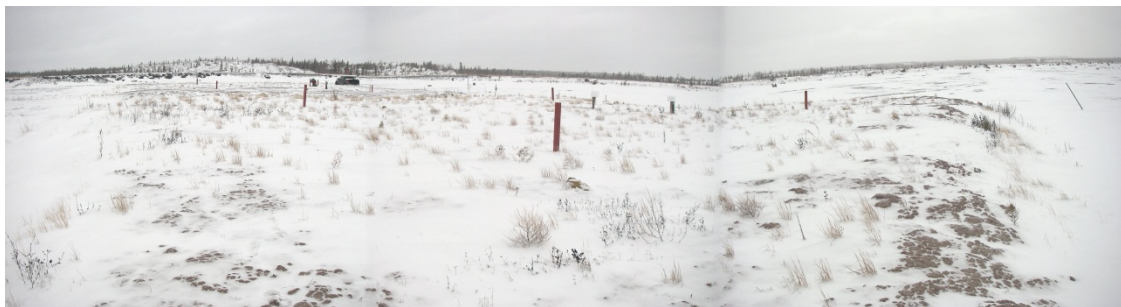
Photo 2: Beach B Plot – panoramic stitched photograph from North-East corner. The optical distortion of the photo stitching technique causes the East and North edges to be almost parallel.

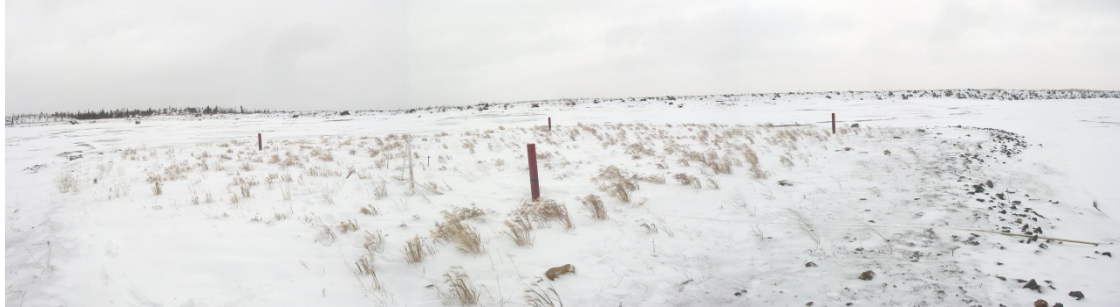
Photo 3: Slimes A Plot – panoramic stitched photograph from South-East corner. The optical distortion of the photo stitching technique causes the East and South edges to be almost parallel.

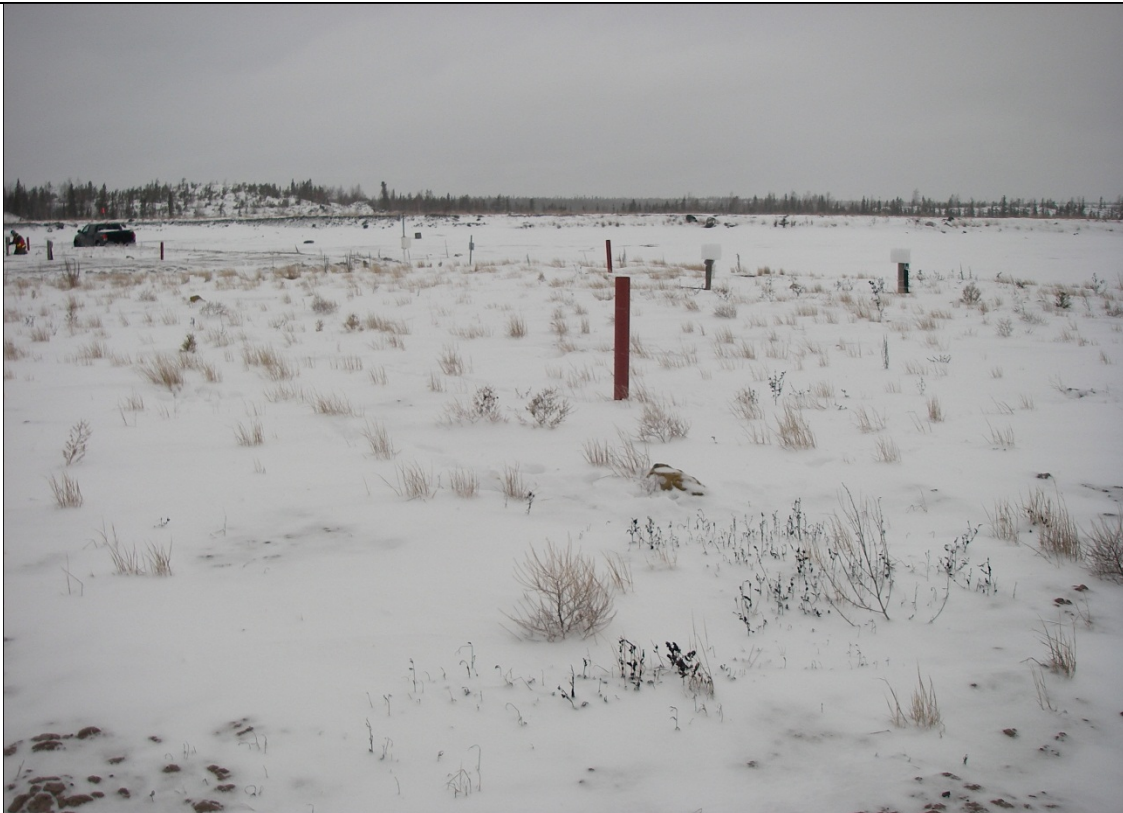
Photo 6: Beach B Plot – looking North from South-East corner. Note the density and type of the vegetation and the increased amount of snow retained by the vegetation.

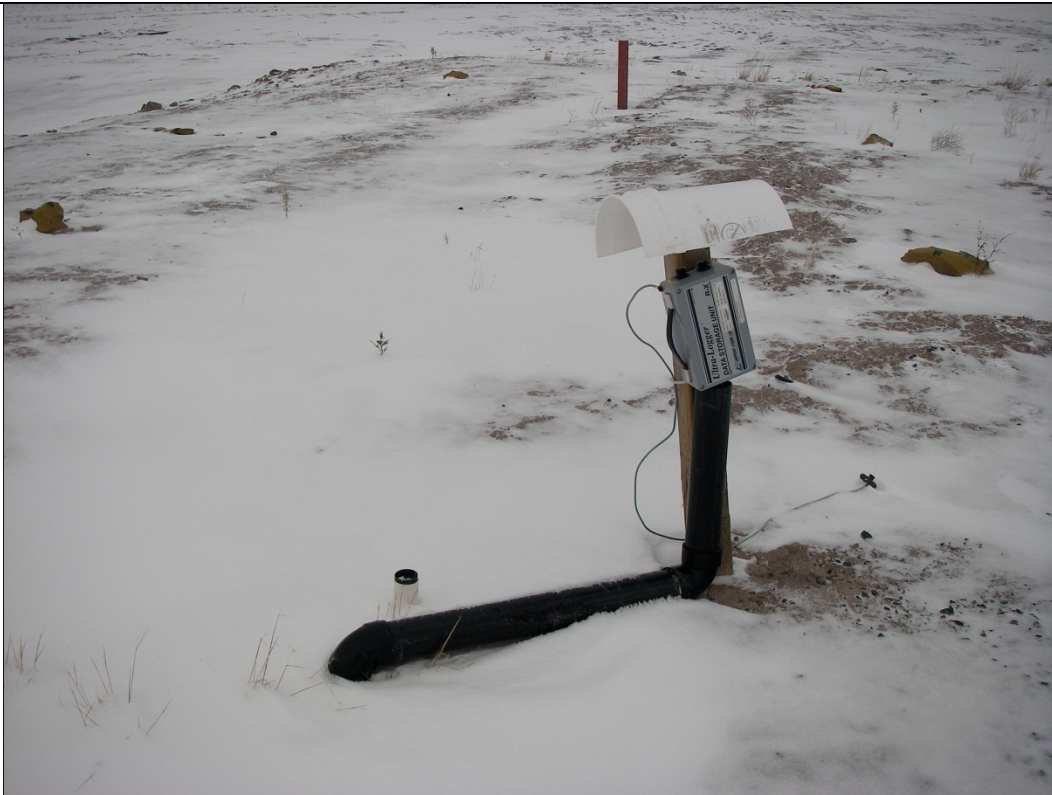
At the time of recommissioning, protection of the exposed portion of the thermistor strings was installed. Sections of ABS pipes were fitted and attached to the datalogger's post and the thermistor cables were threaded through the pipes. No part of the thermistor is now exposed to potential damage from wildlife or other mechanical damage.

Photo 7: Beach A Plot – looking south west. Note the improved protection of the thermistor cable. On the left side of the photo the shallow trench observed in 2009 is noticeable.

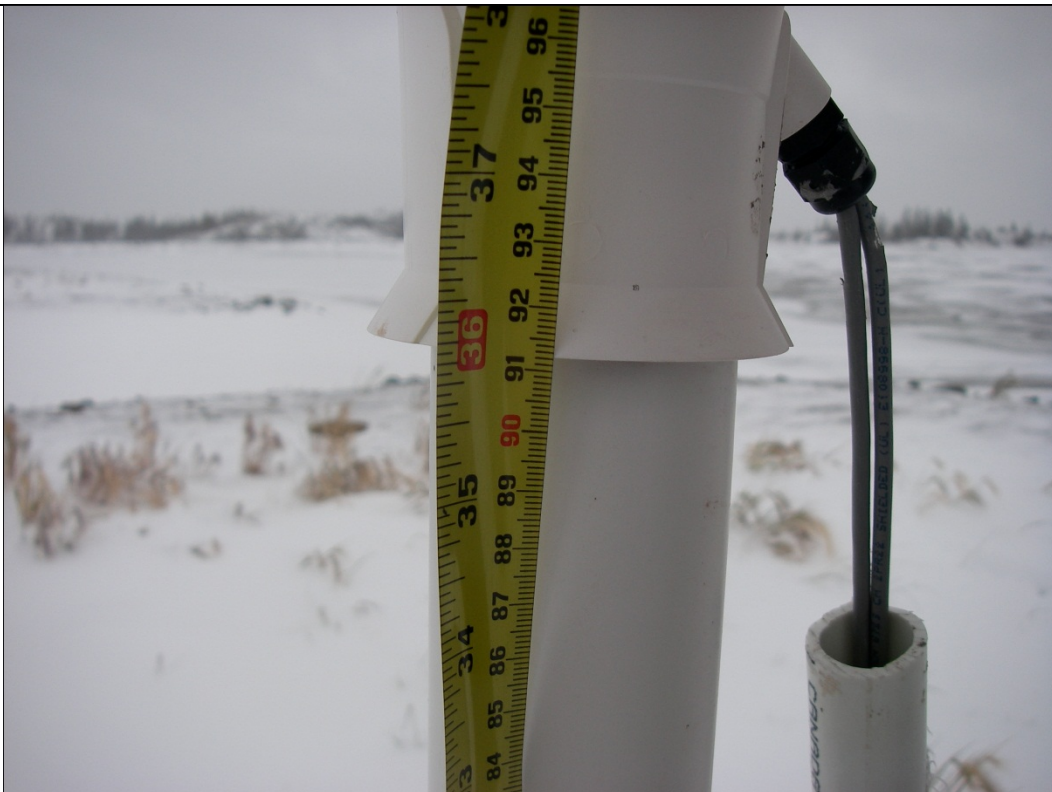
Photo 8: Slimes A Plot – stickup of the EnviroScan probe housing tube is 91 cm.
