Giant Mine Environmental Assessment

The Giant Mine Project Team to provide the investigative report on the tailings cover trial test plot. Any cost information to be removed prior to posting to the registry.

Giant Mine Tailings Cover Trials 2010 Data Summary

SRK Project No. 1CS019.016

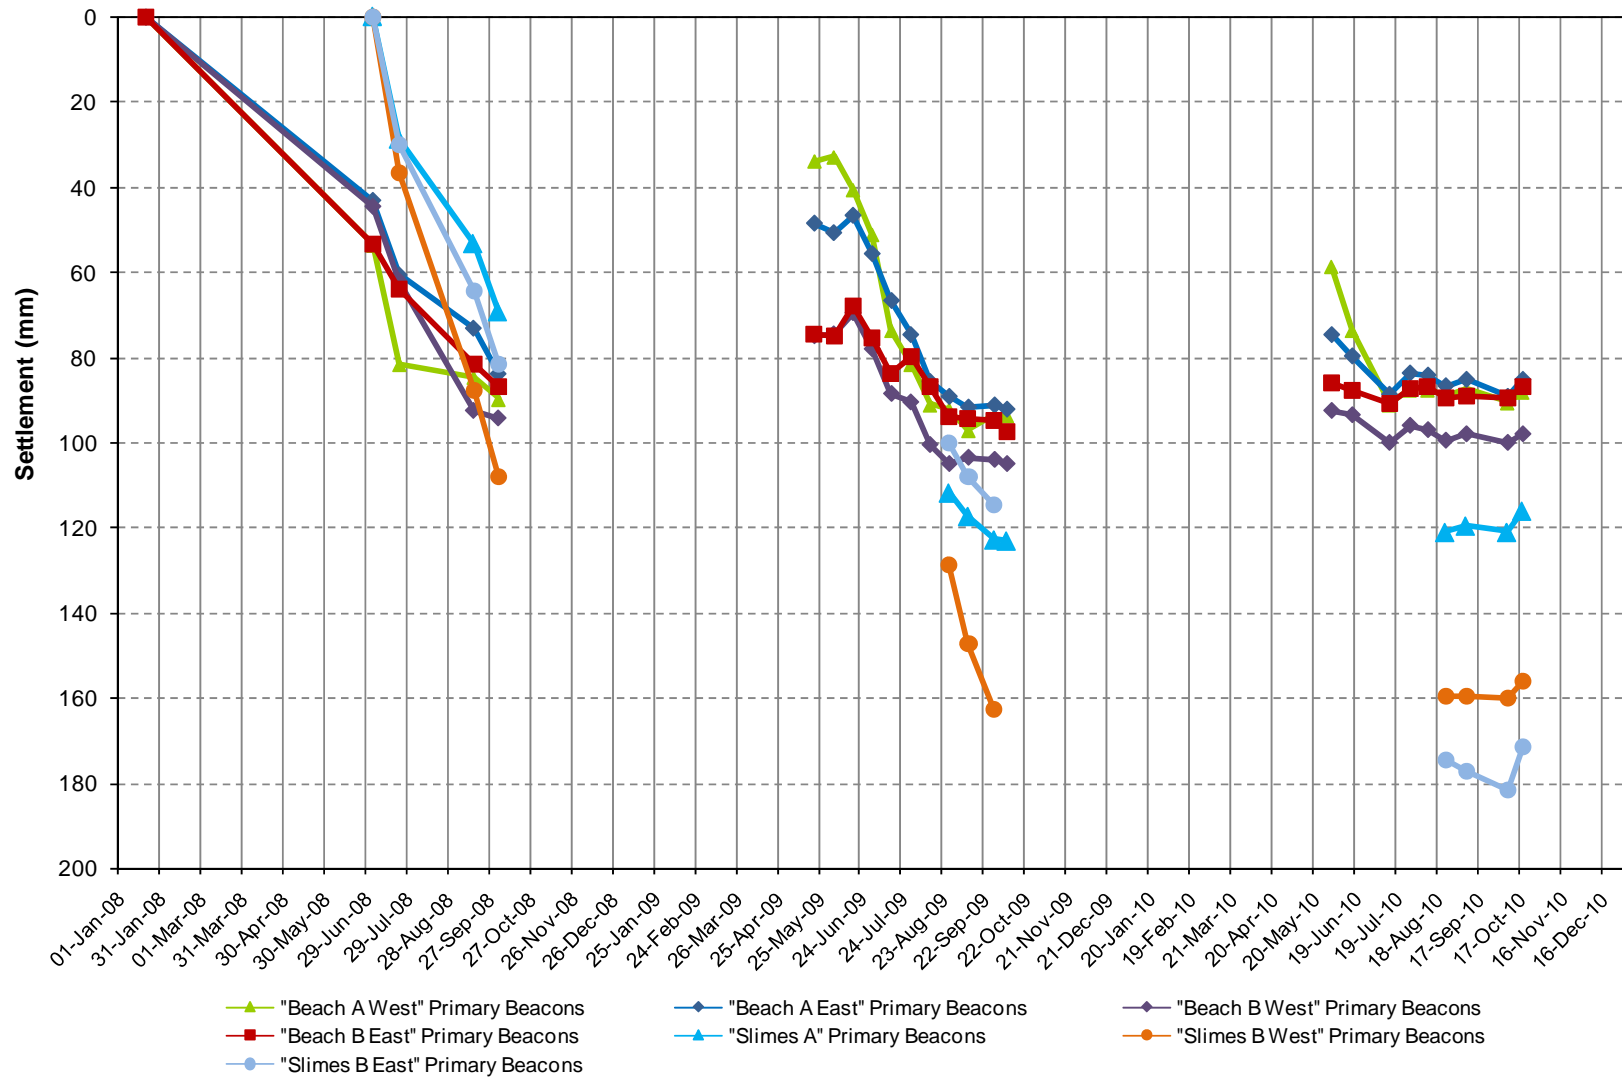
Figure:
5

As shown in Figures 5 through 7, the settlement between the last survey of 2009 and the first survey of 2010 is negative, i.e. surface elevation increased. Although the phenomenon is consistent with the previously observed survey gap during the winter of 2008/2009 (SRK 2010), the amount of the elevation increase is slightly different for each plot. Notwithstanding these observations, the survey of Slime Plot B East shows a significant settlement compared to 2009. The causes of this may be multiple, from survey errors to frost heave during the winter months. A more detailed analysis of the data would be required to narrow down the possible causes.

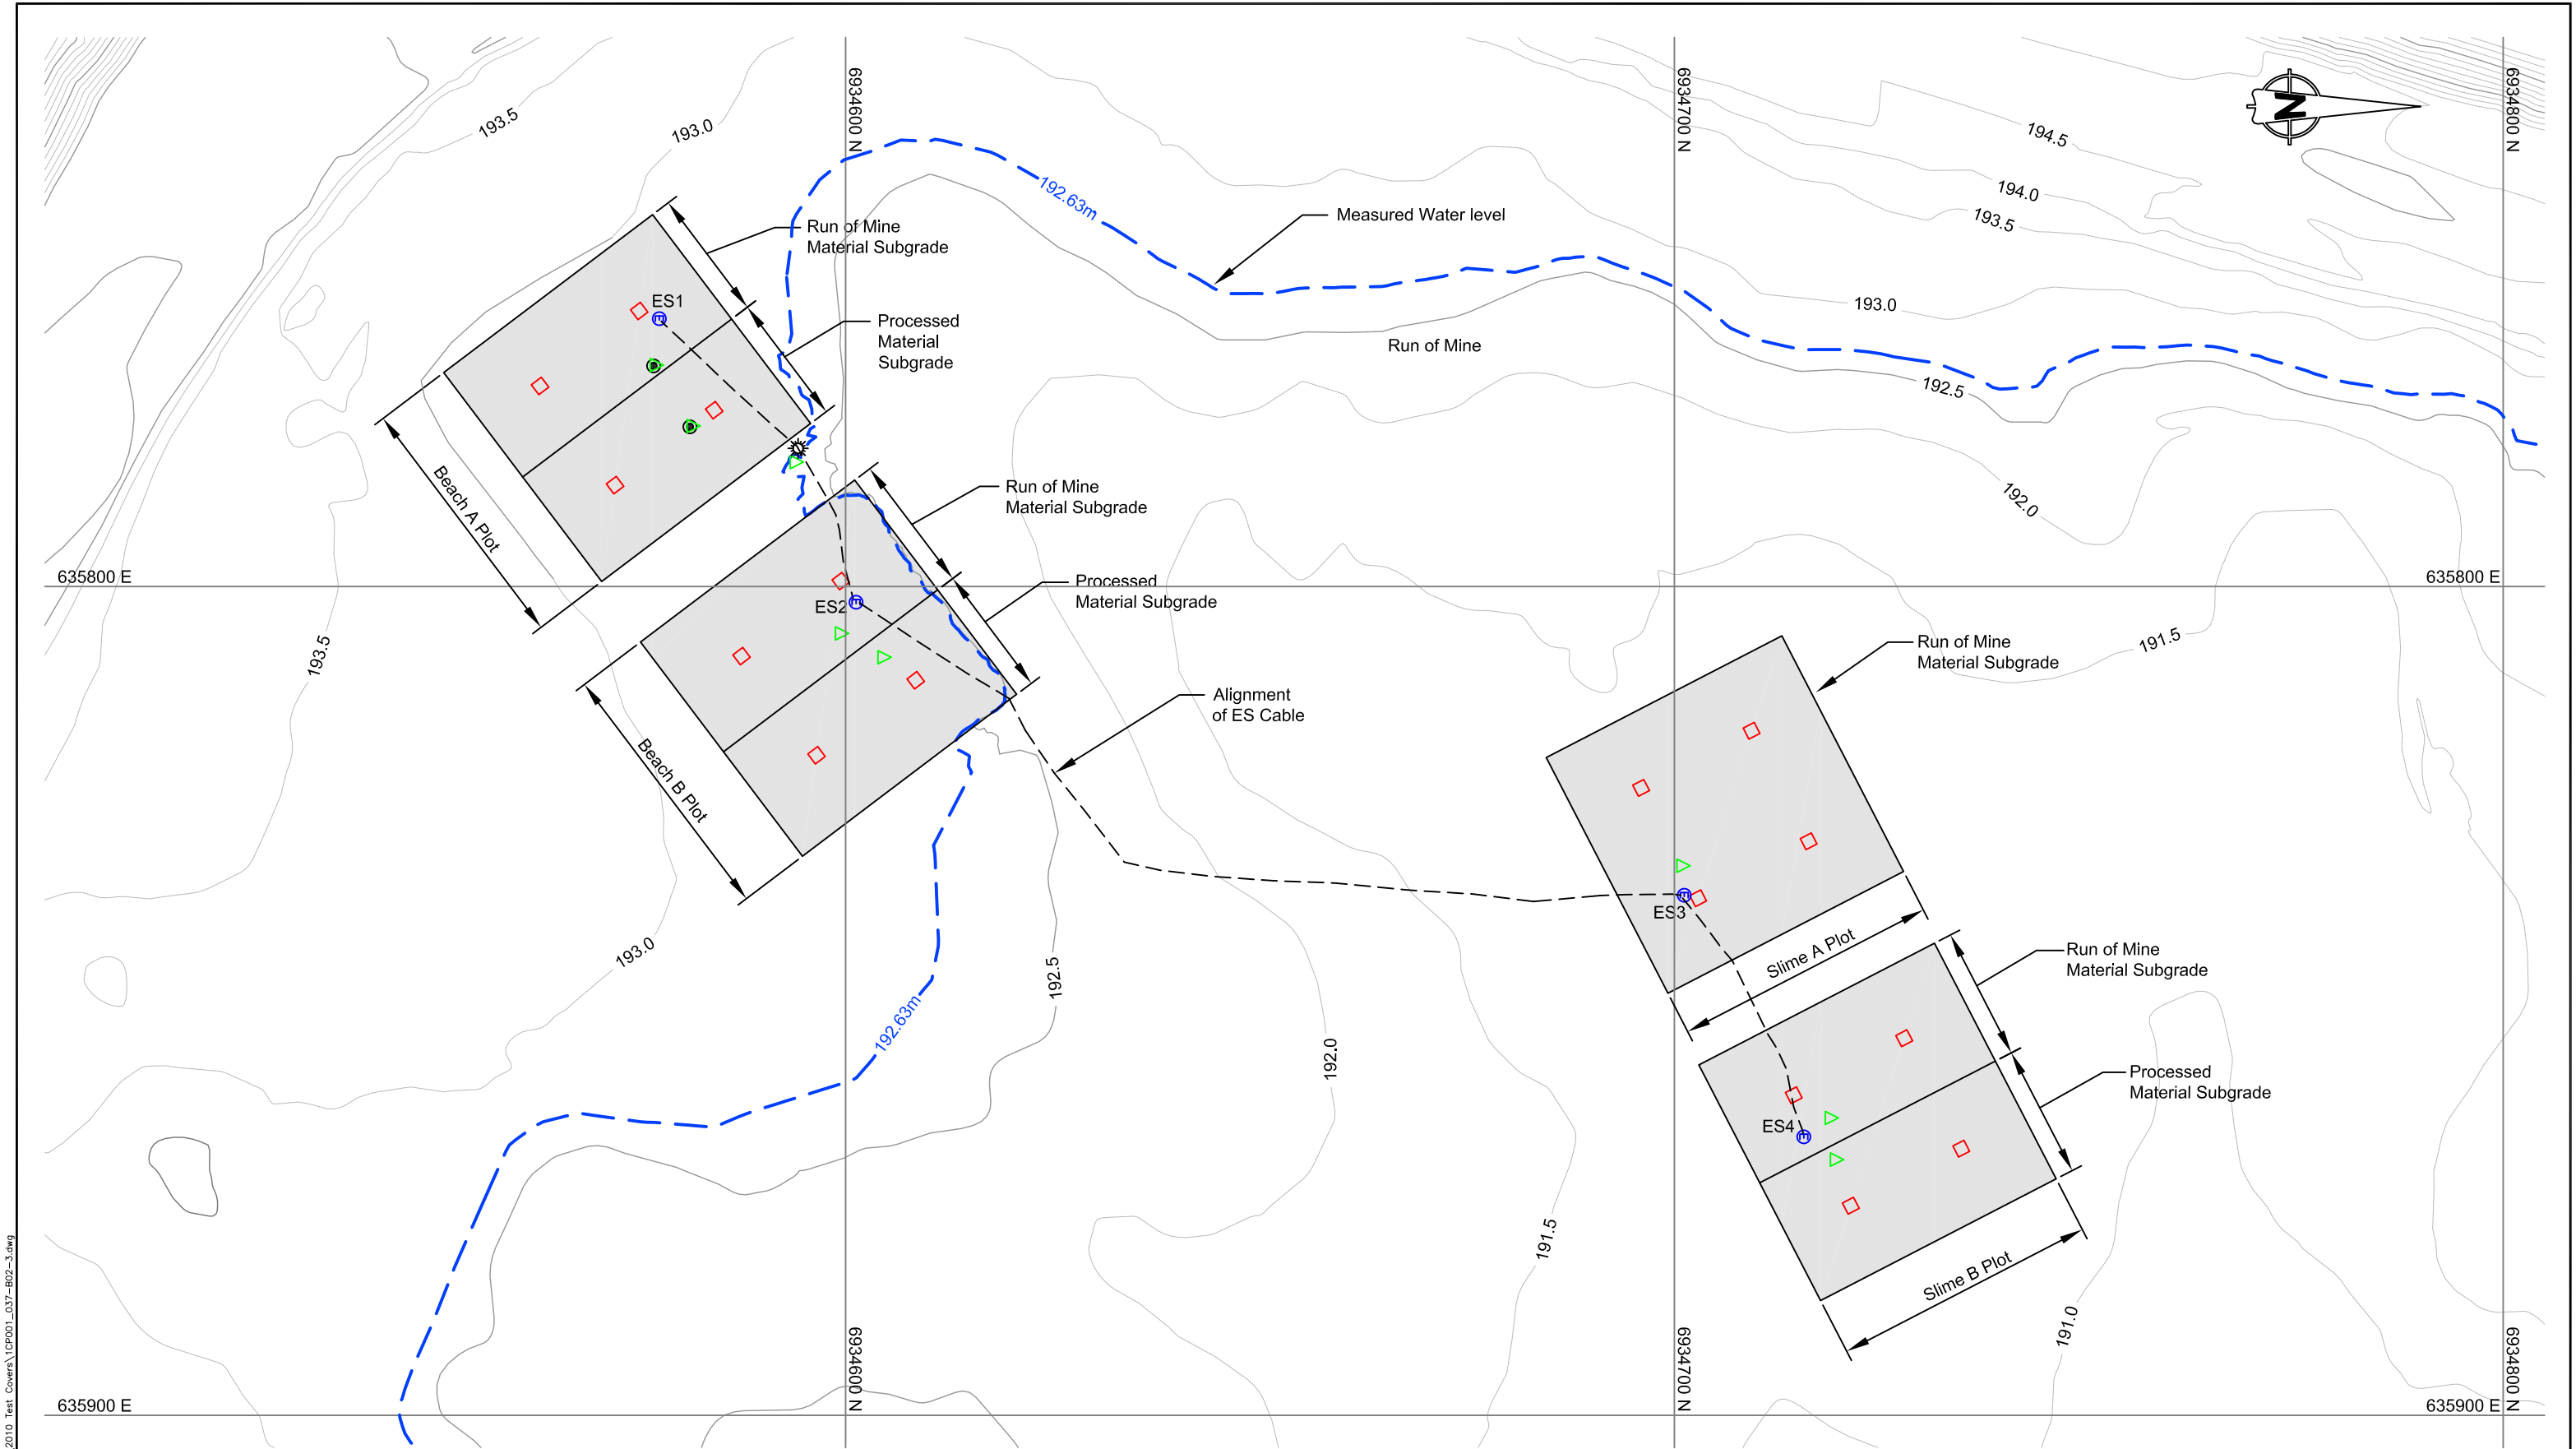
7

- Solar Panel
- Hobo
- Thermistor String
- Enviroscan Sensor
- Survey Beacon
- Enviroscan Cable

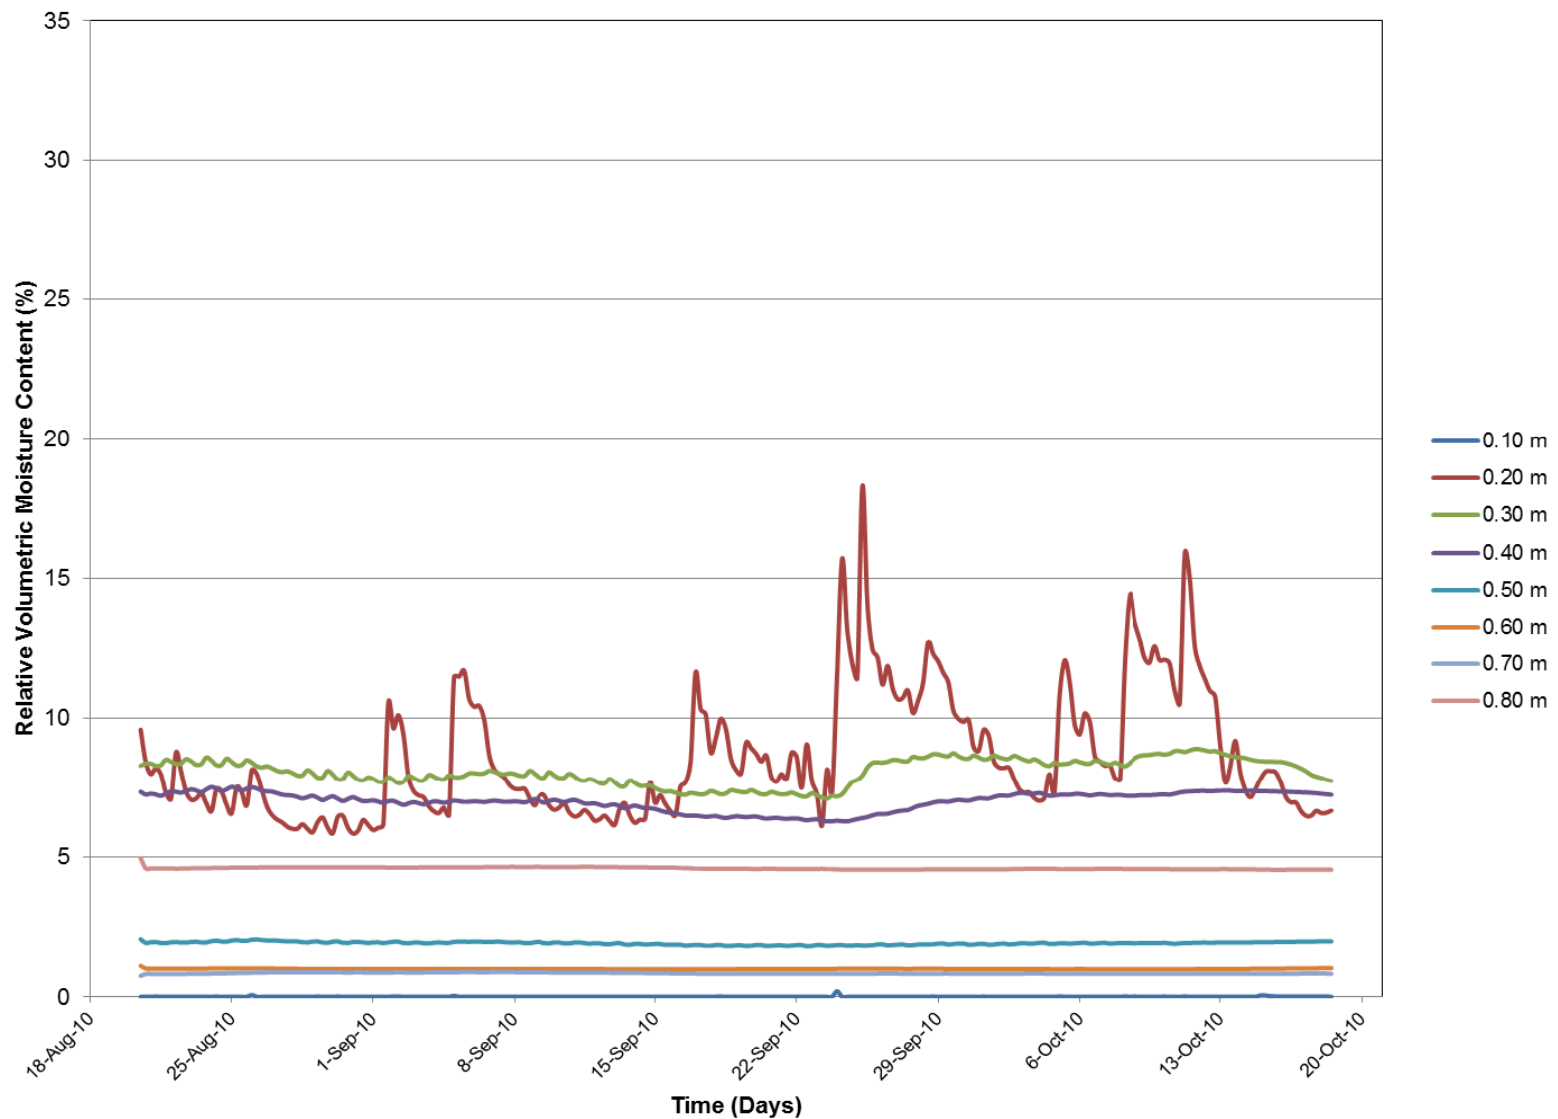
Figure: **14**

As shown in Figures 14 and 15, the instruments performed as intended. As expected, the sensors located close to surface showed highly variable moisture content according to the wetting up and drying cycles following precipitation events. The sensor closest to the cover surface on all trial covers consistently measured moisture content values of zero or near zero. This is an artefact of the consolidation settlement of the growth medium layer, which resulted in the sensors (which have a fixed elevation) gradually becoming airborne, thus the measured values not being representative of the cover soil.

**Volumetric Moisture Content
Measured Using the EnviroScan
Probe on Beach A Plot**

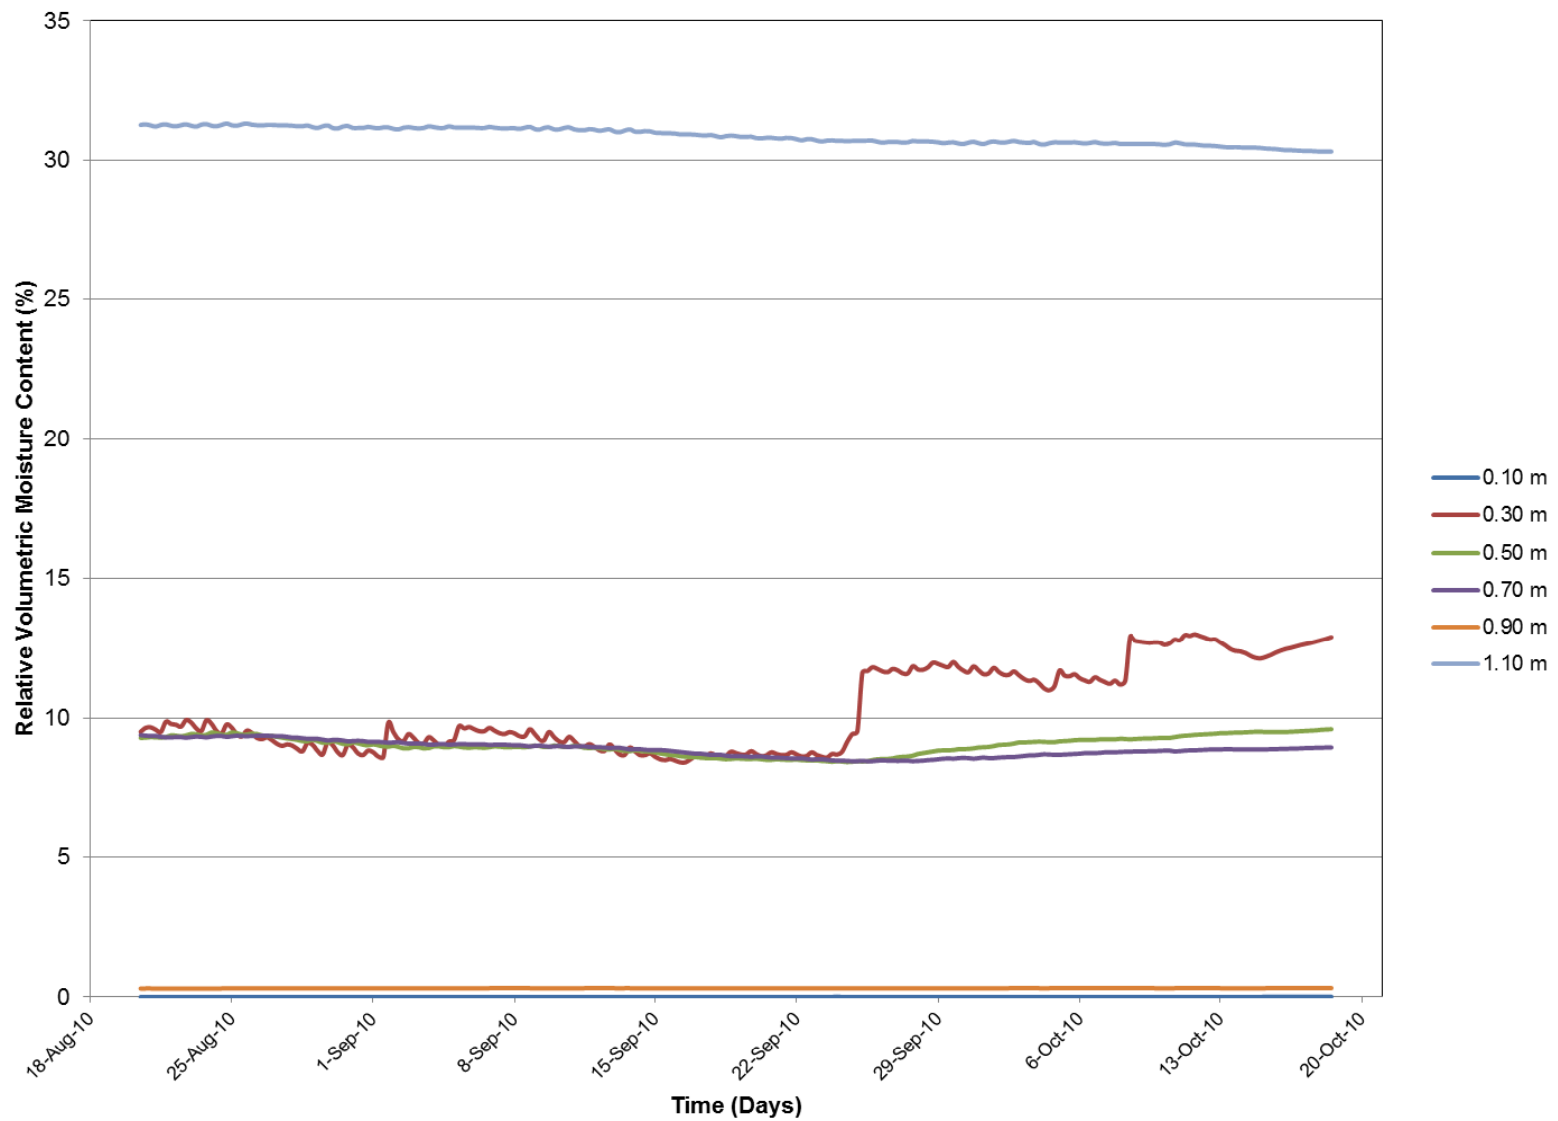
Figure: **15**

The sensor located 1.1 m below the surface of Beach B Plot, shows a much higher moisture content than the other sensors. Most likely this sensor is sitting within the tailings zone, which naturally has a higher moisture content than the crushed rock or the growth medium used to construct the cover.

**Volumetric Moisture Content
Measured Using the EnviroScan
Probe on Beach B Plot**

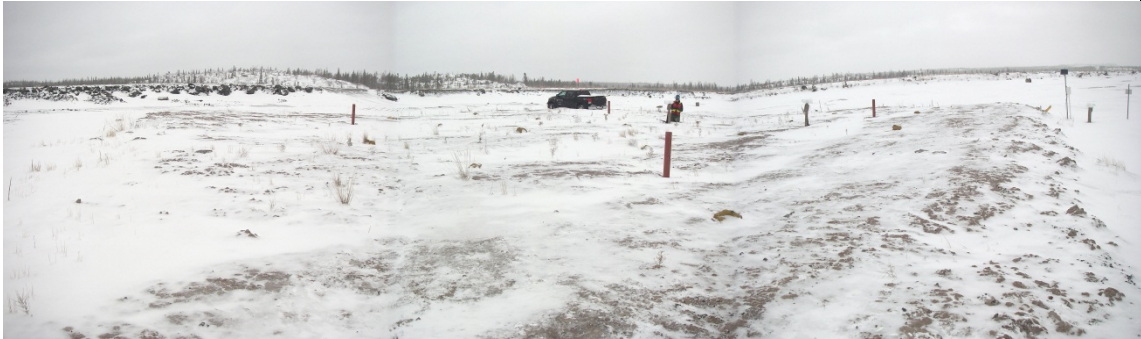
Photo 1: Beach A Plot – panoramic stitched photograph from South-East corner. The optical distortion of the photo stitching technique causes the East and South edges to be almost parallel.

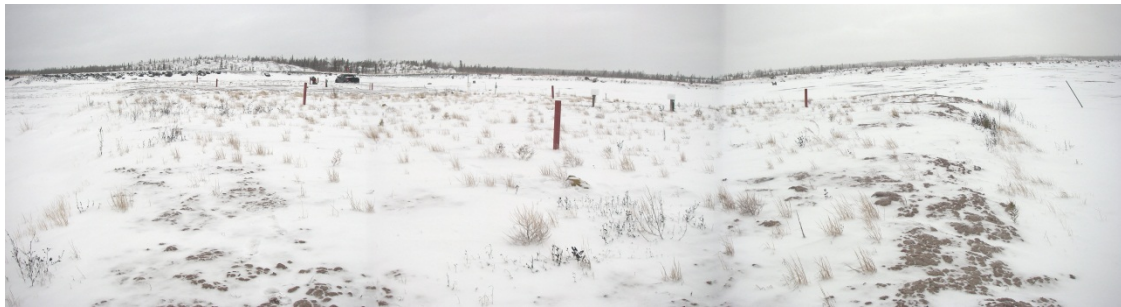
Photo 2: Beach B Plot – panoramic stitched photograph from North-East corner. The optical distortion of the photo stitching technique causes the East and North edges to be almost parallel.

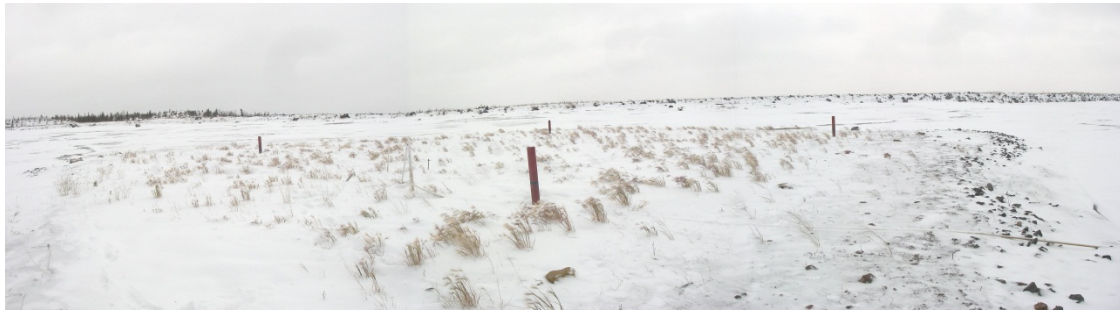
Photo 3: Slimes A Plot – panoramic stitched photograph from South-East corner. The optical distortion of the photo stitching technique causes the East and South edges to be almost parallel.

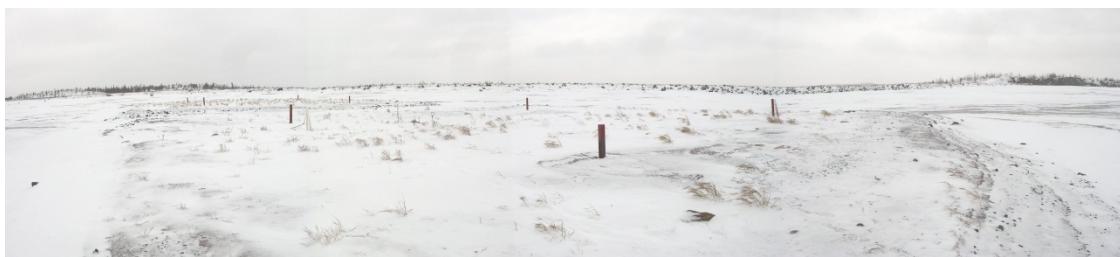
Photo 4: Slimes B Plot – panoramic stitched photograph from South-East corner. The optical distortion of the photo stitching technique causes the East and South edges to be almost parallel

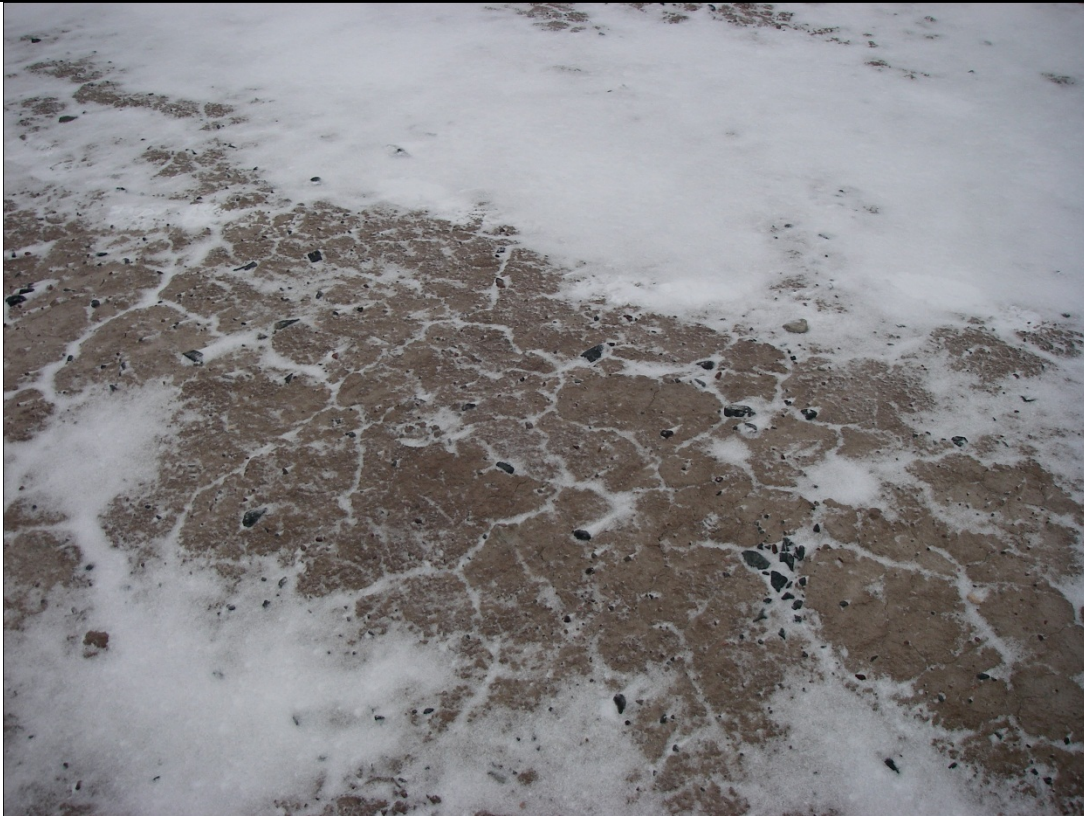
No anthropogenic disturbance of the covers was noted other than what was noted in 2009. An extensive network of shrinkage cracks caused by desiccation of the clayey growth medium was noted on the Beach A and B plots, while the Slimes A and B plots were showing evidence of having been totally submerged and the growth medium was washed away on some areas. For more details please refer to the Inspection Memo in Appendix B.

Photo 5: Beach A Plot – evidence of shrinkage cracking and wind erosion.

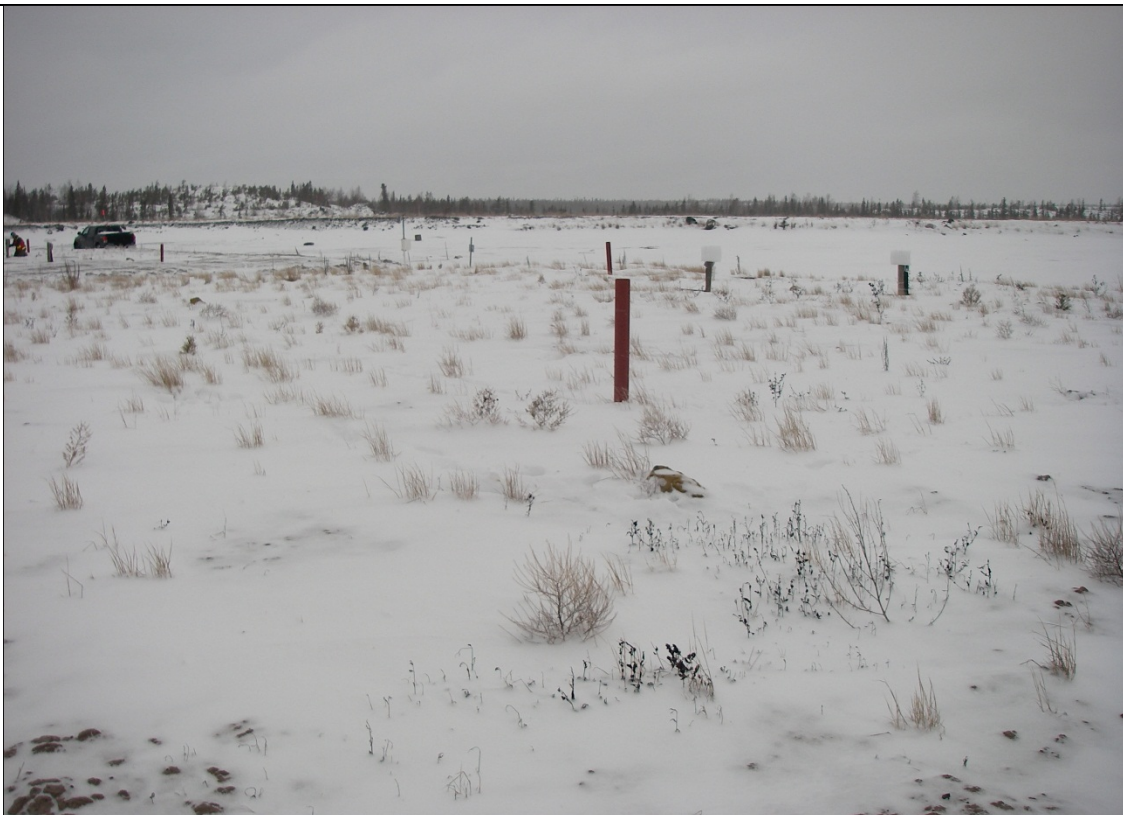
Photo 6: Beach B Plot – looking North from South-East corner. Note the density and type of the vegetation and the increased amount of snow retained by the vegetation.

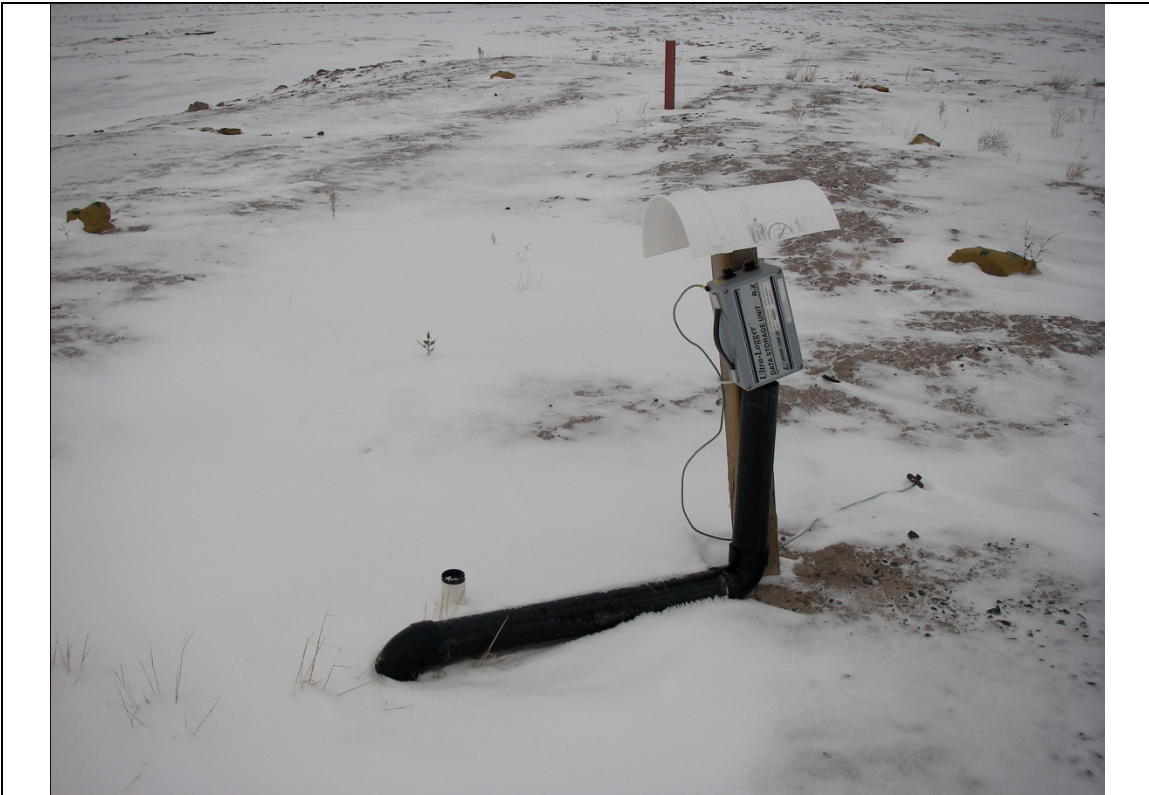
At the time of recommissioning, protection of the exposed portion of the thermistor strings was installed. Sections of ABS pipes were fitted and attached to the datalogger's post and the thermistor cables were threaded through the pipes. No part of the thermistor is now exposed to potential damage from wildlife or other mechanical damage.

- Some sort of a shallow trench is apparent on the East side of the cover, but the location and extent does not seem to have changed since 2009.
- Localized depressions around the primary beacons (same as noted during previous inspections)

Photo 7: Beach A Plot – looking south west. Note the improved protection of the thermistor cable. On the left side of the photo the shallow trench observed in 2009 is noticeable.

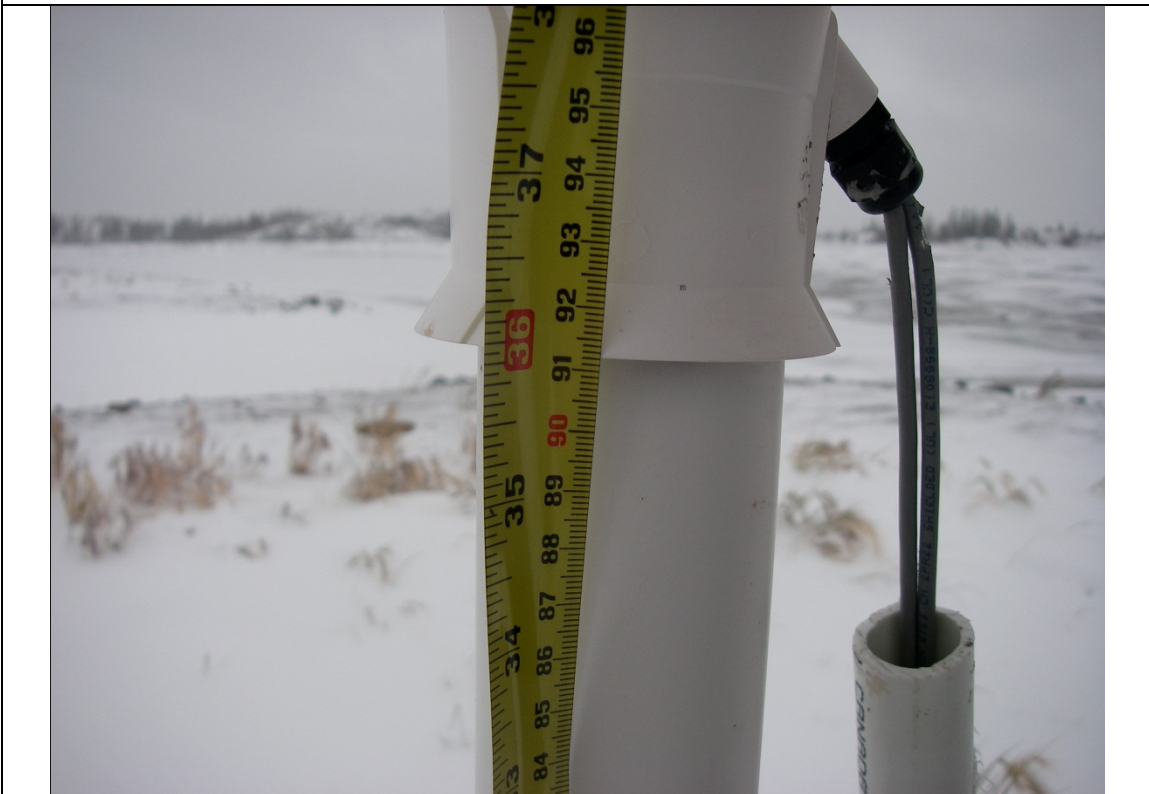
Photo 8: Slimes A Plot – stickup of the EnviroScan probe housing tube is 91 cm.

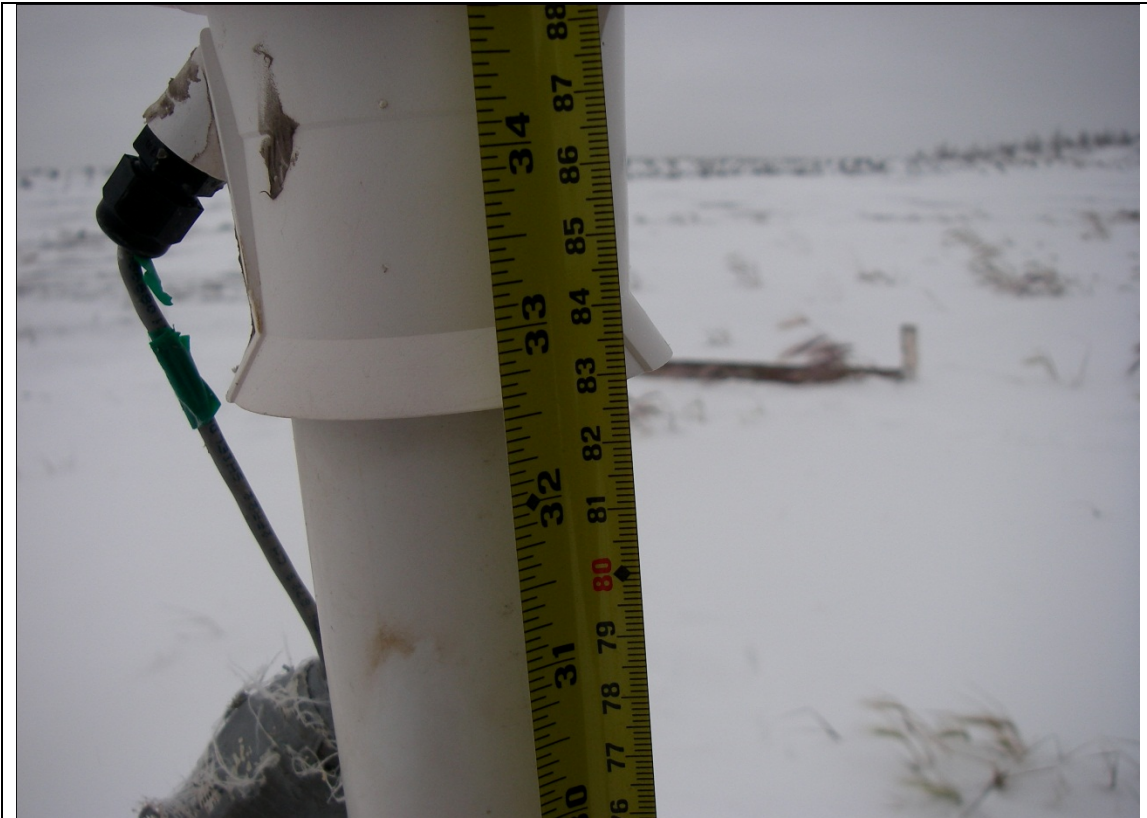
Photo 9: Slimes B Plot – stickup of the EnviroScan probe housing tube is 83 cm.
