PHOTO SUMMARIES

| AVALON RARE METALS INC. | | |
| THOR LAKE PROJECT | | |
| GEOTECHNICAL FIELD PROGRAM SUMMARY<br>TP-2010-01 PHOTO SUMMARY | | |

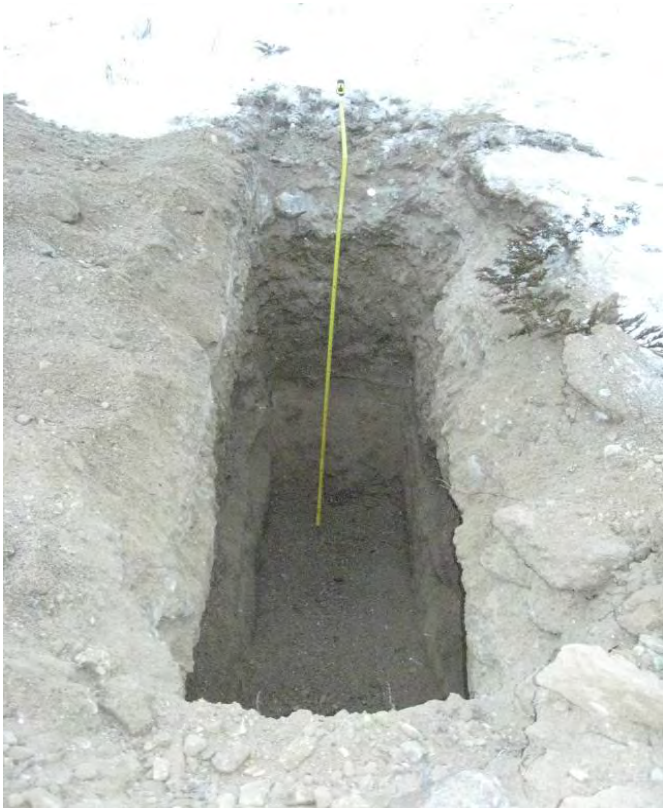
Photo 5 - TP-2010-01 profile (0.00 - 1.90 m)

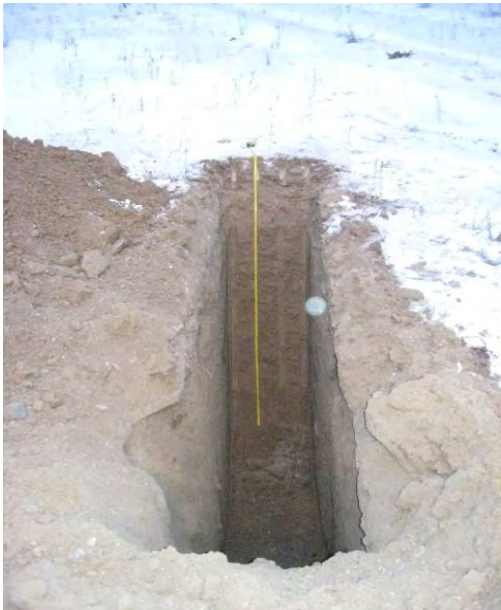
Photo 5 - TP-2010-02 profile (0.00 - 2.12 m)

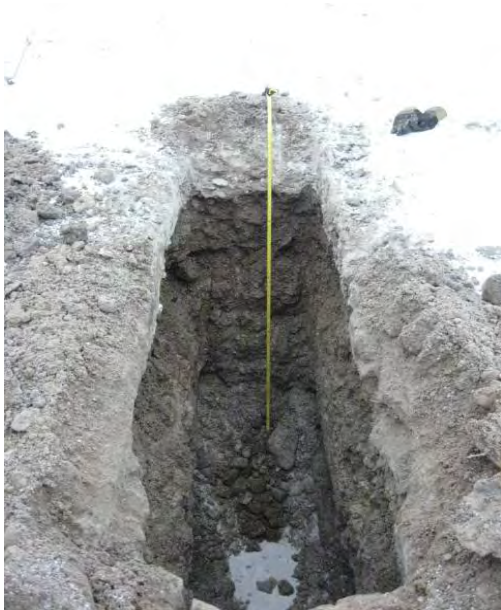
Photo 5 - TP-2010-07 profile (0.00 - 1.84 m)
