# **APPENDIX F**

September 4, 2015

**Subject:** Addendum and Progress Report to Address Adequacy Review of  
Developer's Assessment Report for Environmental Assessment, EA1415-01  
Proposed All-Season Road Access to Prairie Creek Mine, NT

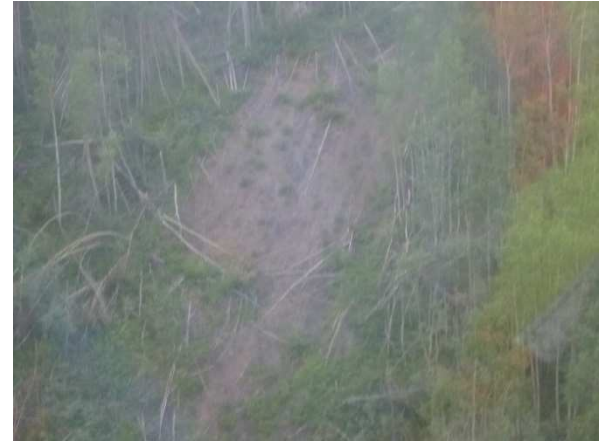
<p>Fresh failure in sandy colluvium, looking west from approximate alternative alignment at KP108.2.</p>

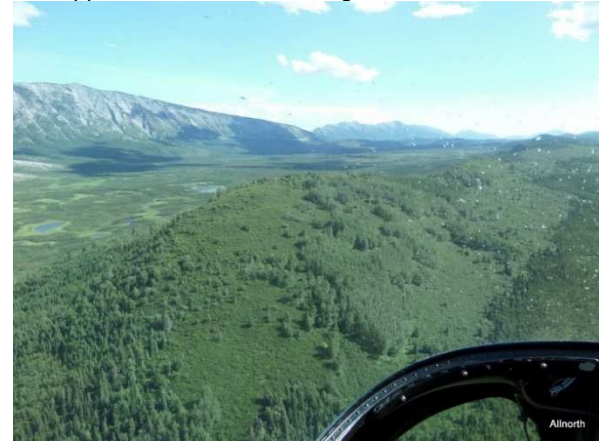
<p>Looking SSE from 600 m due W of KP107. Gentler W side of bluff; slope failures E side (Photo credit: Allnorth).</p>

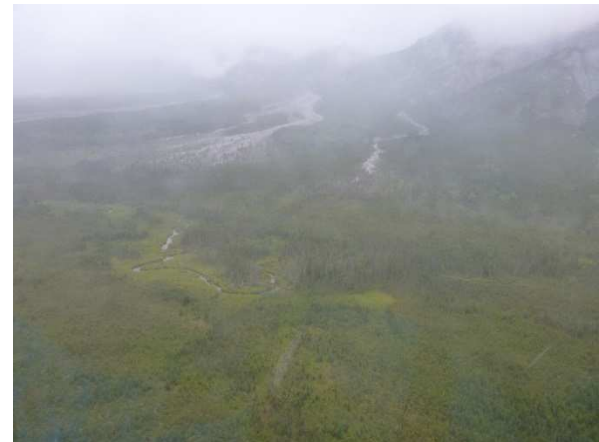
<p>Looking N to NE towards alluvial fan complex from valley bottom at about 1870 m due E of KP108.5.</p>
