APPENDIX 3

November 19, 2012

ISSUED FOR USE
EBA FILE: E22102082
Via Email: david@canadianzinc.com

Subject: High Water Levels for Prairie Creek Mine Access Road Stream Crossings
Northwest Territories

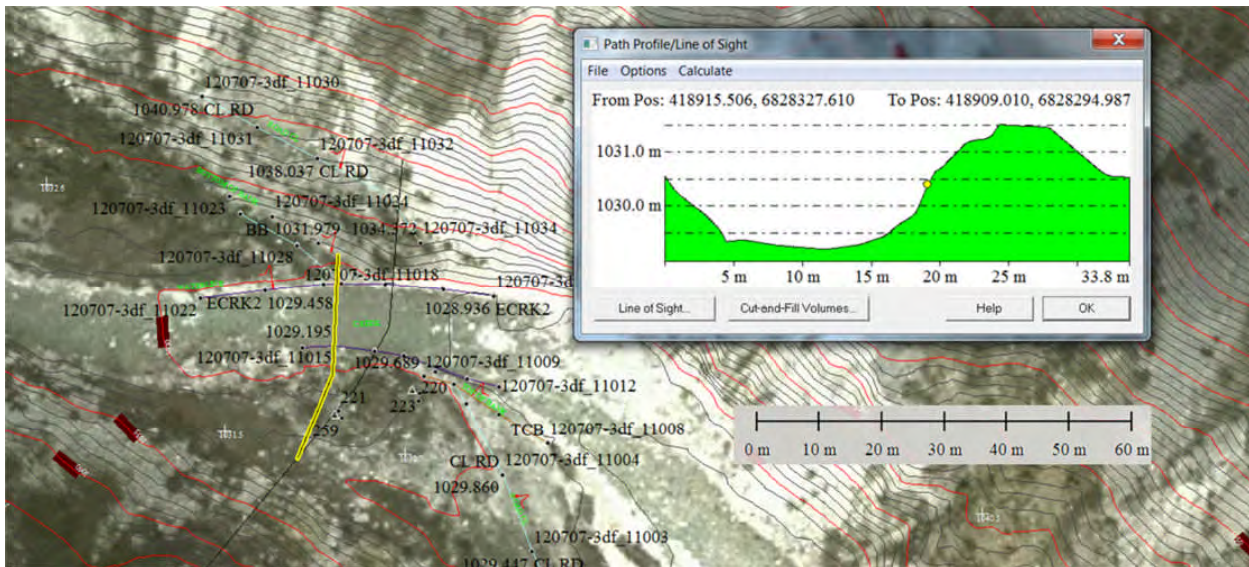
A second temporary span bridge crossing is proposed over Sundog Creek at Road KM 26.4. Figure 3 shows the LiDAR-derived cross section used to determine the high water level at this location. The LiDAR section was used "as-is" without adjustment for bathymetry. Based on ground photos, the flow was very shallow with frequent riffles.

Figure 3: Sundog Creek at KM 26.4. Flow is from left to bottom right. Section plot is viewing downstream

The channel slope through the crossing reach was assumed to be 0.015, considering a surveyed water edge slope of 0.013 and slightly steeper downstream conditions. A Manning's n value of 0.055 was assumed.

The computed water level at Sundog Creek Temporary Crossing 2 is 1030.27 m for the 100-year discharge of 28.6 m³/s. The flow velocity in the main channel is 2.07 m/s and the maximum depth of flow is approximately 1.1 m.

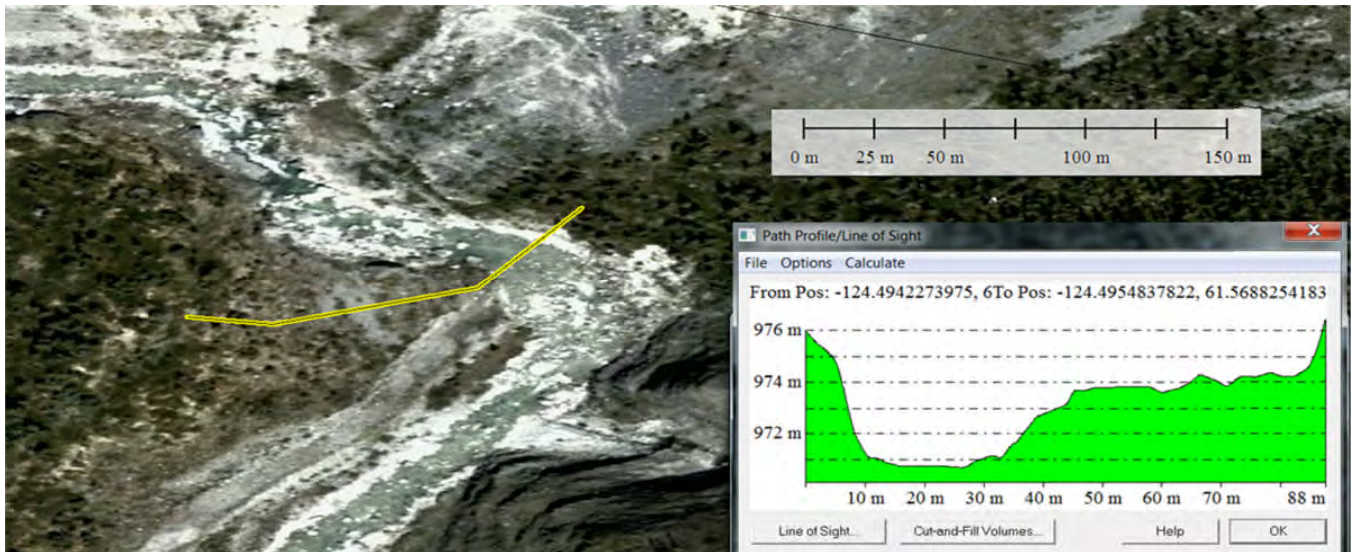
The fourth temporary span bridge crossing is proposed over Sundog Creek at Road KM 28.7. Figure 5 shows the LiDAR-derived cross section used to determine the high water level at this location. The LiDAR section was used "as-is" without adjustment for bathymetry.

Figure 5: Sundog Creek at KM 28.7. Flow is from left to bottom left. Section plot is viewing downstream

The crossing is located in the middle of a short (15 m) relatively flat reach between upstream and downstream rapids with very large boulders in the channel. Due to difficulty in assessing the local channel slope, the hydraulic analysis for this site considered three LiDAR-derived sections, all applied without any adjustment for bathymetry. The two additional sections were located downstream of the crossing, first at the start of the white water section, and second about midway down though the rapids where the channel slope is approximately 10%. A Manning's n value of 0.080 was assumed for all sections.

The computed water level at Sundog Creek Temporary Crossing 4 is 971.52 m for the 100-year discharge of 33.0 m³/s. The flow velocity in the main channel is 2.48 m/s and the maximum depth of flow is approximately 0.8 m.

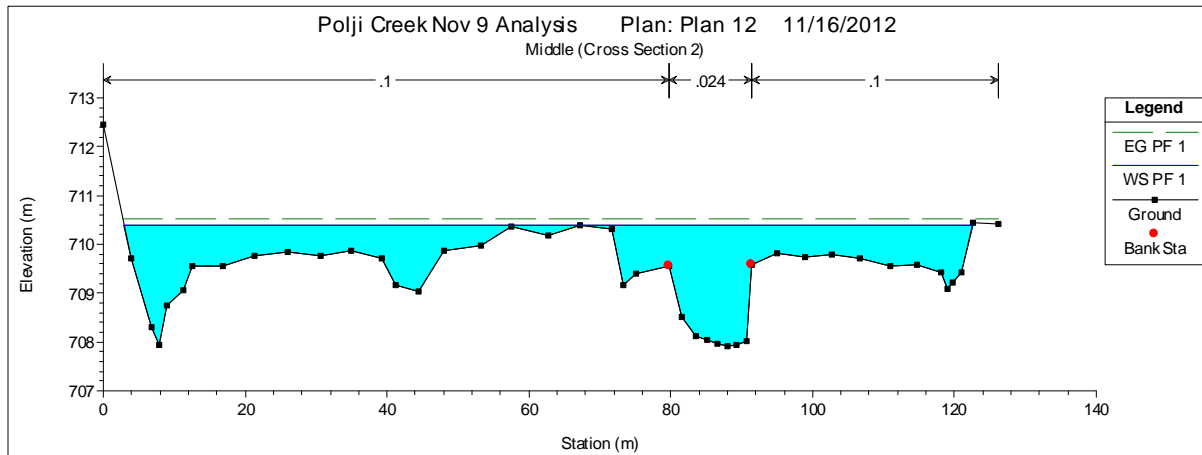
The computed water level at the Polje Creek crossing is 710.40 m for the 100-year discharge of 59.7 m³/s. The flow velocity in the main channel is 1.73 m/s and the maximum depth of flow is approximately 2.5 m. At the design flow, the entire floodplain will be inundated as shown in Figure 9 below. Any obstruction of the floodplain area due to road fill or bridge abutments will result in increased water levels on the upstream side of the crossing.

Figure 9: Polje Creek at KM 53. Depth and extent of inundation at design flow.

The computed design water level is believed to be conservatively high by as much as 0.3 m because it does not account for bypass floodplain flow past the right (east) end of the modelled section. The bypass water would overtop the main channel about 350 m upstream from the crossing, flow north over the right (east) floodplain, and drain into the oxbow channel section that is east from the main active channel.

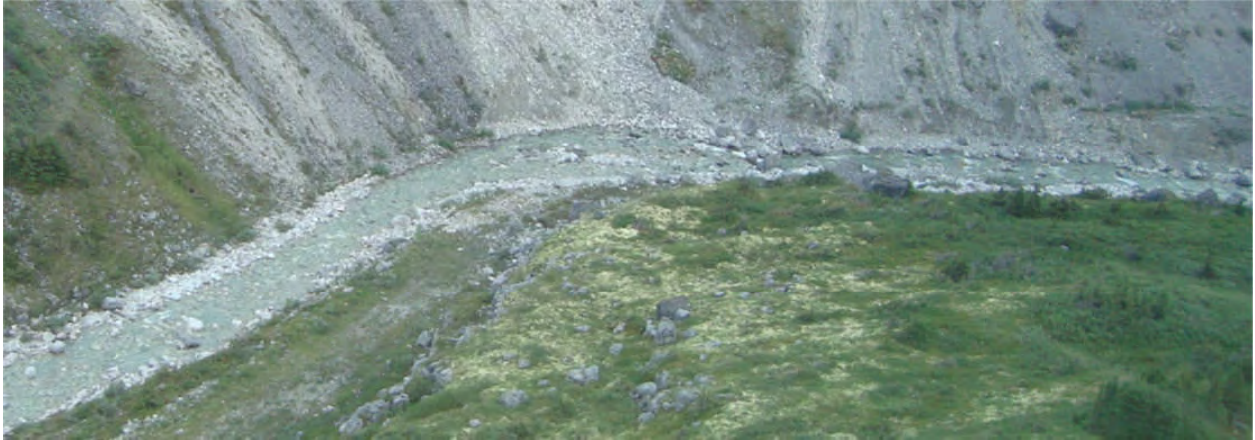
Photo 5: Sundog Temporary Crossing 3, Road KM 26.8. Flow is left to right.

The third temporary span bridge crossing is proposed over Sundog Creek at Road KM 26.8. Figure 4 shows the LiDAR-derived cross section used to determine the high water level at this location. The LiDAR section was used “as-is” without adjustment for bathymetry. Based on ground photos, there are frequent huge boulders which have apparently fallen into the creek from the adjacent hillslope. The boulders are sufficiently large to be observable in the Figure 4 orthophoto image.
