**RE: Environmental Assessment EA1415-001, Prairie Creek Mine
Reasons for Decision on the Adequacy of the DAR**

Subject: Permafrost-Karst Characterization
Developer's Assessment Report for Environmental Assessment, EA1415-01
Proposed All-Season Road Access to Prairie Creek Mine, NT

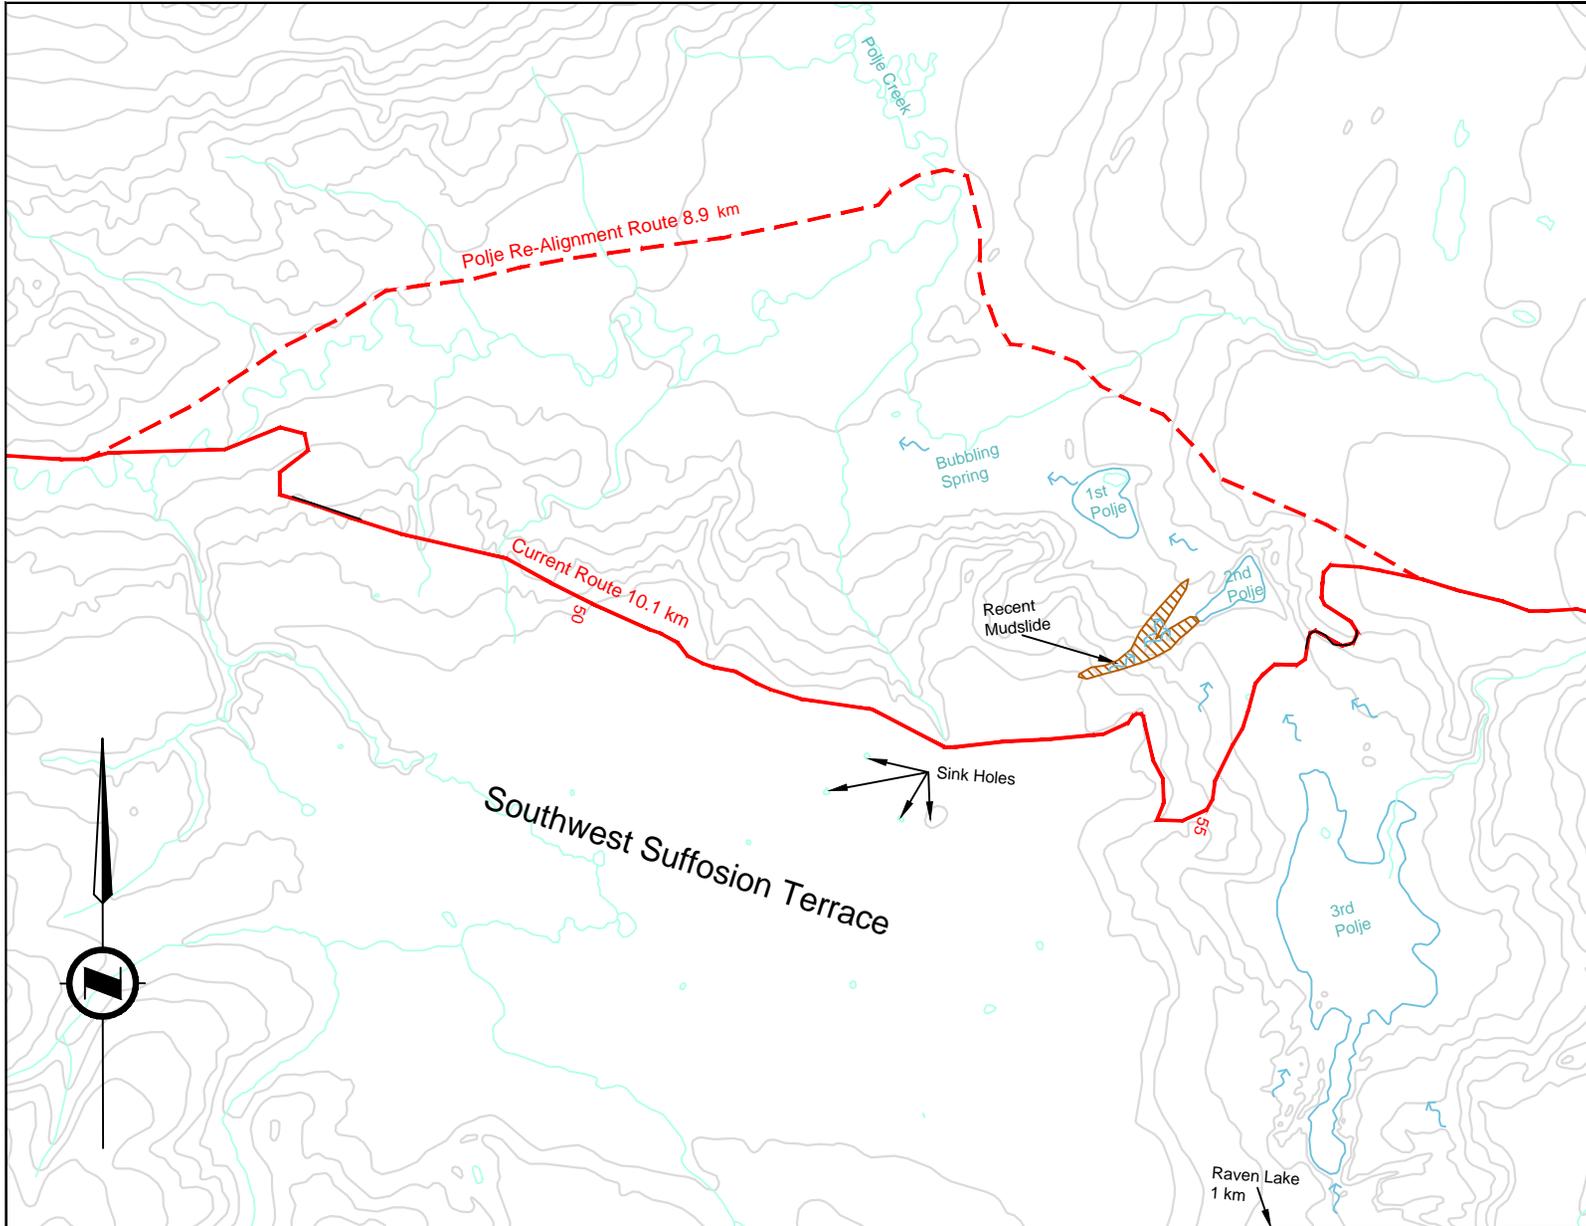
**Figure 6-21:
Access Road;
Polje By-Pass Alternative**

The road section Km 48-59 is identified as the Polje Re-alignment. This re-alignment of the original winter road route was approved by the Review Board during EA0809-002. Figure 6-21 attached is reproduced from the 2010 DAR showing the re-alignment. The re-alignment replaces a winter road section that, from west to east, consists of two switch-backs which allowed the road to climb onto a plateau formed by the Nahanni Formation, followed by a traverse across the plateau before descending to cross the area of the Poljes between the Second and Third Poljes. During CZN-Parks Canada-Dehcho First Nations Technical Committee meetings during EA0809-002, Parks Canada asked CZN to investigate alternative road alignments to avoid bisecting the Poljes, which are considered to be unique karst related features of the region. The figure attached titled "Winter Road Alternatives" illustrates the re-alignment options that were initially considered in July 2008. Subsequent fieldwork ruled out these alternatives because of road grade limitations and proximity to other karst features. However, a more northerly re-alignment was ground-truthed as being acceptable, and was adopted as the Polje Re-alignment to mitigate concerns regarding impacts on karst features. The attached minutes from the committee meetings provide details of the engagement undertaken. Therefore, the re-alignment already represents mitigation in terms of the proposed all season road minimizing impacts on karst features. As a result of fieldwork conducted in 2014 for the all season road, additional minor adjustments were made to the re-alignment to further improve road grades, and avoid or set-back from areas of potential instability or karst feature presence. Subsequent terrain mapping has resulted in further minor adjustments in this regard.

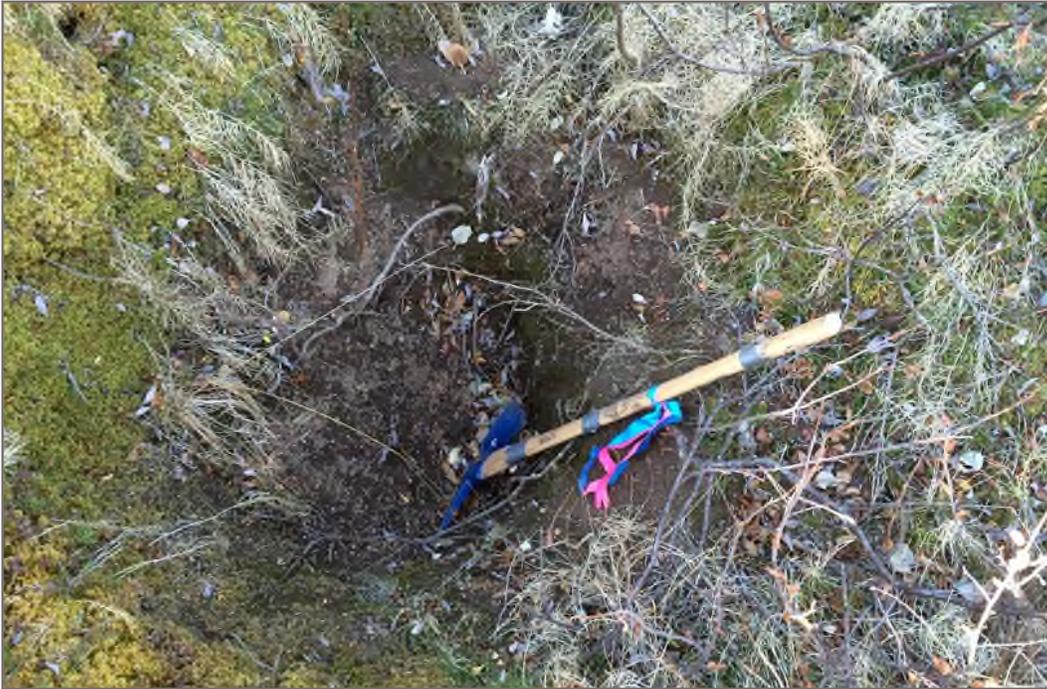
Photo 1: Suspected suffosion feature at about KP025.6. This is the largest of three micro-features in this area of the route, at about 0.6 m depth and 1.5 m diameter. This feature is nearly perfectly conical. Other features just below the route are less regular.

At about KP025.6, three very small depressions, of which the largest was less than about 1.5 m in diameter and 0.6 m deep, were noted in soils along the route (Photo 1). The smallest depressions were just downslope, about 10 m from the route. At about KP026, a cluster of shallow depressions of unknown depth and up to about 15 m estimated diameter was identified on the 2012 aerial coverage between the route and the creek, about 60 to 80 m downslope of the road alignment. Within this area, two well-defined round depressions were identified and are thought to be potentially related to suffosion or piping (Photo 2). These are considered unlikely to pose a risk to the road, however, consistent with other areas where such features have been identified, they will be groundtruthed during the detailed design phase, as further discussed below.

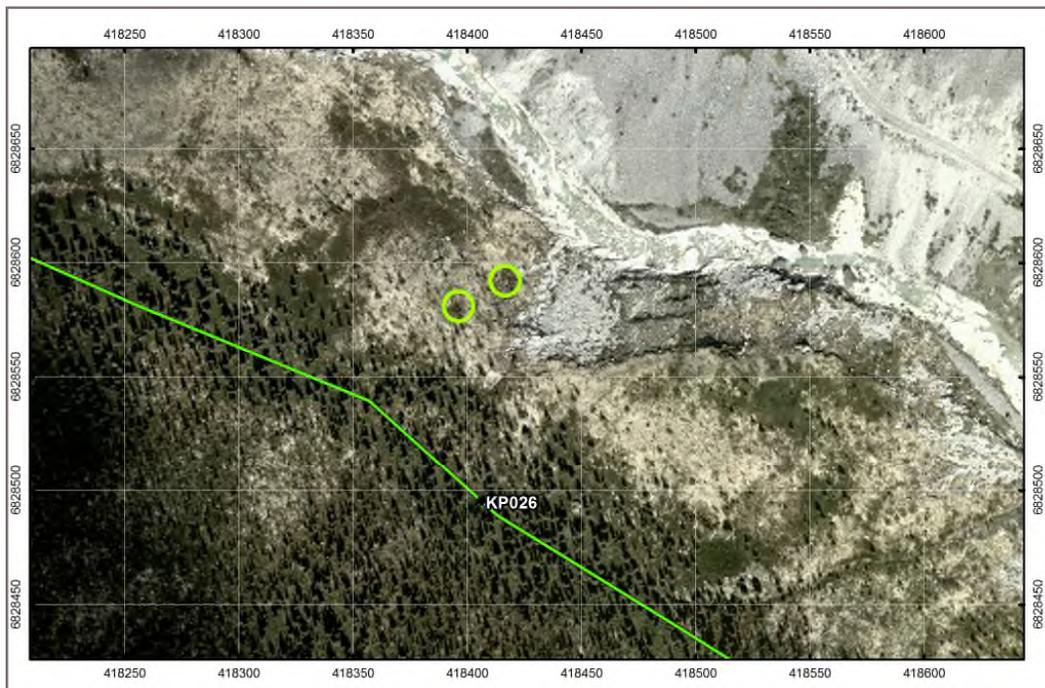
Photo 2: Excerpt from 2012 high-resolution imagery. Two suspected suffosion features are located about 60 to 80 m downslope of the route near KP026. They are about 25 m apart, and are likely very shallow as they are not visible on bare-earth LiDAR.

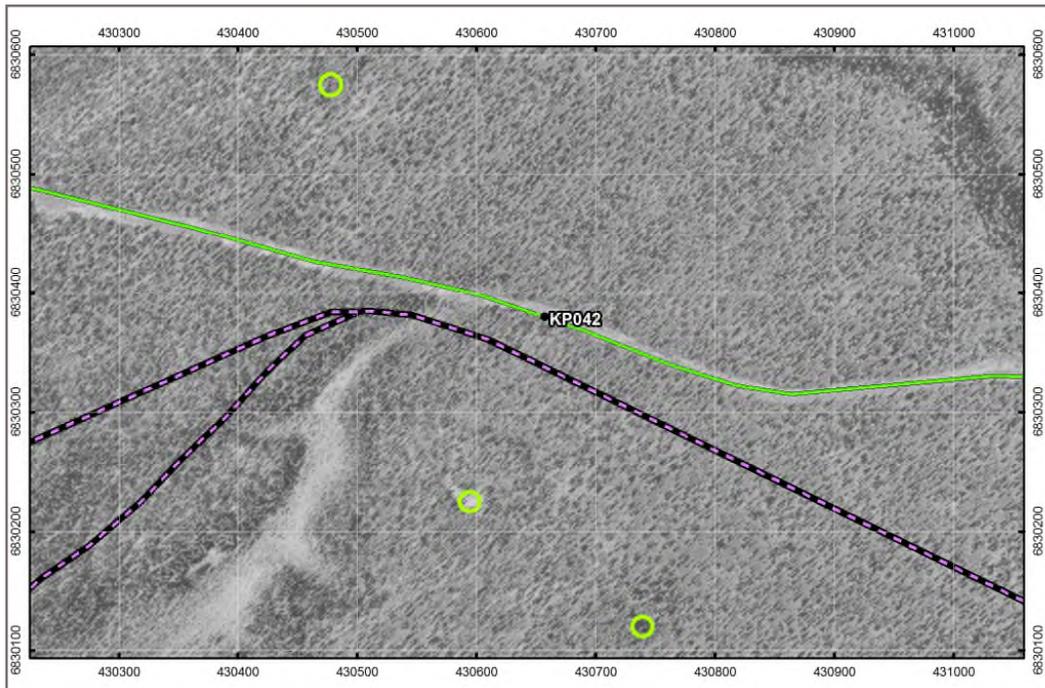
Photo 3: Kettles near KP042 in thick glaciofluvial deposit. These are unlikely to be sinkholes due to bedrock type and the lack of other karst features in the area. Green line is current route. Kettles are 100 to 220 m from proposed realignment (pink/black).

At KP042, the road crosses wooded terrain overlying fine soils, and some depressions are visible on air photos (Photo 3). These are interpreted to be kettles from glacial ice melt, not karst features. These features are about 150 to 190 m away from the existing winter road, and about 100 to 220 m away from the proposed re-alignment to the south.

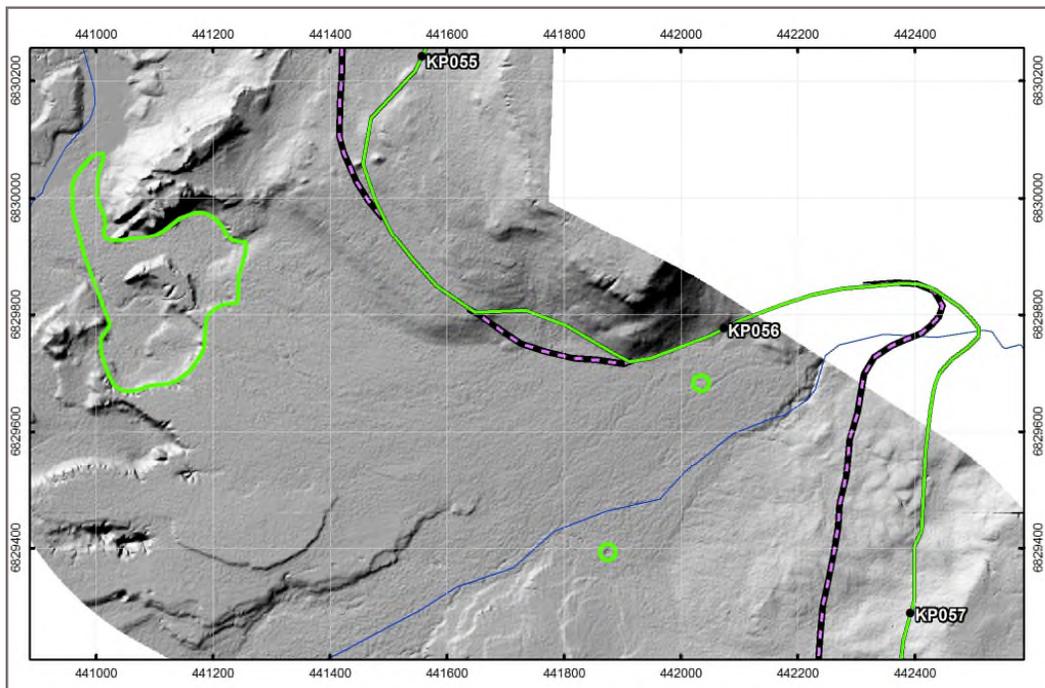
Photo 4: Excerpt from bare-earth LiDAR, showing locations of depressions that are suspected karst features. These features are located 250 m southwest of KP055.3 (edge of large subsidence at outcrops), 330 m south of KP055.7, and 70 m south of KP055.9.

At KP055.3 and 055.7, depressions are noted approximately 250 m southwest and 330 m south of the proposed realignment, respectively. The former is near the Poljes area that has undermined the fluvial fan sediments (Photo 4), while the latter is a small depression visible on the 2012 bare earth LiDAR image (Photo 5). These are far enough away from the alignment to not pose an issue for the road. Another very small feature is located about 70 m south-southeast of the route near KP056, with a small pond in it. It was not visible on the aerial coverage but was seen from the helicopter (Photo 6). It appears to be only about 3 m metres wide. It could be either formed by thermokarst or by bedrock karst.

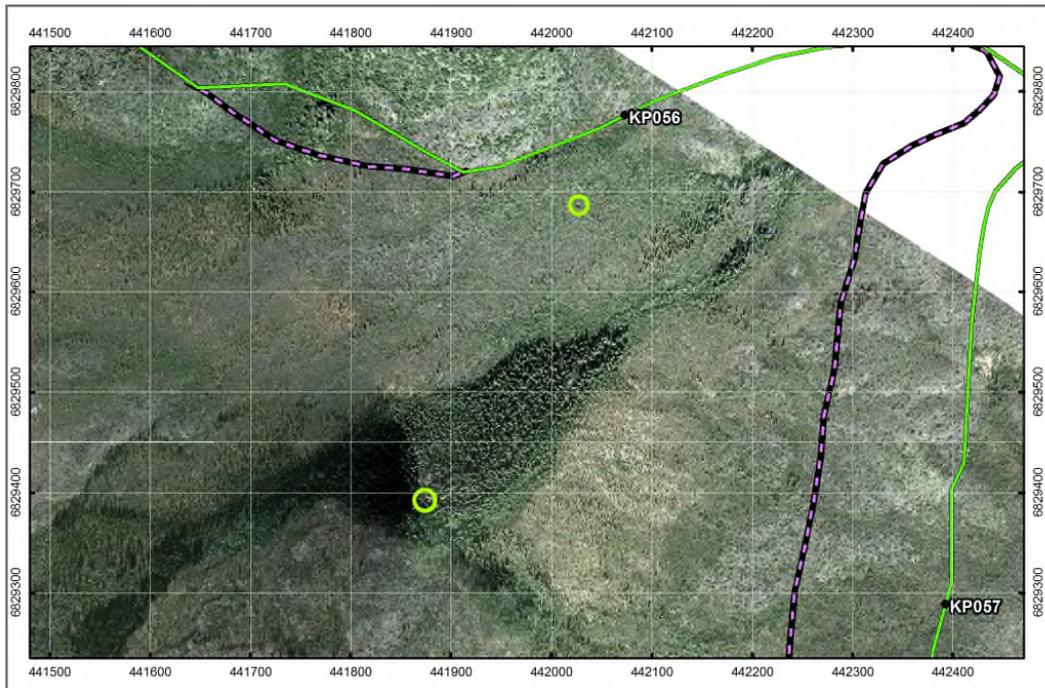
Photo 5: Excerpt from 2012 high-resolution imagery. Feature nearest KP056 is about 70 m from the route and contains a small pond (Photo 6). Feature along lower edge of photo is about 330 m from the route and 8 m diameter.

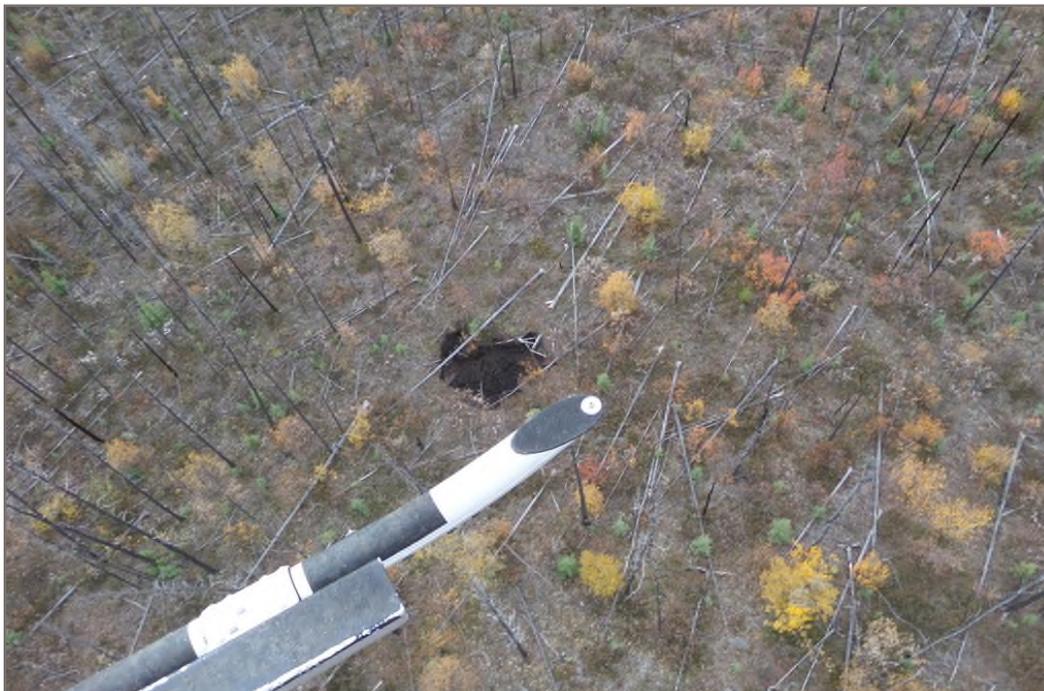
Photo 6: Suspected suffusion feature located about 70 m south-southeast of route near KP056, and estimated at about 3 m in diameter. This feature could also be thermo-karst-related. See also Photos 5 and 6 for location. (Photo credit: Allnorth.)

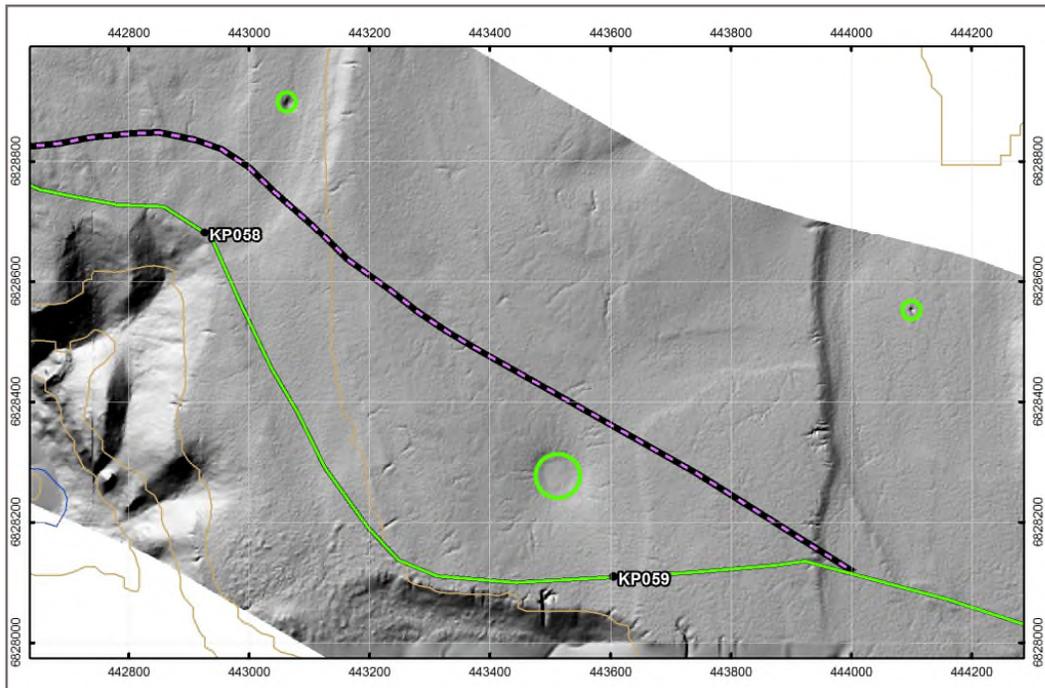
Photo 7: Excerpt from bare-earth LiDAR. Suspected kettles or sinkholes are about 80 and 130 m from the realignment at KP058 and KP058.8, and 420 m at KP059.5. Slope failures are about 130 to 250 m from the realignment at KP058 and KP058.8.

At KP058 and 058.7 south of the road, rock (slope) failures associated with the Poljes are present (Photo 7). At the top of these steep slopes, the overlying glaciofluvial sediments have also failed. Rounded depressions were also noted at a few locations in the glaciofluvial terrain to the north and east of the slope failures, ranging from 170 to 450 m away from the road route. These features were considered more likely to be kettles than sinkholes, although both are possibilities (Photos 7 and 8). The largest of these rounded areas is 70 m in diameter. We recommended that the road alignment be moved further north away from the slopes to avoid potential effects from slope failure retrogression. This move brings the route closer to the depressions (about 80 to 130 m), but proximity to these is considered a lower risk to the road than is presented by the slope failures to the south.

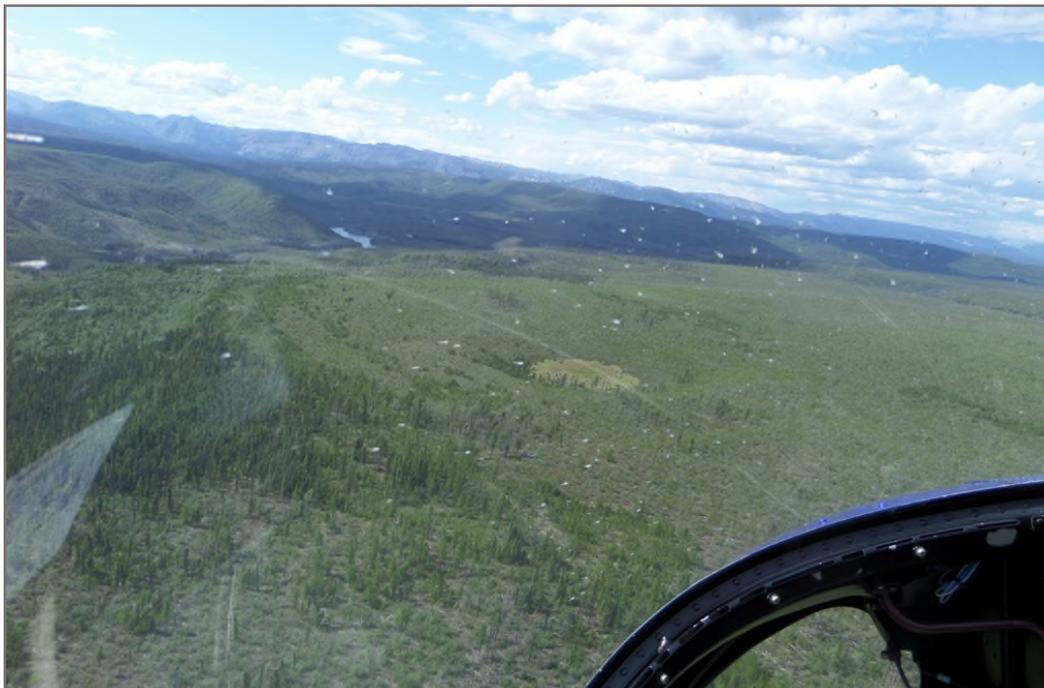
Photo 8: Looking west-northwest from about KP059.3, note lighter-coloured depression north of KP058.9. Possible sinkhole due to large size (70 m) and mapped so by Golder (2010). May be more likely a kettle (Tetra Tech EBA, 2015c). (Photo credit: Allnorth.)
