SECTION	METALLURGY	CLIENT	CADILLAC EXPLORATIONS LTD	TITLE	PRAIRIE CREEK PROJECT	PROJECT NO.	78-86
SCALE	AS SHOWN	LOCATION	PRAIRIE CREEK N.W.T.	DEFINITIVE FEASIBILITY STUDY	DRAWING NUMBER	300-03-DF1	REV
DRAWN BY	O.C.	DATE	AUG 13 63	METALLURGICAL FLOWSHEET			
CHECKED BY	J.B.E.	DATE					
APPROVED BY	J.B.E.	DATE

CLIENT: CADILLAC EXPLORATIONS LTD. LOCATION: PRAIRIE CREEK, N.D.T.		TITLE: PRAIRIE CREEK PROJECT DEFINITIVE PLANT GENERAL ARRANGEMENT OPERATING FLOOR PLAN		DRAWING NUMBER: 300-10-DP1
PROJECT NO.: SHEET NO.:		SCALE: 5/8" = 1'-0" DATE:		REV. NO.: 0
DESIGNED BY: DRAWN BY: J.C. COOP CHECKED BY: J.B.F.		APPROVED BY: J.B.F.		KILBORN
REVISIONS				
NO.	DESCRIPTION	NO.	DESCRIPTION	NO.

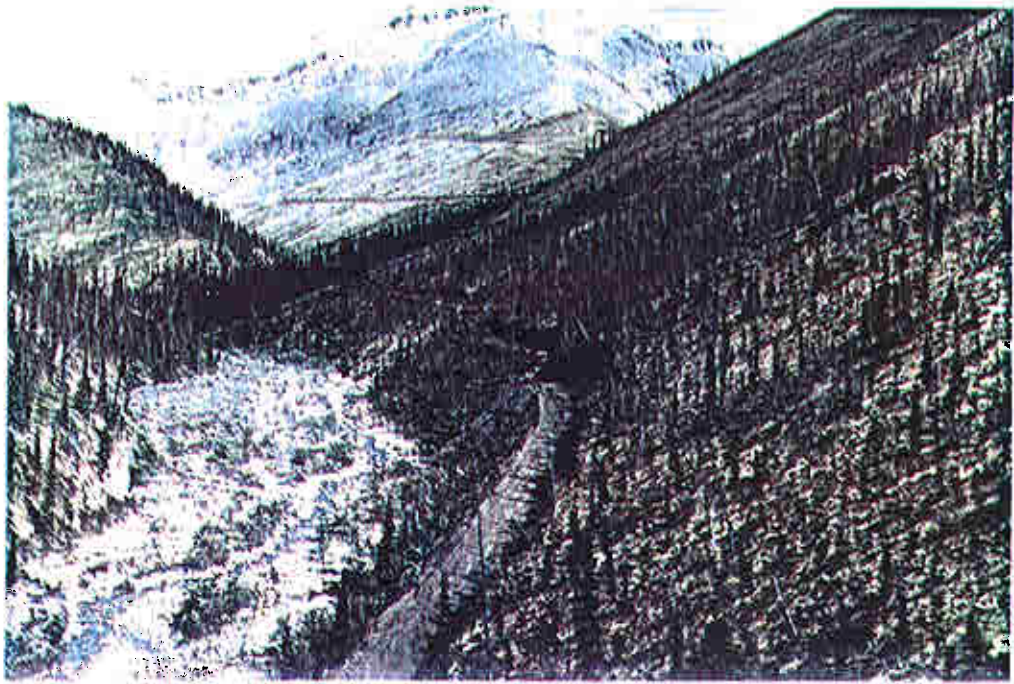
Figure 4: Looking east, Mile 7.2 to Mile 9.0 Km 11.5 - 14.5
under construction (27/07/80).

The alignment runs up the bottom of the "North" valley with grades approximately equal to the natural gradient of the valley bottom over this section of the route. There are 13 crossings of the "North" valley water course as the alignment crosses the valley to avoid steep bedrock walls which are encountered frequently in the south facing slope of the valley. In three areas where the alignment was restricted to the north facing slope, permafrost was encountered and these areas were treated with a 3 ft. insulating layer of locally borrowed weathered shale material shortly after the road cut was completed. This treatment, combined with the free draining nature of the coarse grained talus slope deposits, resulted in stable cuts showing no evidence of any continuing degradation, immediately following construction. Wash-outs, after periods of high stream flows, may necessitate a certain amount of maintenance in this portion of the route.

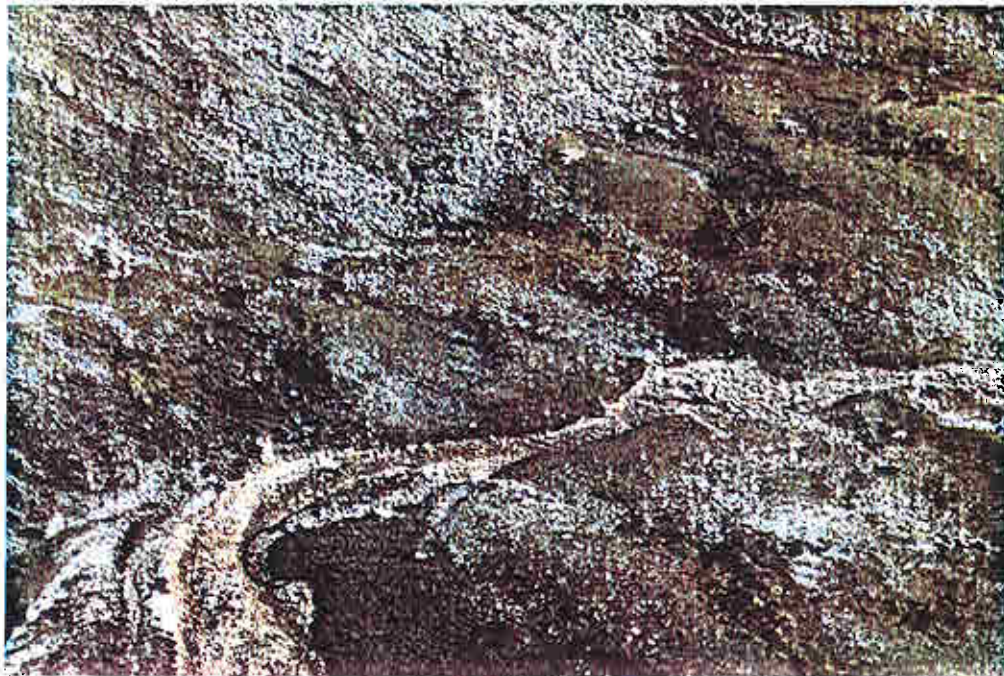
Figure 6: Looking south, Mile 9.9 before road construction (27/07/80). Km 15.8

In this section of the route, the alignment climbs a sidehill cut in the north facing slope of the valley to Mile 9.9 and subsequently in the south facing slope at a maximum grade of 8 per cent to reach the summit of the route at Mile 10.3 (elevation 4,994 ft.). Road construction in the south facing slope of the valley from Mile 7.2 to Mile 9.9 was not considered feasible. An extensive area of permafrost was encountered from Mile 7.2 to 8.3 which was treated in a manner similar to that outlined in the previous section, with similar results. This section of the alignment includes four stream crossings. Some maintenance due to occasional snow avalanche damage and/or small stability failures along this portion of the route should be anticipated.

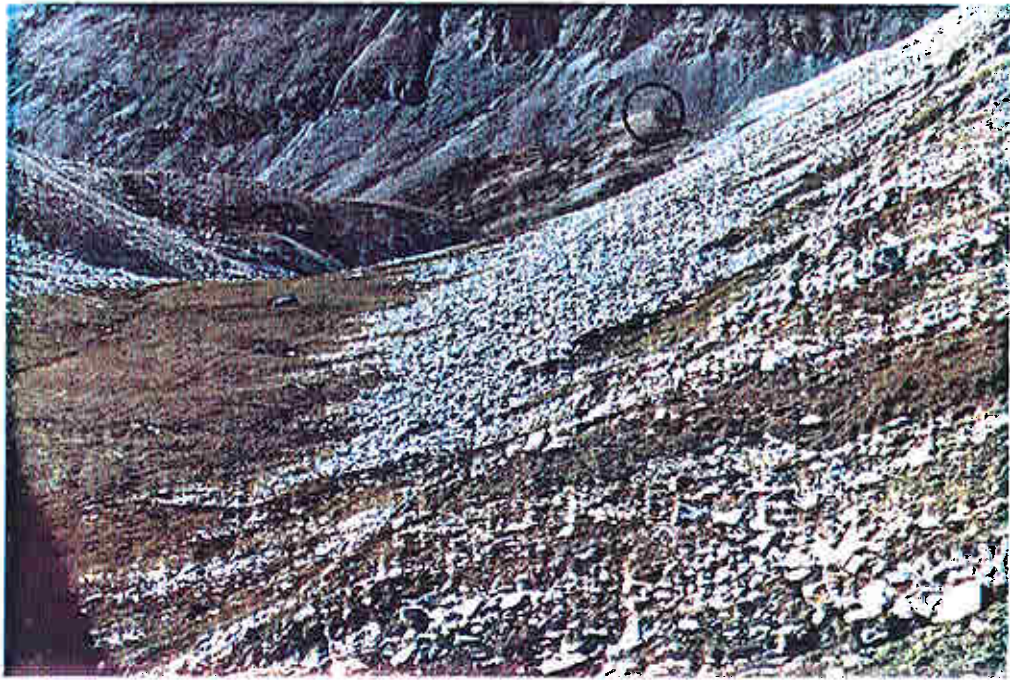
Figure 8: Looking west, Mile 10.3 before road construction (27/07/80).

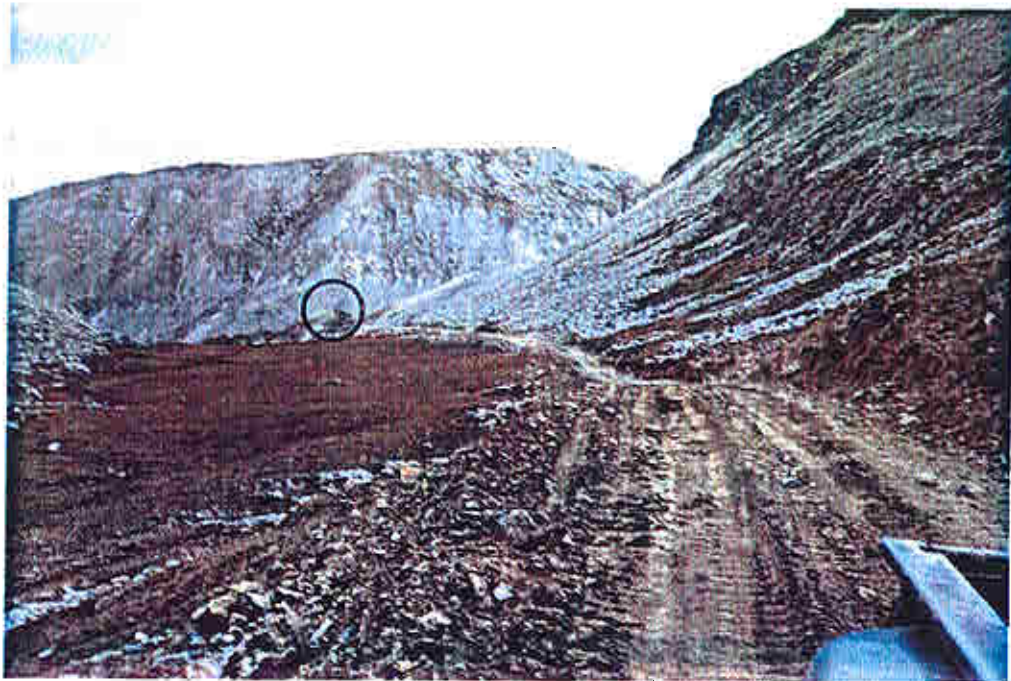
Figure 9: Looking west, Mile 10.3 after road construction (26/08/80). Note point of reference.

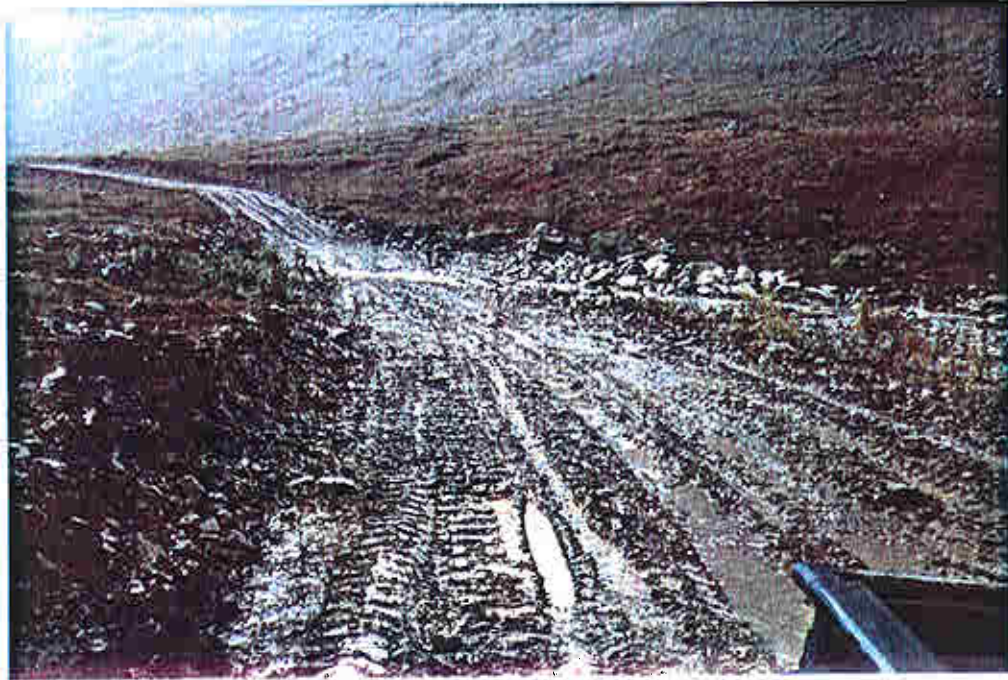
Figure 10: Looking northwest, stream crossing
at Mile 12.6 (26/08/80).

Over this portion of the alignment, the roadway is, or will be, constructed in the gently sloping valley bottom or, where necessary, in shallow sidehill cuts. The alignment is constructed on the south facing valley slope to Mile 12.6 where it crosses to the north to avoid steeply sloping bedrock walls. After crossing the creek at Mile 14.5, which includes a short stretch with a grade of 10 per cent, the alignment returns to the south facing slope at Mile 15.5 and continues there to Mile 19.0. No permafrost was encountered or is expected in this section of the route. There are six stream crossings in this section of the alignment. Maintenance will be limited to repair of snow avalanche damage and/or minor stability failures.
