RE: Environmental Assessment EA1415-001, Prairie Creek Mine
All Season Road, Undertakings from Technical Session

Prairie Creek Mine Fish Habitat Compensation Plan

Construction of Fish Compensation Habitat near Prairie Creek Mine

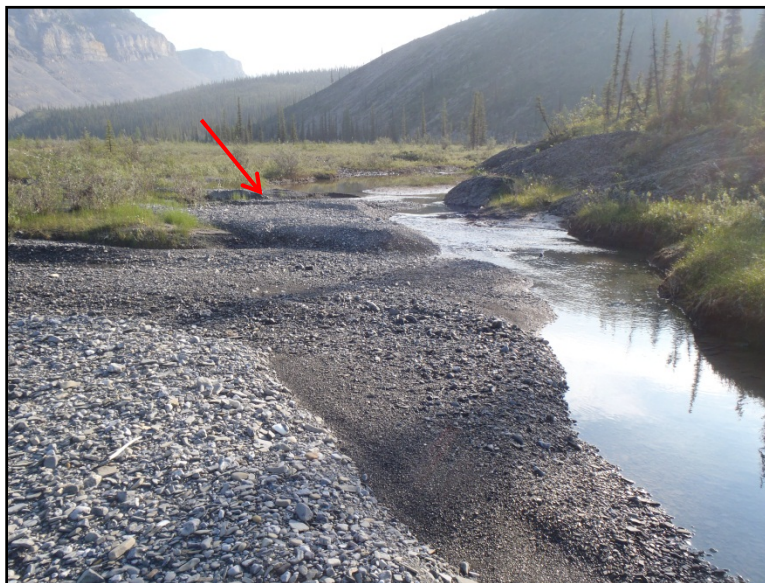
B. North view (upstream) of the Tributary at the confluence with Prairie Creek; the red arrow depicts the proposed confluence with the compensation habitat (July 9, 2012).

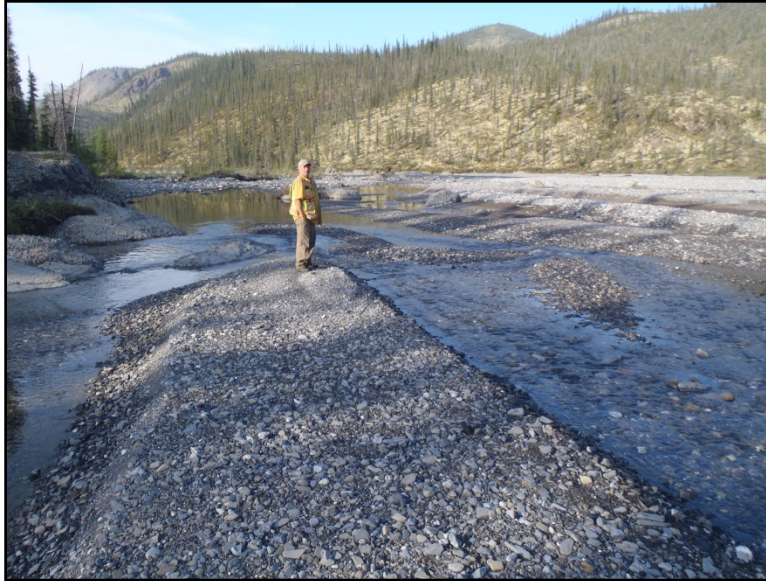
C. South view (downstream) of the Tributary confluence with Prairie Creek (July 9, 2012).

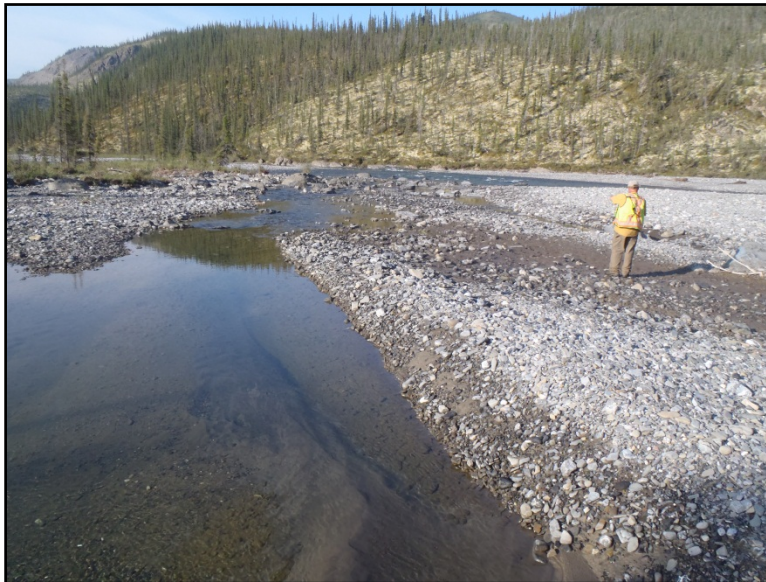
D. South view (downstream) of Tributary flow across a gravel bar to the main channel in Prairie Creek (July 9, 2012).

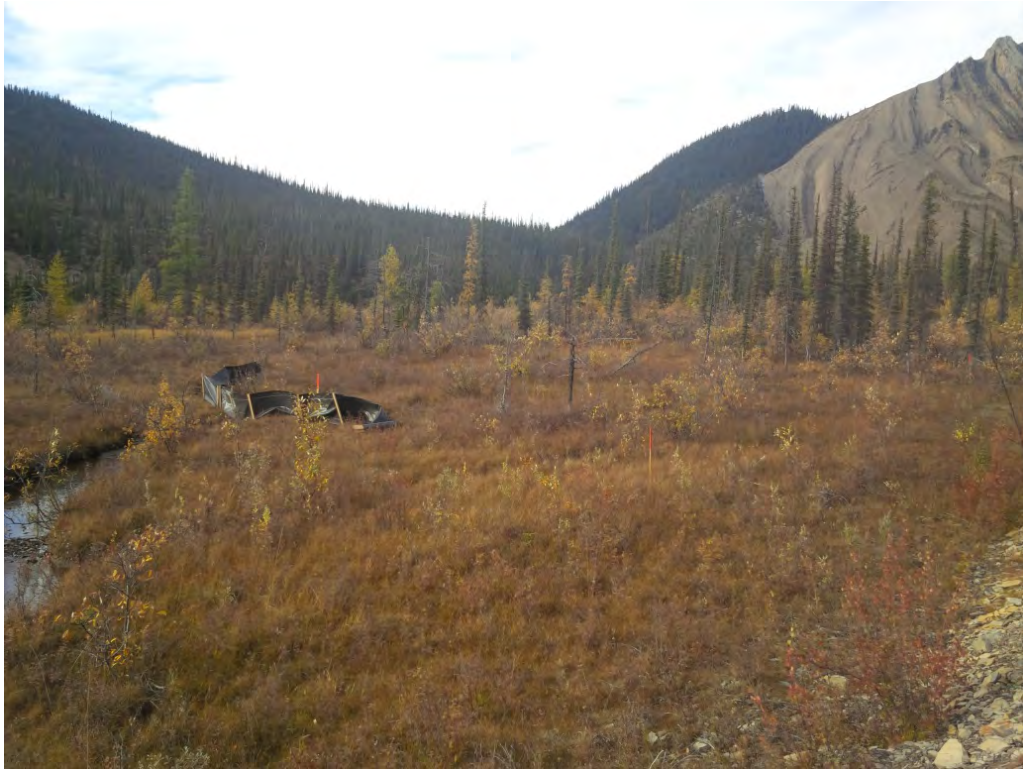
Silt fence erected downstream from South Pond Site prior to excavation

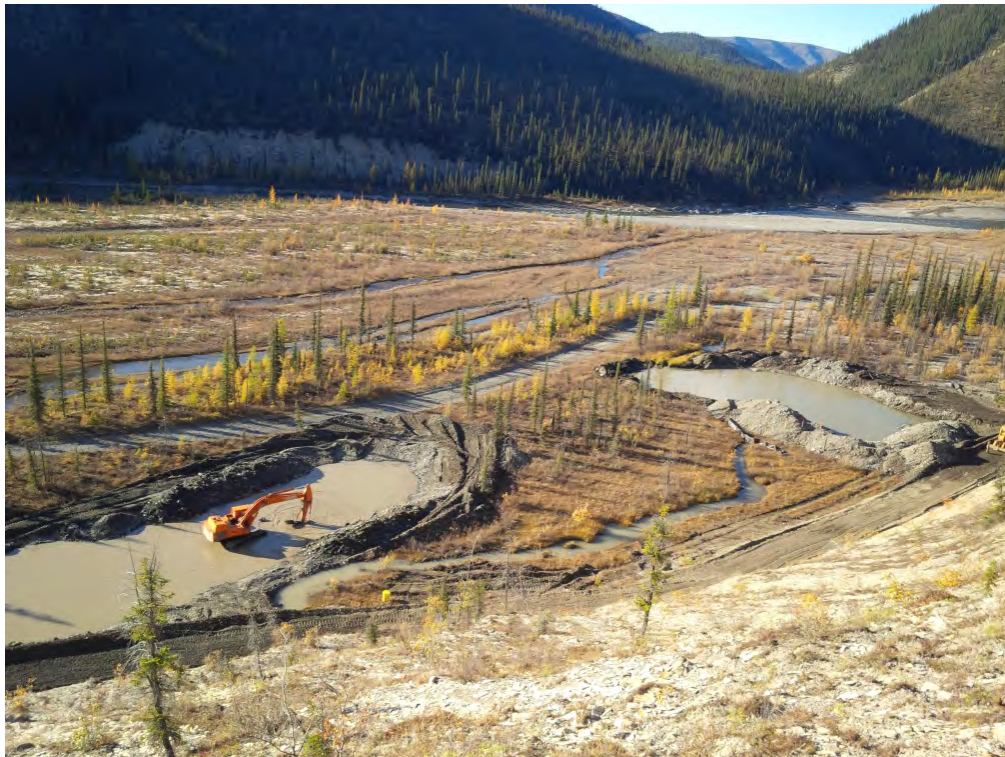
Looking north from lower silt fence. Cat is excavating South Pond and backhoe is excavating North Pond

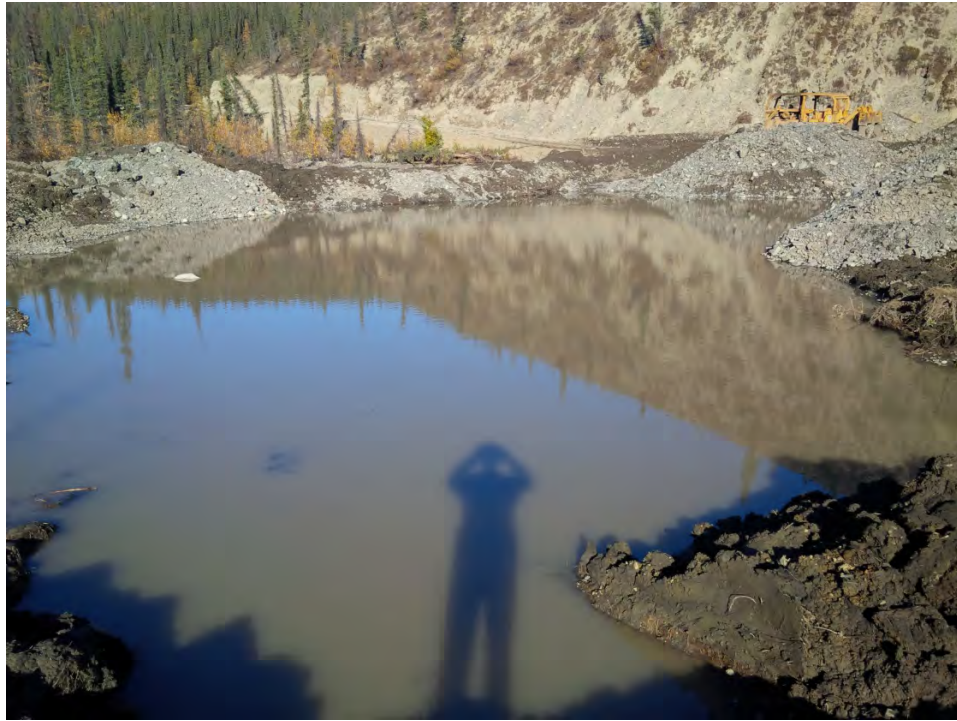
Completed North Pond and back hoe working in South Pond, both self-contained

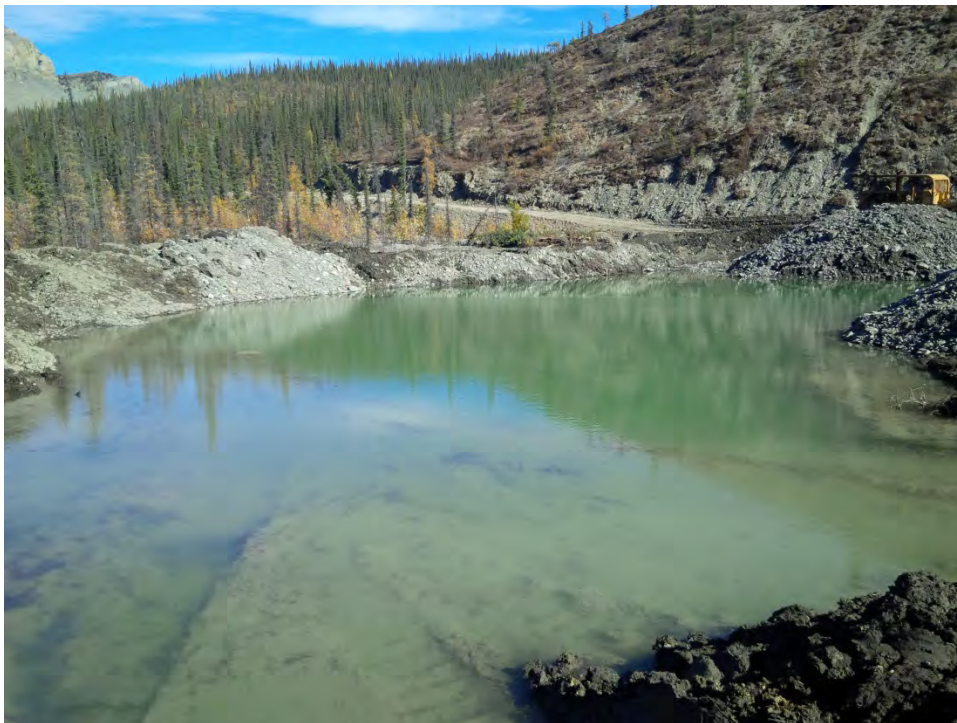
North Pond: September 12, turbid water (still self-contained)

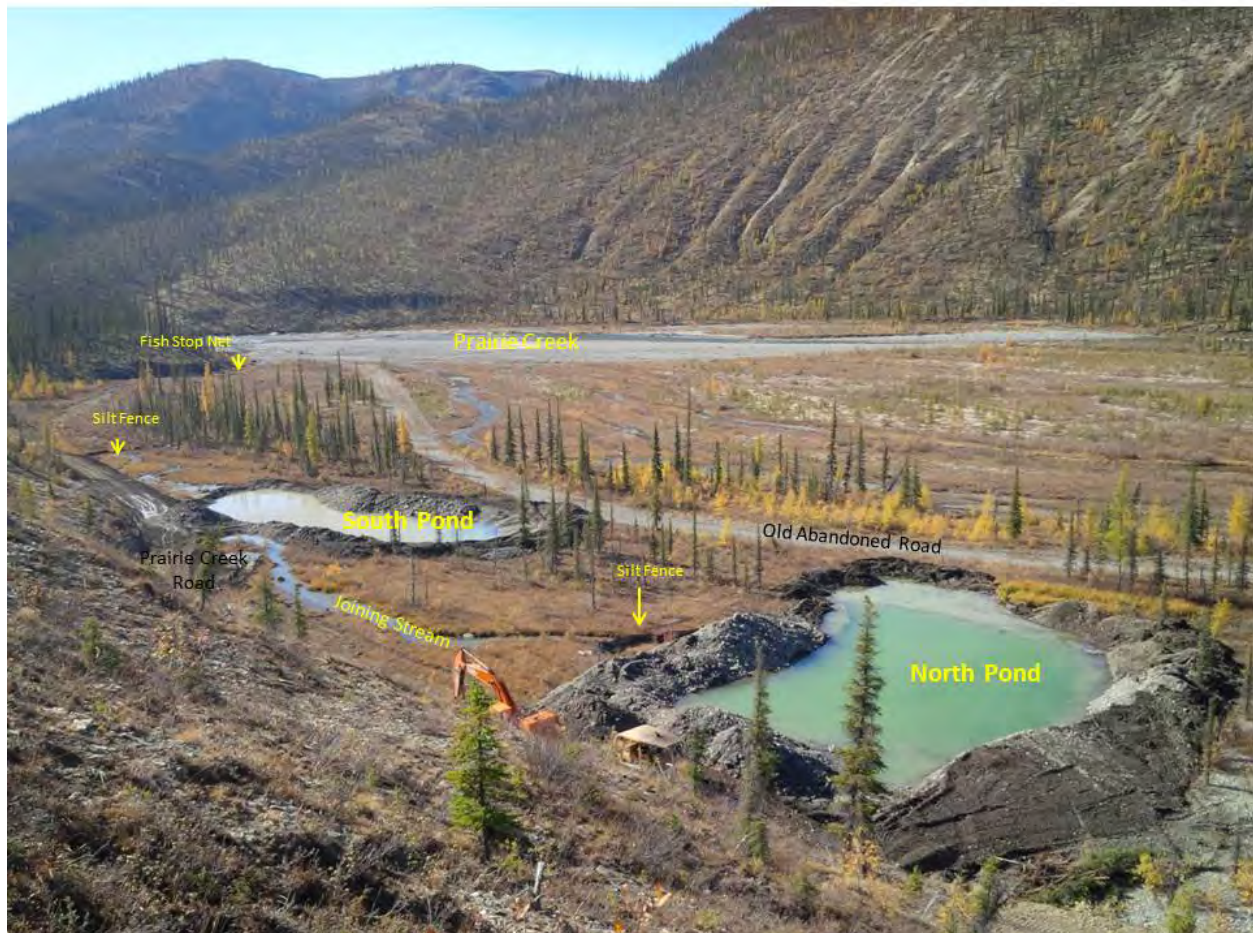
North Pond: September 13th, showing rapid settling and clearing of pond

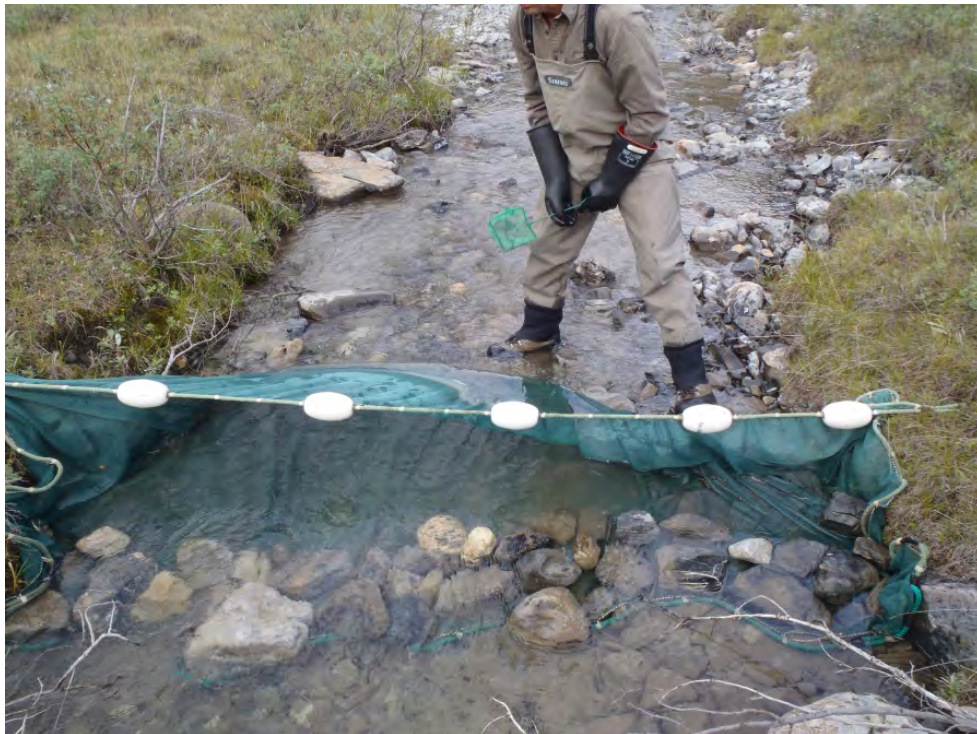
Installed stop-net looking downstream
