**DATE** October 12, 2012**PROJECT No.** 11-1365-0012/DCN-106**TO** Veronica Chisholm  
De Beers Canada Inc.**CC** Gary Ash, John Faithful, and Amy Langhorne**FROM** Cameron von Bratt and Kasey Clipperton**EMAIL** Cameron\_vonBratt@golder.com**GAHCHO KUÉ FLOW MITIGATION: FIELD REPORT AND ASSESSMENT - 2012**

**1.0 INTRODUCTION**

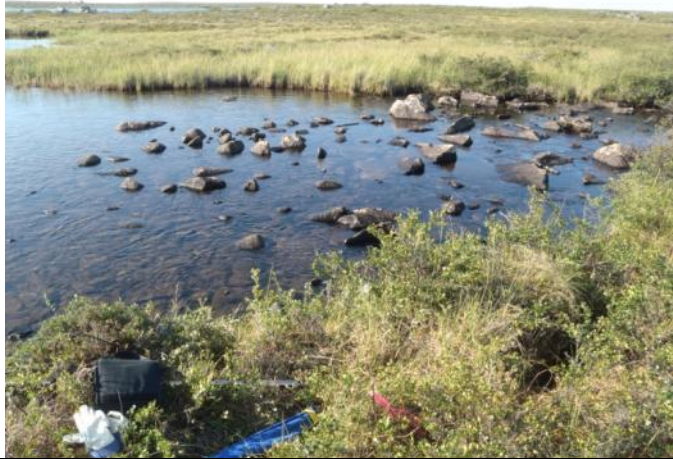
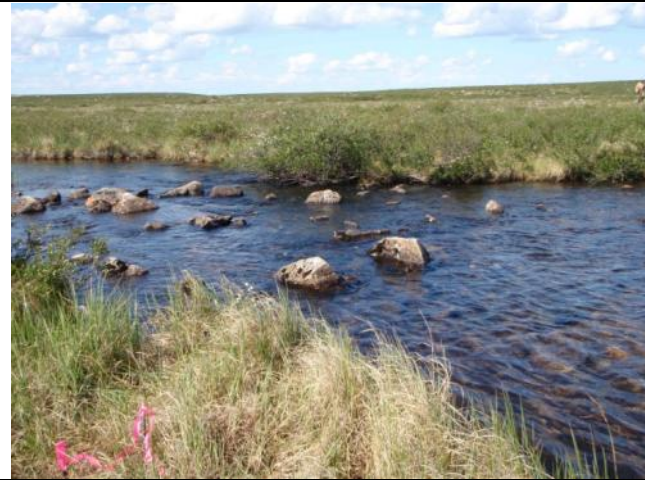
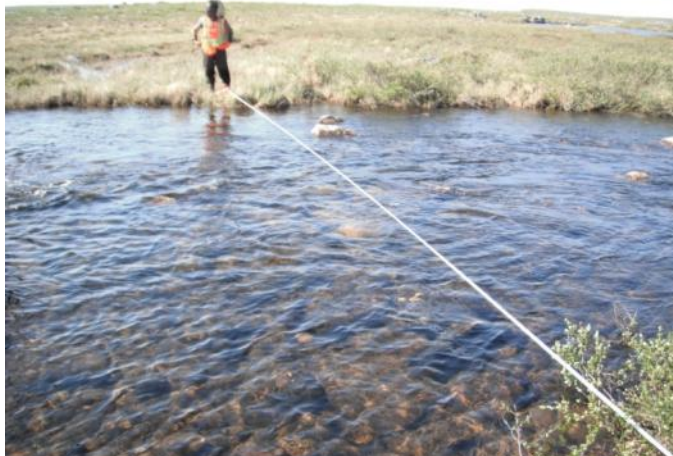
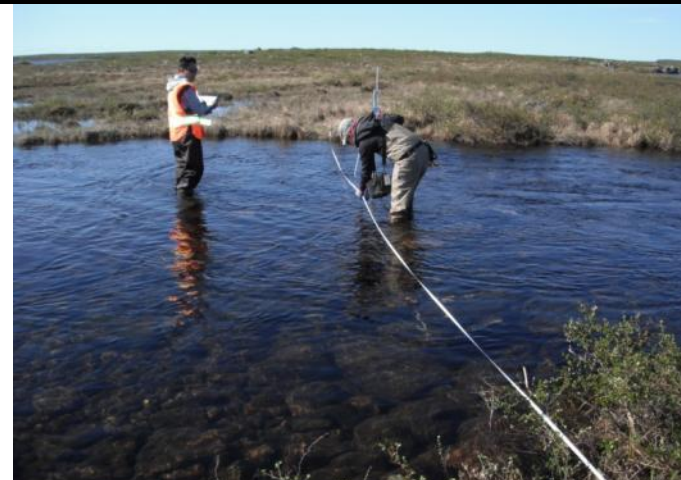
Plate 01: Site K5 looking from right downstream bank.  
Photo taken July 8, 2011;  $Q = 0.08 \text{ m}^3/\text{s}$ .

Plate 02: Site K5 looking downstream from left downstream bank.  
Photo taken July 8, 2011;  $Q = 0.14 \text{ m}^3/\text{s}$ .

Plate 03: Site K5 looking downstream. J  
Photo taken June 25, 2012;  $Q = 0.38 \text{ m}^3/\text{s}$ .

Plate 04: Site K5 looking across from right downstream bank.  
Photo taken June 20, 2012;  $Q = 0.62 \text{ m}^3/\text{s}$ .

The target discharge range at Site K5 for the fish passage assessment was between 0.20 m<sup>3</sup>/s and 0.80 m<sup>3</sup>/s in order to better define the flow at which fish passage becomes restricted. Selecting a suitable discharge transect was difficult due to the general lack of a well defined single channel at this site, and the presence of large boulders throughout the channel. The discharge transect at Site K5 is shown in Appendix A, Plate 01 through Plate 04.

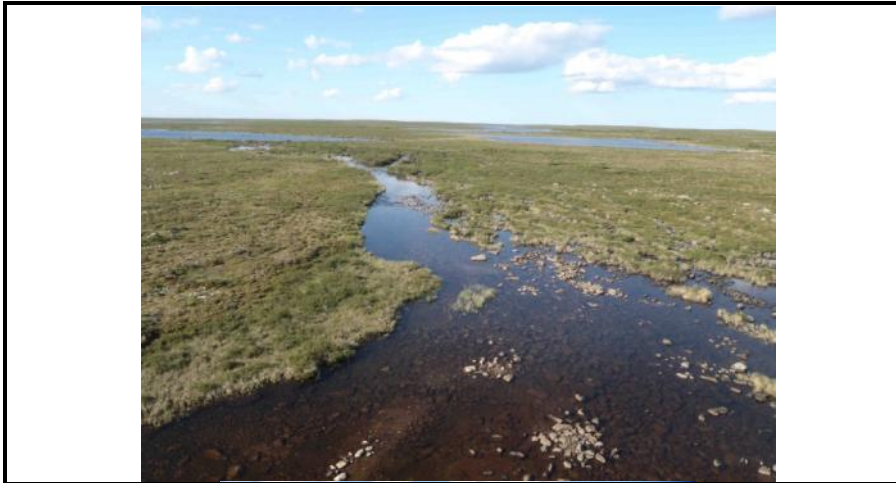
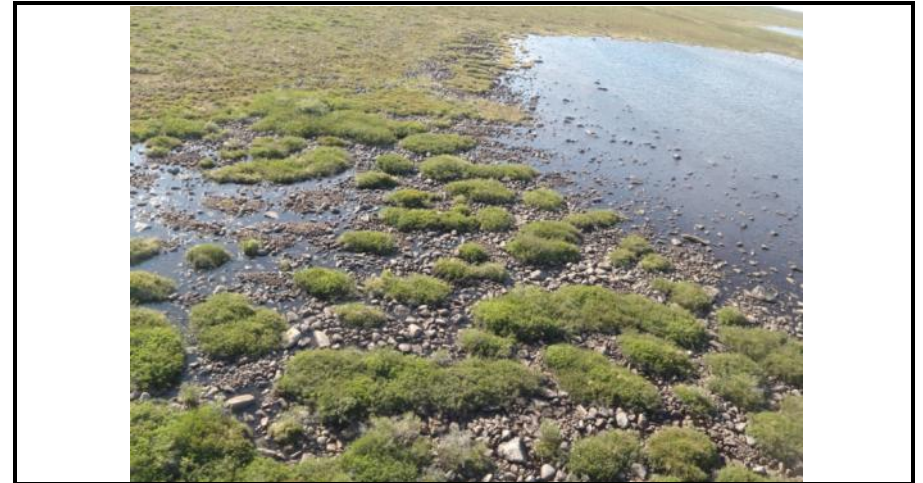
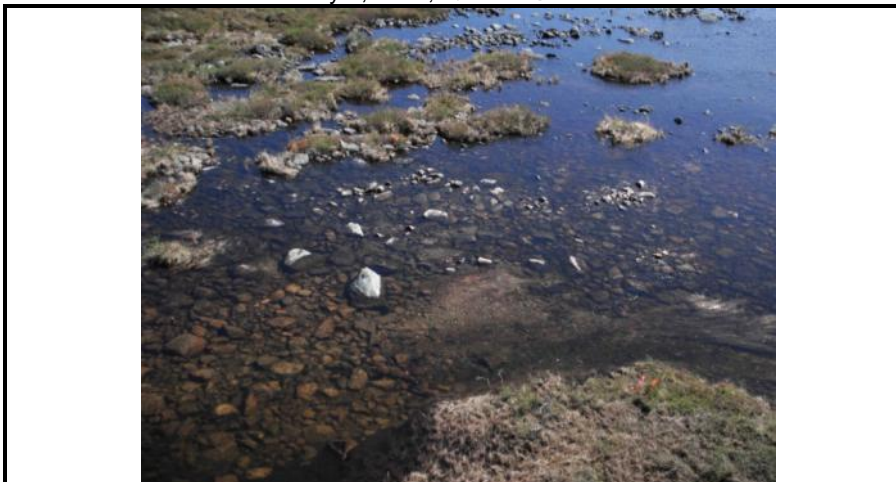
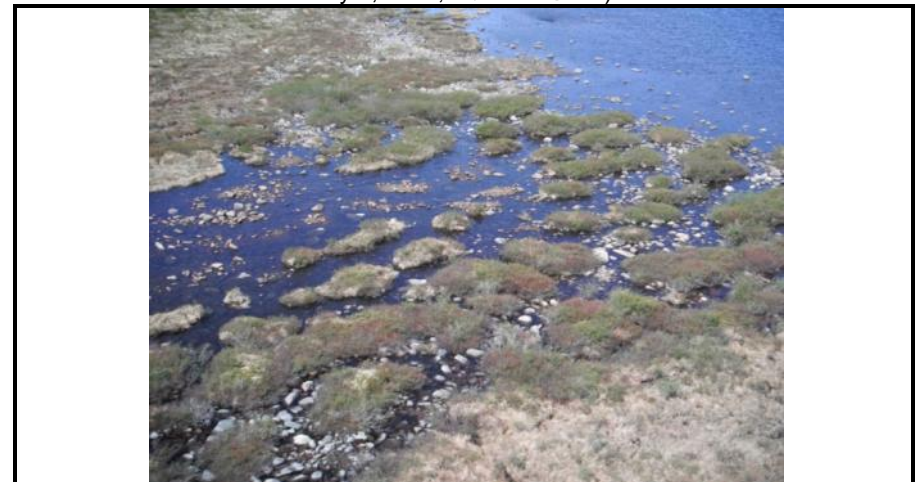
Plate 05: Site M4 - 2011 survey at the upstream inlet .  
Photo taken July 8, 2011;  $Q=0.14$  @ K5.

Plate 06: Site M4 - 2011 fish barrier at the downstream mouth.  
Photo taken July 8, 2011;  $Q=0.14$  @ K5).

Plate 07: Site M4 - 2012 survey at the upstream inlet.  
Photo taken June 21, 2012,  $Q=0.62$  @ K5.

Plate 08: Site M4 - 2012 with no barrier present .  
Photo taken June 21, 2012;  $Q=0.62$  @ K5.

Photographs of habitat transects, barrier locations and aerial views are presented in Appendix A (Plate 05 through Plate 16). Stream M4 maintained good connectivity upstream to Lake M4 under all flow conditions assessed. Near the downstream end of the channel, the watercourse widens and disperses into a large boulder field with the channel splitting into multiple small braided and discontinuous channels, with lower flows resulting in a barrier to upstream and downstream movement of adult fish (Appendix A, Plates 06, 09, and 10). Some potential downstream movement by fry might be possible, although difficult, at flows down to 0.10 m<sup>3</sup>/s through sub-surface channels that are likely present between boulders; however, a complete barrier was likely present at 0.08 m<sup>3</sup>/s. The braided channels were passable over the full range of higher flows observed in June 2012 (Appendix A, Plates 11 and 12).

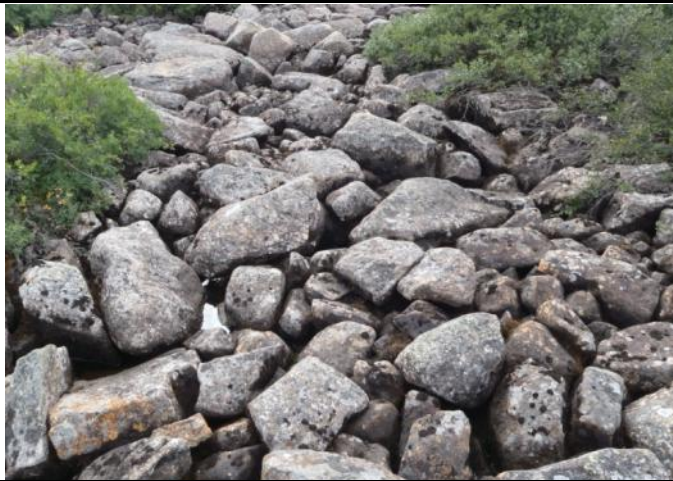
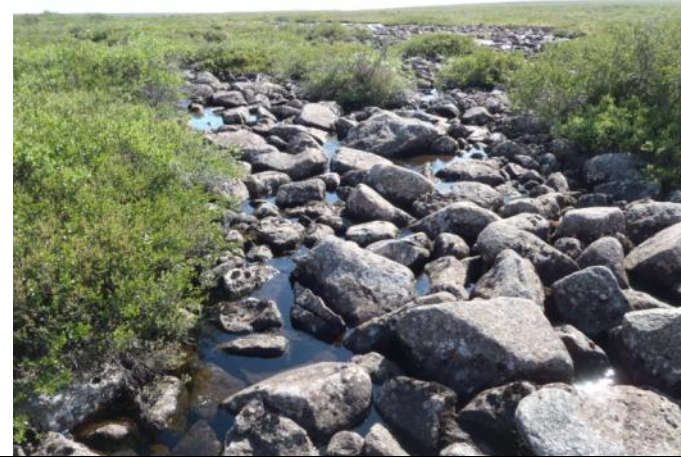
Plate 09: Stream M4 looking at fish barrier near outlet.  
Photo taken August 7, 2011; Q = 0.08 m<sup>3</sup>/s @ K5).

Plate 10: Stream M4 looking at fish barrier near outlet.  
Photo taken July 8, 2011; Q = 0.14 m<sup>3</sup>/s @ K5).

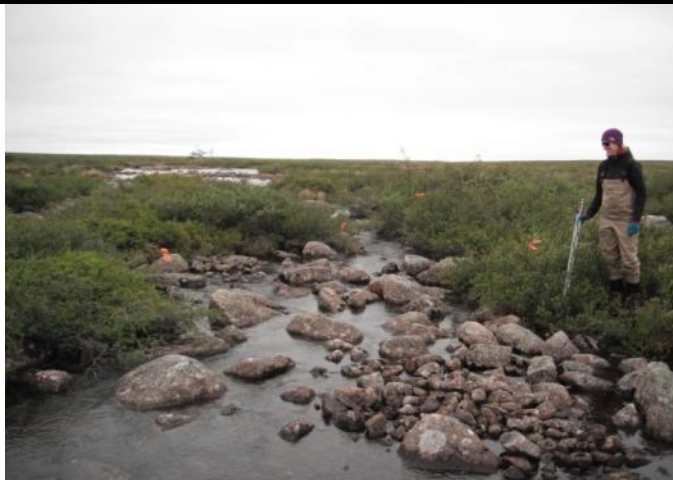
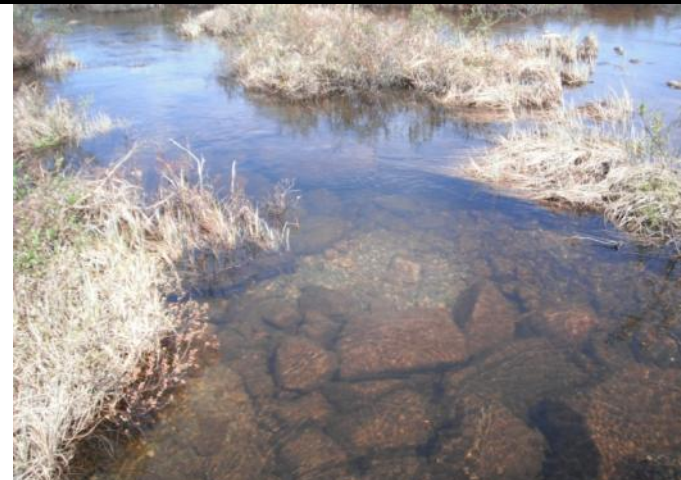
Plate 11: Stream M4 looking at fish barrier location identified at lower flows, no barrier present.  
Photo taken June 27, 2012; Q = 0.36 m<sup>3</sup>/s @ K5.

Plate 12: Stream M4 looking typical channel that was dry under lower flows, no barrier present.  
Photo taken June 20, 2012; Q = 0.62 m<sup>3</sup>/s @ K5.

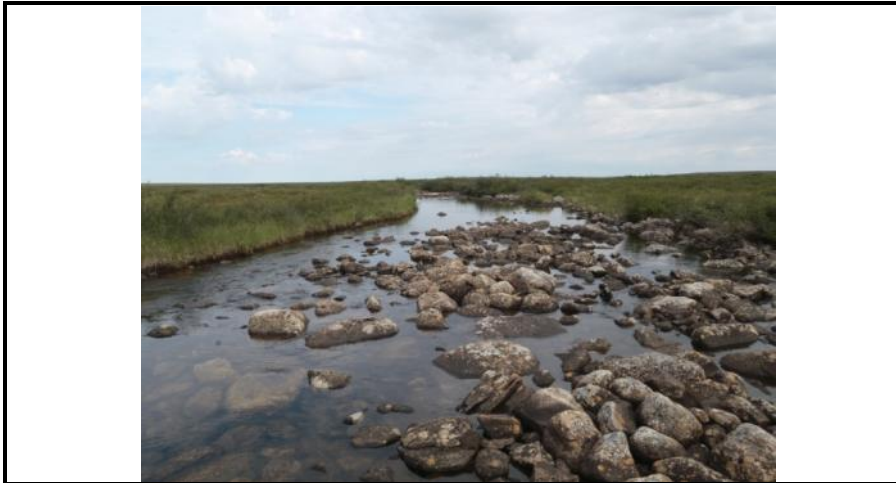
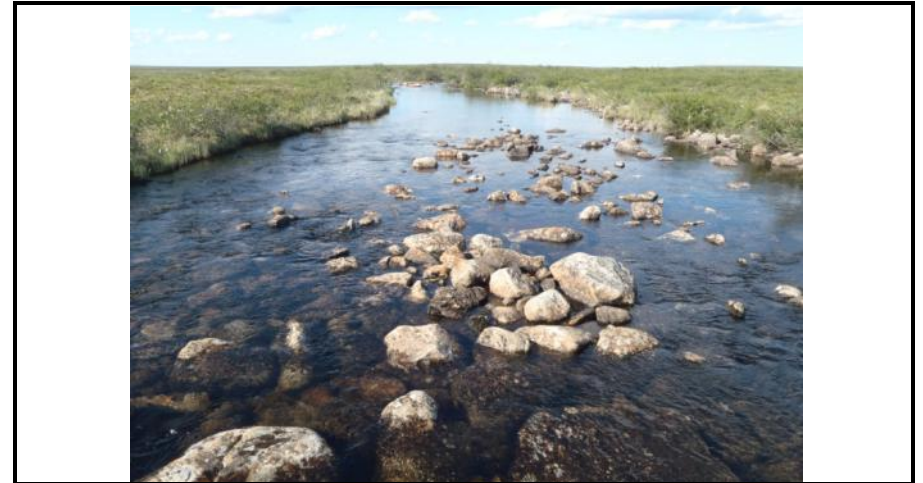
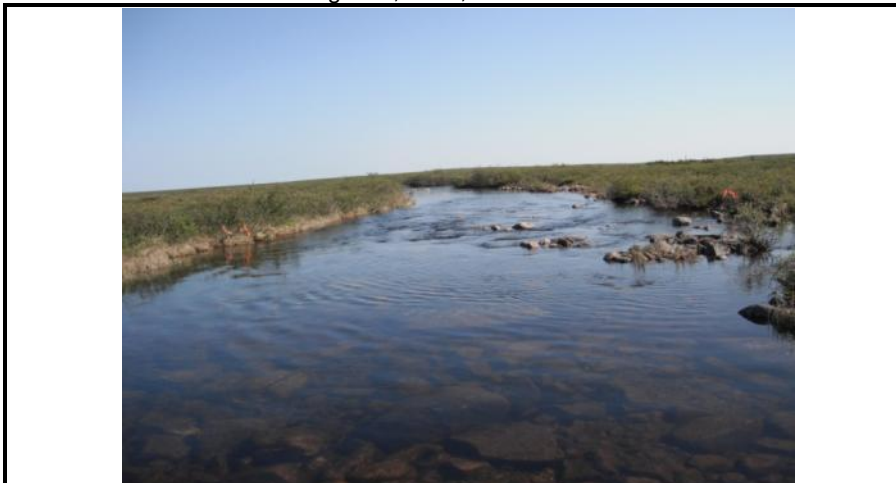
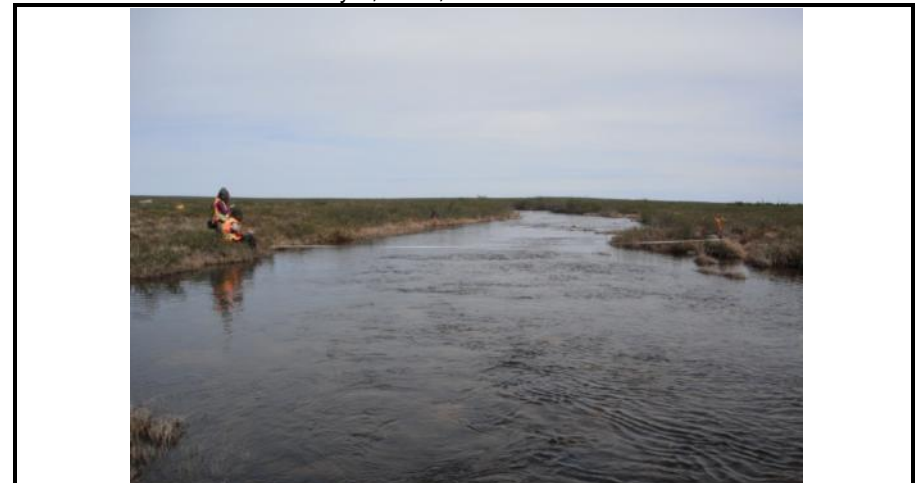
Plate 13: Stream M4 looking downstream from Transect 3 showing general habitat conditions.  
Photo taken August 7, 2011;  $Q = 0.08 \text{ m}^3/\text{s}$  @ K5.

Plate 14: Stream M4 looking downstream from Transect 3 showing general habitat conditions.  
Photo taken July 8, 2011;  $Q = 0.14 \text{ m}^3/\text{s}$  @ K5.

Plate 15: Stream M4 looking downstream from Transect 3 showing general habitat conditions.  
Photo taken June 25, 2012;  $Q = 0.38 \text{ m}^3/\text{s}$  @ K5.

Plate 16: Stream M4 looking downstream at Transect 3 showing general habitat conditions.  
Photo taken June 20, 2012  $Q = 0.62 \text{ m}^3/\text{s}$  @ K5.

Habitat consists of primarily deep and shallow runs with boulder, cobble, and gravel substrates throughout (Appendix A, Plate 13 through Plate 16). Good Arctic grayling spawning and rearing habitat was observed throughout the upper portion of the channel. Numerous adult and juvenile Arctic grayling were observed throughout Stream M4 during July and August trips in 2011 and in June 2012. Juvenile northern pike were also observed in August 2011. A small number of juvenile Arctic grayling were observed in August 2012. As larger bodied fish were observed within Stream M4 at discharges where downstream movement was likely not possible, it is assumed that these fish likely move upstream to Lake M4 to overwinter.

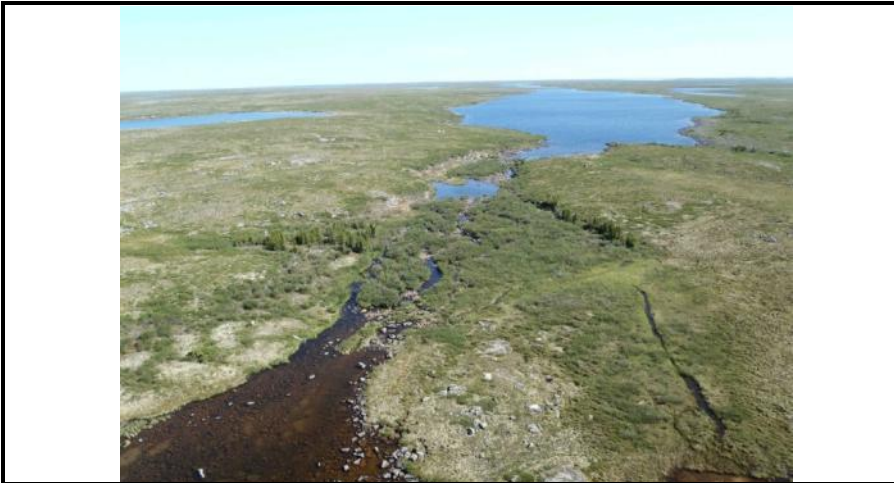
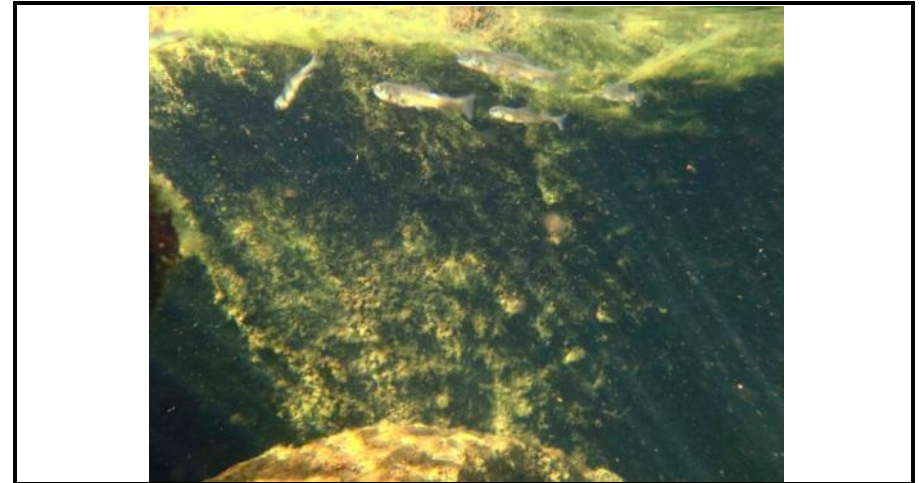
Plate 17: Stream L1A – 2011 survey  
Photo taken: July 8, 2011;  $Q = 0.14$  @ K5.

Plate 18: Stream L1A Arctic Grayling (ARGR) fry observed in flat open water area between barriers.  
Photo taken July 9, 2011.

Arctic grayling fry were observed in the July 2011 survey and adult and juvenile Arctic grayling observed throughout the stream in July 2012, suggesting that this stream is used for spawning and rearing. Abundant rearing habitat is present; however, clean spawning gravel is limited to a few small areas. Abundant deeper water habitat with good cover created by boulders was present at all flows observed. No fish were observed during the August field visits in 2011 or 2012, which may suggest the fry observed in the spring had emigrated out of the stream earlier in the summer.

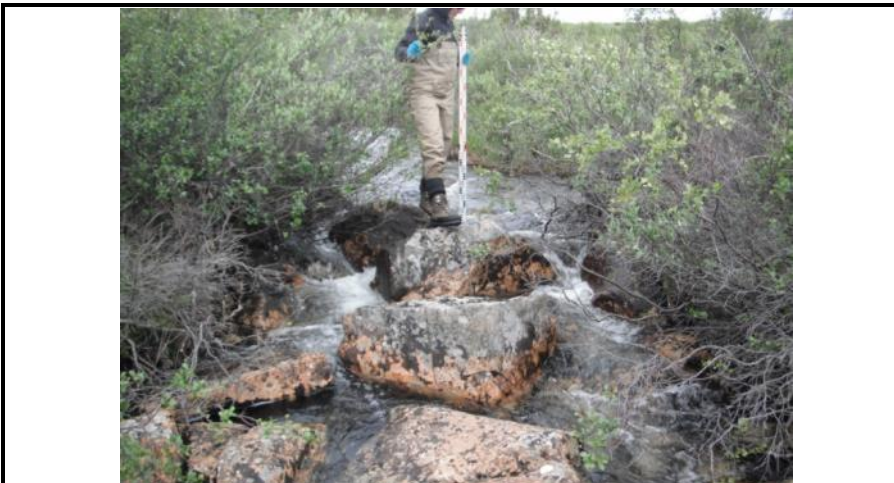
Plate 19: Stream L1A chute becoming shallow and potential restriction to upstream movement.  
Photo taken June 27, 2012;  $Q = 0.36$  @ K5.

and juvenile Arctic grayling were observed above this point and a barrier was not likely. As flows receded in 2012, shallower depths within the chute habitats present may also begin to restrict upstream movements of adult fish (Appendix A, Plate 19). Fish in the lower section of Stream L1a would not likely be able to move upstream as flows recede throughout the summer.

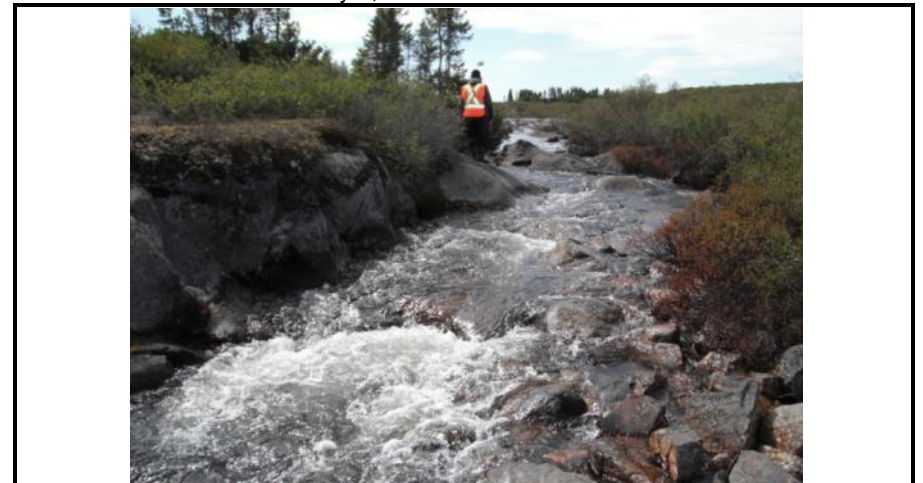
Plate 20: Stream L1a high velocity chute with maximum velocity of 1.79 m/s  
Photo taken June 20, 2012;  $Q = 0.62$  @ K5.

The channel in Stream L1a is confined with a steeper gradient than the other channels observed downstream of Kennady Lake. At higher flows, some areas of high velocity and shallow depth were observed within chute areas, with point velocities measured between 1.29 m/s and 1.79 m/s (Appendix A, Plate 20); however, adult

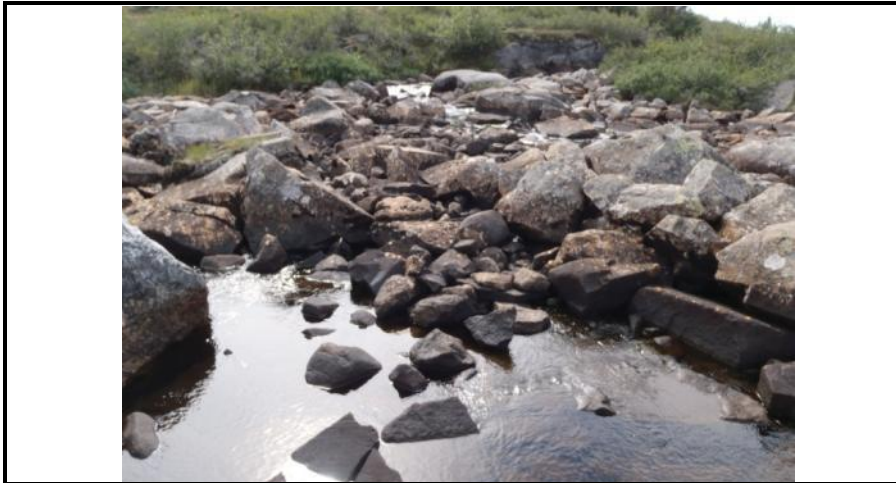
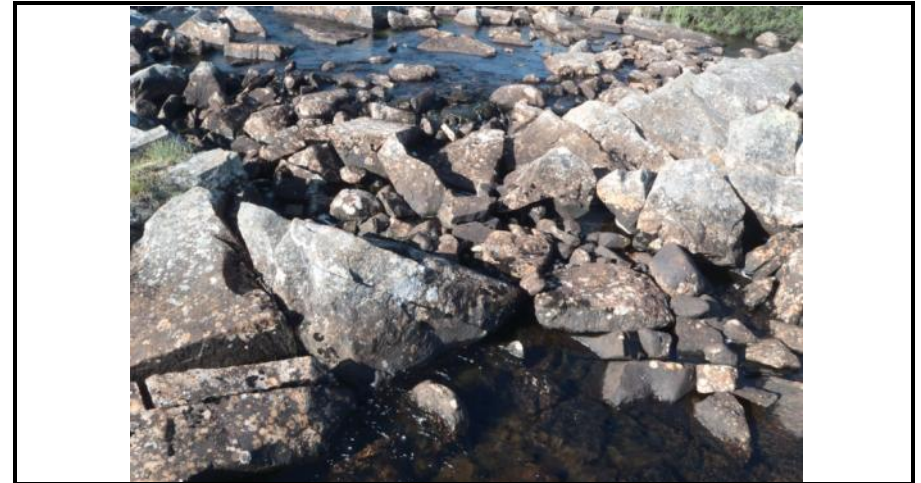
Plate 21: Stream L1A barrier near outlet looking upstream.  
Photo taken August 7, 2011; Q = 0.08 @ K5.

Plate 22: Stream L1A barrier near outlet looking upstream.  
Photo taken July 9, 2011; Q = 0.13 @ K5.

Stream L1a has a major barrier to upstream fish movement caused by a boulder ledge that lacks surface flow under low flow conditions (Appendix A, Plates 21 and 22). Downstream movement by fry is likely possible at flows down to 0.10 m<sup>3</sup>/s, as water flow was observed moving underneath and between small gaps in the boulders; a complete barrier was beginning to form at 0.08 m<sup>3</sup>/s. Upstream passage was possible at 0.38 m<sup>3</sup>/s and higher; however, shallow depths may have started to restrict upstream passage at 0.36 m<sup>3</sup>/s, although passage was still likely possible (Appendix A, Plates 23 and 24).

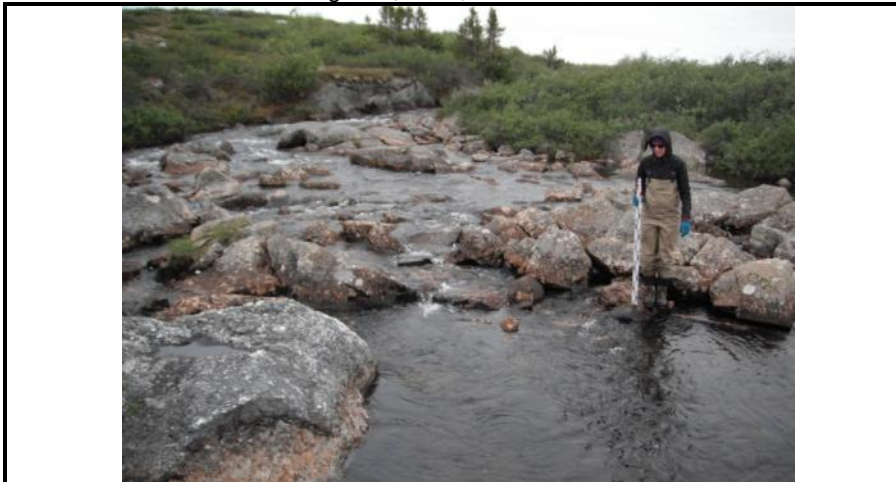
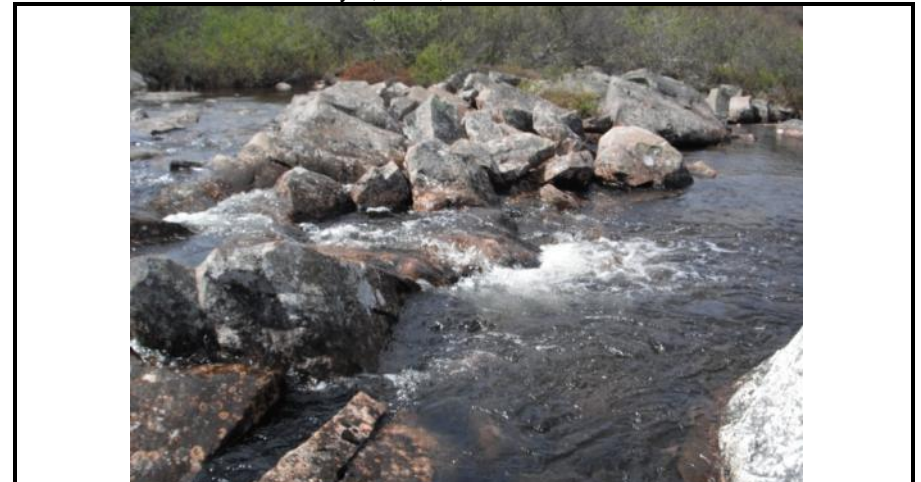
Plate 23: Stream L1A near outlet looking upstream with fish passage possible.  
Photo taken June 27, 2012; Q = 0.36 @ K5.

Plate 24: Stream L1A barrier near outlet looking across boulder ledge, fish passage possible.  
Photo taken June 20, 2012; Q = 0.62 @ K5.

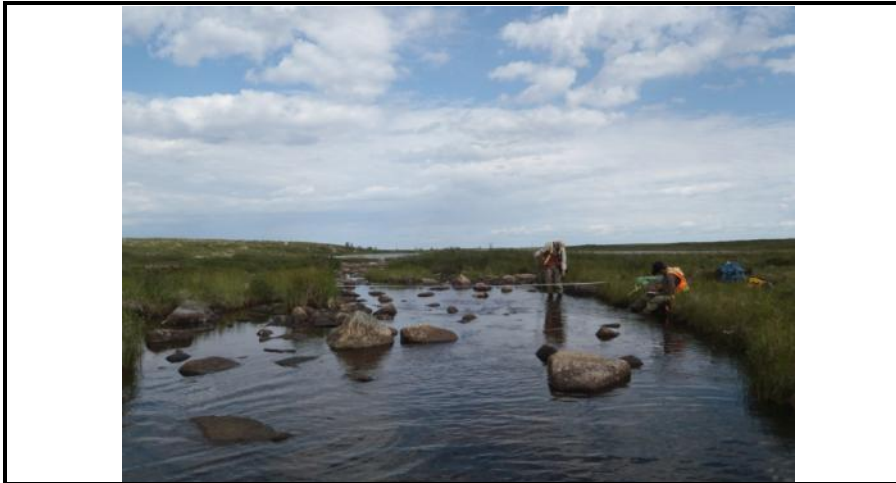
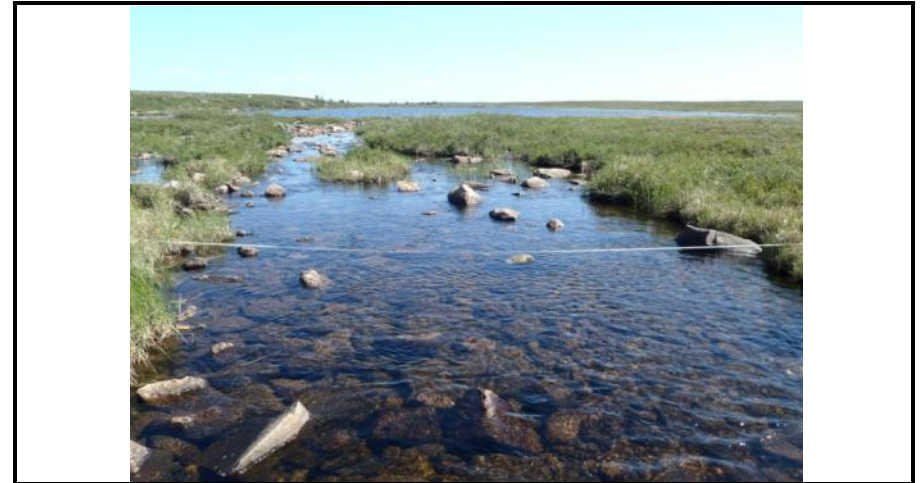
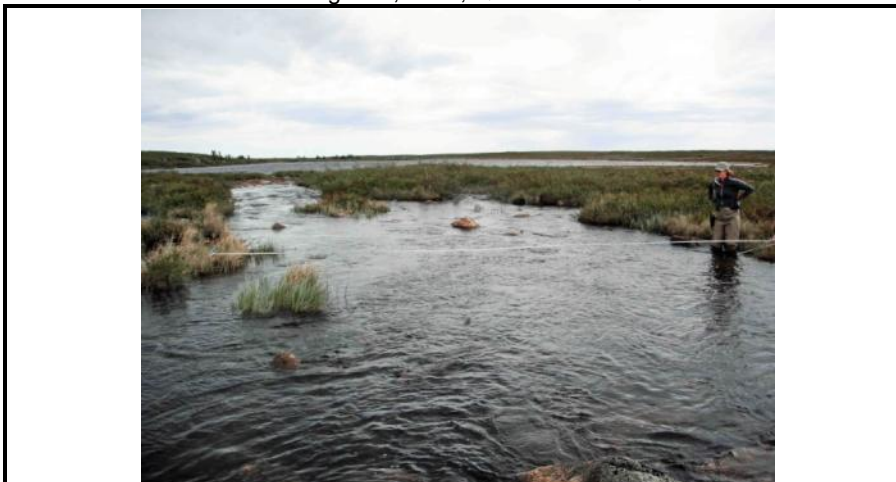
Plate 25: Stream L1B looking downstream at Transect 2.  
Photo taken August 7, 2011;  $Q = 0.08 \text{ m}^3/\text{s}$  @ K5.

Plate 26: Stream L1B looking downstream at Transect 2.  
Photo taken July 9, 2011;  $Q = 0.13 \text{ m}^3/\text{s}$  @ K5.

Plate 27: Stream L1B looking downstream at Transect 2.  
Photo taken June 21, 2012;  $Q = 0.62 \text{ m}^3/\text{s}$  @ K5.

Arctic grayling fry were observed in the July 2011 assessment; however, no fish were observed in the August 2011 assessment. One juvenile Arctic grayling was observed during the August 2012 assessment. The habitat within Stream L1b is comprised mainly of moderate to shallow run habitat with suitable depth and cover present for all life stages of Arctic grayling at all flows investigated during 2011 and 2012 (Appendix A, Plate 25 though Plate 27).

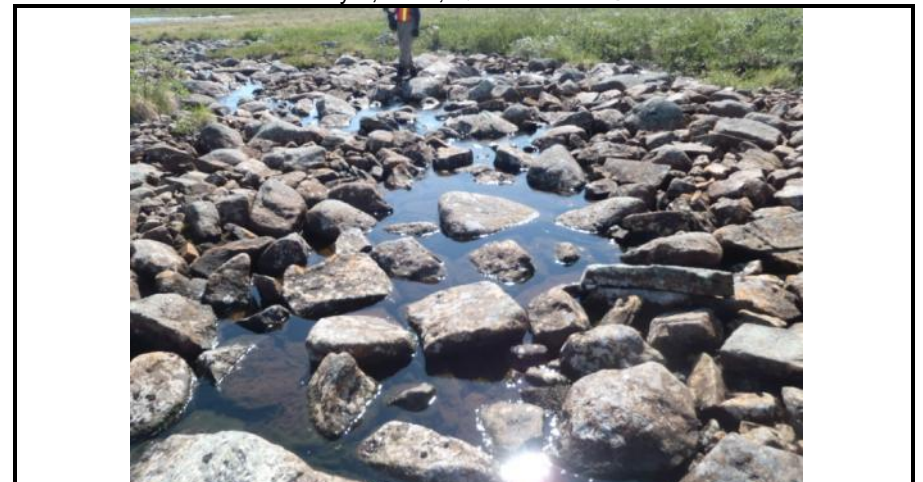
Plate 28: Stream L1b restriction to fish passage for adult fish  
Photo taken July 9, 2011;  $Q = 0.13 \text{ m}^3/\text{s}$  @ K5.

Fish passage at Stream L1b was likely restricted as water flowed through a boulder field near the outlet (Appendix A, Plate 28). At flows less than  $0.14 \text{ m}^3/\text{s}$ , surface water was flowing overtop small interstitial spaces of the boulders and cobble, which would allow for downstream movements of fry and small juvenile fish; however, adult movement would be restricted. No barriers to upstream or downstream fish movements were noted for flows between  $0.36 \text{ m}^3/\text{s}$  and  $0.62 \text{ m}^3/\text{s}$  during the field assessments conducted in June 2012.

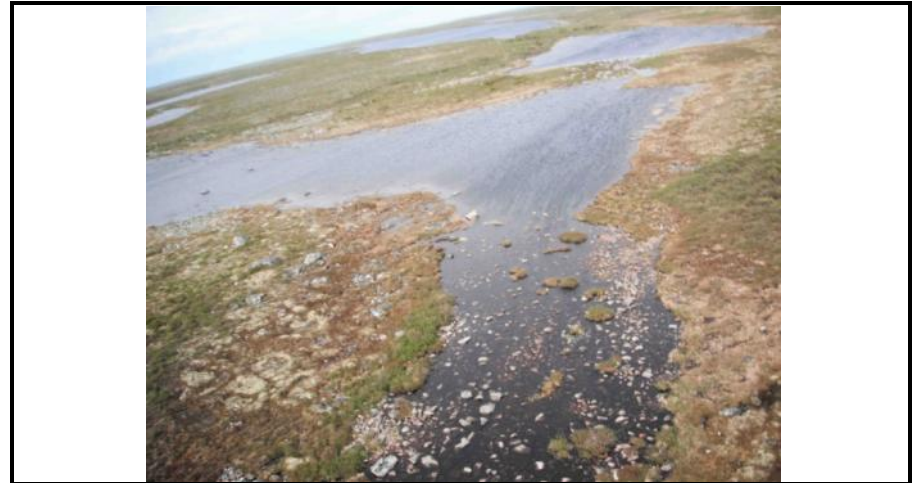
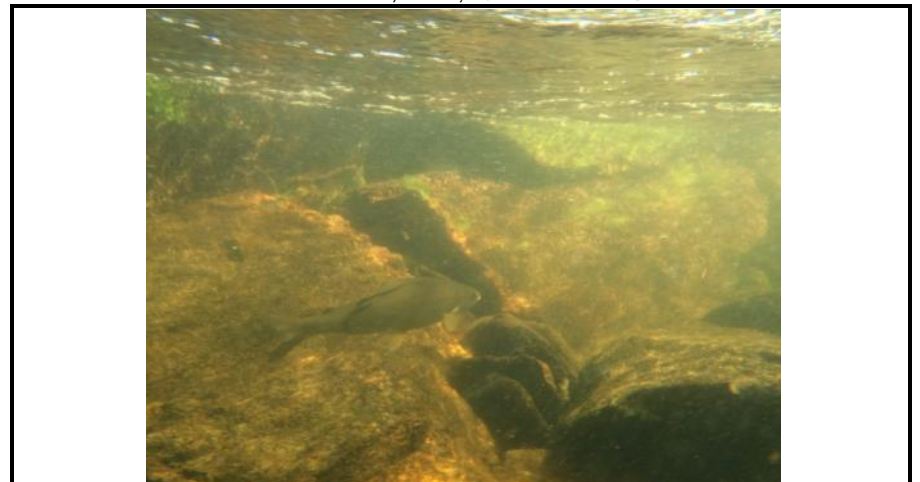
Plate 29: Stream L1c looking at upstream under low flows.  
Photo taken July 9, 2011;  $Q = 0.13 \text{ m}^3/\text{s}$  @ K5.

Plate 30: Stream L1c looking at downstream end under high flows.  
Photo taken June 21, 2012;  $Q = 0.62 \text{ m}^3/\text{s}$  @ K5.

Plate 31: Stream L1c riffle-pool habitat where adult Arctic grayling were observed.  
Photo taken June 21, 2012;  $Q = 0.62 \text{ m}^3/\text{s}$  @ K5.

Plate 32: Adult Arctic grayling observed at site L1C during the August 2011 survey.

During both 2011 and 2012, no barriers to fish movement through the site were found at Stream L1c, and both adult and juvenile Arctic grayling were observed throughout the site in both years, and during spring and summer seasons. Suitable depth and cover is provided for all life stages of Arctic grayling throughout the stream with abundant boulders and cobble. Small areas of gravel provided suitable spawning habitat at all flows observed. Terrestrial vegetation was becoming flooded in some sections at a flow of  $0.62 \text{ m}^3/\text{s}$ .

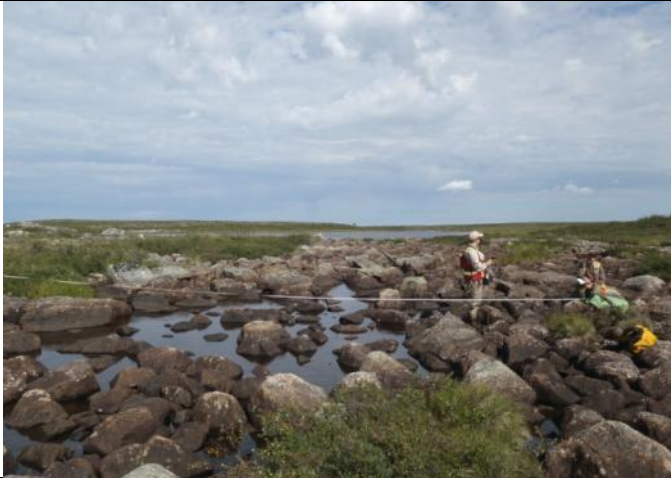
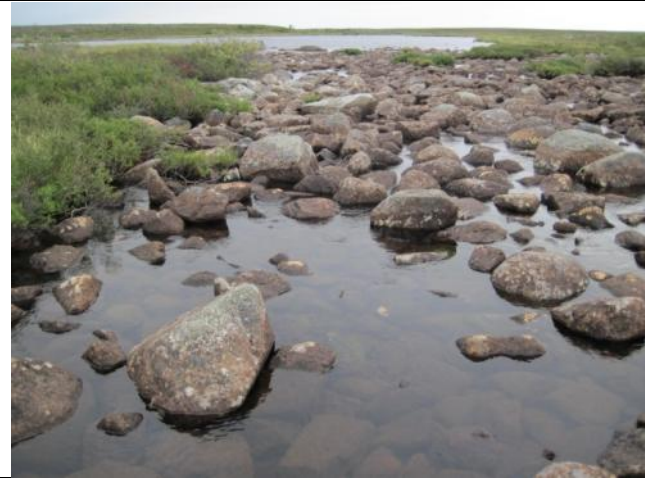
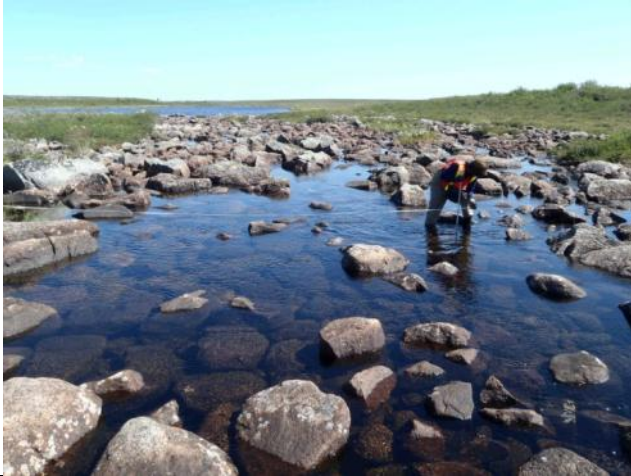
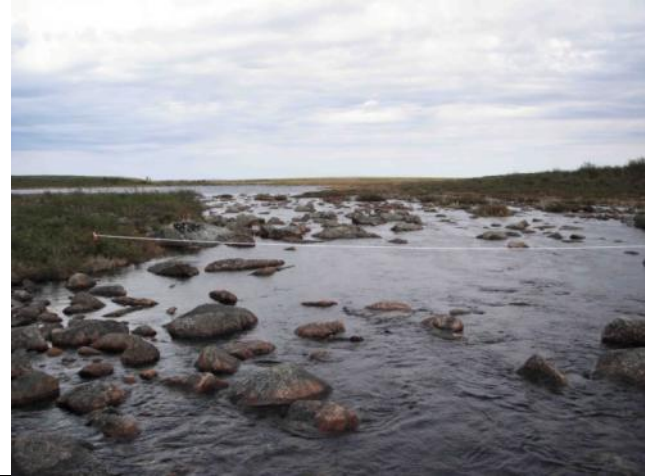
Plate 33: Stream L1C looking upstream from Transect 1 at potential fish passage restriction.  
Photo taken August 7, 2011;  $Q = 0.08 \text{ m}^3/\text{s}$  @ K5.

Plate 34: Stream L1C looking upstream from Transect 1 at potential fish passage restriction.  
Photo taken August 17, 2012;  $Q = 0.10 \text{ m}^3/\text{s}$  @ K5.

Plate 35: Stream L1C looking upstream towards Transect 1 at the potential fish passage restriction .  
Photo taken July 9, 2011;  $Q = 0.13 \text{ m}^3/\text{s}$  @ K5.

Plate 36: Site L1C looking upstream towards Transect 1 with no restriction to fish passage.  
Photo take June 21, 2012;  $Q = 0.62 \text{ m}^3/\text{s}$  @ K5.

Fish passage for all life stages of Arctic grayling is possible at all flows observed during the 2011 and 2012 surveys (Appendix A, Plate 33 through Plate 36). Flows passed through a boulder field near the mouth of the stream, which results in the flow becoming dispersed with the absence of a single clearly defined channel. Movements likely become restricted at flows of  $0.10 \text{ m}^3/\text{s}$  and lower; however, a suitable flow path was still present amongst the boulders.

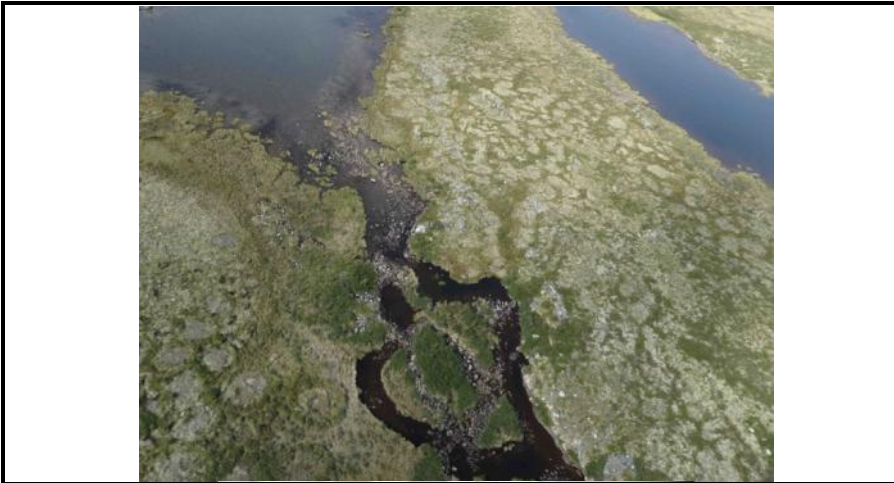
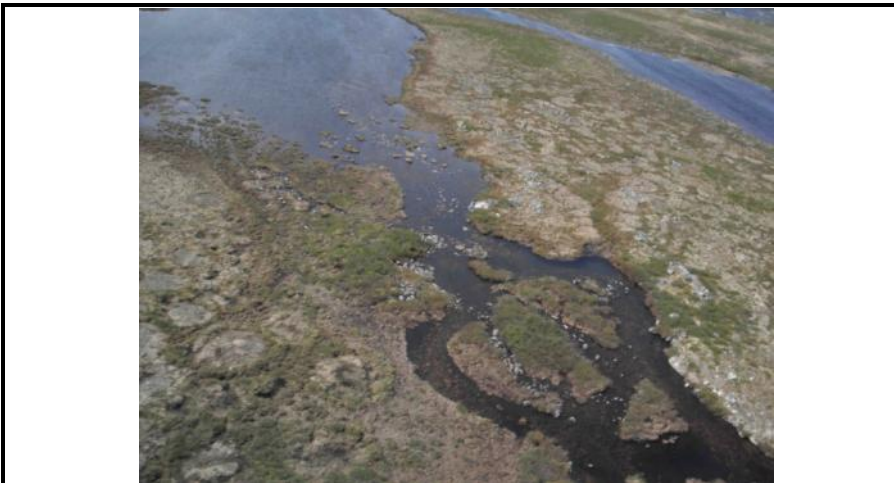
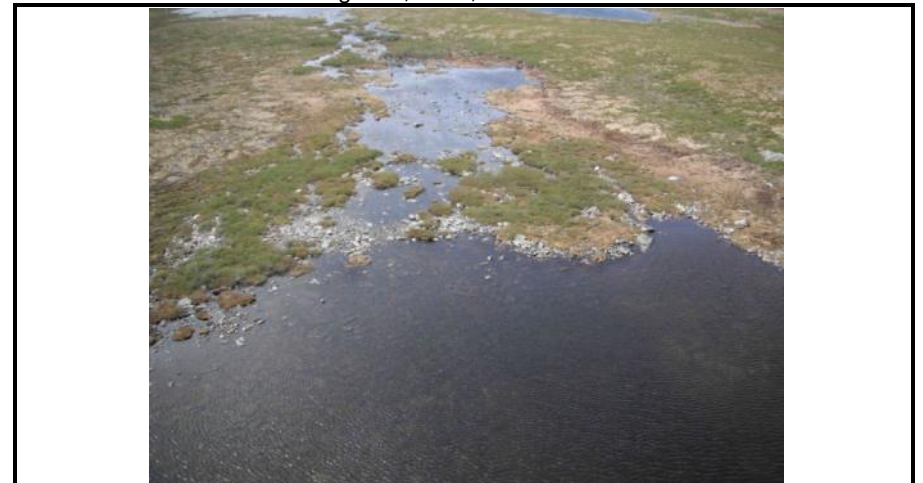
Plate 37: Stream L3 - 2011 survey at the upstream inlet .  
Photo taken August 7, 2011;  $Q = 0.08 \text{ m}^3/\text{s}$  @ K5.

Plate 38: Stream L3 - 2011 survey at the downstream mouth showing no connectivity.  
Photo taken August 7, 2011;  $Q = 0.08 \text{ m}^3/\text{s}$  @ K5.

Plate 39: Site L3 - 2012 survey at the upstream inlet .  
Photo taken June 20, 2012;  $Q = 0.62 \text{ m}^3/\text{s}$  @ K5.

Plate 40: Site L3 - 2012 survey at the downstream mouth .  
Photo taken June 20, 2012;  $Q = 0.62 \text{ m}^3/\text{s}$  @ K5.

In Stream L3, fish movement would be completely restricted for all life stages at flows of  $0.14 \text{ m}^3/\text{s}$  and lower (Appendix A, Plate 38). A large section of completely dry channel located at the downstream end of the stream was observed during July and August 2011 and again in August 2012 (Appendix A, Plates 41 and 42). This section was wetted and passable during all flows observed in June 2012 ranging from  $0.36 \text{ m}^3/\text{s}$  to  $0.62 \text{ m}^3/\text{s}$  (Appendix A, Plates 43 and 44).

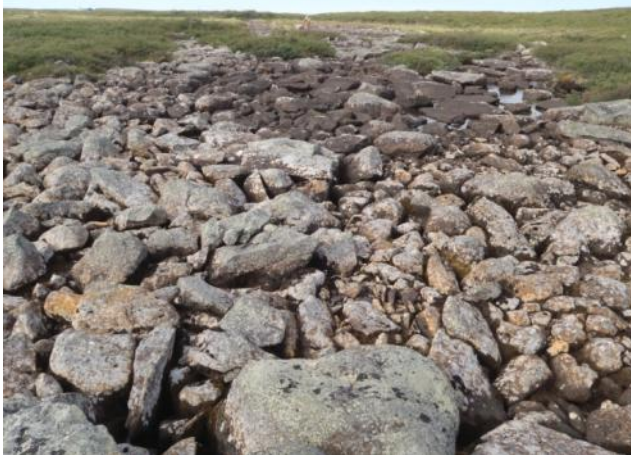
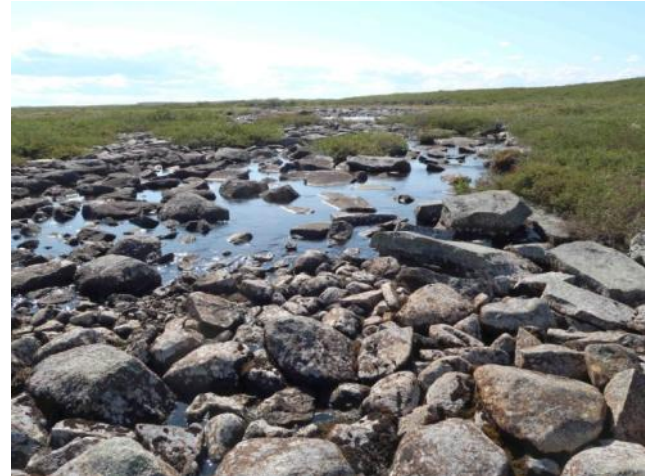
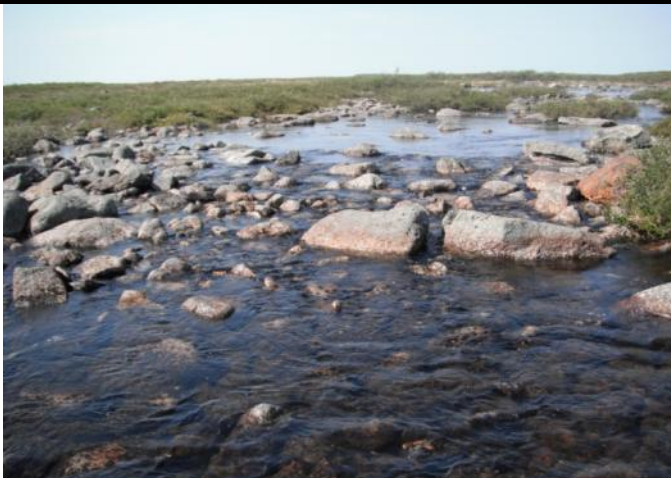
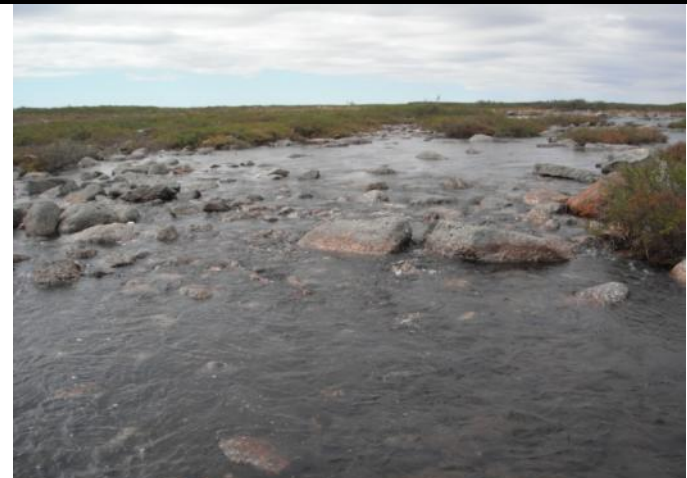
Plate 41: Stream L3 looking upstream at the complete fish barrier near outlet. Photo taken August 7, 2011;  $Q = 0.08 \text{ m}^3/\text{s}$  @ K5.

Plate 42: Stream L3 looking upstream at the potential fish barrier near outlet. Photo taken July 8, 2011;  $Q = 0.14 \text{ m}^3/\text{s}$  @ K5.

Plate 43: Stream L3 looking upstream near outlet, no barrier present. Photo taken June 25, 2012;  $Q = 0.38 \text{ m}^3/\text{s}$  @ K5.

Plate 44: Stream L3 looking upstream near outlet, no barrier present. Photo taken June 20, 2012;  $Q = 0.62 \text{ m}^3/\text{s}$  @ K5.

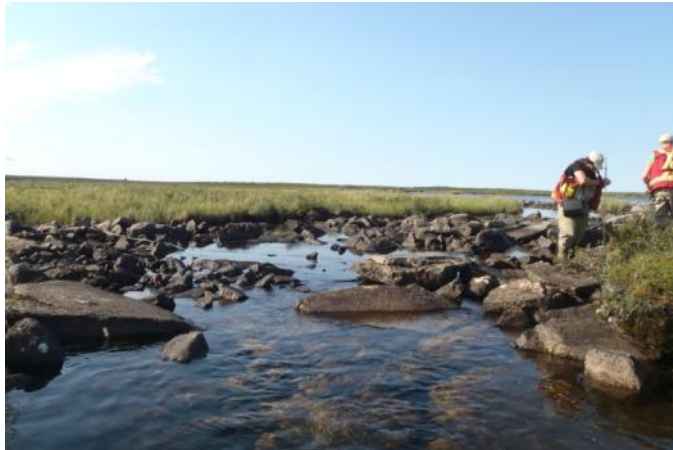
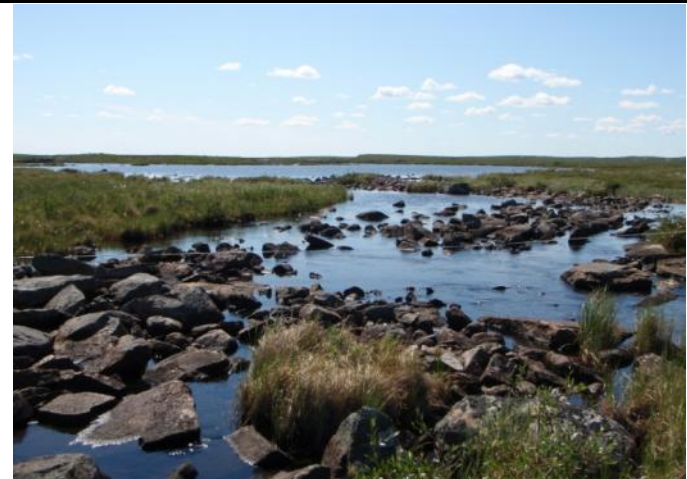
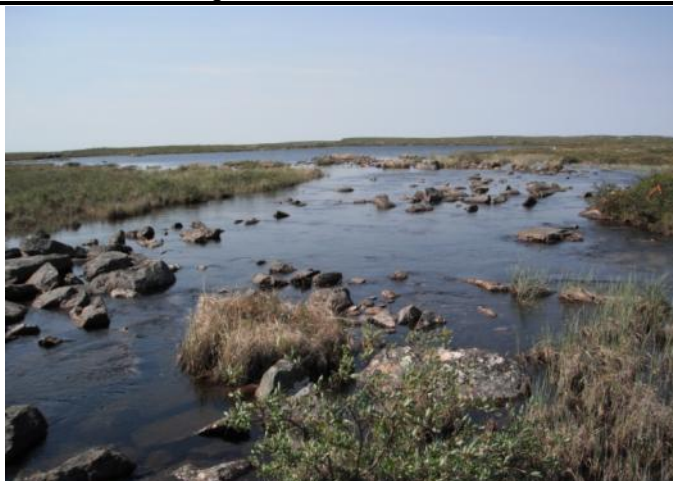
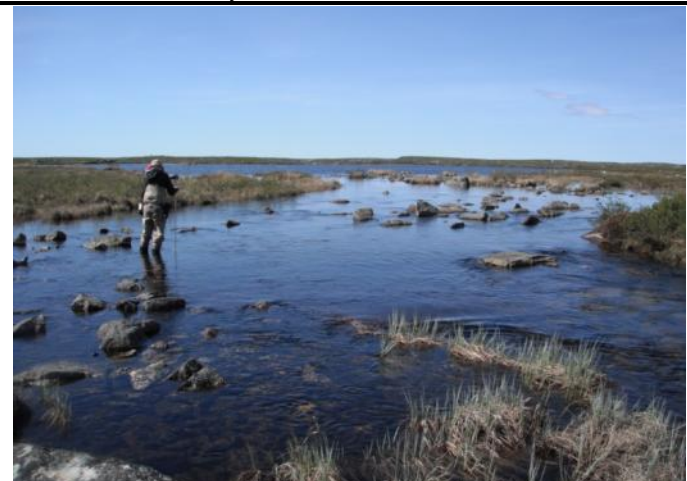
Plate 45: Stream L3 looking upstream at Transect 1 at shallow and moderate depth run habitat.  
Photo taken August 7, 2011;  $Q = 0.08 \text{ m}^3/\text{s}$  @ K5.

Plate 46: Stream L3 looking upstream at Transect 1 at shallow and moderate depth run habitat.  
Photo taken July 8, 2011;  $Q = 0.14 \text{ m}^3/\text{s}$  @ K5.

Plate 47: Stream L3 looking upstream at Transect 1, some flooded vegetation observed.  
Photo taken June 27, 2012;  $Q = 0.36 \text{ m}^3/\text{s}$  @ K5.

Plate 48: Stream L3 looking upstream at Transect 1, some flooded vegetation observed  
Photo taken June 20, 2012;  $Q = 0.62 \text{ m}^3/\text{s}$  @ K.

Upstream of the barrier, habitat consists of primarily moderate to shallow runs and flats with depth and cover suitable for all life stages of Arctic grayling at all flow conditions assessed (Appendix A, Plate 45 through

Plate 48). Arctic grayling fry and juvenile life stages were observed in the 2011 and 2012 surveys. Near the upstream end of Stream L3, areas of flooded vegetation provide suitable spawning and rearing habitat for northern pike. Juvenile northern pike were observed in July 2011 and June 2012. Juvenile Arctic grayling were observed during the August 2011 assessment, and with the downstream barrier present, this suggests that fish in this stream likely move upstream to Kennady Lake to overwinter.
