MEMORANDUM

FROM Cam Stevens and Damian Panayi, Golder Associates Ltd.

PROJECT NO. 1665943

FISH HABITAT SURVEY FOR THE TŁJCHQ ALL-SEASON ROAD

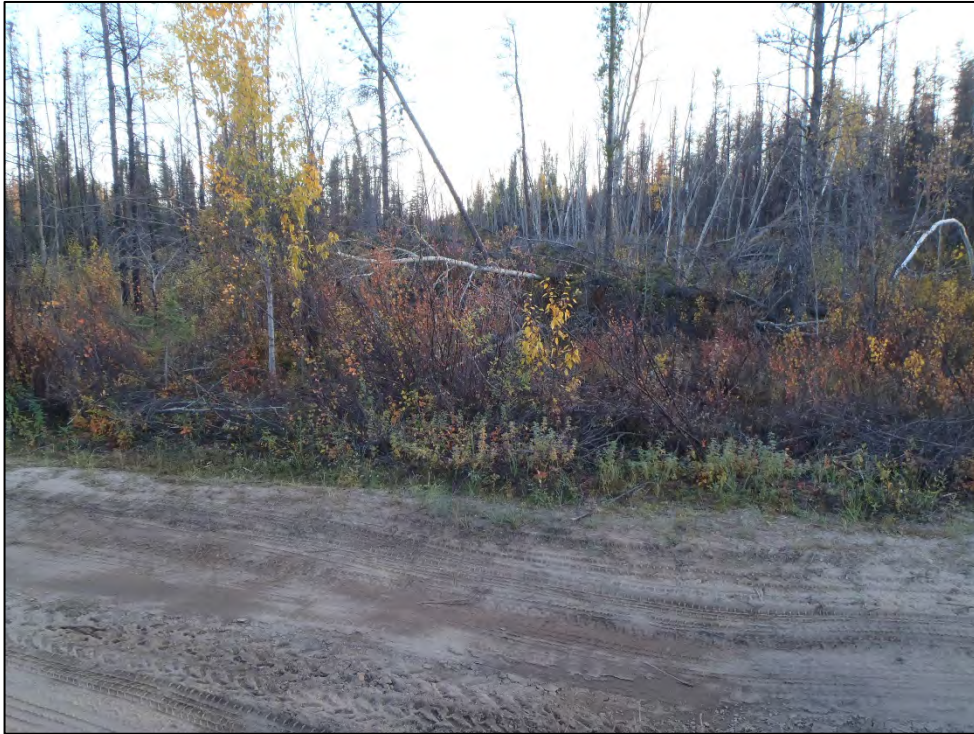
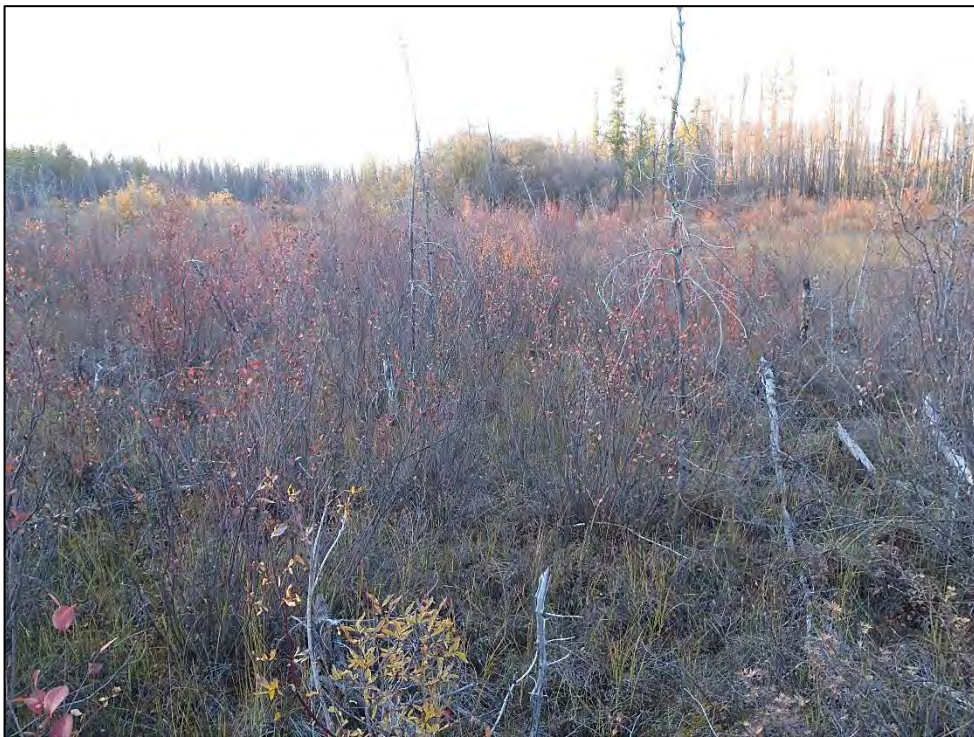
1.1	Ephemeral Draw	Dry	<ul style="list-style-type: none"> ▪ 20 m south of existing trail¹ ▪ birch seep/shrubby wetland 	<ul style="list-style-type: none"> ▪ no defined bed or banks ▪ ephemeral draw extends beyond ROW 	None	Minimal	None

Photo 1: Crossing 1.1, From Centreline, Facing South (Upstream), Sept. 21, 2017

Photo 2: Crossing 1.1, From Centreline, Facing North (Downstream), Sept. 21, 2017

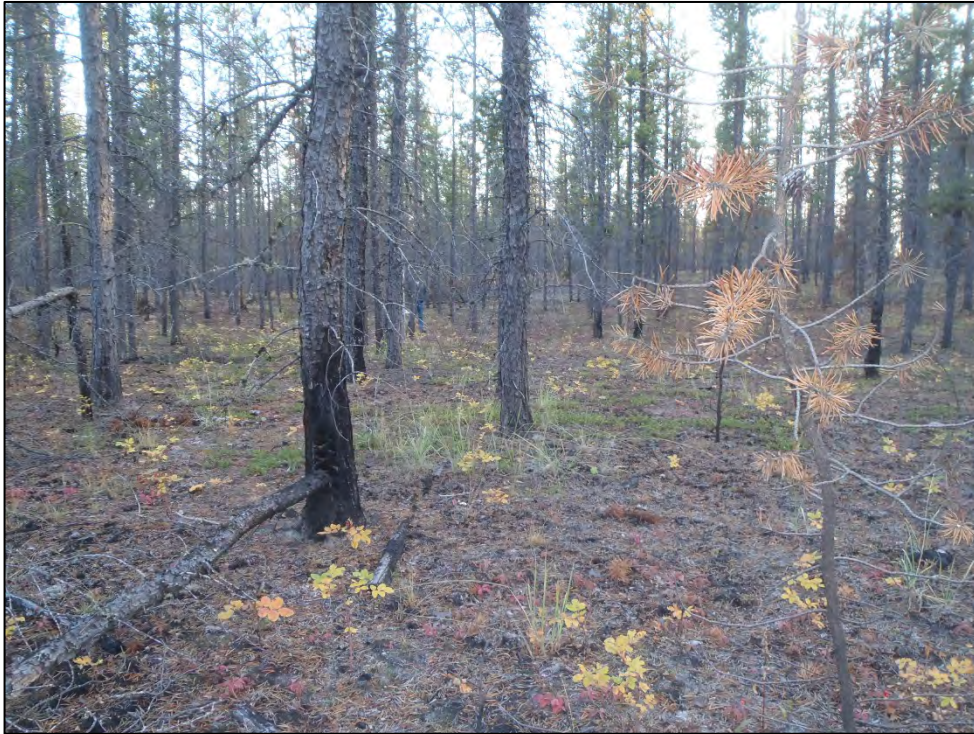
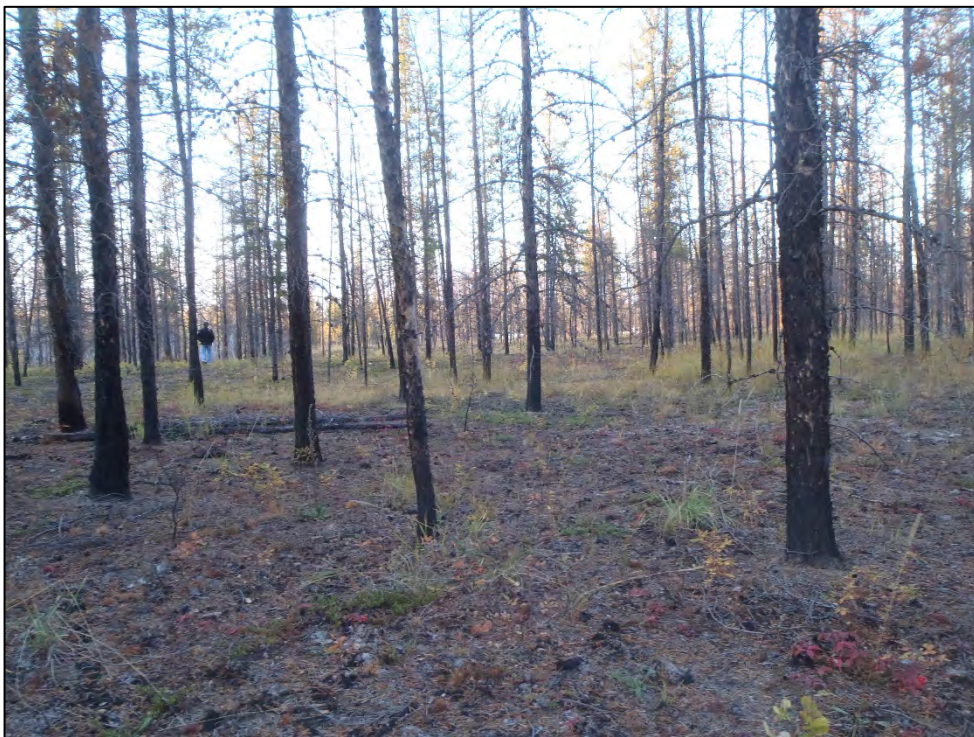
1.2	Ephemeral Draw	Dry	<ul style="list-style-type: none"> ▪ 100 m south of existing trail ▪ dry upland forest 	<ul style="list-style-type: none"> ▪ no defined bed or banks ▪ upland forest 	None	None	None
2	Ephemeral Draw	Dry	<ul style="list-style-type: none"> ▪ 200 m south of existing trail ▪ dry upland forest 	<ul style="list-style-type: none"> ▪ no defined bed or banks ▪ upland forest 	None	None	None
3	Ephemeral Draw	Dry	<ul style="list-style-type: none"> ▪ near existing trail ▪ dry, early stage upland forest 	<ul style="list-style-type: none"> ▪ no defined bed or banks ▪ upland forest 	None	None	None
4	Ephemeral Draw	Dry	<ul style="list-style-type: none"> ▪ near existing trail ▪ dry upland forest 	<ul style="list-style-type: none"> ▪ no defined bed or banks ▪ upland forest 	None	None	None
5	Ephemeral Draw	Dry	<ul style="list-style-type: none"> ▪ near existing trail ▪ dry upland forest 	<ul style="list-style-type: none"> ▪ no defined bed or bank ▪ upland forest 	None	None	None

Photo 3: Crossing 1.2, From Centreline, Facing South (Upstream), Sept. 21, 2017

Photo 4: Crossing 1.2, From Centreline, Facing North (Downstream), Sept. 21, 2017

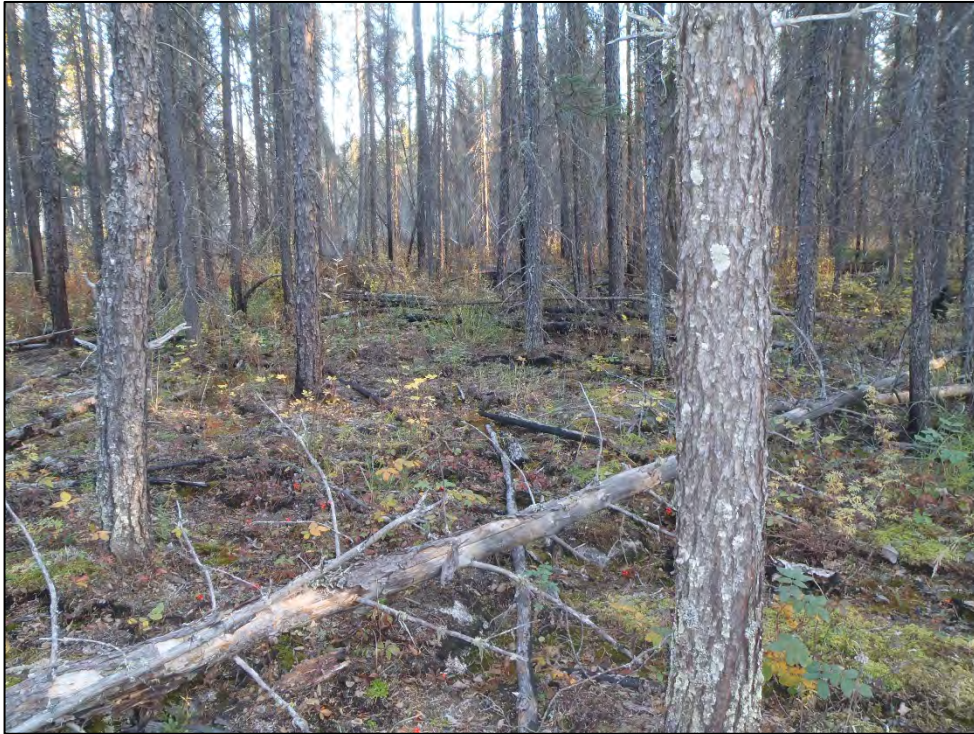
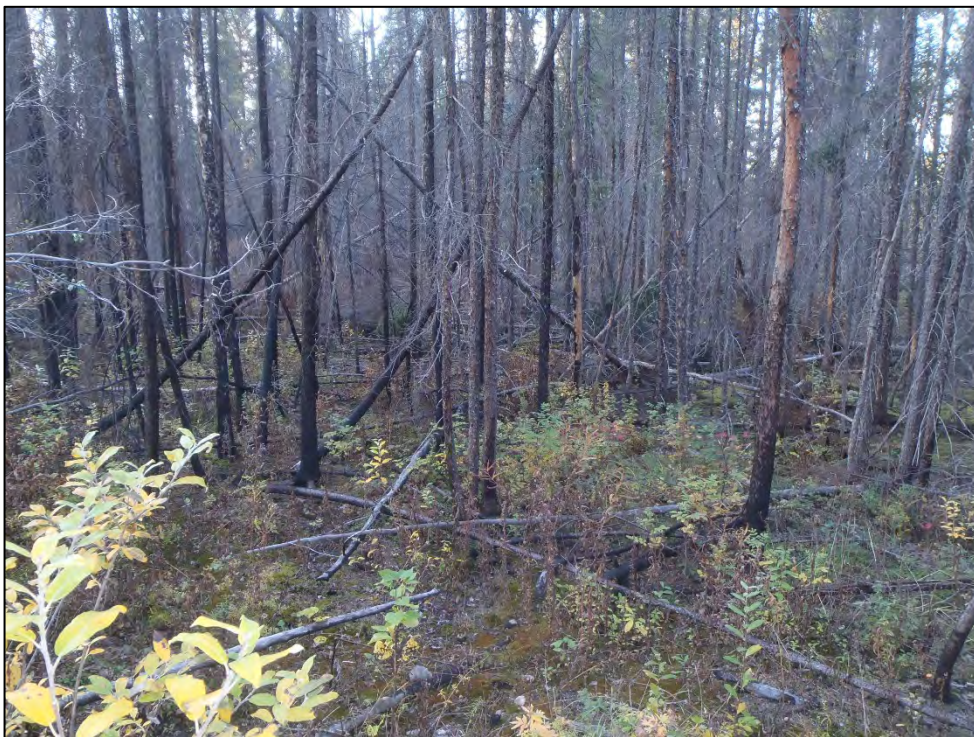
Photo 5: Crossing 2, From Centreline, Facing South (Upstream), Sept. 21, 2017

Photo 6: Crossing 2, From Centreline, Facing North (Downstream), Sept. 21, 2017

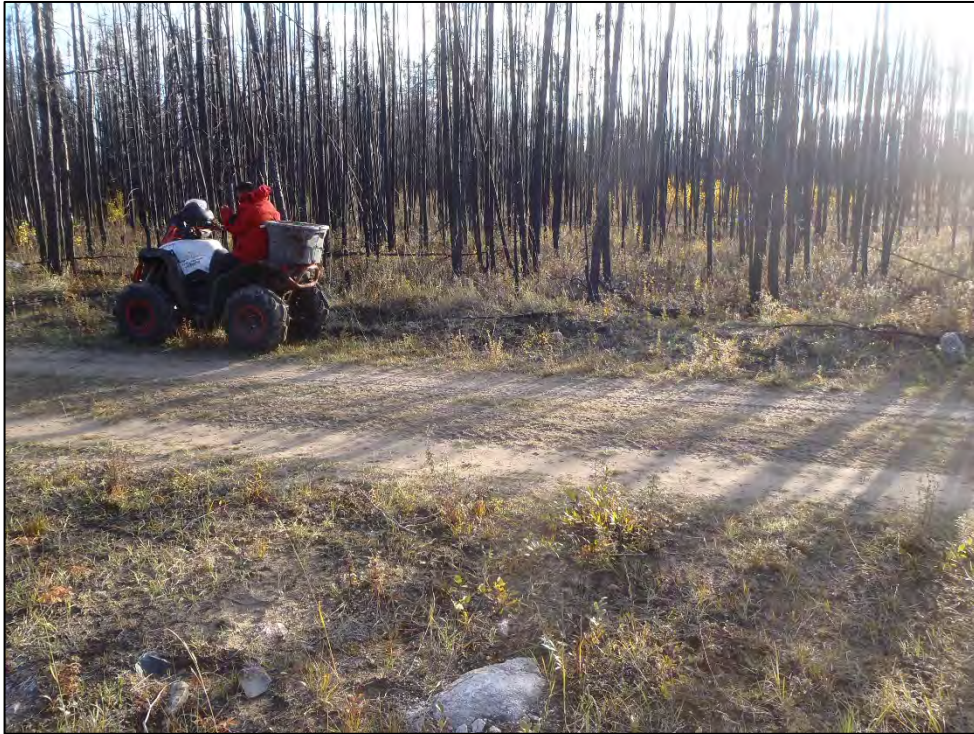
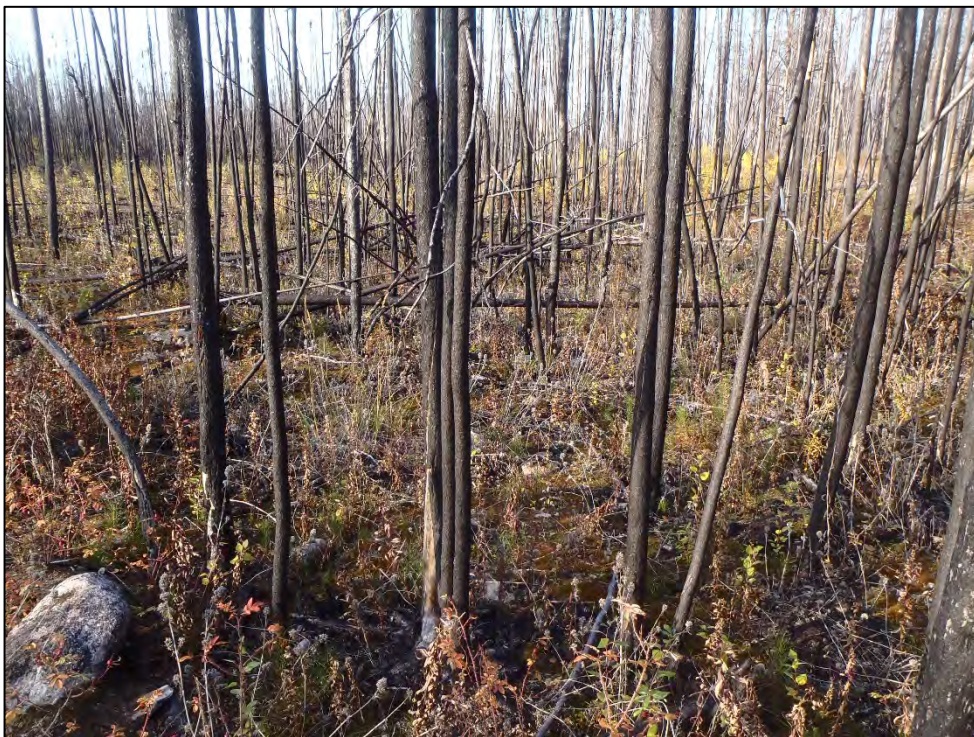
Photo 7: Crossing 3, From Centreline, Facing South (Upstream), Sept. 21, 2017

Photo 8: Crossing 3, From Centreline, Facing North (Downstream), Sept. 21, 2017

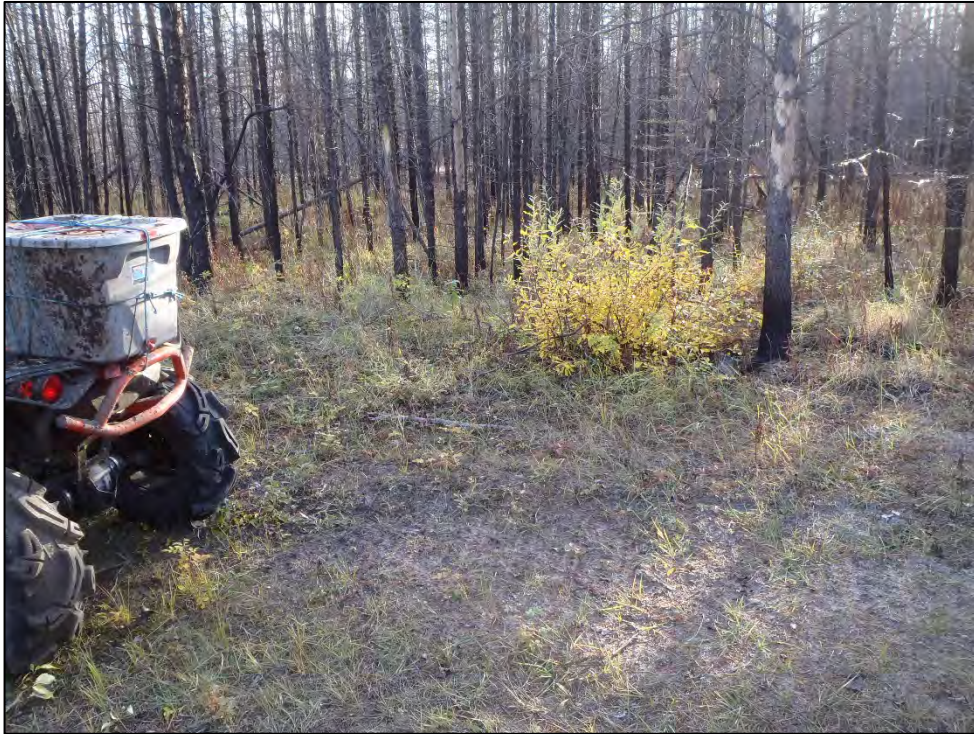
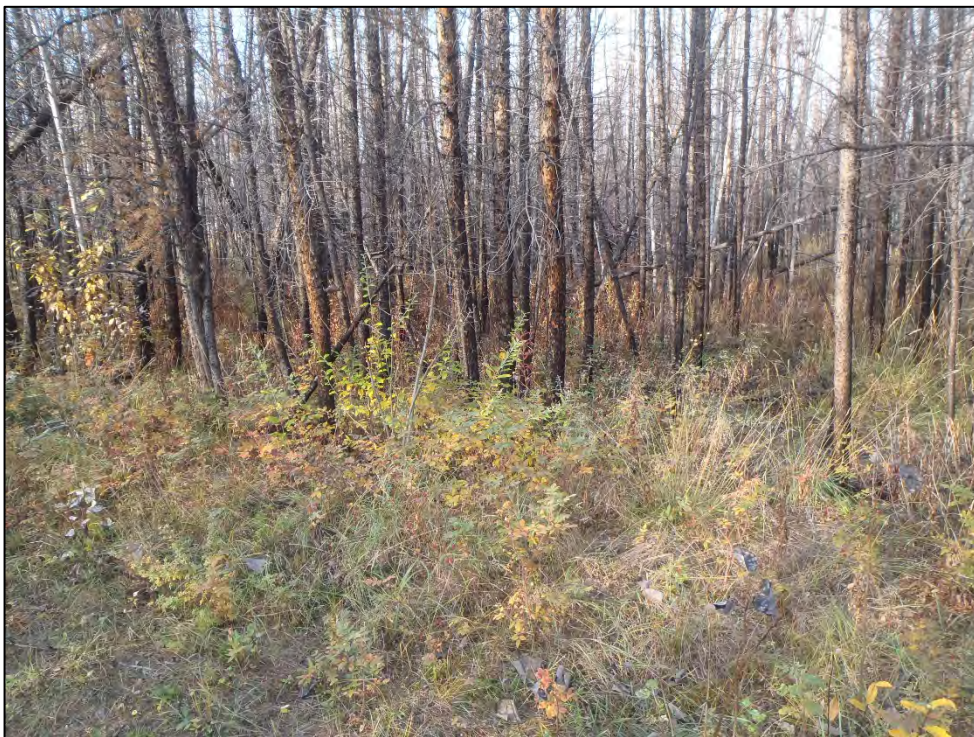
Photo 9: Crossing 4, From Centreline, Facing Southwest (Upstream), Sept. 21, 2017

Photo 10: Crossing 4, From Centreline, Facing Northeast (Downstream), Sept. 21, 2017

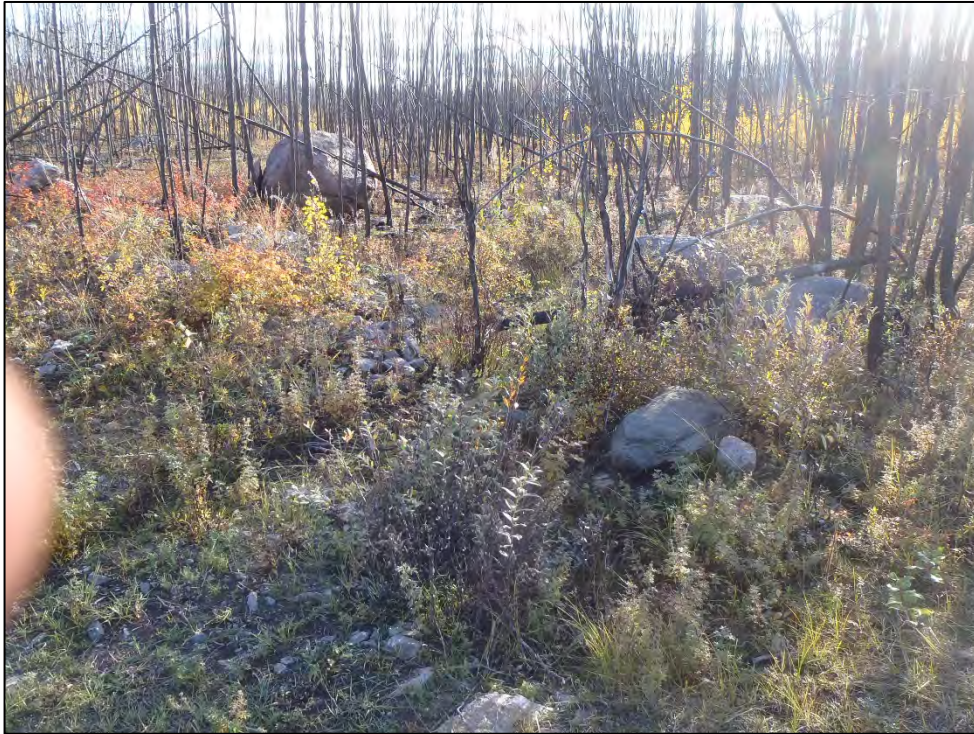
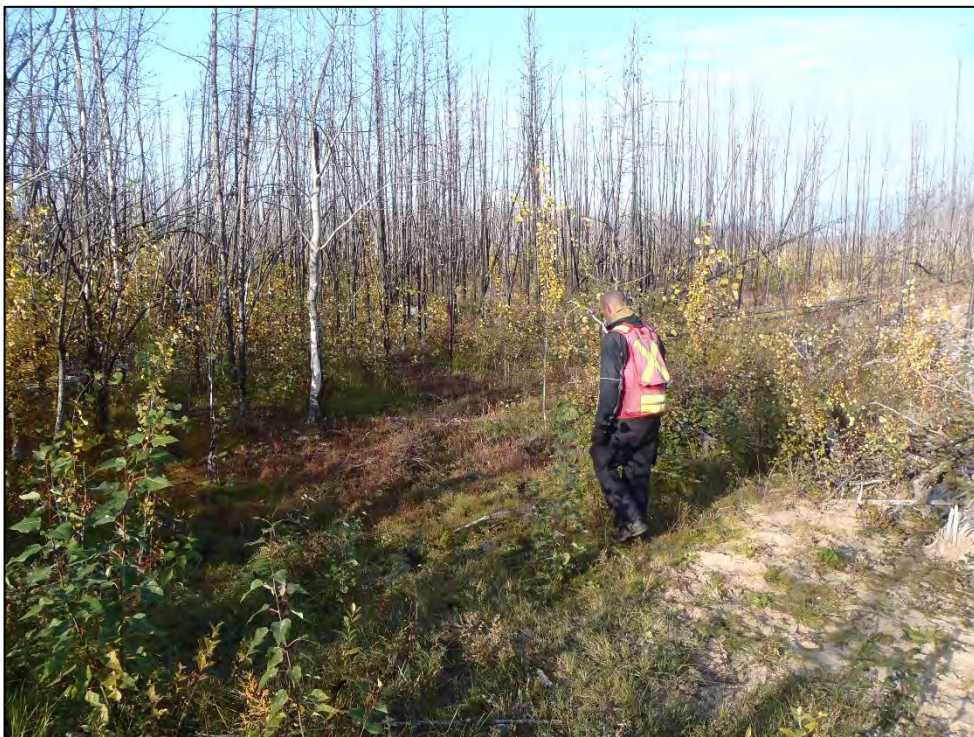
Photo 11: Crossing 5, From Centreline, Facing Southwest (Upstream), Sept. 21, 2017

Photo 12: Crossing 5, From Centreline, Facing Northeast (Downstream), Sept. 21, 2017

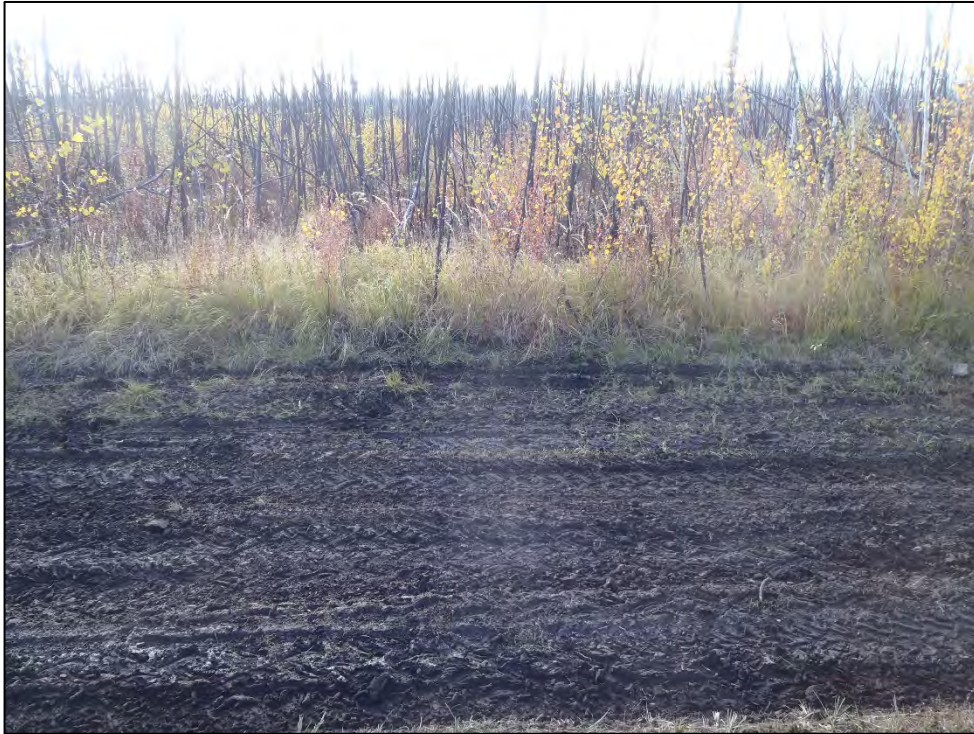
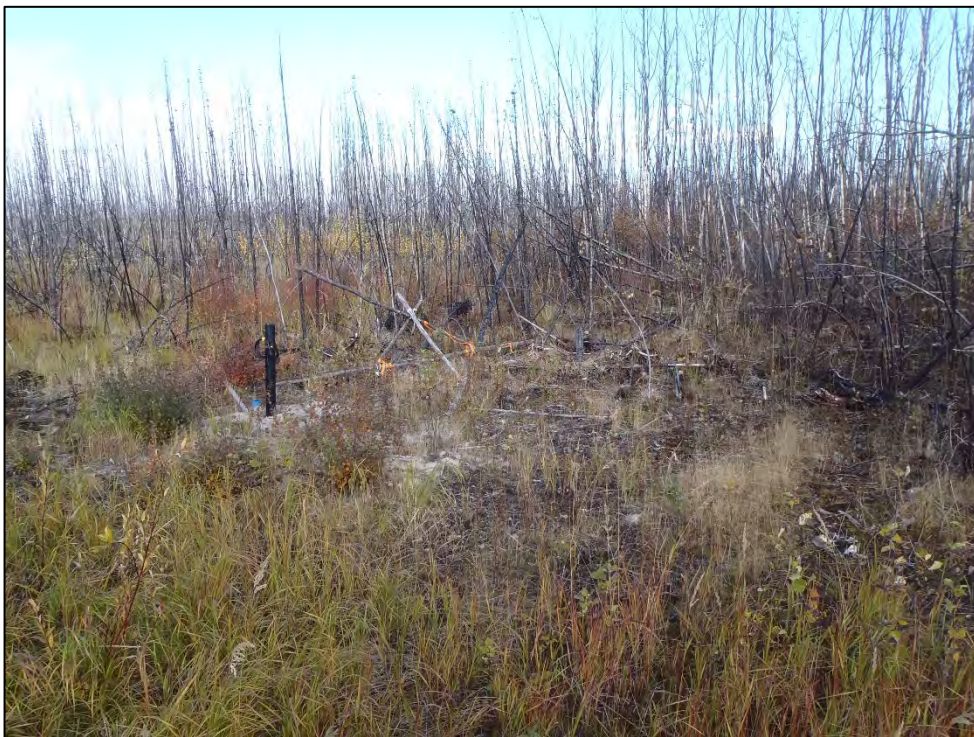
6	Ephemeral Draw	Dry	<ul style="list-style-type: none"> ▪ near existing trail ▪ ephemeral wetland to NE (downstream) ▪ dry, early stage forest to SW (upstream) ▪ less than 20 m width draw 	<ul style="list-style-type: none"> ▪ no defined bed or banks ▪ upland forest 	None	None	None
7	Ephemeral Draw	Dry	<ul style="list-style-type: none"> ▪ near existing trail ▪ ephemeral wetland to NE (downstream) ▪ dry forest to SW (upstream) ▪ less than 30 m width draw 	<ul style="list-style-type: none"> ▪ no defined bed or banks ▪ ephemeral draw extends downstream beyond ROW 	None	None	None
8	Large Permanent	Low-Moderate	<ul style="list-style-type: none"> ▪ crossing is 160 m E (downstream) of existing crossing ▪ braided channels; two main channels in ROW, each with 5 m wetted/bankfull width ▪ cobble/fine substrate types ▪ deep run habitat (3 m max. depth) 	<ul style="list-style-type: none"> ▪ 1,747 µS/cm, 8.1 pH, 6.6°C ▪ braided, meandering, occasionally confined, and incised stream ▪ shrub/meadow riparian habitat (moderate bank stability) ▪ debris at existing crossing may be a barrier at low flows 	High	High	Unidentified small-bodied fish

Photo 13: Crossing 6, From Centreline, Facing West (Upstream), Sept. 21, 2017

Photo 14: Crossing 6, From Centreline, Facing East (Downstream), Showing Thermistor, Sept. 21, 2017

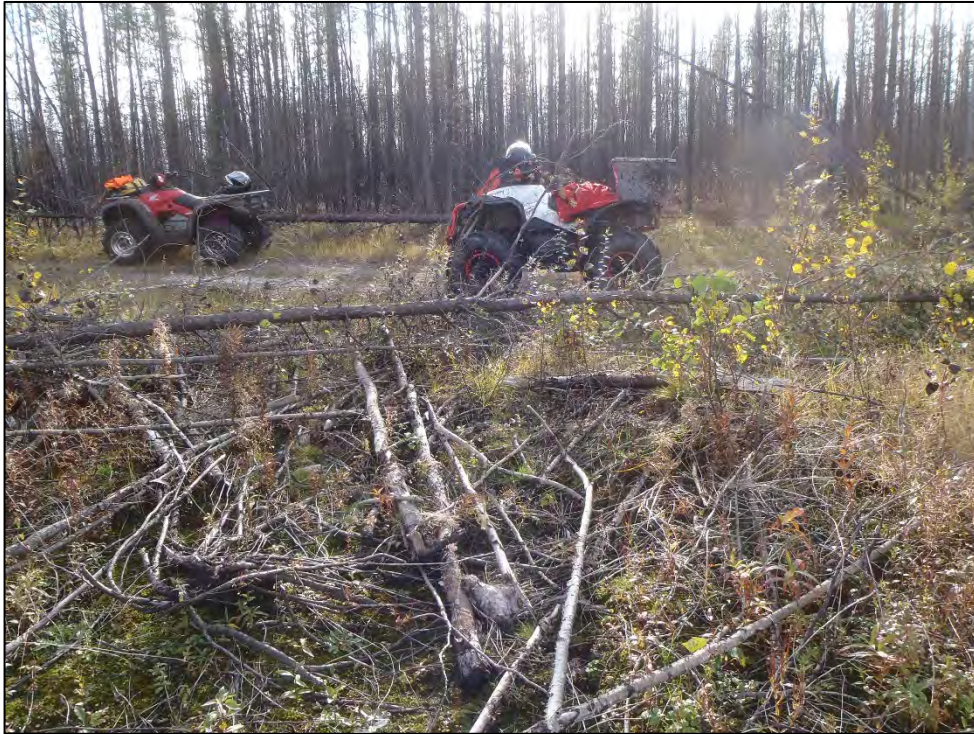
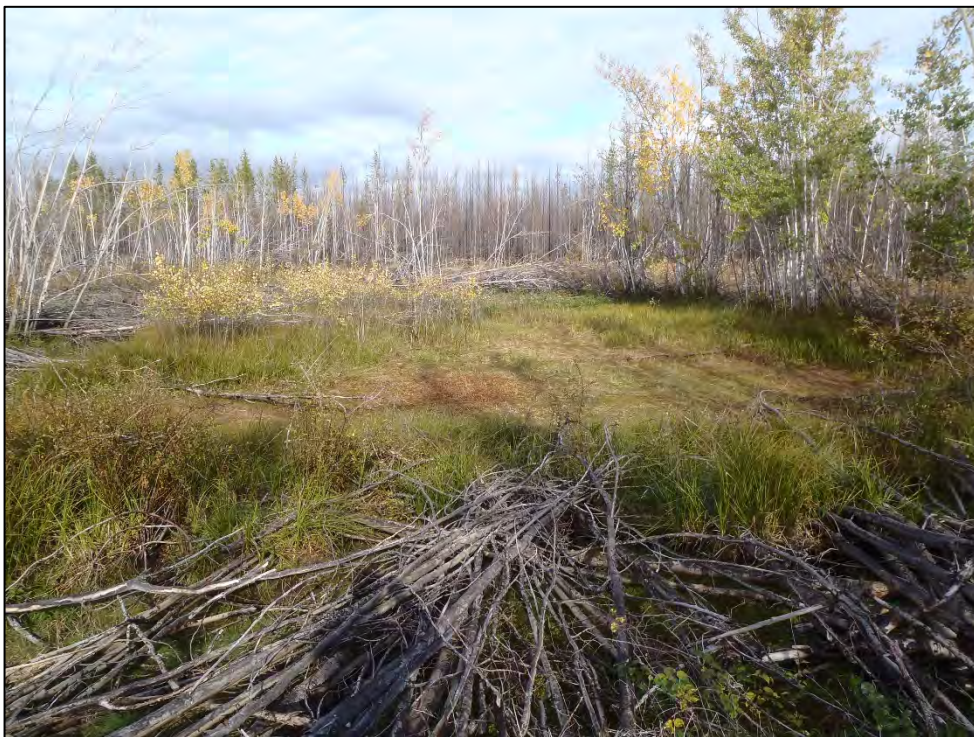
Photo 15: Crossing 7, From Centreline, Facing West (Upstream), Sept. 21, 2017

Photo 16: Crossing 7, From Centreline, Facing East (Downstream), Sept. 21, 2017

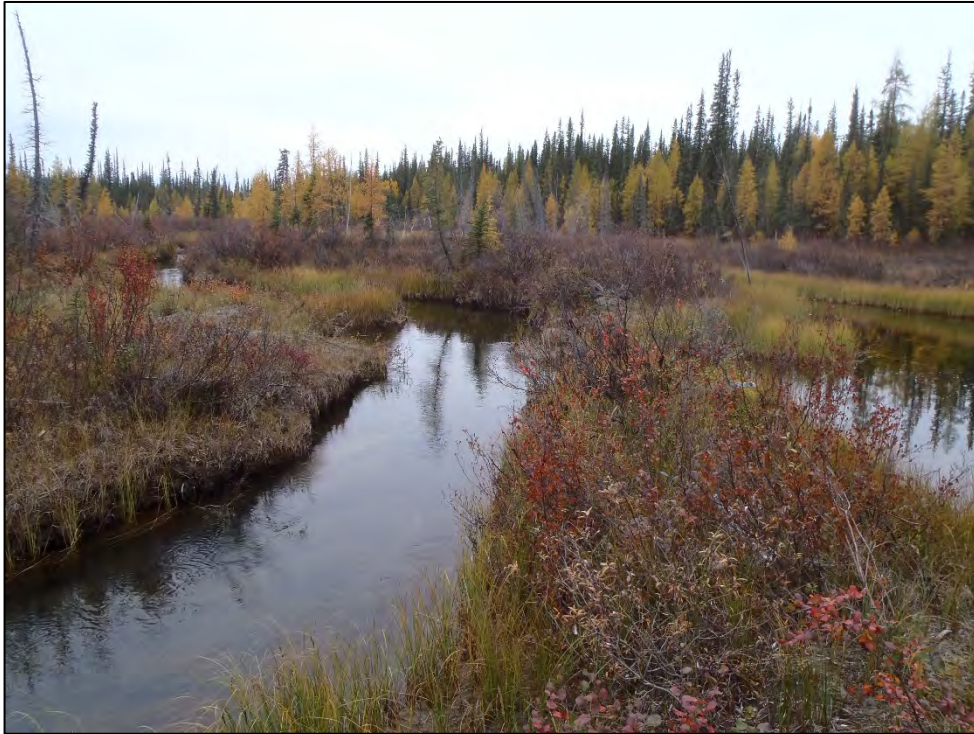
Three of the proposed crossings are on permanent watercourses, including crossing 8 (Duport River crossing), 9, and 10a. Based on habitat present at these locations, the watercourses have the potential to support at least one of the following large-bodied fish species: Arctic Grayling, Walleye, Northern Pike, Burbot, White Sucker, and Longnose Sucker. Crossing 10a is the only crossing where there will be a culvert installed and where there is the potential for effects to large-bodied fish habitat during construction; clear span bridges are proposed for crossing 8 and 9.

Photo 17: Duport River Crossing (8), From Centreline, Facing West (Upstream), Sept. 21, 2017

Photo 18: Duport River Crossing (8), From Centreline, Facing East (Downstream), Sept. 21, 2017

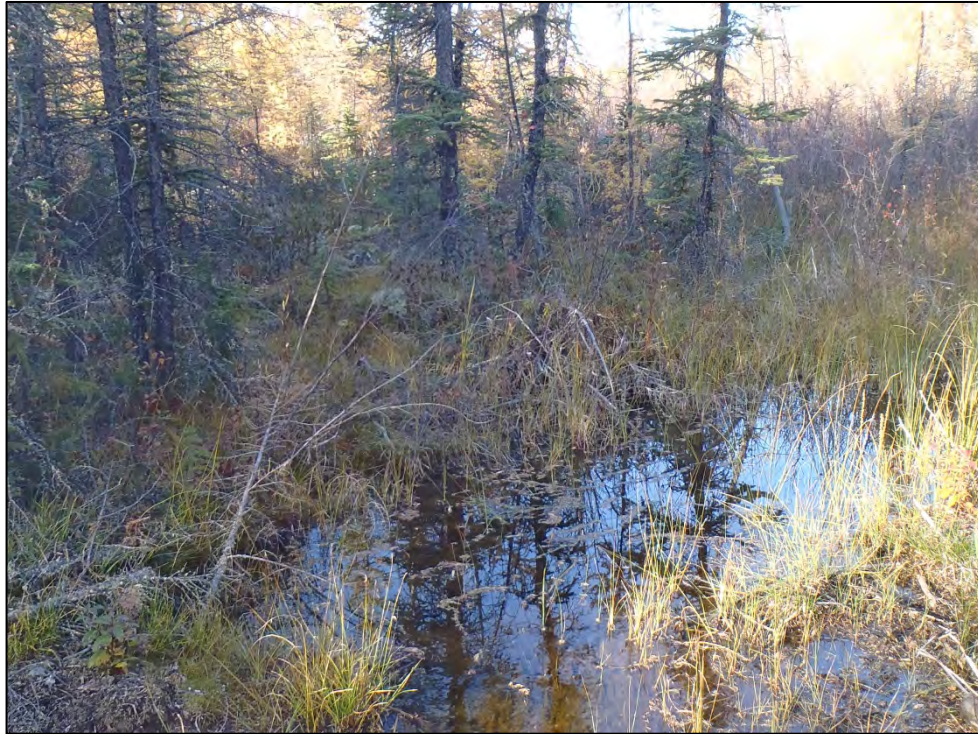
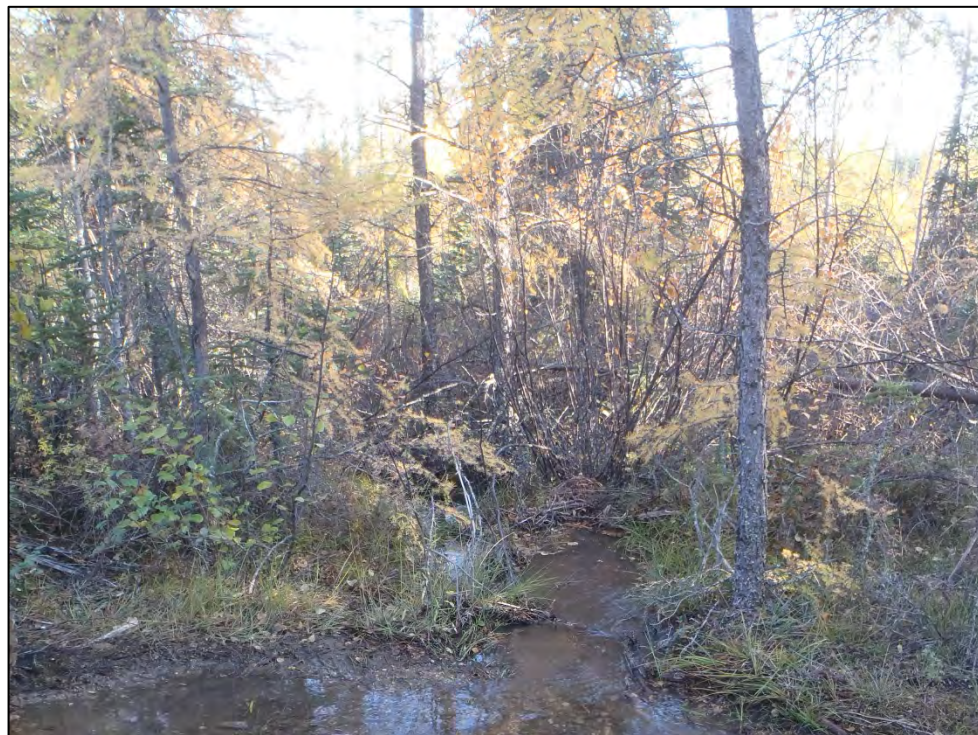
One new watercourse crossing was identified. The new crossing (8.1) is located approximately 0.84 road-km north of the Duport River crossing (Table 1; Figure 1). The watercourse at this crossing was classified as an ephemeral draw-intermittent class (see Photos 19 and 20) with moderate potential to support small-bodied fish and minimal potential to support large-bodied fish.

8.1 ²	Ephemeral Draw-Intermittent	Low-Moderate	<ul style="list-style-type: none"> ▪ approximately 0.5 to 1 m stream width ▪ gravel/fine substrate types ▪ shallow run and riffle habitat within ROW; ▪ cascade downstream of centreline may be barrier to fish 	<ul style="list-style-type: none"> ▪ discontinuous defined bed and bank ▪ winding, confined, and open channel ▪ treed/shrub riparian habitat ▪ seasonal low-flows may be a barrier to fish movements 	Minimal	Low-Moderate	None
9	Large Permanent	Low	<ul style="list-style-type: none"> ▪ crossing is 170 m SE (downstream) of existing trail ▪ 6 m bankfull/wetted width, with maximum depth of 0.75 m in ROW ▪ cobble/fines as dominant substrate types ▪ run, riffle, and pool habitat 	<ul style="list-style-type: none"> ▪ 1,125 µS/cm, 8.0 pH, 8.2°C ▪ winding, confined, and neutral channel ▪ forest dominated riparian cover (moderate to high bank stability) ▪ no barriers to passage within 100 m of centreline 	Moderate-high	High	Cyprinids

Photo 19: Potential Crossing 8.1, Facing West (Upstream), Sept. 20, 2017

Photo 20: Potential Crossing 8.1, Facing East (Downstream), Sept. 20, 2017

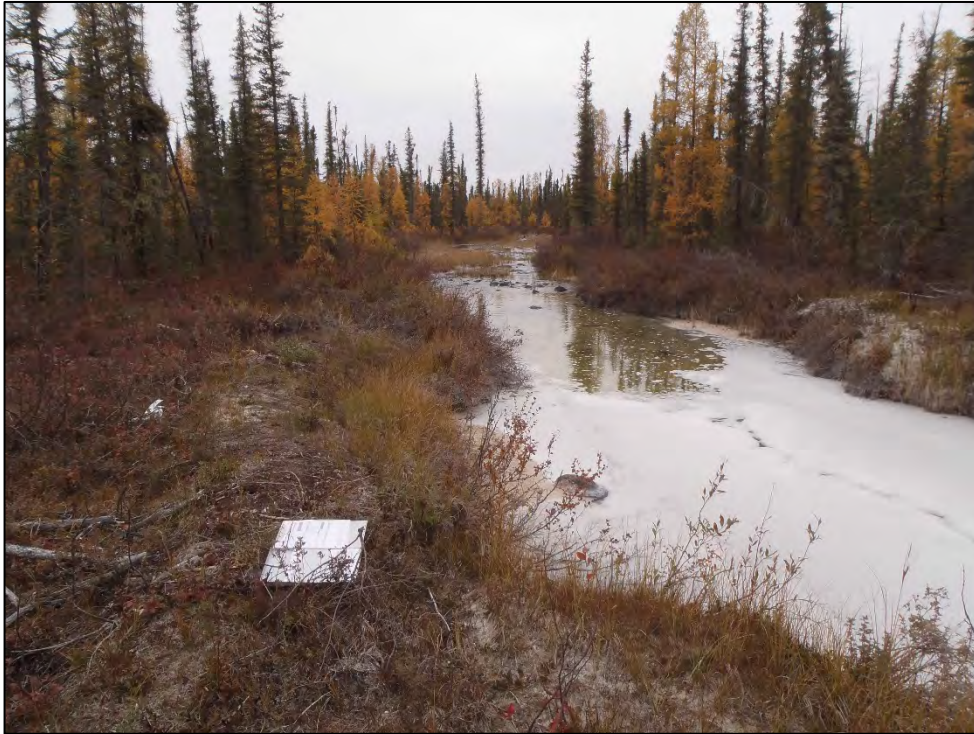
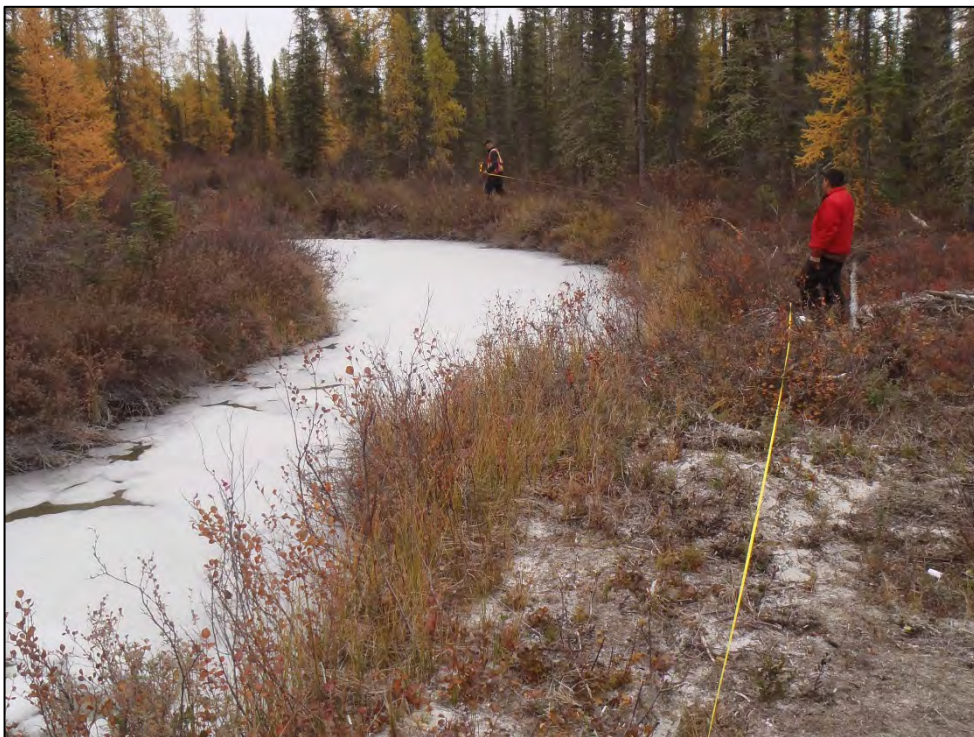
Photo 21: Crossing 9, From Centreline, Facing West (Upstream), Sept. 21, 2017

Photo 22: Crossing 9, From Centreline, Facing East (Downstream), Sept. 21, 2017

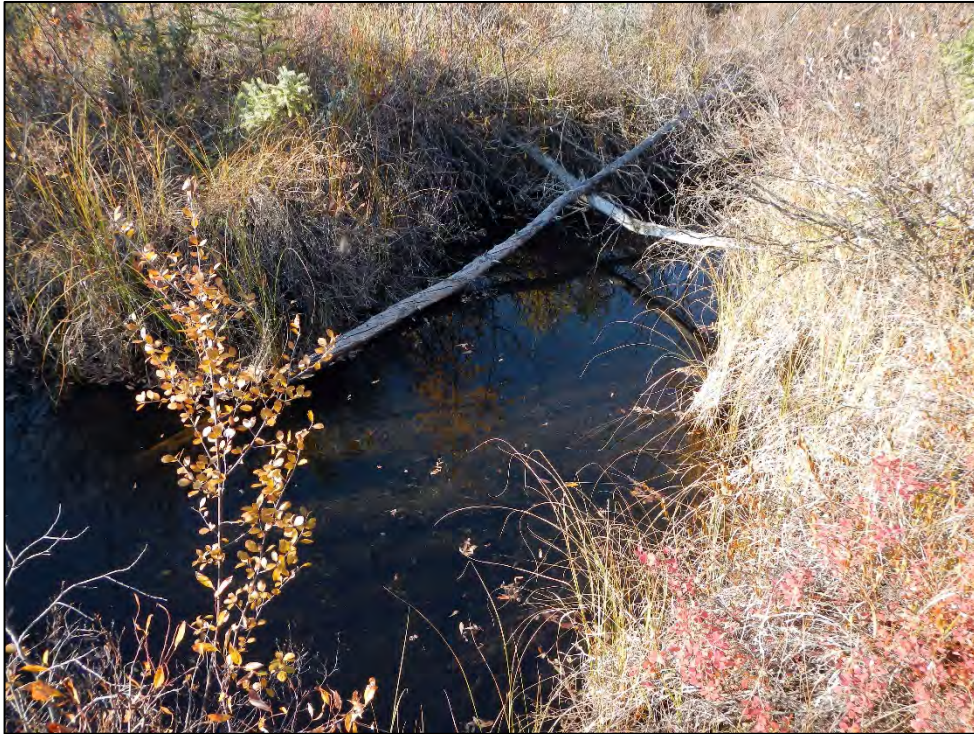
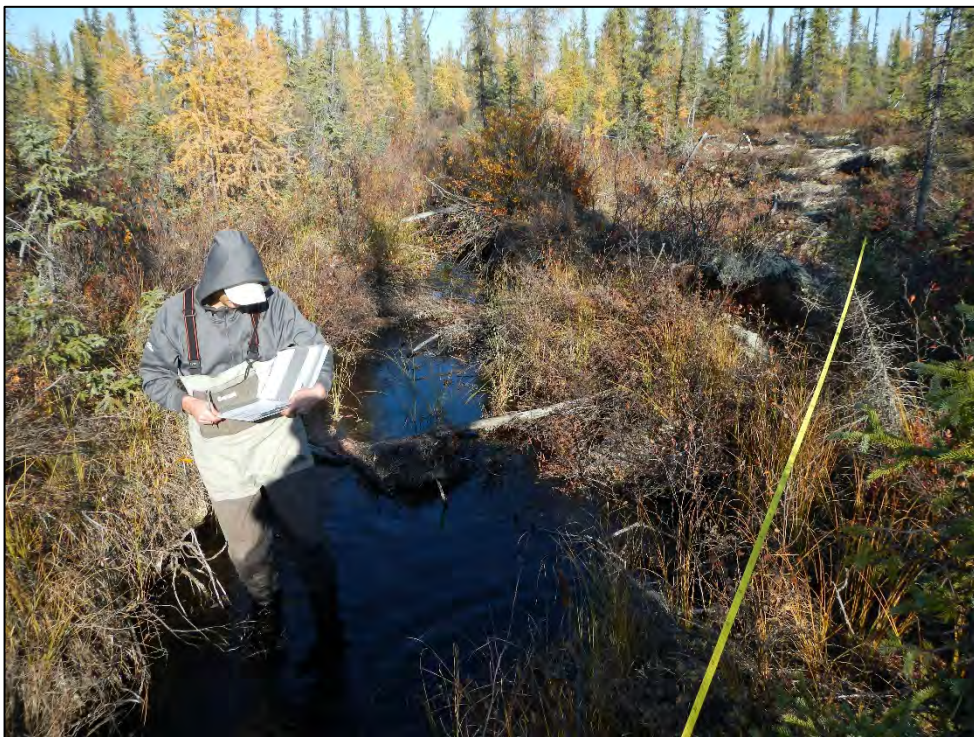
The watercourse at crossing 10a was described as an irregular meander, confined to the stream banks, and with an incised channel form (Photos 23 and 24). Within the ROW, the maximum depth was 0.4 m, the mean bankfull width was 1.8 m, and the bank height from the water surface was approximately 0.6 m. The bankfull width and the wetted width measurements were similar at the time of the survey. Stream banks were described as moderately to highly stable with scrubland vegetation dominating riparian areas. The stream habitat within the ROW was classified as a shallow run (or glide), with riffle and deeper run habitats occurring outside of the ROW. Substrate was a near equal combination of fines (e.g., organics, silt) and coarse substrates (mainly cobble). Stream cover (approximately 40%) was provided by wood debris, overhanging vegetation, and undercut banks. No fish were observed at the time of the survey; however visibility was limited by stream cover. *In-situ* water measurements included a high conductivity reading of 2,626 microsiemens per centimetre ($\mu\text{S}/\text{cm}$) that suggests an upstream groundwater influence.

Photo 23: Crossing 10a, Approximately 10 m Upstream from Centreline, Sept. 21, 2017

Photo 24: Crossing 10a, Approximately 10 m Downstream from Centreline (Facing Southwest), Sept. 21, 2017

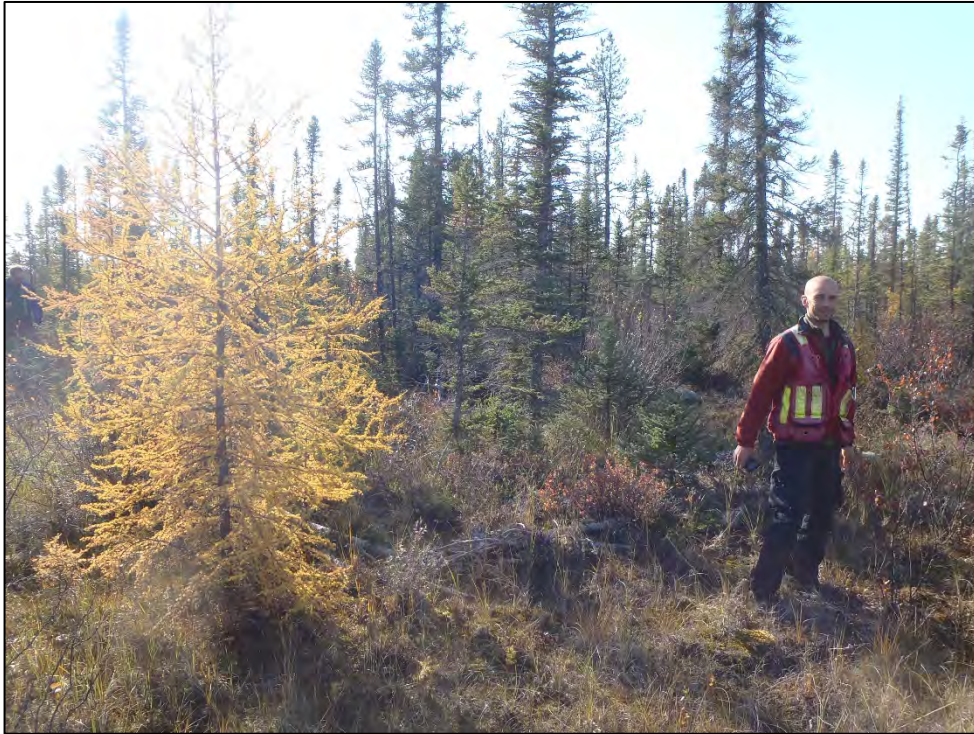
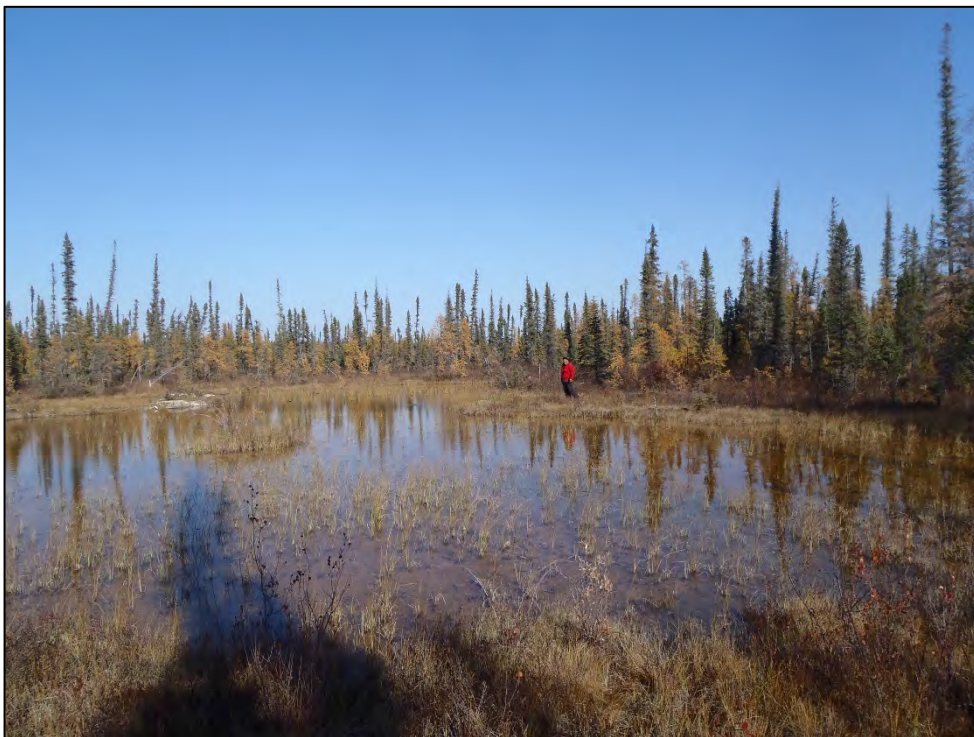
10	Ephemeral Draw	Low	<ul style="list-style-type: none"> ▪ 30 m west of existing trail ▪ shrubby fen to NW, treed fen to SE ▪ 55 m wide fen ▪ open water 20 m east centreline 	<ul style="list-style-type: none"> ▪ no defined bed or banks ▪ fen extends beyond ROW 	None	Low	None
10a	Small Permanent	Low-Moderate	<ul style="list-style-type: none"> ▪ crossing is 30 m SW (downstream) of existing trail ▪ 2 m wetted/bankfull width with maximum depth of 0.5 m in ROW ▪ cobble/fines as dominant substrate ▪ shallow run habitat 	<ul style="list-style-type: none"> ▪ 2,626 µS/cm, 8.0 pH, 8.3°C ▪ irregular meandering, incised, and confined stream ▪ shrub-dominated riparian cover (moderate to high bank stability) ▪ no barriers to passage in vicinity 	Moderate-high	High	None
11	Ephemeral Draw	Dry	<ul style="list-style-type: none"> ▪ near existing trail ▪ treed fen west and east of crossing ▪ 55 m wide fen 	<ul style="list-style-type: none"> ▪ no defined bed or banks ▪ fen extends beyond ROW to east ▪ small lake west of ROW 	None	Minimal	None

Photo 25: Crossing 10, From Centreline, Facing Southwest, Sept. 20, 2017

Photo 26: Crossing 10, From Centreline, Facing Northeast, Sept. 20, 2017

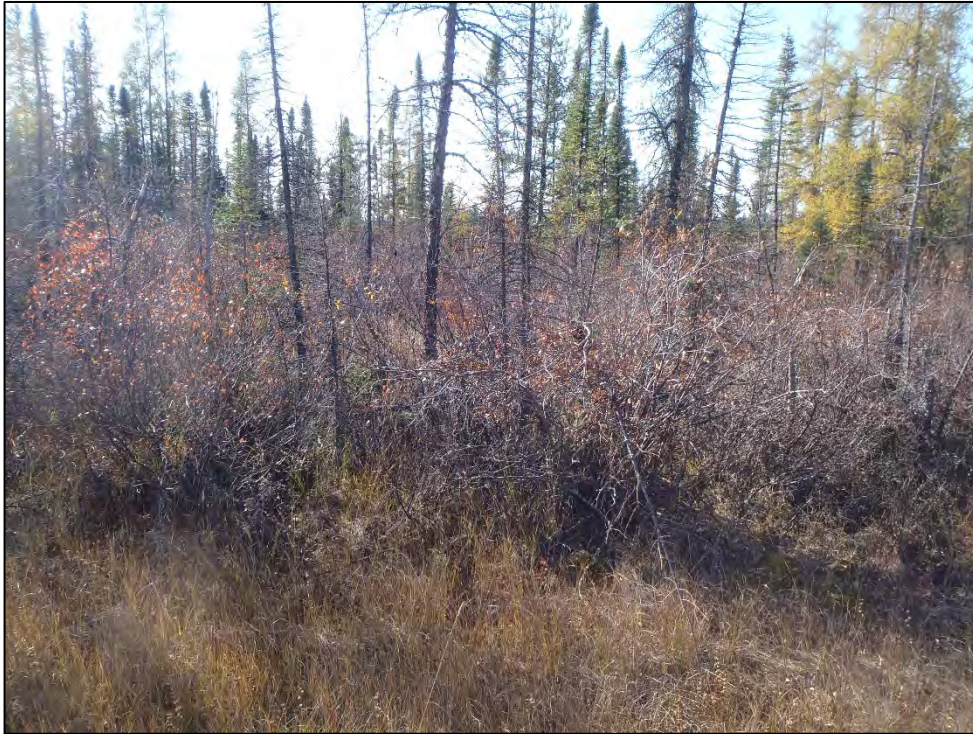
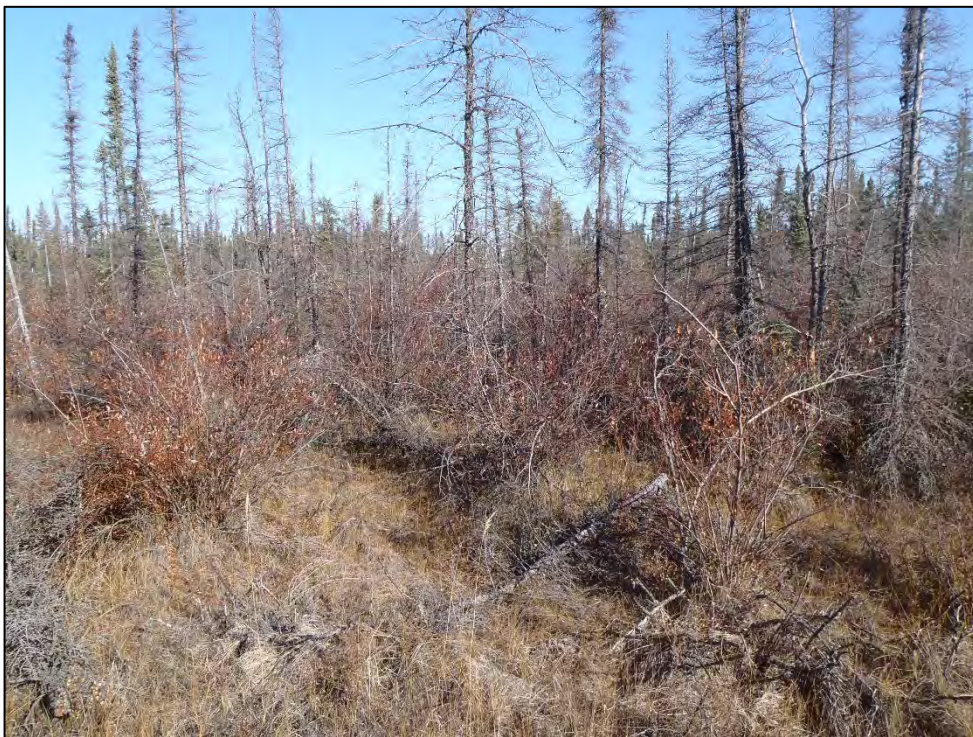
The culvert crossing results from the field survey are generally consistent with the ephemeral descriptions of the culvert crossings in the ASR. For two crossings (crossing 11 and 13), the field survey showed that the environmental assessment overestimated fish habitat quality. There is no discernible watercourse channel, and there is no potential to support Northern Pike and White Sucker at crossings 11 and 13. For one crossing (10a), the field survey noted that the actual watercourse hydroperiod may be longer due to groundwater influences, however, the determination of habitat potential or likelihood of supporting large-bodied fish in the field was similar to that made in the ASR (moderate-to-high versus moderate) such that the conclusions in the ASR do not change.

Photo 27: Crossing 11, From Centreline, Facing West (Upstream), Sept. 20, 2017

Photo 28: Crossing 11, From Centreline, Facing East (Downstream), Sept. 20, 2017
