MEMORANDUM

FROM Cam Stevens and Damian Panayi, Golder Associates Ltd.

PROJECT NO. 1665943

FISH HABITAT SURVEY FOR THE TŁJCHQ ALL-SEASON ROAD

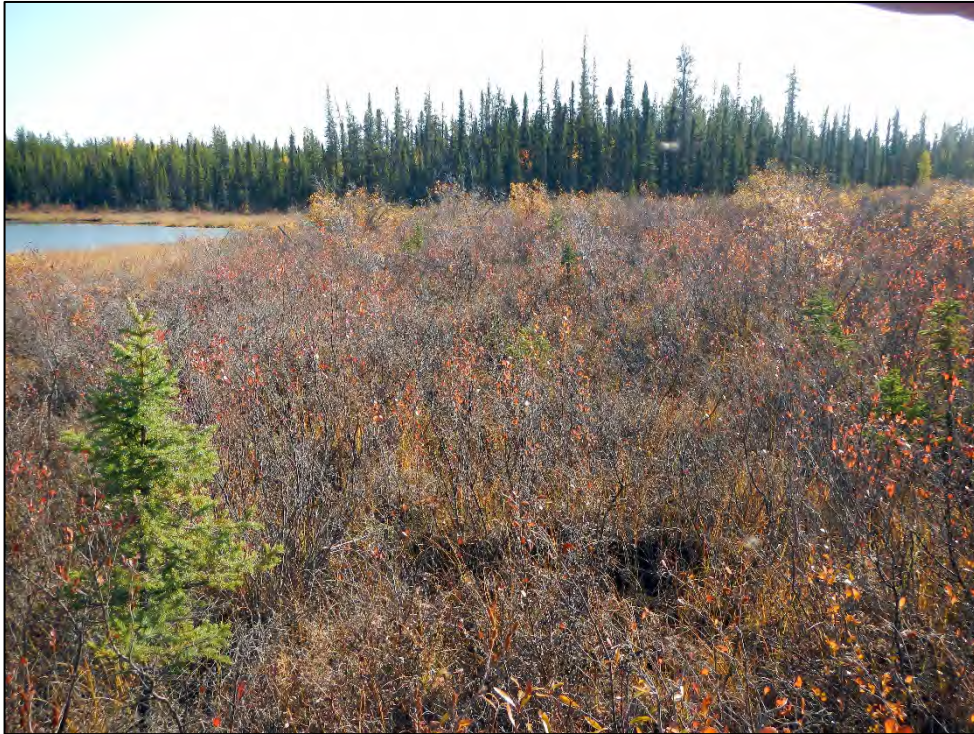
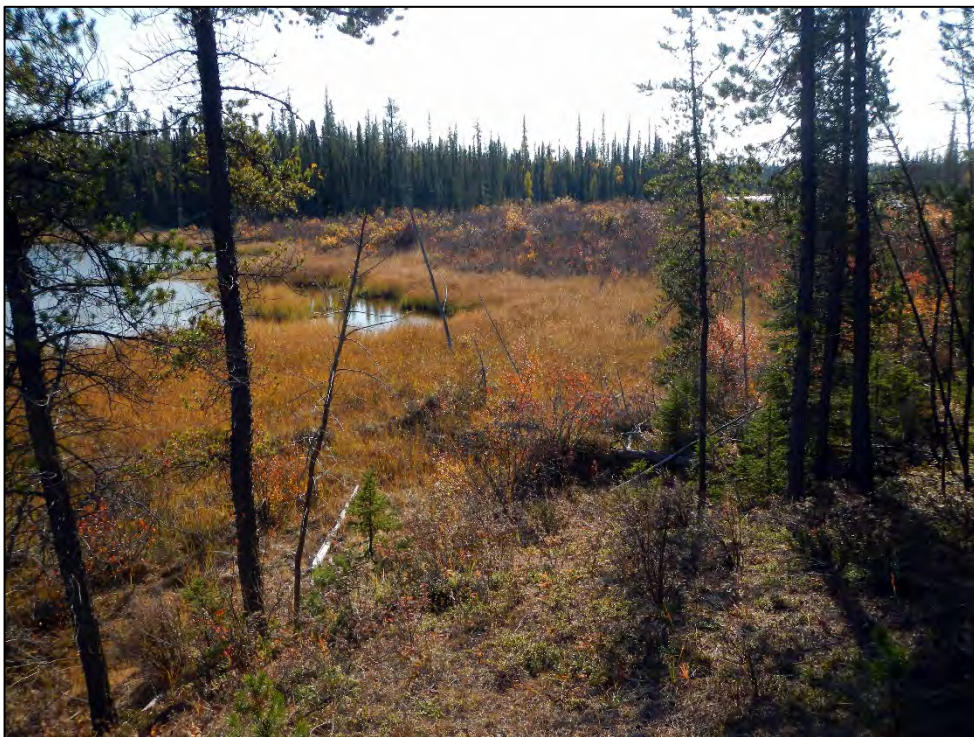
The survey confirmed that twelve of the crossings will be installed on ephemeral watercourses, all of which lack a defined bed and banks (Table 1). Nine crossings were characterized by dry habitats where flows would only be present for a short period during the spring freshet (i.e., Crossing 1.1 to 7, and 11). All crossings proposed at ephemeral watercourses are unlikely to affect fish habitat with the possible exception of crossing 12 where the road will cross a riparian wetland connecting two ponds. There is the potential for the road to affect fish habitat as the ROW may extend into riparian areas that may be inundated during high flows (e.g., during spring freshet) (see Photos 29 and 30).

12	Ephemeral Draw	Low	<ul style="list-style-type: none"> ▪ 160 m west of existing trail ▪ shrub riparian wetland between two ponds ▪ 60-m wide riparian wetland 	<ul style="list-style-type: none"> ▪ no defined bed or banks ▪ Cyprinids observed in ponds NE and SW of ROW 	Minimal	Moderate	None
13	Ephemeral Draw	Low	<ul style="list-style-type: none"> ▪ near existing trail ▪ treed fen west and east of crossing; 190 m wide fen 	<ul style="list-style-type: none"> ▪ no defined bed or banks ▪ fen extends beyond ROW 	None	Minimal	None

Photo 29: Crossing 12, Approximately 20 m Northwest of Centreline, Facing Southeast, Sept. 20, 2017

Photo 30: Immediately North of Crossing 12, Facing South and Crossing Location, Sept. 20, 2017

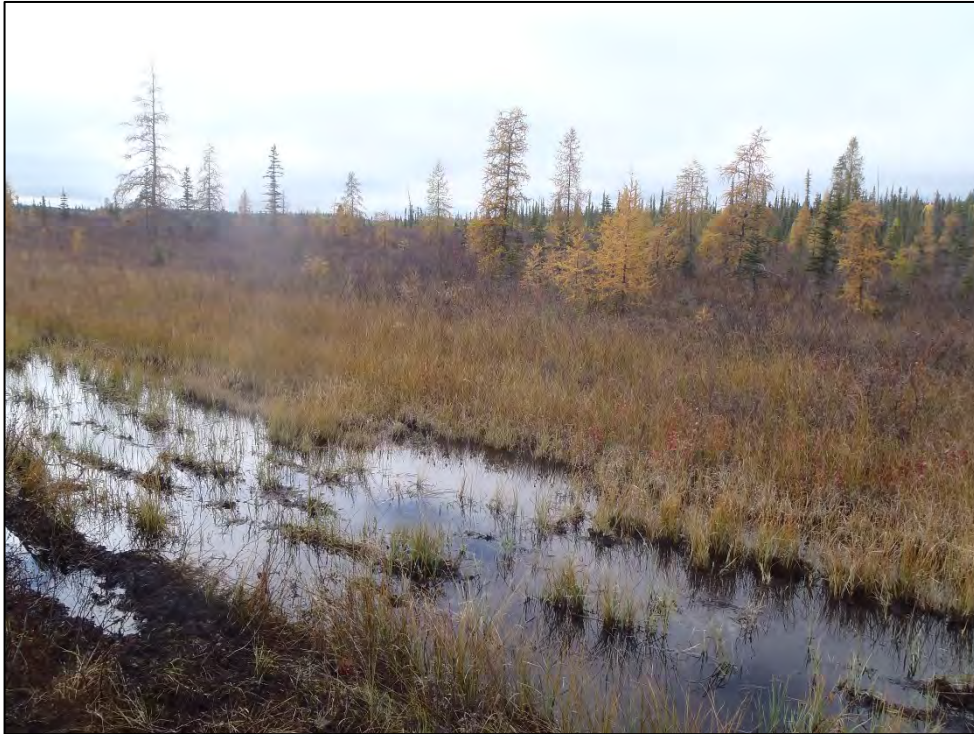
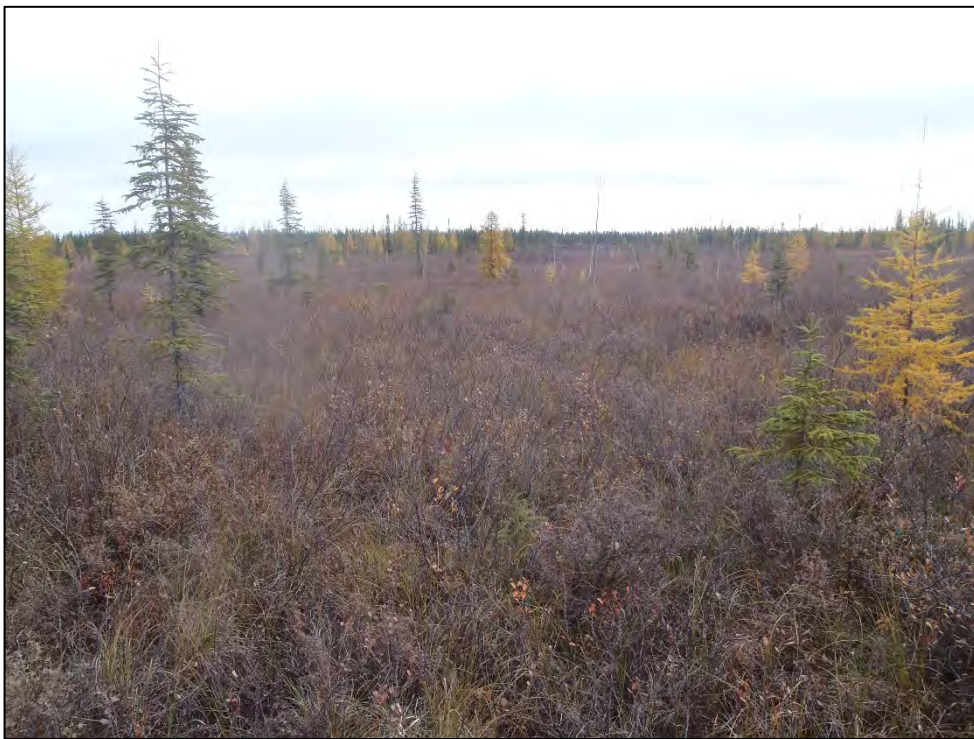
Photo 31: Crossing 13, From Centreline, Facing West, Sept. 20, 2017

Photo 32: Crossing 13, From Centreline, Facing East, Sept. 20, 2017
