RE: ENVIRONMENTAL ASSESSMENT METALLURGICAL PILOT PLANT
AND UNDERGROUND DECLINE DEVELOPMENT AND EXPLORATION
DRILLING (MVEIRB FILE 01-002)

**Re: Prairie Creek Mine Tailings Impoundment Facility, NT
GNWT-RWED and DIAND Information Requests**

**Re: Prairie Creek Mine Tailings Facility
Summary of Past Work and Preliminary Recommendations for Rehabilitation**

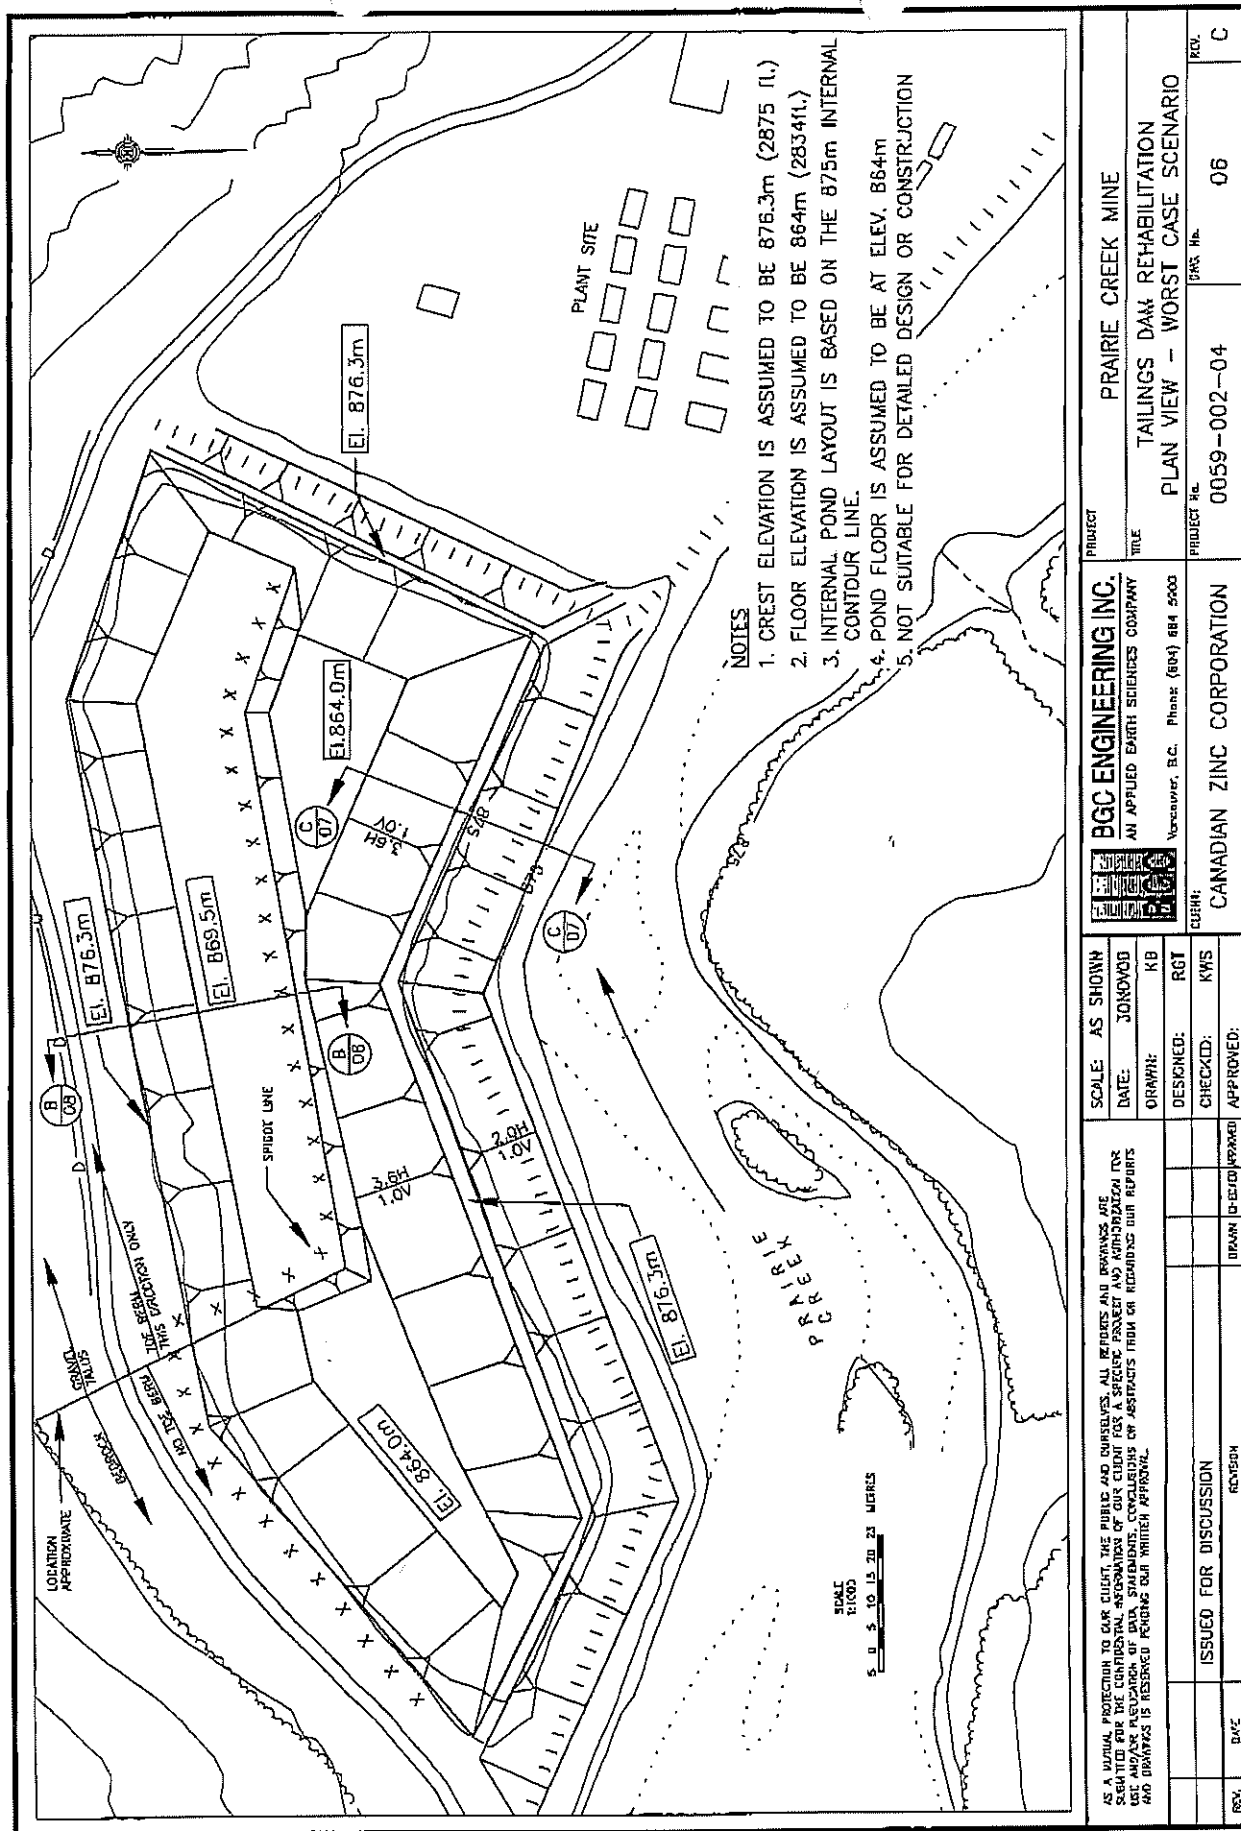
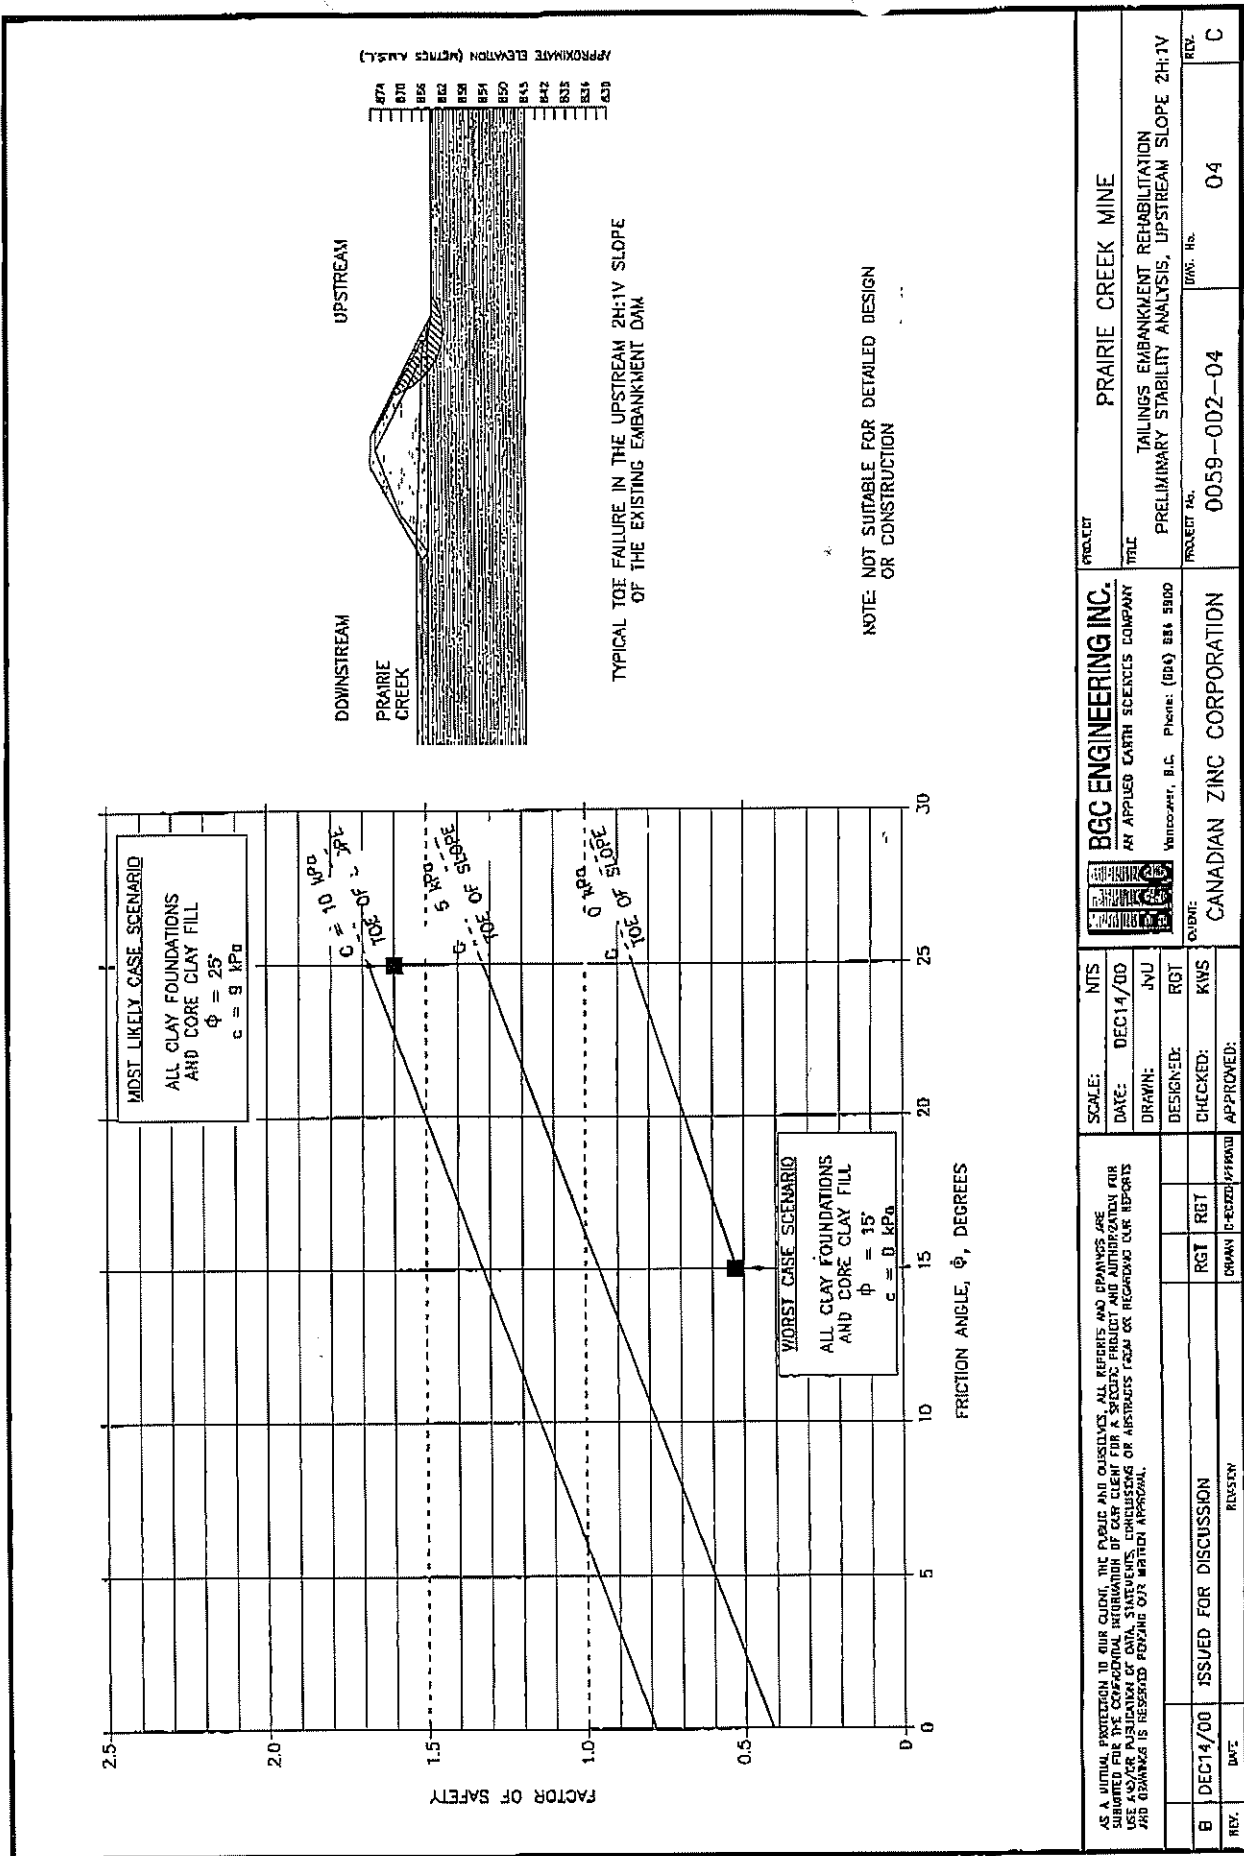
As stated in Section 2.6, we believe permafrost and ground ice were important factors contributing to engineered backslope instability. The 1994-95 geothermal analyses suggested extensive degradation of permafrost and ground ice had already occurred. Geothermal analyses completed in 1995 indicated that the rate of thaw penetration at depth had attenuated to levels that are unlikely to produce excess pore pressures. This means that some of the factors contributing to backslope instability (viz. ground ice, rapid rate of thaw and attendant excess pore pressures) may no longer be significant design impediments.

The backslope will require re-design, but we believe a more routine, "thawed soil mechanics" approach is appropriate. Of particular importance in the re-design is that available strengths on the deep-seated failure surface are limited to residual rather than peak values.
