ISSUED FOR USE
2009 GEOTECHNICAL INSPECTION OF AIRSTRIP, APRON AND ACCESS ROAD
YELLOWKNIFE GOLD PROJECT, NT

Y14101177

October 1, 2009

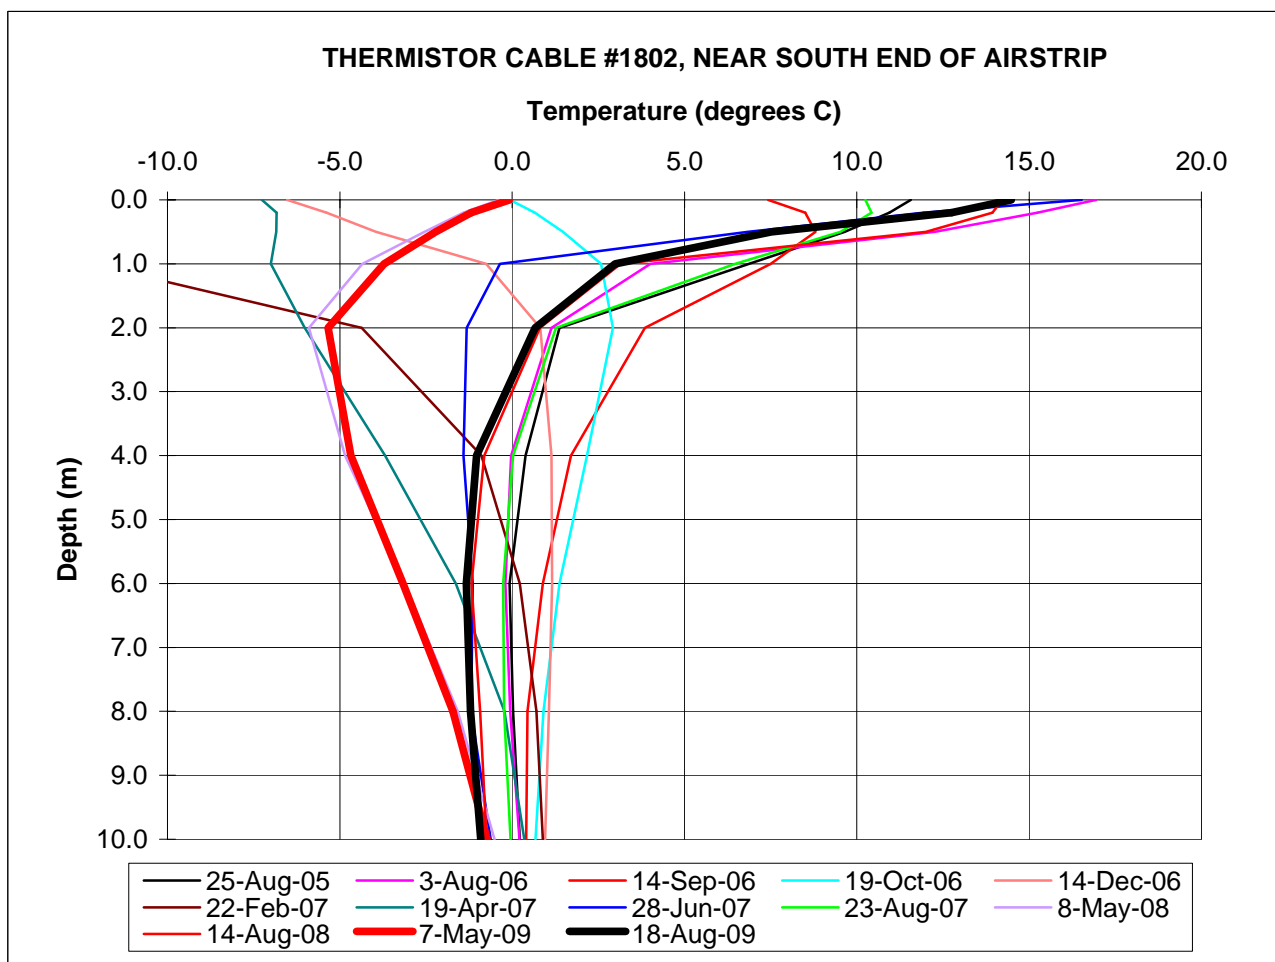
TABLE 6
TEMPERATURE MONITORING SUMMARY
THERMISTOR CABLE NEAR SOUTH END OF AIRSTRIP
BOREHOLE 21; CABLE 1802
TYHEE, YELLOWKNIFE GOLD PROJECT

At the time of the August 2009 monitoring visit, the ground was frozen below a depth of about 4 m at the north end of the airstrip (Borehole 19; Table 4) and below a depth of about 3 m at the south end of the airstrip (Borehole 21; Table 6). This should not be interpreted to mean that there is permafrost at these locations. The ground at depth will continue to warm into the fall, so ground temperatures will likely rise above 0 °C.

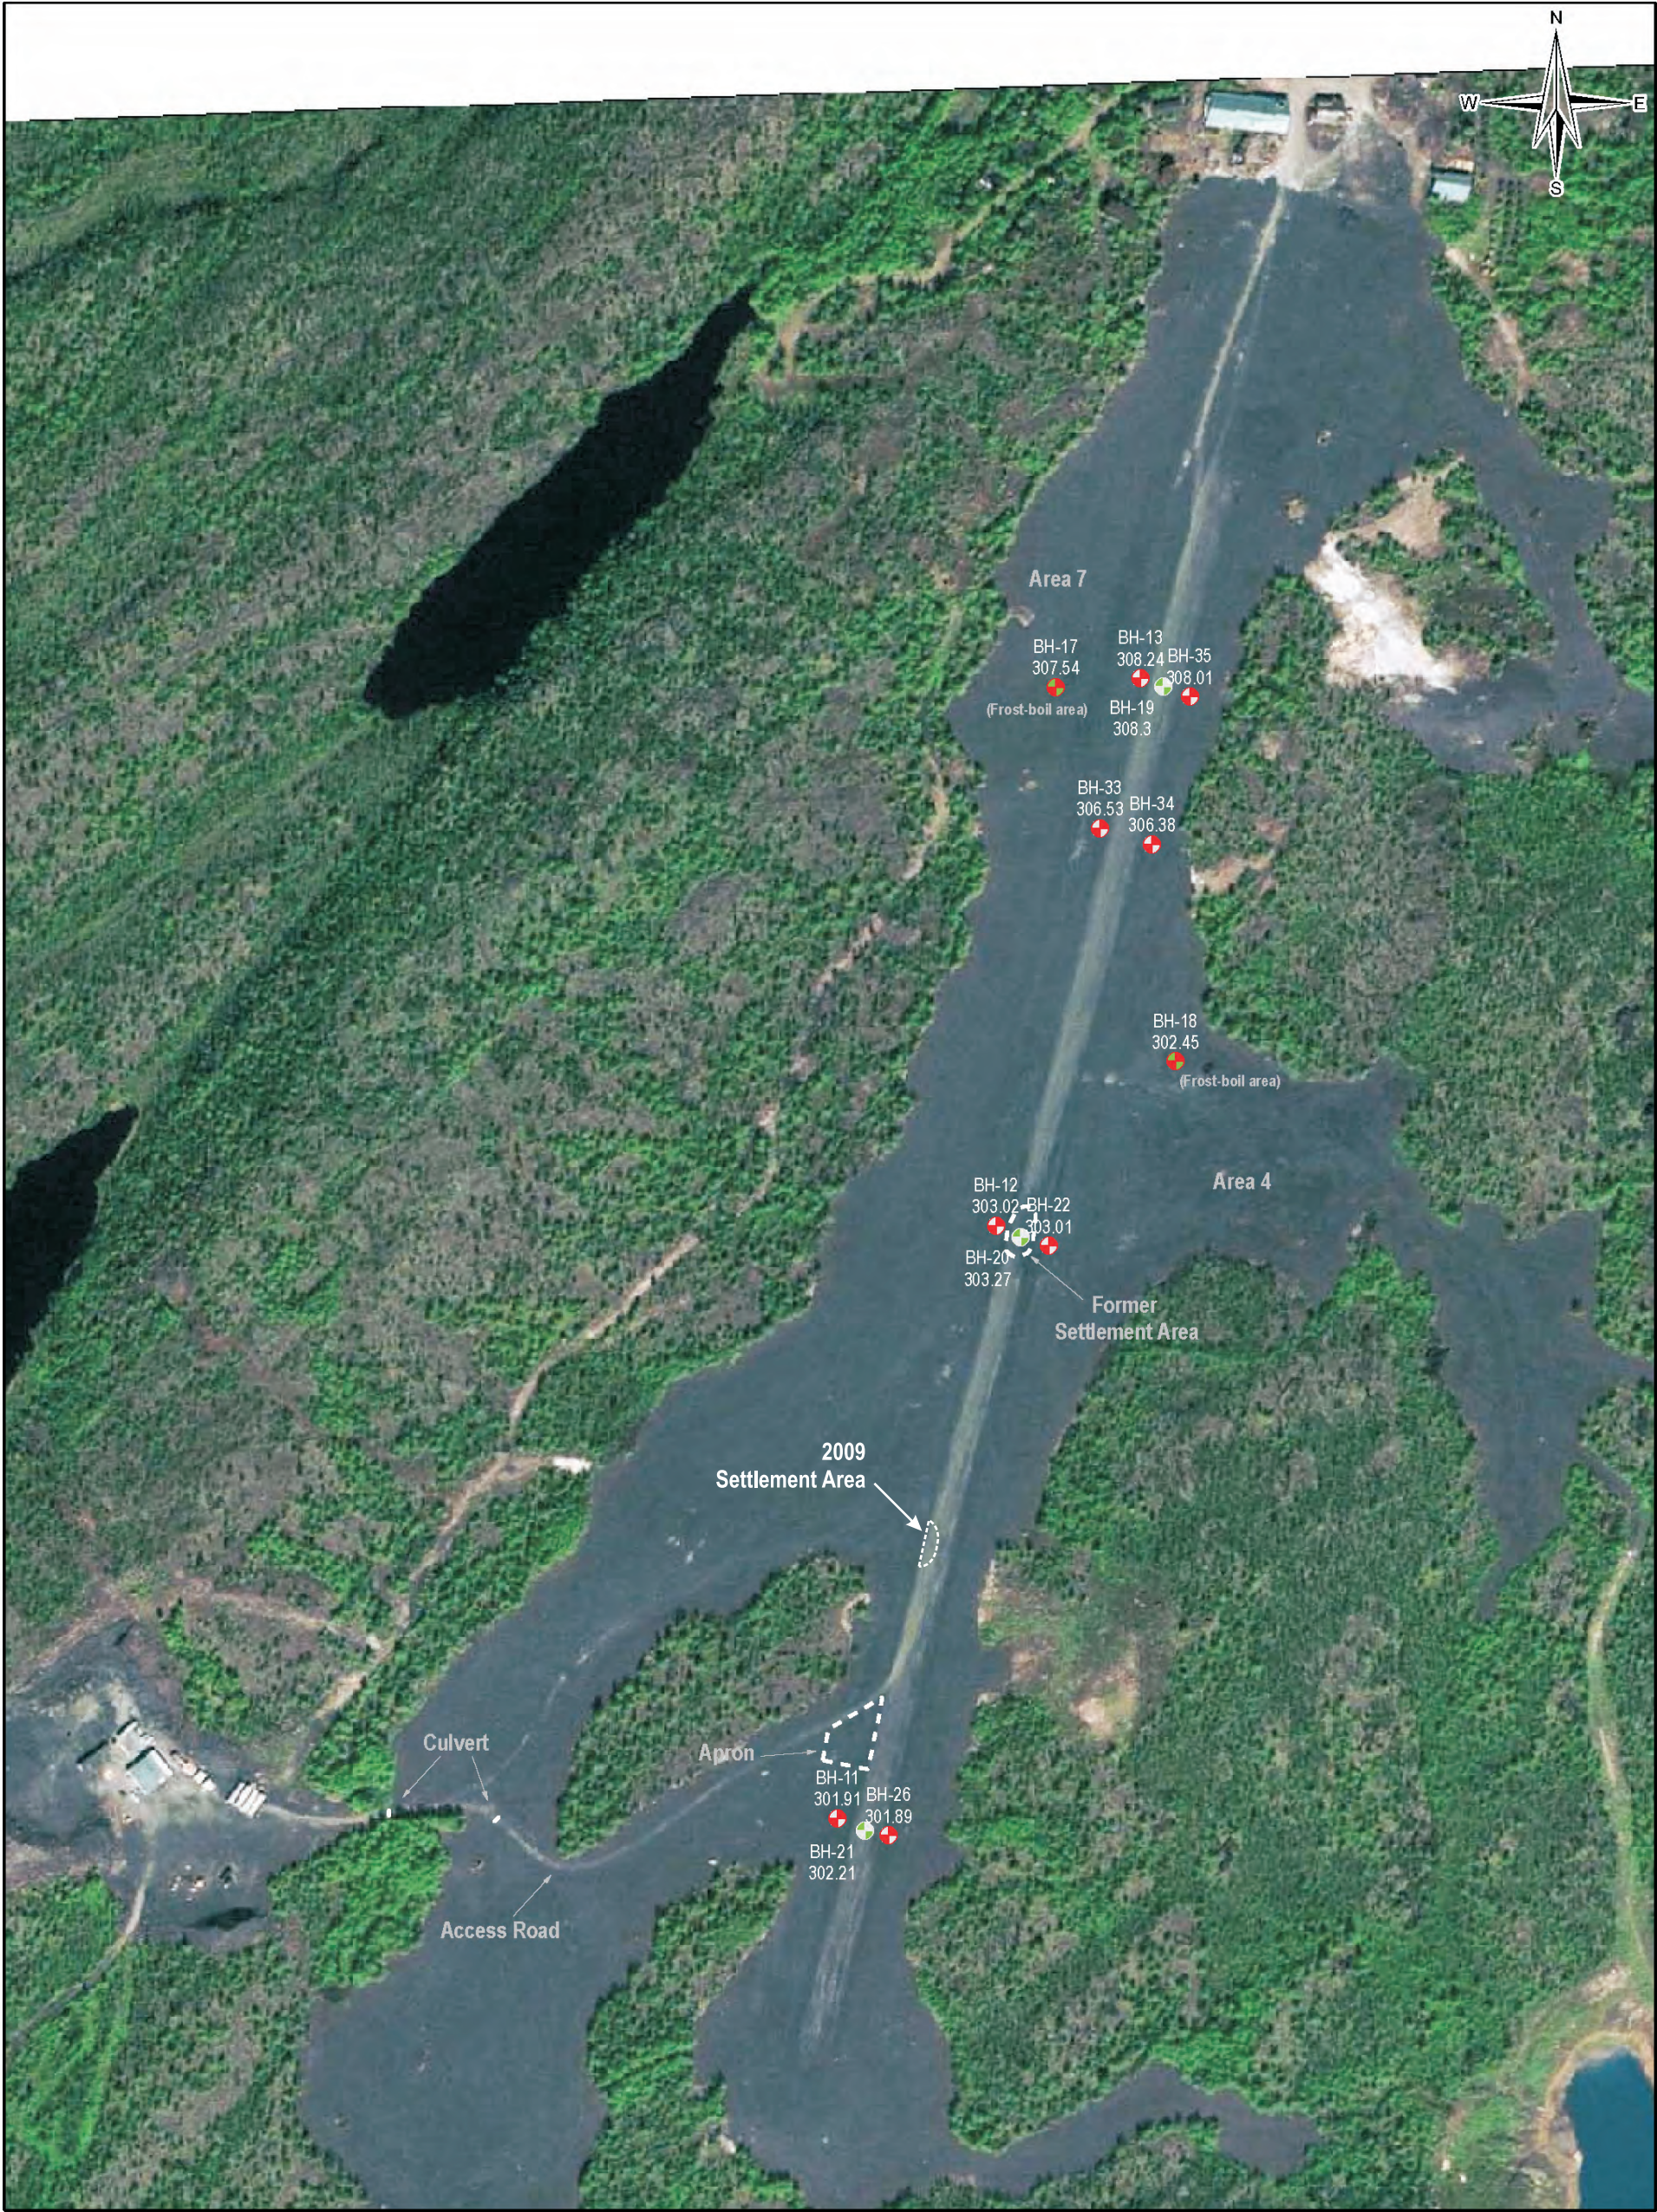
Figure 1 shows the locations of the thermistor cables. Ground temperatures measured to-date are presented on Tables 2 to 6. While the plots appear “busy”, the intent is to show the range of observed ground temperatures over the monitoring period. To assist with interpreting the information, the readings from this past year (2009) have been plotted with a heavier line weight than prior readings, with May’s data being plotted in red and August’s data being plotted in black.
