**Date:** September 4, 2014  
**From:** John Wilcockson  
**To:** Dave Harpley, Canadian Zinc Corp  
**Subject:** All Season Road – Review of Stream Crossings in NNPR - DRAFT

HCP Ref No.: CZN6788

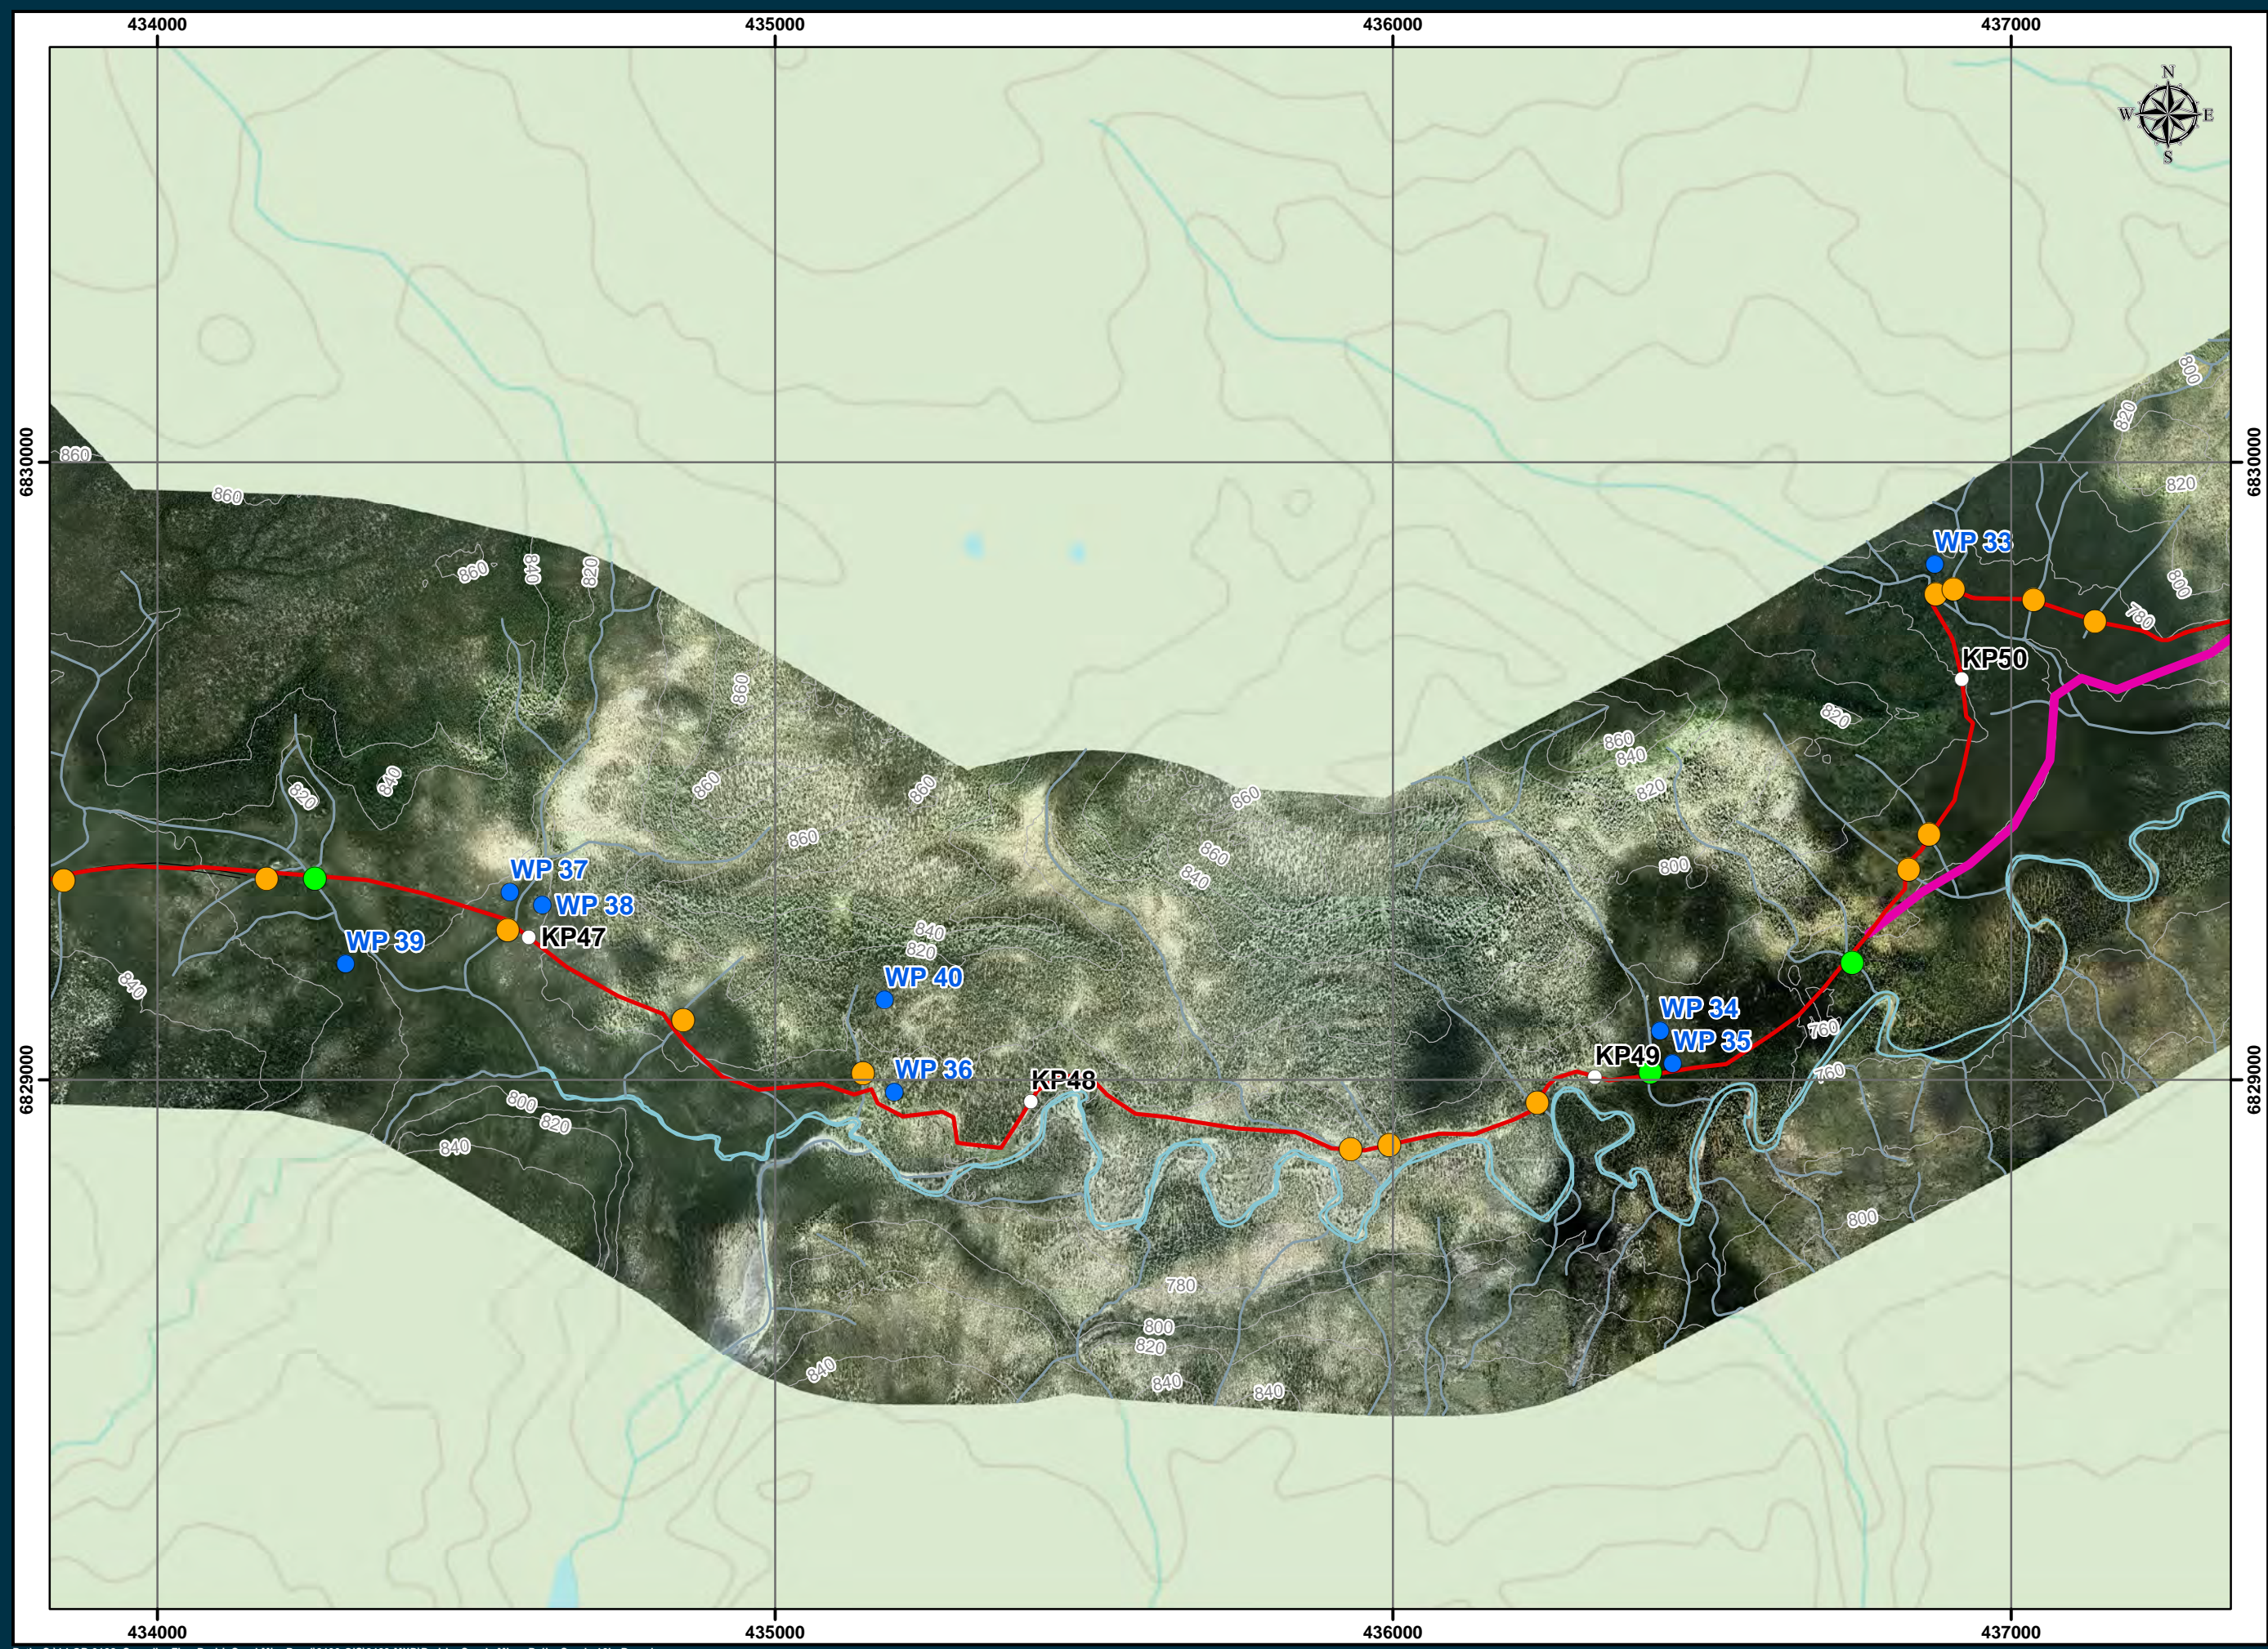
Map of Polje Creek Tributaries, Prairie Creek Mine

A ground-based assessment was conducted on the Polje Creek Crossing and two smaller creek crossings to the west. Both of the smaller creeks were identified as tributaries to Polje Creek. The first tributary west of Polje Creek was small, having an average wetted width of 1.5 m; however, water quality appeared to be good, and there was abundant surface cover for fish (Figure 10). The second tributary, further to the west, did not have a defined channel and flow, if present, would occur subsurface under a blanket of moss, small plants and buried, decaying logs (Figure 11). The second tributary would not provide suitable habitat for fish. Full habitat assessments were conducted on Polje Creek (Figure 12) and the first tributary to the west. Both contain good habitat for fish, including a “diversity of cover and habitat types including deep water pools, undercut banks, in-stream structure from overhanging vegetation and woody debris” (Dillon, 2009). Electrofishing was not conducted in Polje Creek as part of this reconnaissance investigation. During a previous survey, researchers were unable to capture fish and no fish were observed (Dillon, 2009<sup>2</sup>). Despite this, the investigators indicated that the creek is likely to support fish similar to those species found in Sundog Creek, and fish were found upstream previously.
