From: Lorraine Seale [sealel@inac-ainc.gc.ca]
Sent: April 5, 2007 4:59 PM
To: Alan Ehrlich; Patrick Duxbury
Cc: Ginger Arnold; David Livingstone; Lionel Marcinkoski
Subject: RTL Ice Road Break-through Report

From: [Mike Beauregard](#)
To: [Brent Edmunds](#)
Cc: [Robert Paterson](#) ; [Larry Fairbairn](#) ; [Peter Lennie-Misgeld](#) ; [Kenneth Dahl](#) ; [Louie Azzolini](#)
Sent: Tuesday, March 21, 2006 11:46 PM
Subject: Ice Road Accident Report - RTL - Snowfield Mud Lake Kimberlite Sampling Program

**RTL Robinson Enterprises Ltd.
Evaluation of Recovery Options
Drybones Break-Thru
Prepared by S. Langlois
June 27, 2006**

**RTL Robinson Enterprises Ltd.
Drybones Break-thru Clean-up Report
Prepared by S. Langlois, shane_langlois@rtl.ca
RTL Incident # RY-06-81**

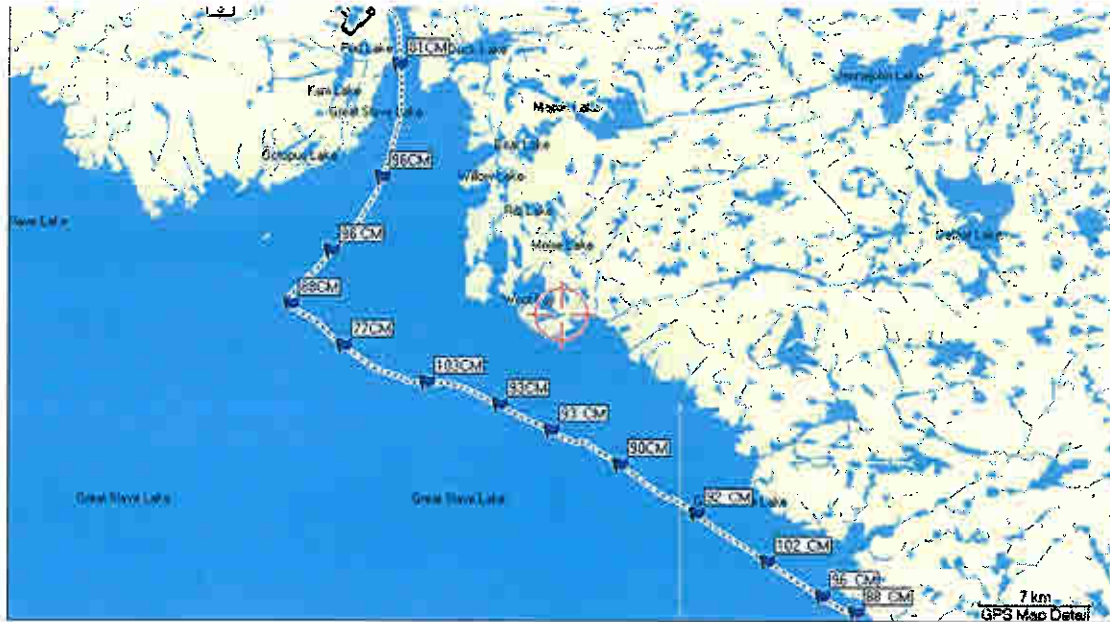
Drill Log performed March 7, 2006:

- Wayne and Shane Langlois inspected the site, drilled 7 holes randomly around the perimeter of the break-thru to establish ice thickness and to check for fuel
- Measurements of the ice recorded between 94 cm and 107 cm
- No fuel was found in the test holes, some fuel was visible in the opening
