**RE: FLOOD EROSION PROTECTION – PRAIRIE CREEK MINE, NT**

**Condition Inspection Report Summary  
Bulk Fuel Storage Facilities  
Canadian Zinc Corporation Mine  
Prairie Creek, NT**

**BULK FUEL STORAGE FACILITIES  
CONDITION INSPECTION REPORT**

Bulk Fuel Storage Facility  
Condition Inspection  
July 21-22, 2005

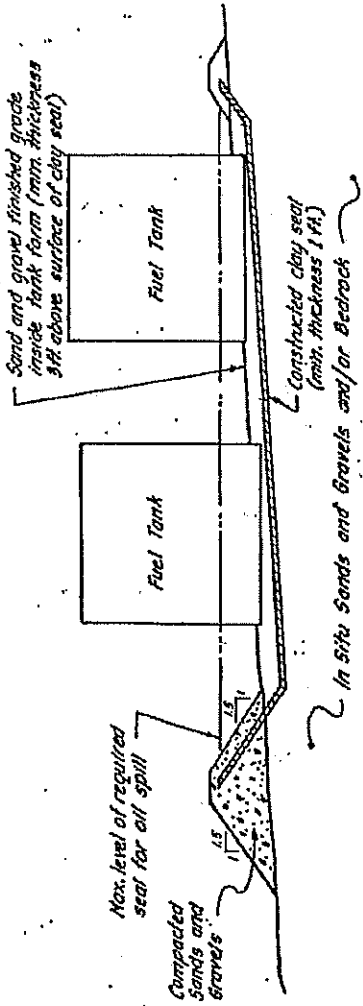
Fig. 10a) SCHEMATIC SECTION OF TANK FARM AND CLAY SEAL SPILL PROTECTION WHERE FOUNDATION SOILS CONSIST OF PERVIOUS MEDIA

Note: Clay seal also required beneath fuel tanks.

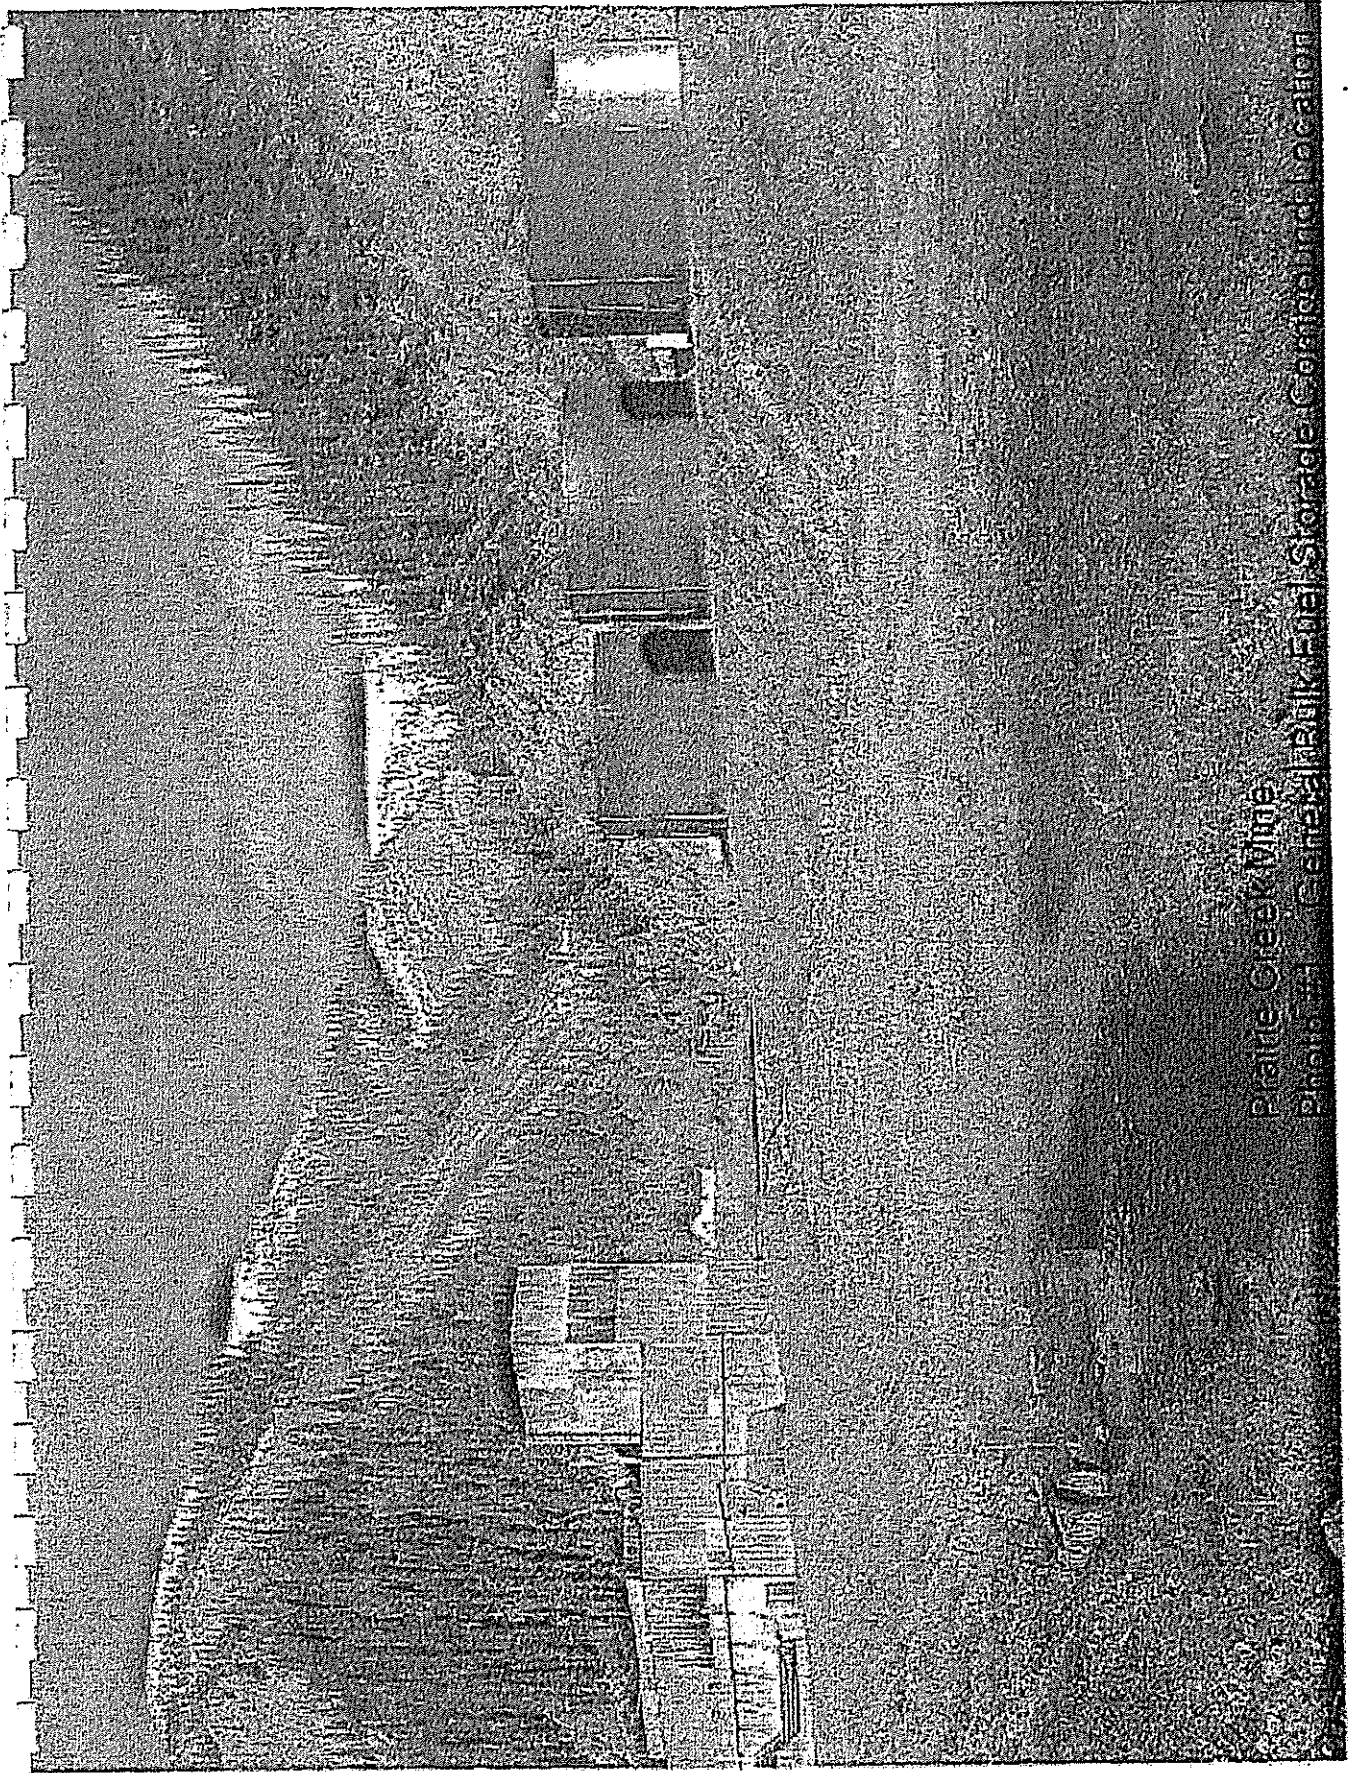
Pratt Creek Mine  
Photo #1 - General Pit - Fuel Storage Corridor Location

1. A Diesel Fuel Storage Compound, as shown in Photos #1, #2 and #4 containing the following diesel fuel storage tanks:

- Photo #1| General Bulk Fuel Storage Compound Location
- Photo #2 Diesel Fuel Compound  
Showing Impermeability of Clay Liner
- Photo #3 View of Pump House and Dispensing Area
- Photo #4 North Side of Diesel fuel Compound  
Showing Diesel Fuel Tanks
- Photo #5| Diesel Fuel Piping in the Pump House
- Photo #6| Gasoline Piping in the Pump House
- Photo #7| Loading Rack Area

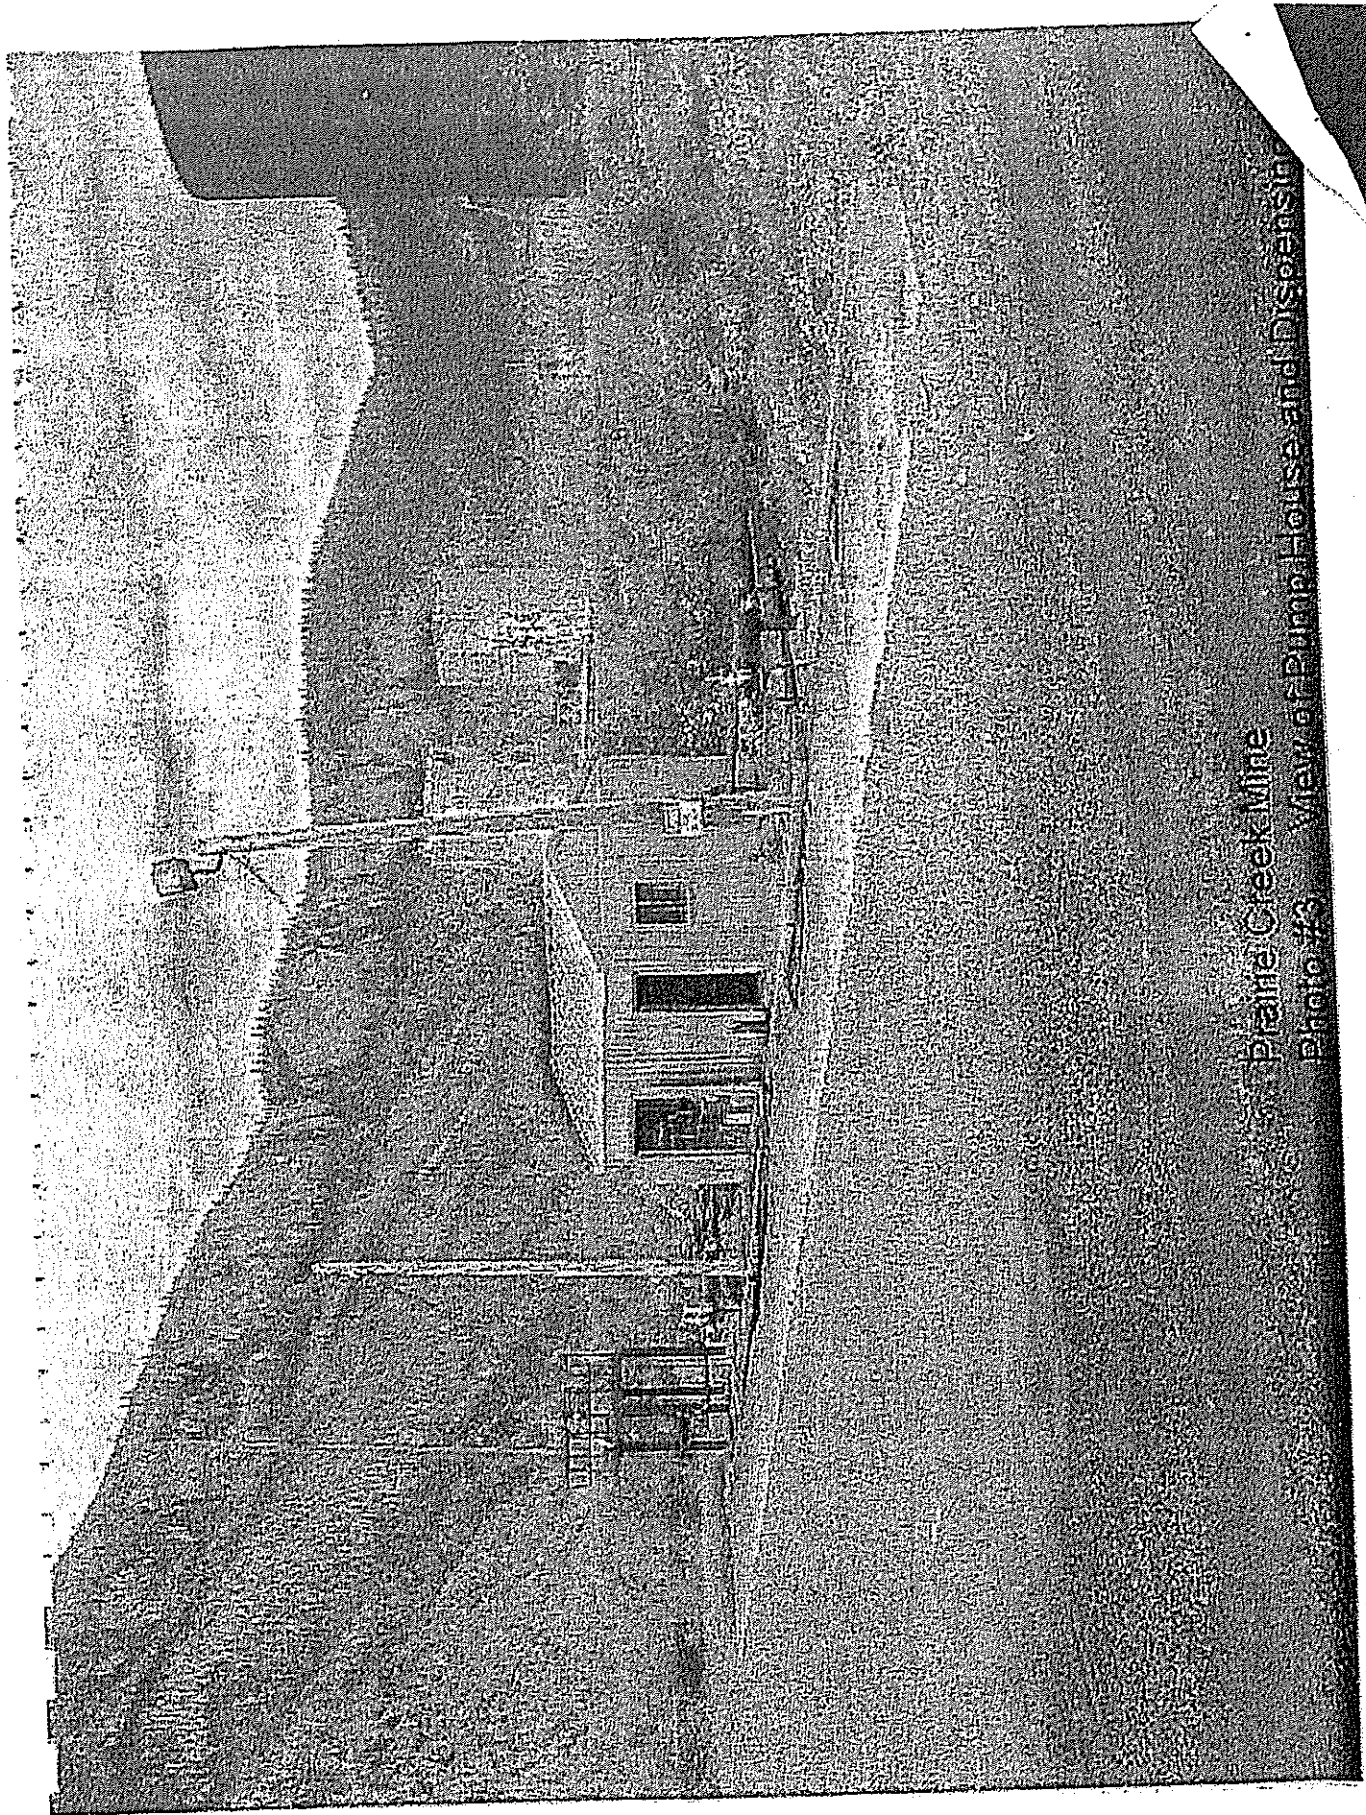
Prairie Creek Mine  
Photo #3 View of Pump House and Dispensing

- 2.3.6 The tanker truck resupply and fuel dispensing area, in front of the Pump House and Loading Platform, shown in Photo #3, is provided with a concrete vehicle loading apron, approximately 4 m wide x 36.7 m long. The apron includes a pad around the Loading Platform, see Photo #7, and drain channels to a sump located on each end of the Pump House to contain any spillage that may occur on the fuelling apron. Spill preventers are provided at each resupply manifold to further minimize and fuel spillage during fuelling operations. The apron and spill containment systems are in excellent condition.

- 2.3.7 The Pumhouse, shown in Photo #3, is an insulated metal clad steel frame building approximately 4 500 mm (15') x 6 700 mm (22') x 2 400 mm (8') high with a peaked roof and a concrete floor. The building is provided with explosion proof wiring, lights and fire alarm system. Fire extinguishers (20 lb. dry chemical) are provided in the Pump House and at the resupply manifold locations.

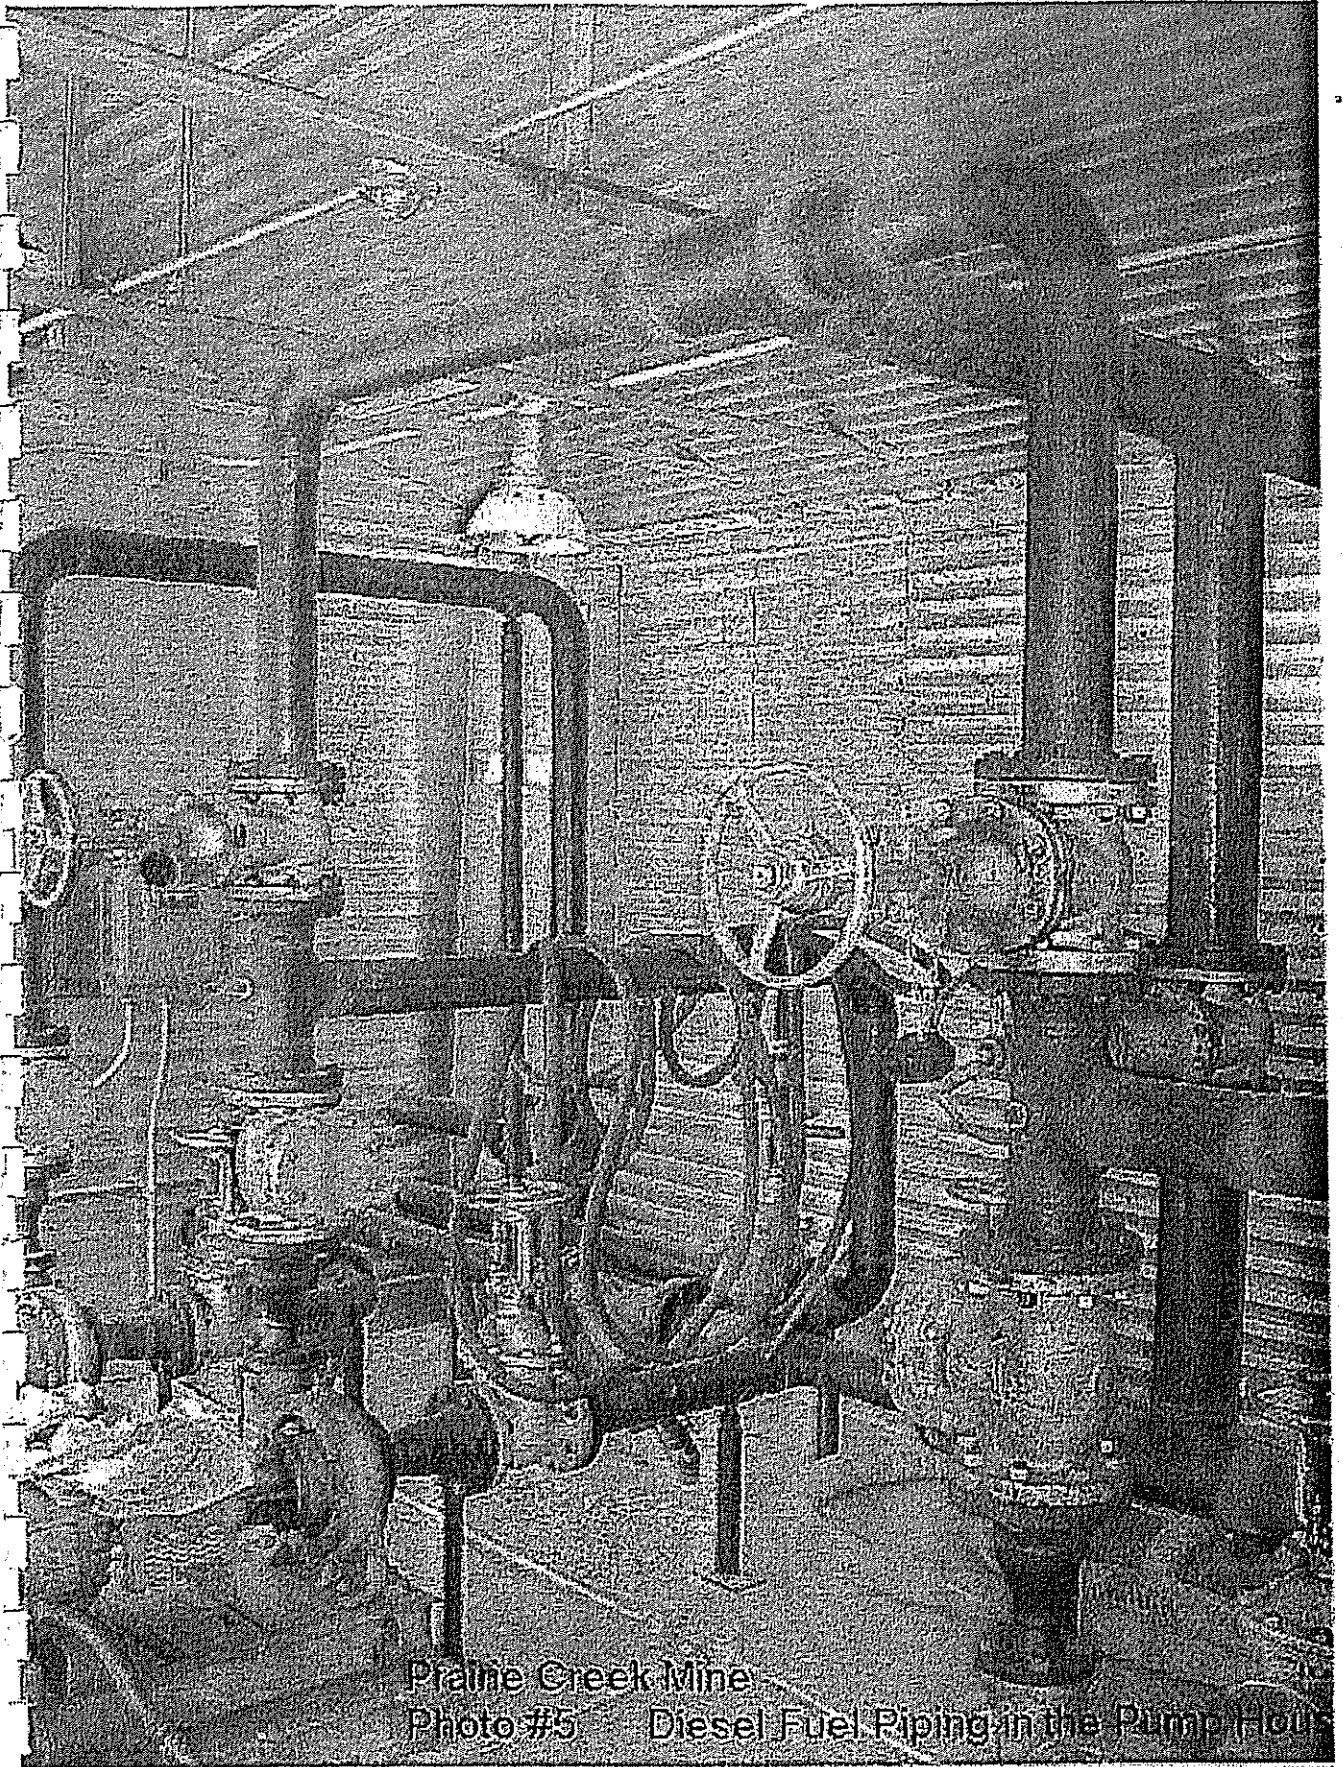
Prairie Creek Mine  
Photo #5 Diesel Fuel Piping in the Pump House

The pumps are mounted on concrete pads and include two 3" x 2" pumps for double diesel fuel tanker truck unloading. The pumps, shown in Photo #5, are also piped for mine vehicle fuelling.

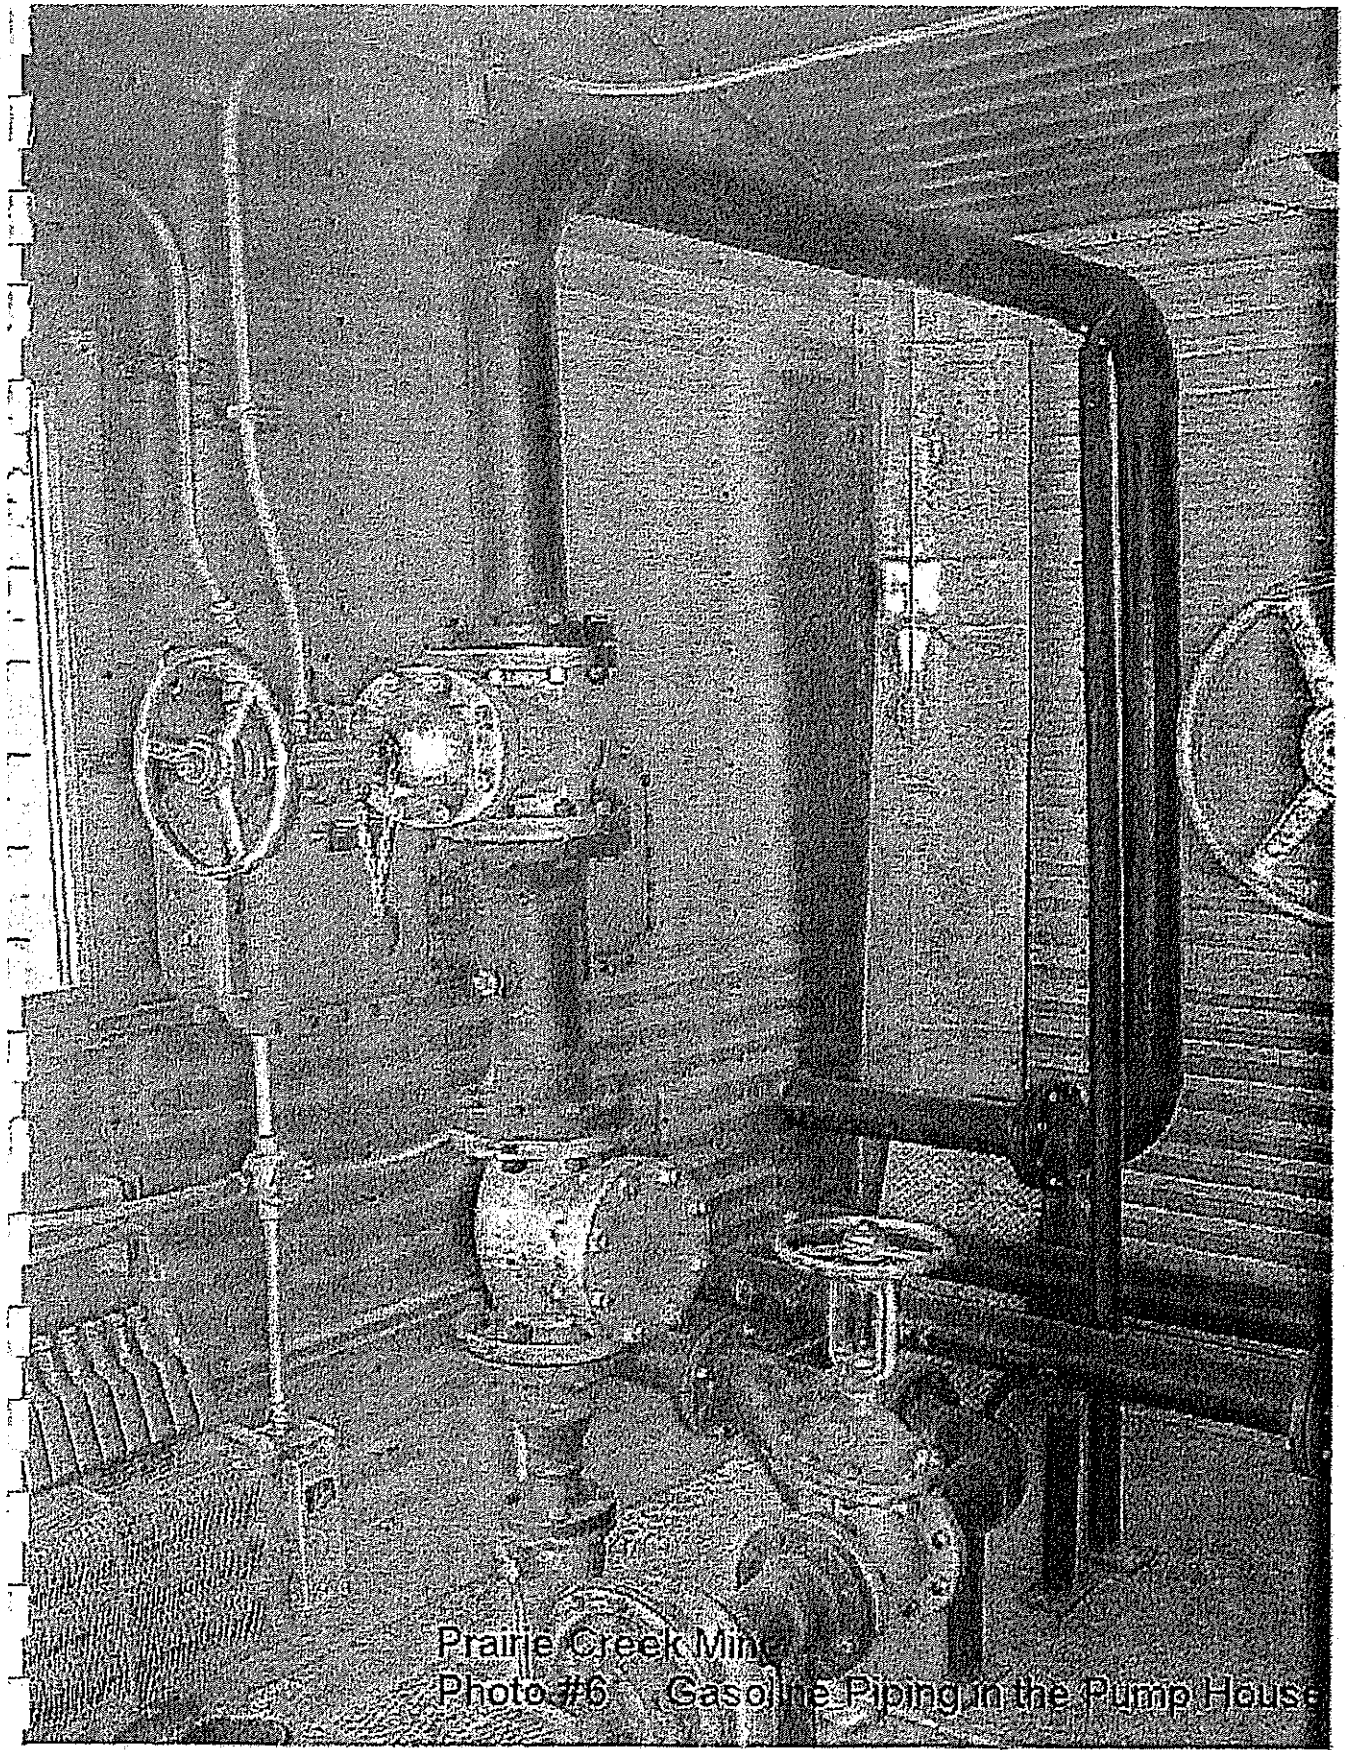
Prairie Creek Mine  
Photo #6 Gasoline Piping in the Pump House

There is also a 3" x 2" gasoline tanker truck unloading pump, shown in Photo #6. Gasoline dispensing is by gravity through a Gas Boy dispenser pump, shown in Photo #7.
