RE: Debogorski Public Hearing – undertaking # 3 submerged truck and excavator Great Slave Lake

**RTL Robinson Enterprises Ltd.
Drybones Break-thru Clean-up Report
Prepared by S. Langlois, shane_langlois@rtl.ca
RTL Incident # RY-06-81**

RTL Robinson Enterprises Ltd.
Pilot Islands Break-thru Inspection Report
Prepared by S. Langlois, shane_langlois@rtl.ca
RTL Incident # RY-06-81

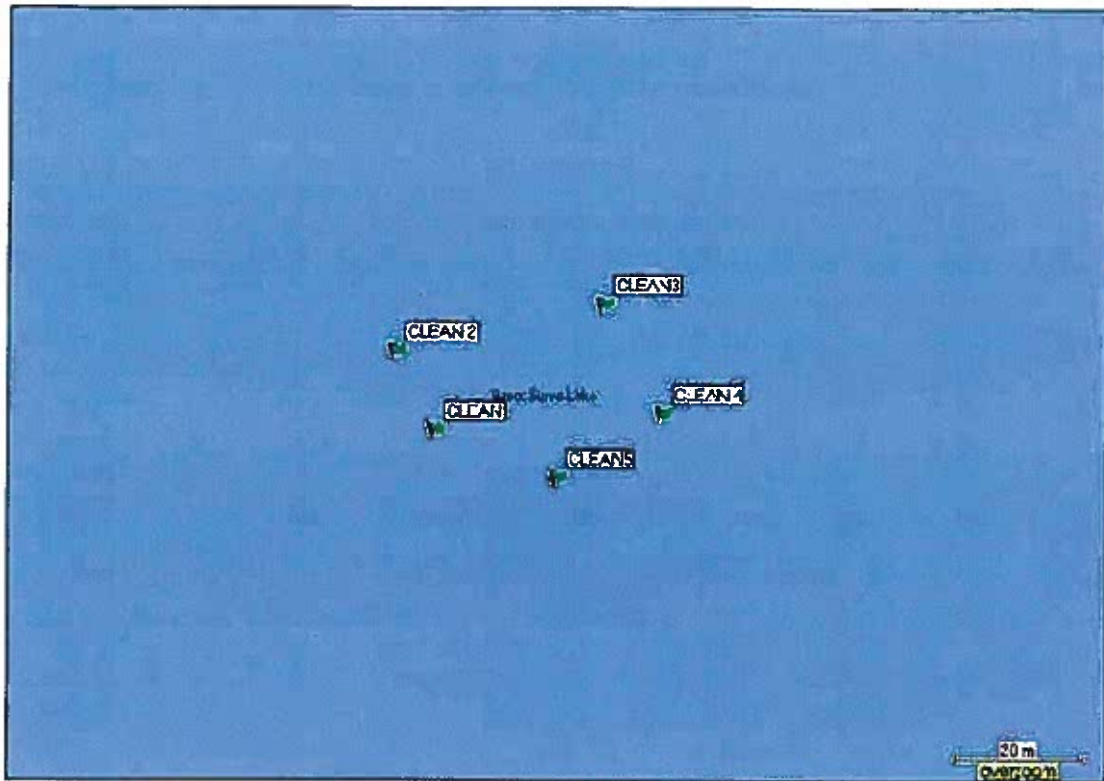
May 1, 2006 Drill Locations:

Waypoint Name	Date & Time Recorded	Waypoint Location	Comments
Clean	01-MAY-06 12:07:51PM	N62 11.957 W114 04.396	drill hole, no fuel found, ice porous
Clean2	01-MAY-06 12:08:29PM	N62 11.964 W114 04.403	drill hole, no fuel found, ice porous
Clean3	01-MAY-06 12:09:33PM	N62 11.968 W114 04.365	drill hole, no fuel found, ice porous
Clean4	01-MAY-06 12:10:20PM	N62 11.959 W114 04.354	drill hole, no fuel found, ice porous
Clean5	01-MAY-06 12:11:00PM	N62 11.953 W114 04.373	drill hole, no fuel found, ice porous

The drill holes previously drilled on May 1, 2006 were inspected again, no fuel was found.

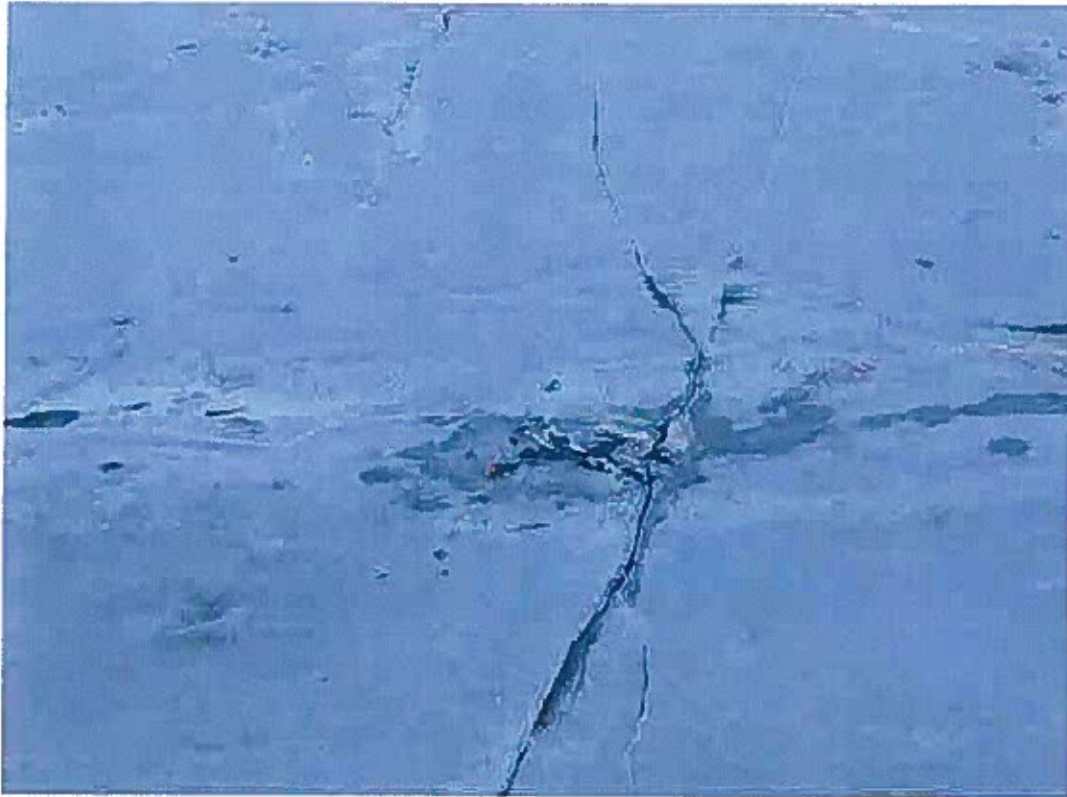
May 10, 2006 Aerial Pix:

At the site we found no fuel laying on the surface of the water directly over the break-thru location. We did find one small pocket of fuel in an area that was snow covered on May 1, 2006. This fuel was burned off, the fire burned for approximately five minutes.

The pilot felt it was unsafe to land the helicopter on the ice; we exited the machine while under power and performed the clean up while the chopper waited on shore. The ice had "candled" about 12" from the surface; water is also collecting at this point beneath the rotten ice.

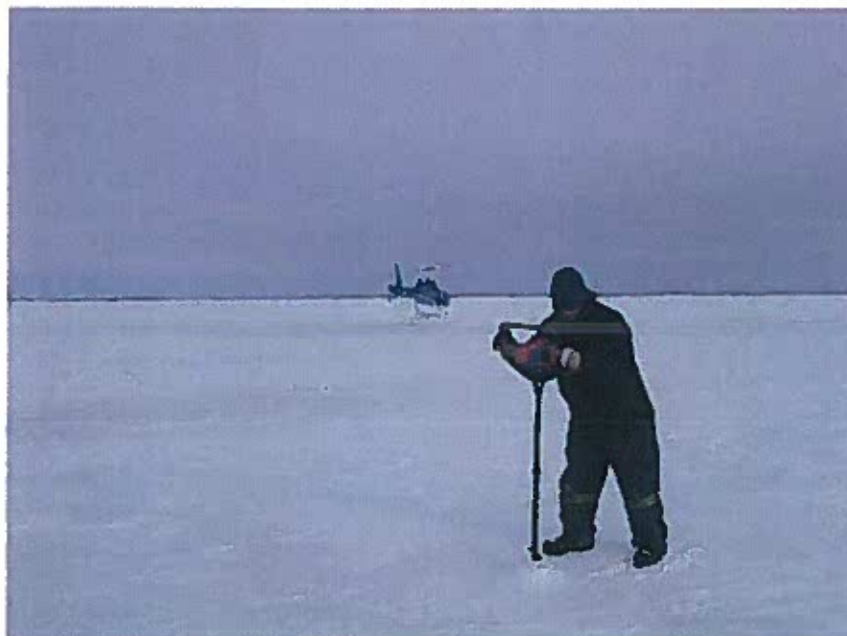
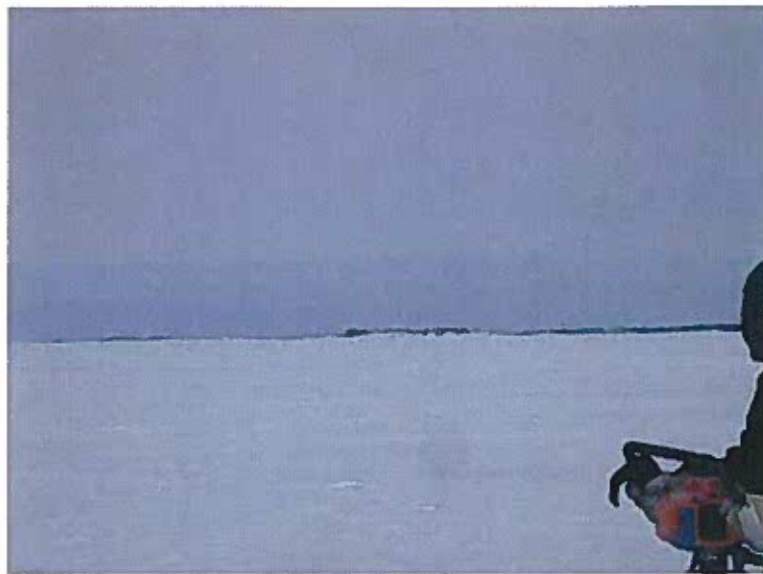
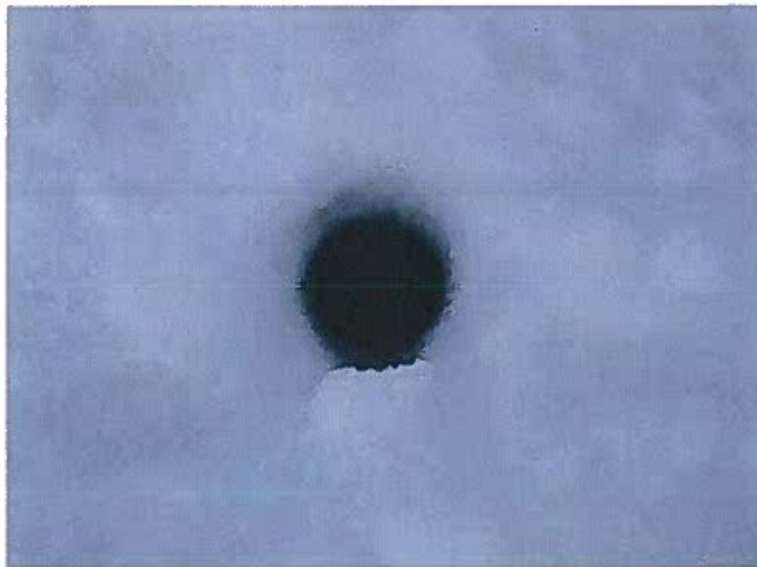
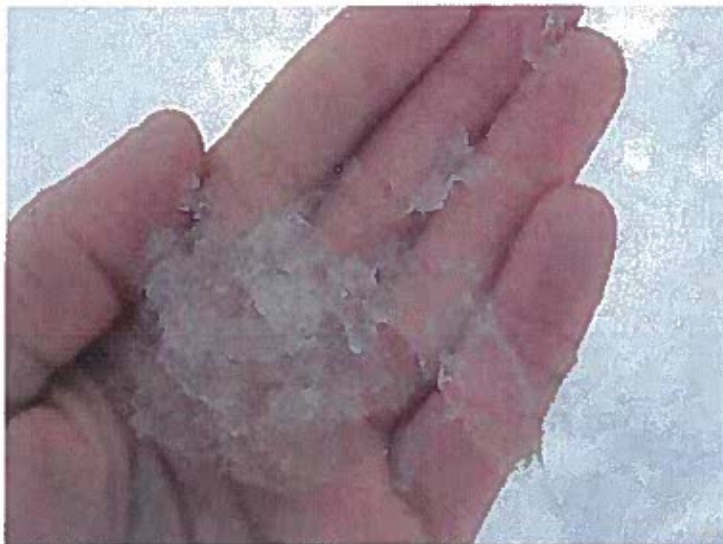
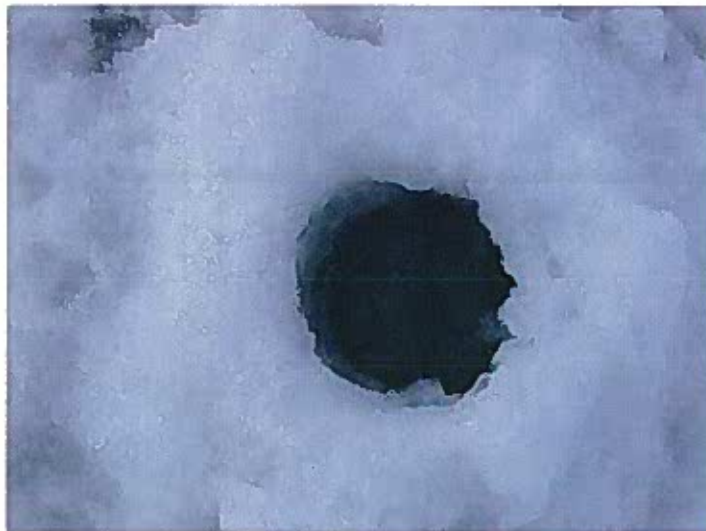
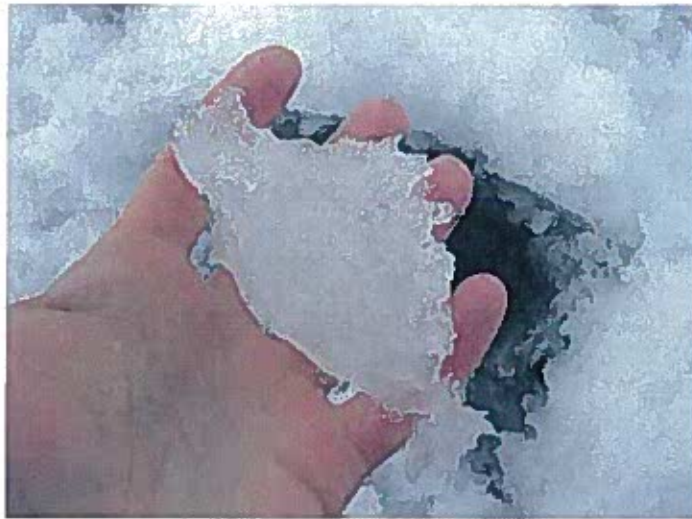
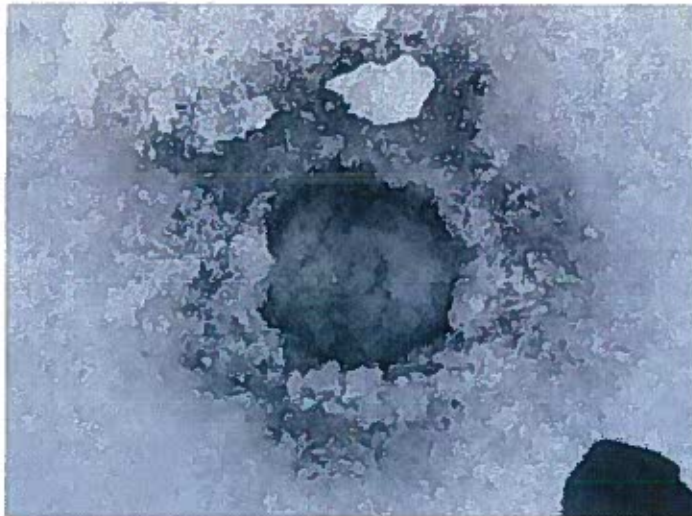
April 17, 2007 Inspection Pix:

We drilled six holes through the ice surrounding the incident location. There was no fuel or oil visually evident in the auger fillings or in the water. Nor could we smell anything.

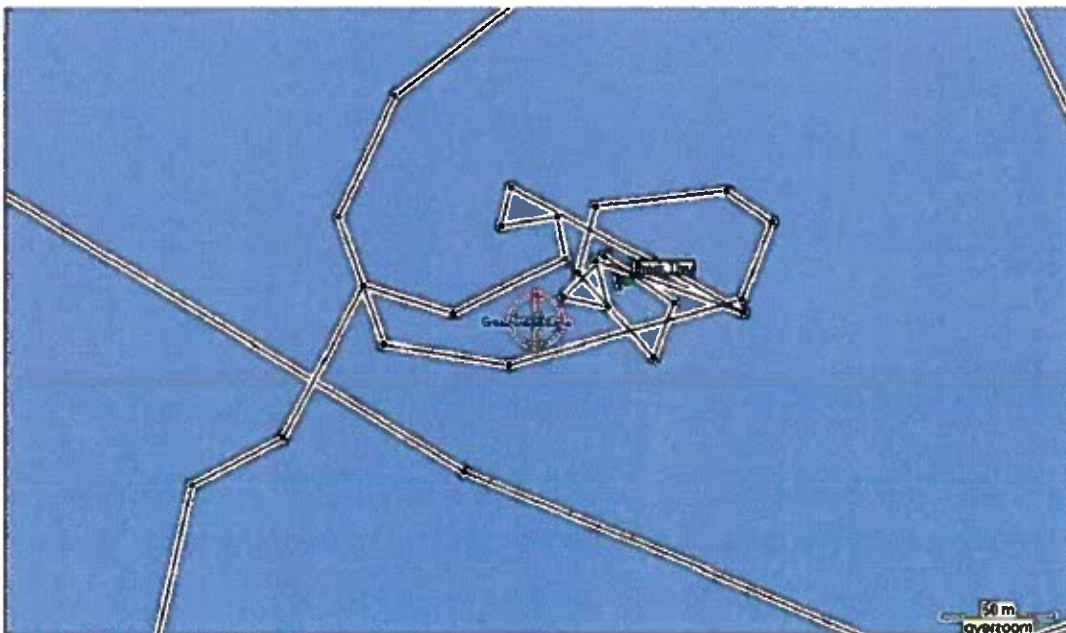
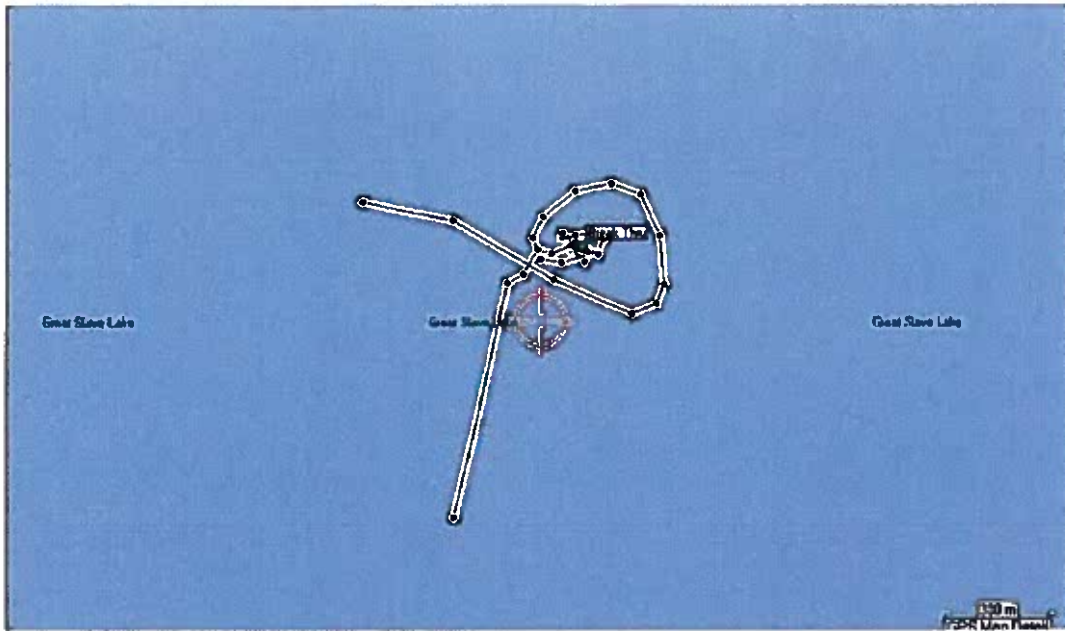
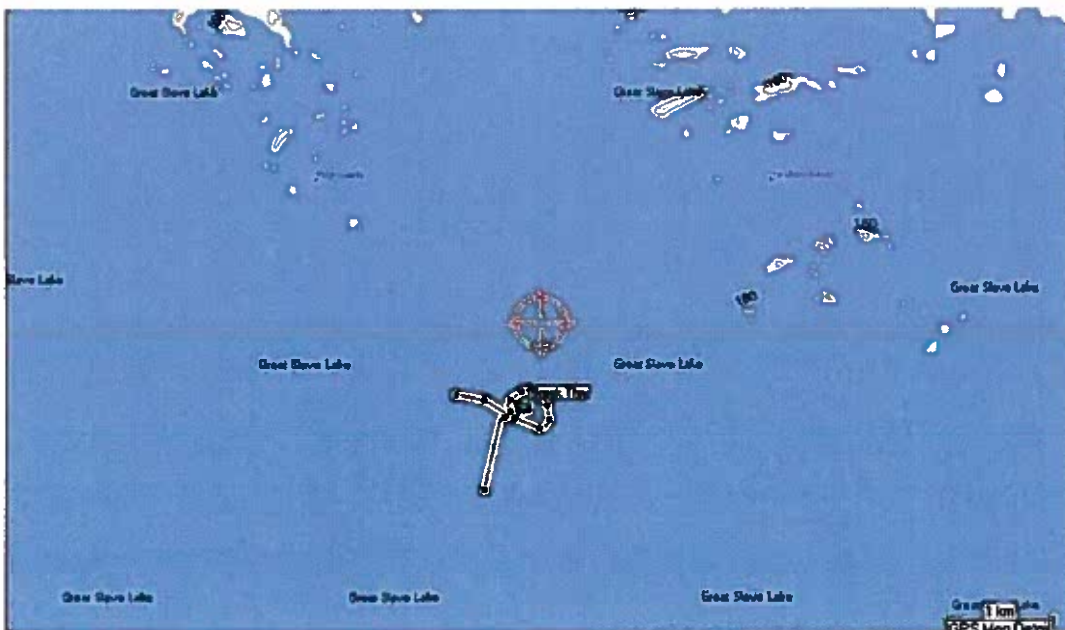
Sept 1, 2007 Inspection Tracks

On Sept 7, 2007 Larry Fairbairn & I traveled to the “break thru” location SE of the Pilot Islands to inspect for hydrocarbons. The winds very light, the water calm, the area was circled several times. There was no evidence of Hydrocarbons in the water.

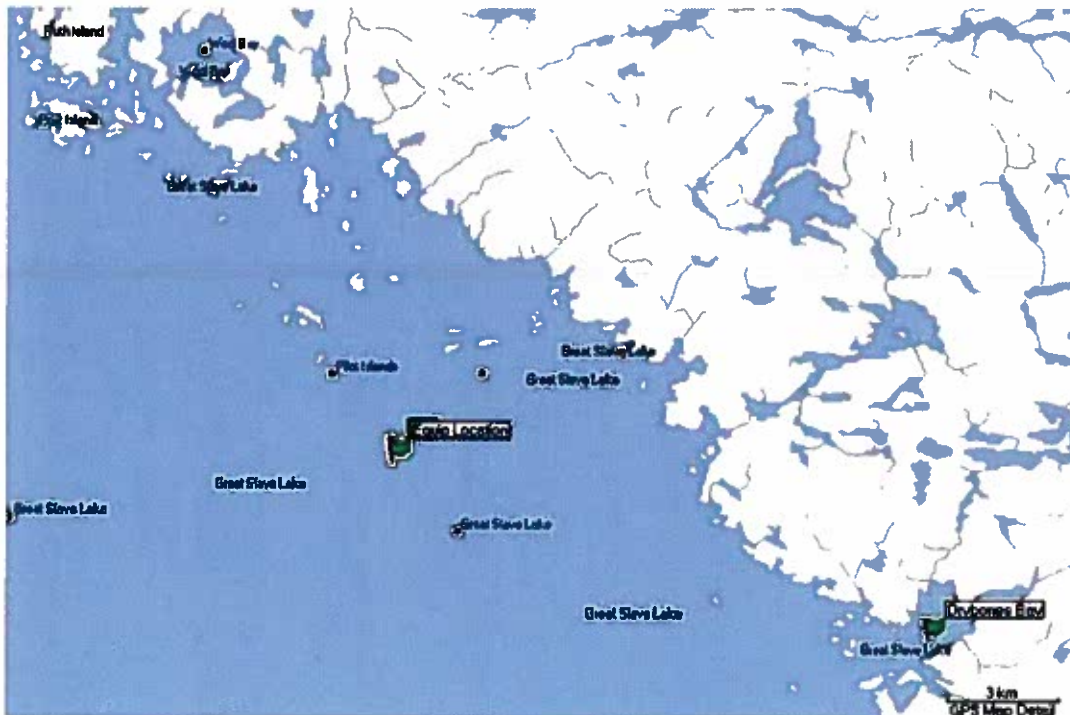
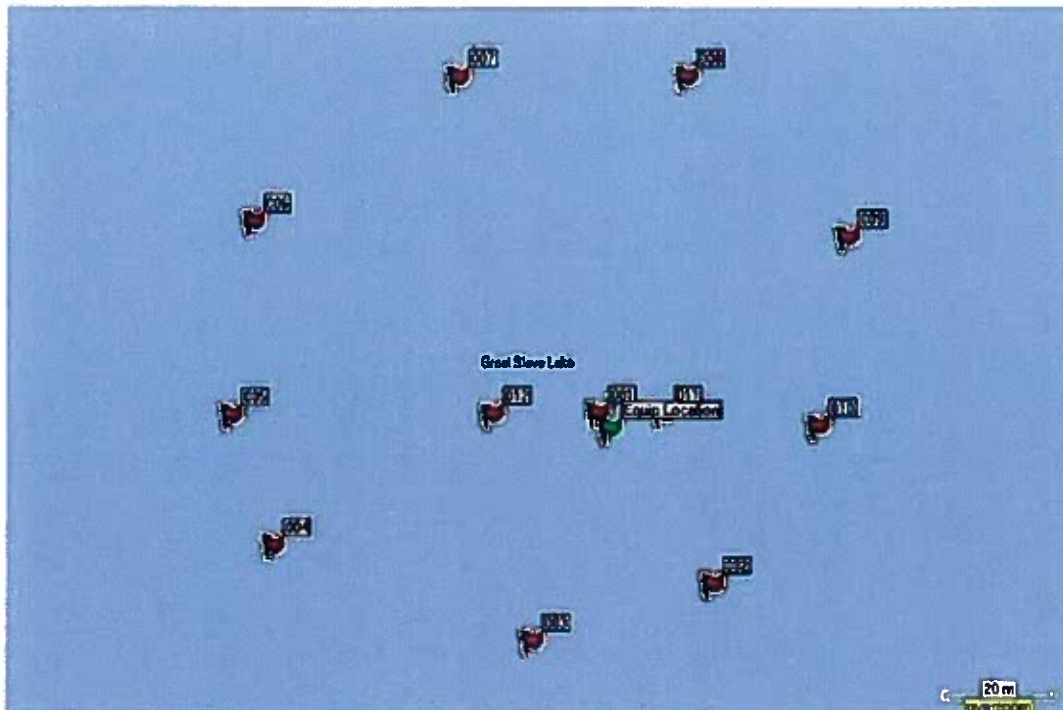
April 12, 2008 Inspection Location

On April 12, 2008 Larry Kish & I traveled to the "break thru" location 14 Km's NW of Drybones Bay to inspect for hydrocarbons. We drilled nine test holes through the ice at approximately a 50 m radius around the equipment and three more directly above. All of the ice and water samples inspected showed no visual evidence of Hydrocarbons in the water and no smell. All water was clear and cold and the snow and ice was pure with no residue. We actually drank it.

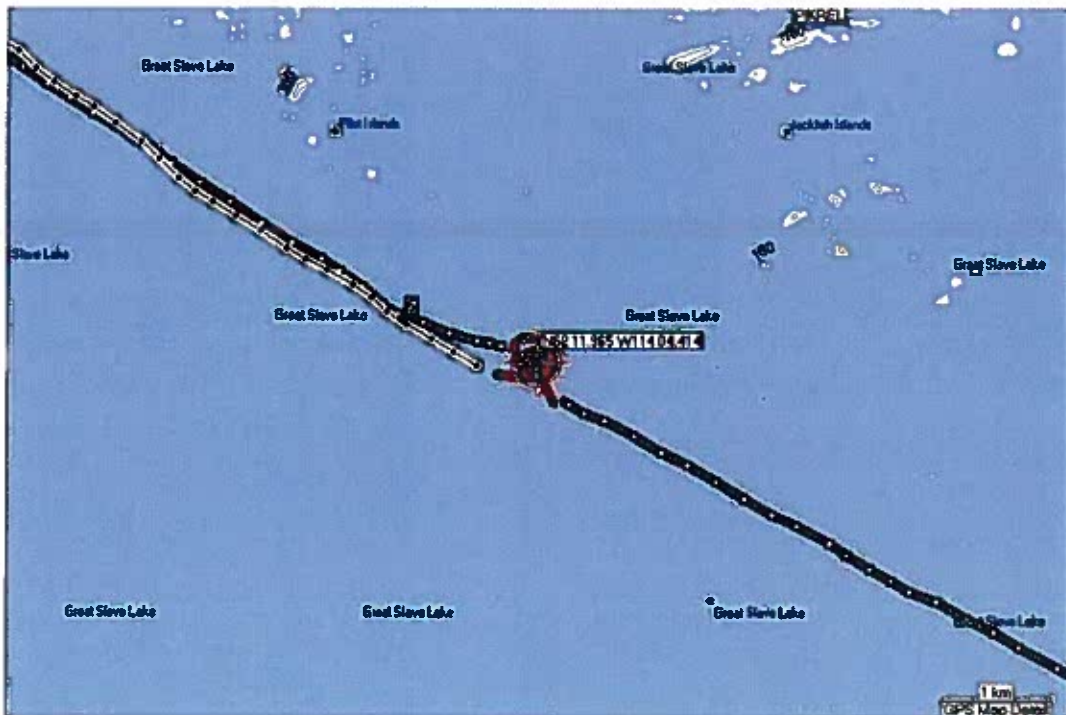
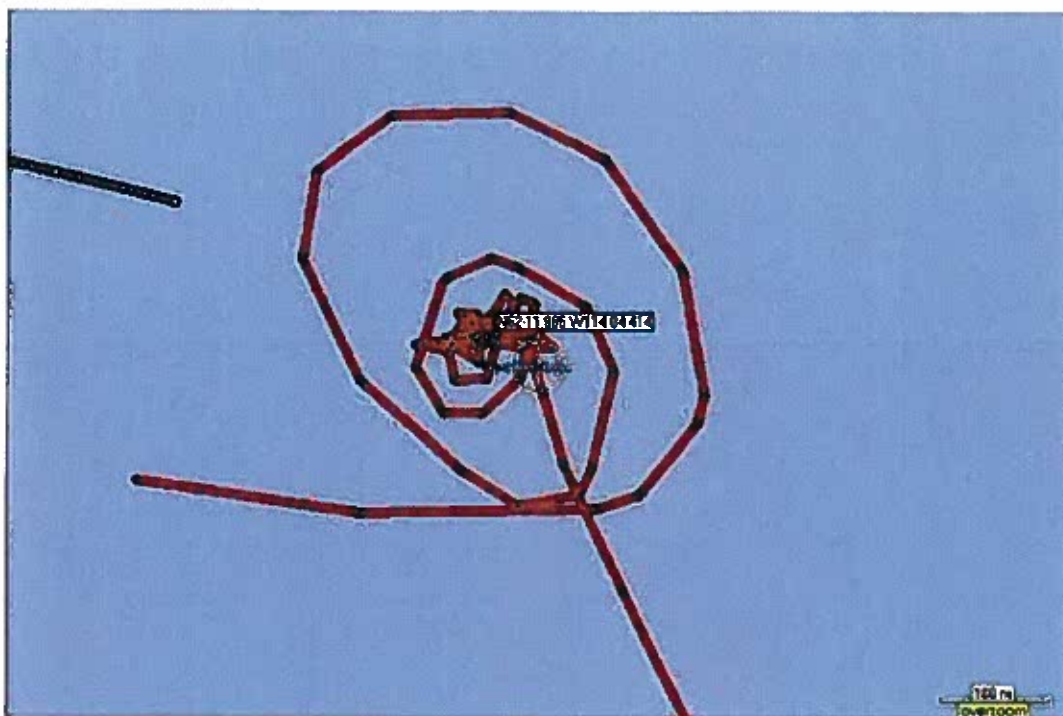
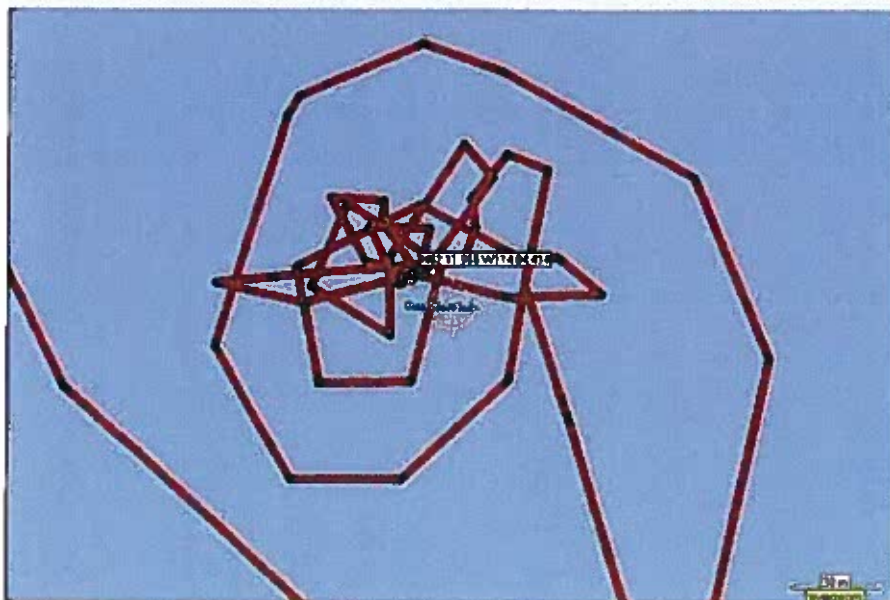
June 27, 2008 Inspection Location

On June 27, 2008 Larry Fairbairn & I traveled to the "break thru" location 14 Km's NW of Drybones Bay to inspect for hydrocarbons. Winds were light at approximately 10km per hour, we circled the incident location for several minutes, NO hydrocarbons were evident, there was NO sheen on the water whatsoever, we touched the water in several areas. No smell was evident and NO oily residue was found. All water was clear and cold.

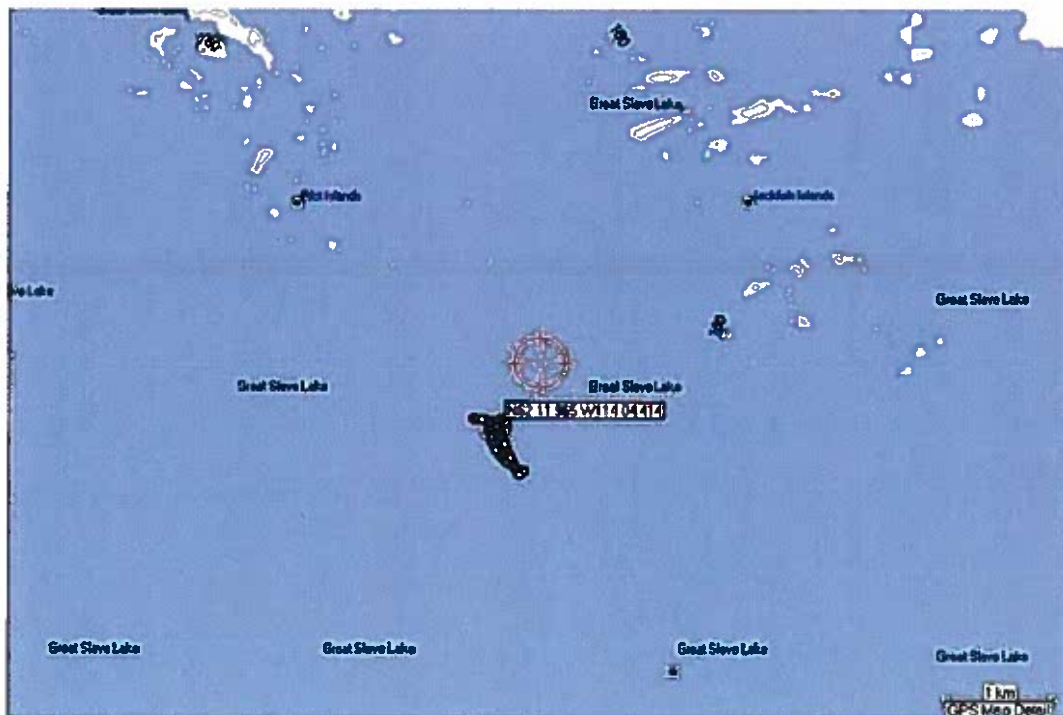
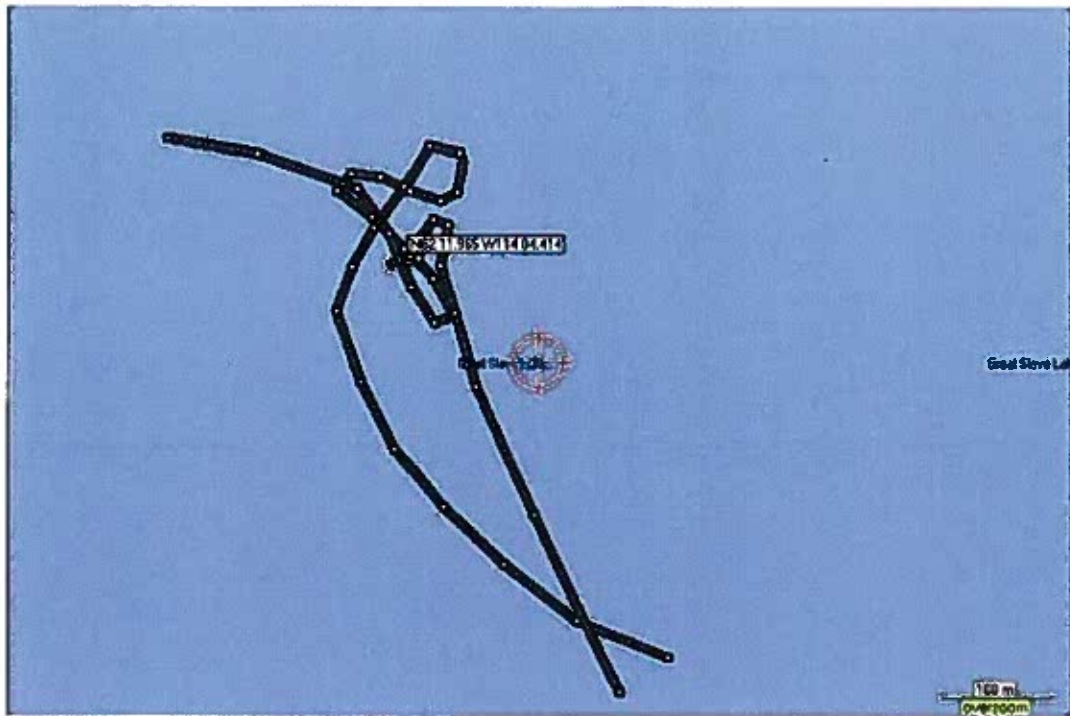
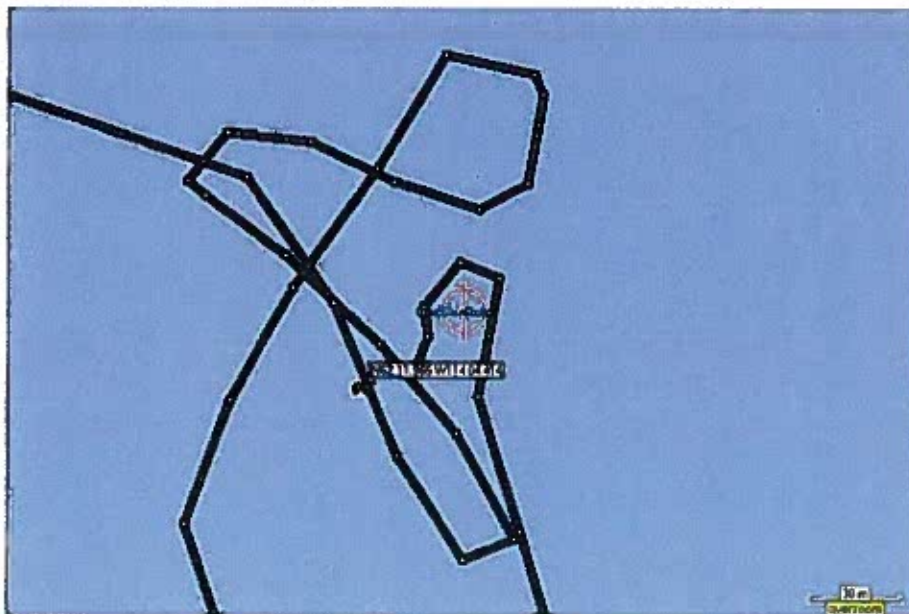
July 5, 2008 Inspection Location

On July 5, 2008 Larry Fairbairn & I traveled to the "break thru" location 14 Km's NW of Drybones Bay to inspect for hydrocarbons. Winds were approximately 15 km per hour, we travelled back and forth by boat over the incident location for several minutes, NO hydrocarbons were evident, there was NO sheen on the water whatsoever, we touched the water in several areas. No smell was evident and NO oily residue was found. All water was clear and cold.

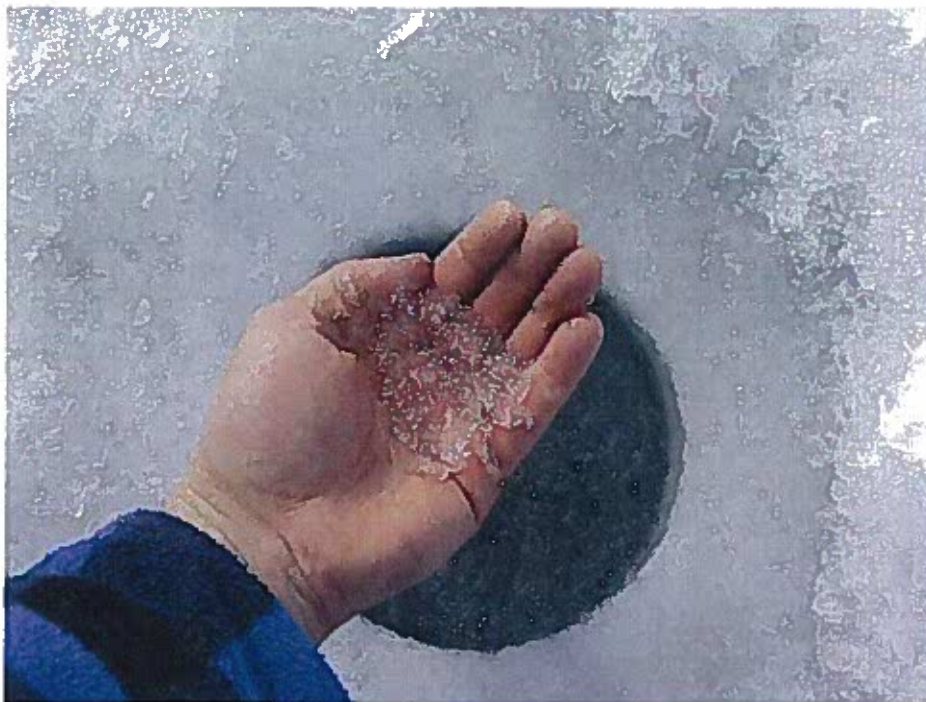
April 16, 2009, RTL Photo's

As observed from all the holes drilled through the ice, no visible sheen or odor was detected and the water appeared to be clean and free of hydrocarbons.

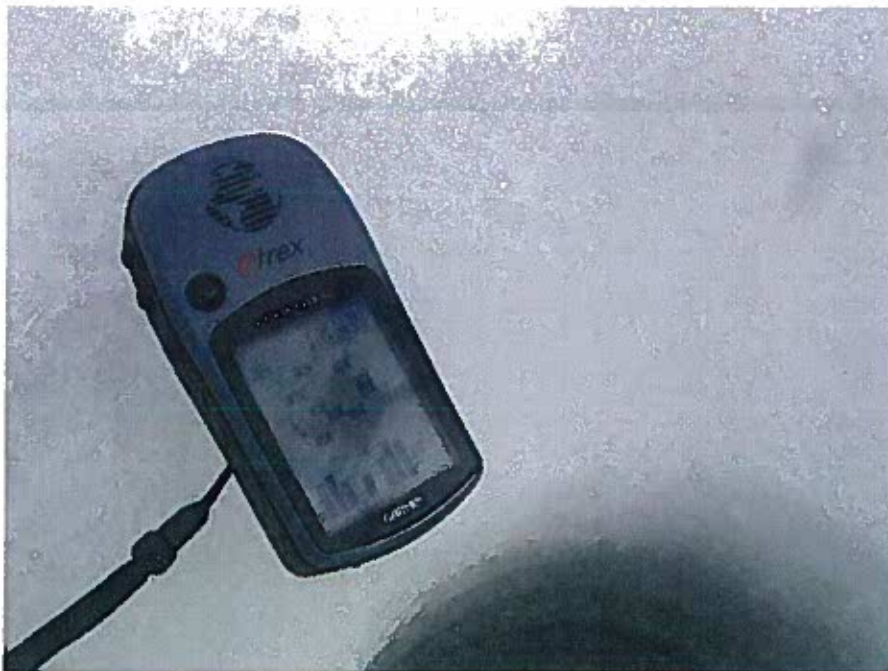
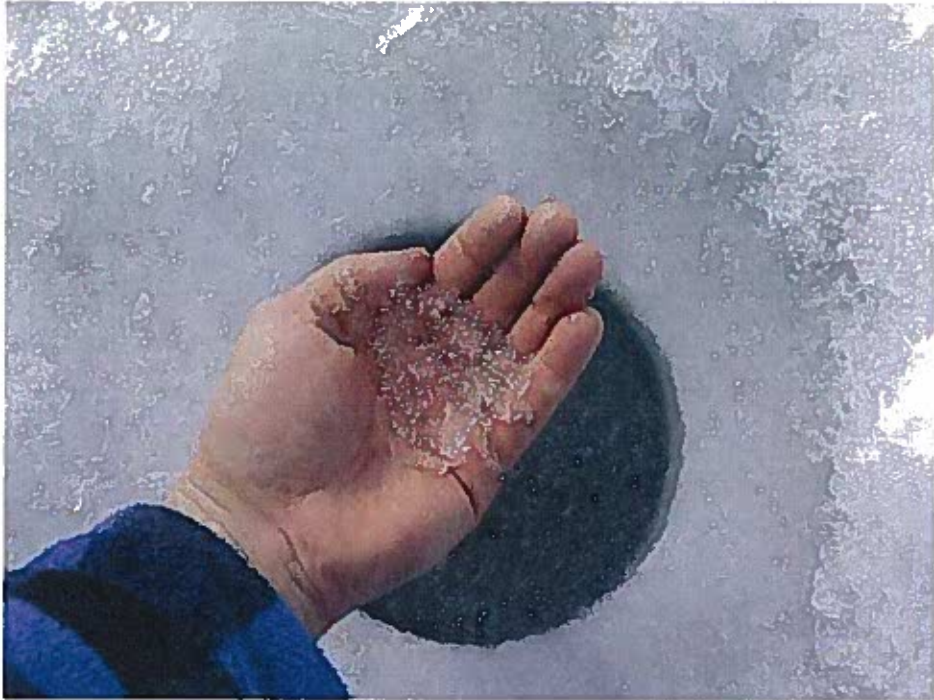
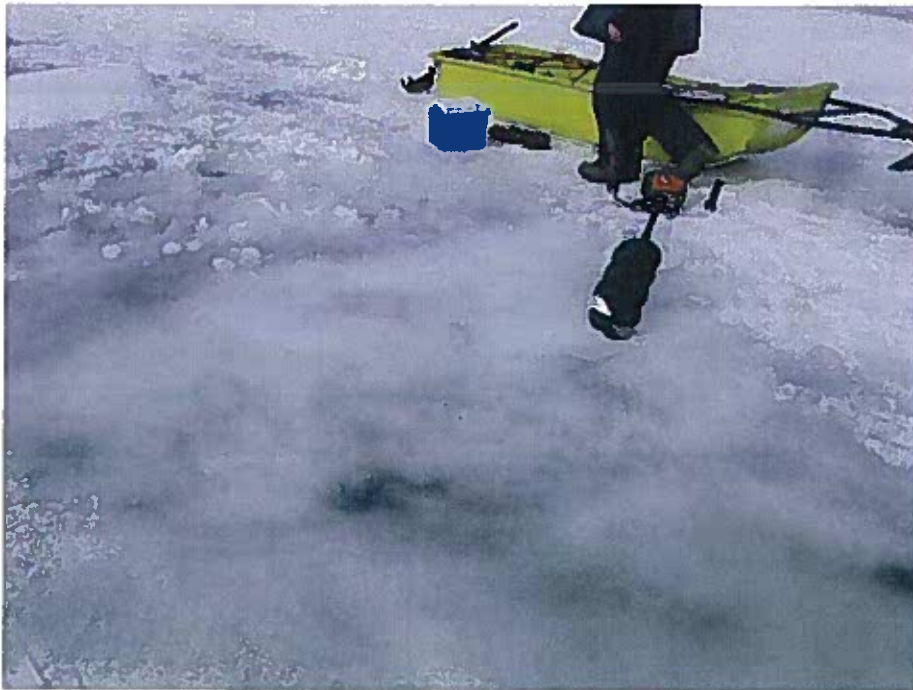
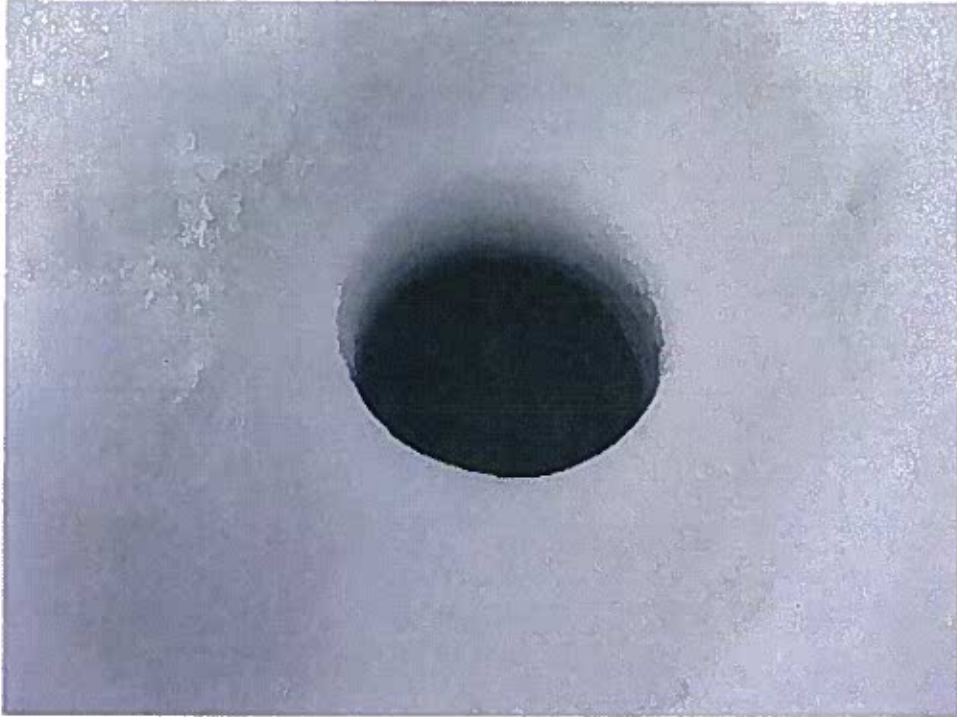
April 16, 2009, RTL Photo's

As observed from all the holes drilled through the ice, no visible sheen or odor was detected and the water appeared to be clean and free of hydrocarbons.

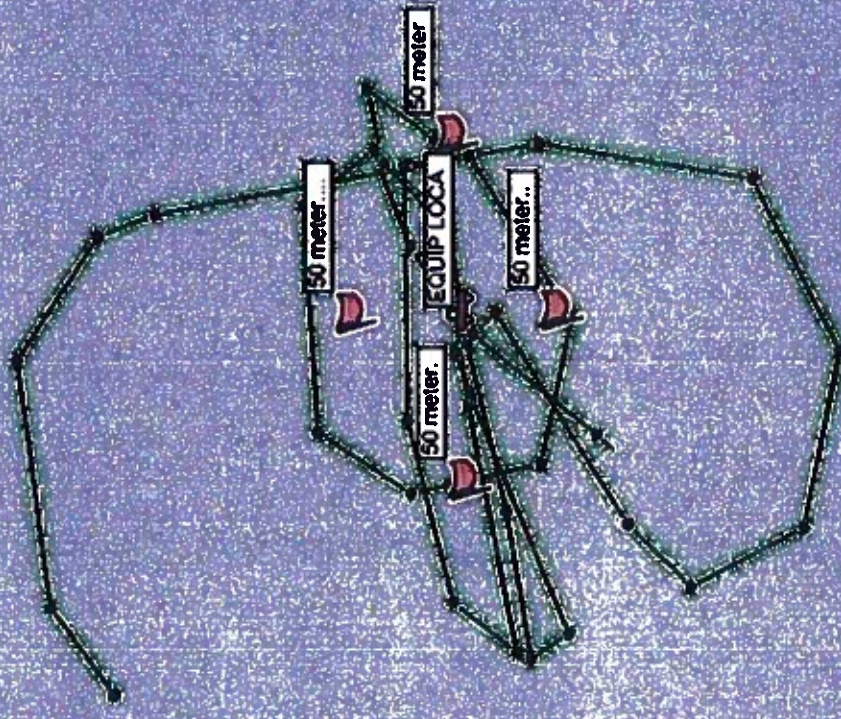
On July 12, 2009 I traveled to the "break thru" location at the Pilot Islands approximately 14 Km's NW of Drybones Bay to inspect for hydrocarbons. Winds were approximately 10 km per hour from the North. I travelled back and forth by boat over the incident location within a 50 meter radius of the equipment and directly above the equipment, NO hydrocarbons were evident, there was NO sheen on the water whatsoever, I touched the water in several areas. No smell was evident and NO oily residue was found. All water was clear and cold.

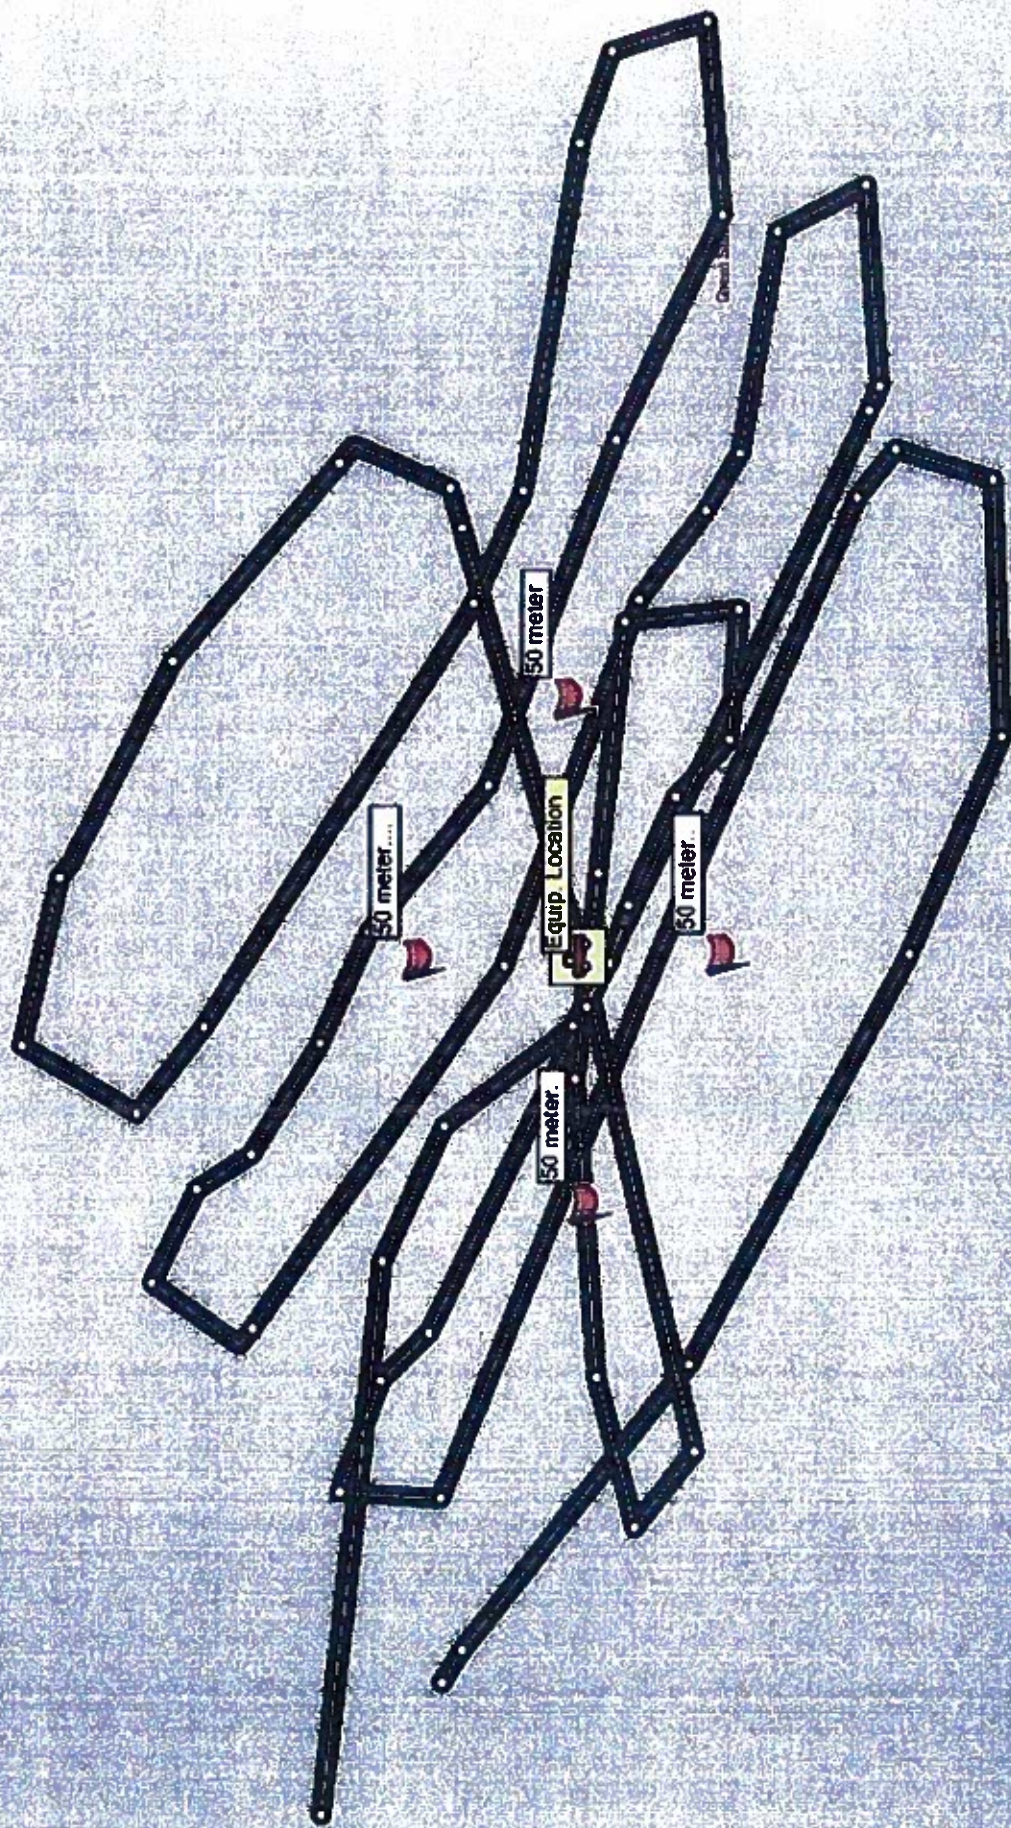
On August 2, 2009 I traveled to the "break thru" location at the Pilot Islands approximately 14 Km's NW of Drybones Bay to inspect for hydrocarbons. Winds were stronger than most of our inspections at approximately 15-20 km's per hour from the North-east. I travelled back and forth by boat over the incident location within a 100 meter radius of the equipment and directly above the equipment, NO hydrocarbons were evident, there was NO sheen on the water whatsoever, I touched the water in several areas. No smell was evident and NO oily residue was found. All water was clear and cold.

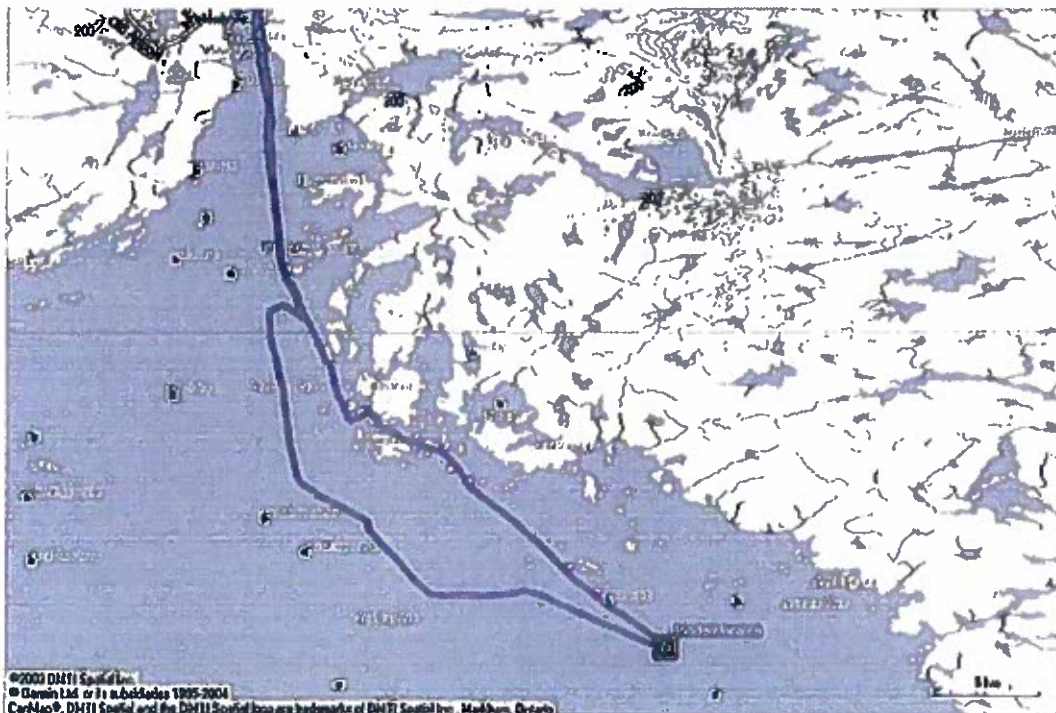
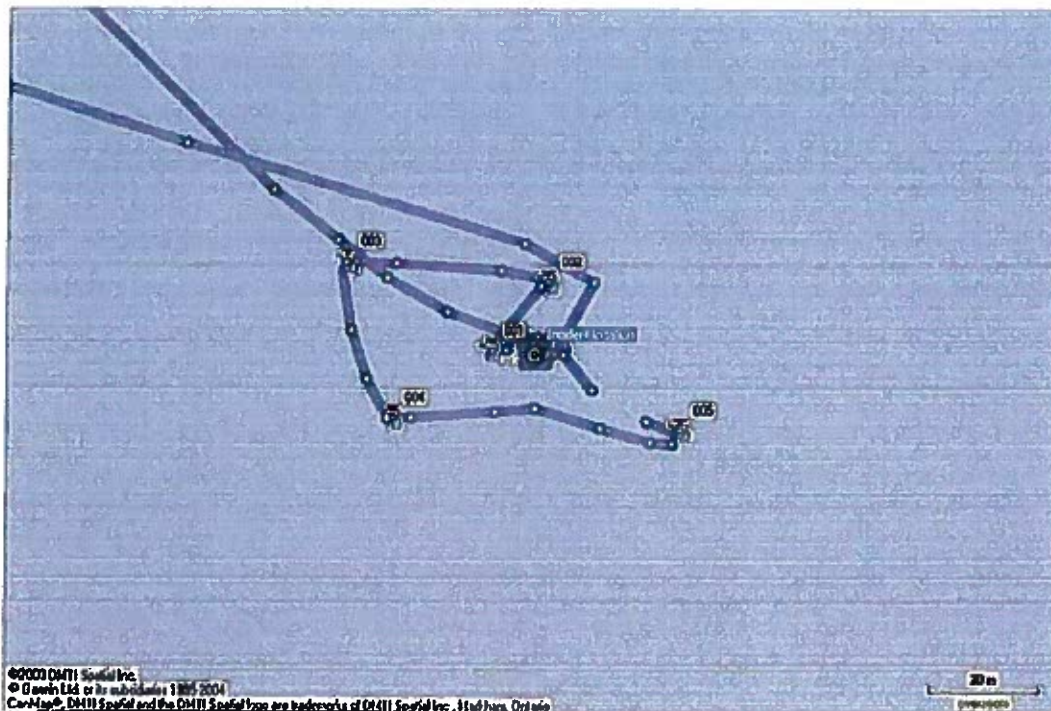
May 5, 2011 Inspection Location

On May 5, 2011 RTL traveled to the "break through" location 3.5 Km's SE of the Pilot Islands to inspect for hydrocarbons. We drilled four test holes through the ice at approximately a 25 m radius around the equipment and one more directly above. All of the ice and water samples inspected showed no evidence of Hydrocarbons in the water and no smell. All water was clear and cold. The snow and ice was clean and pure with no residue. Water Samples were taken and examined at the Taiga Water Lab for Hydrocarbons and other pollutants...NONE were found. Please see attached report.
