**RE: Environmental Assessment EA1415-001, Prairie Creek Mine  
Reasons for Decision on DAR Adequacy – Inadequate Items**

**Sundog Creek Re-alignment**

**Subject:** Magnitude/Frequency Analysis – Landslide Hazards  
Proposed Prairie Creek All Season Road, NT

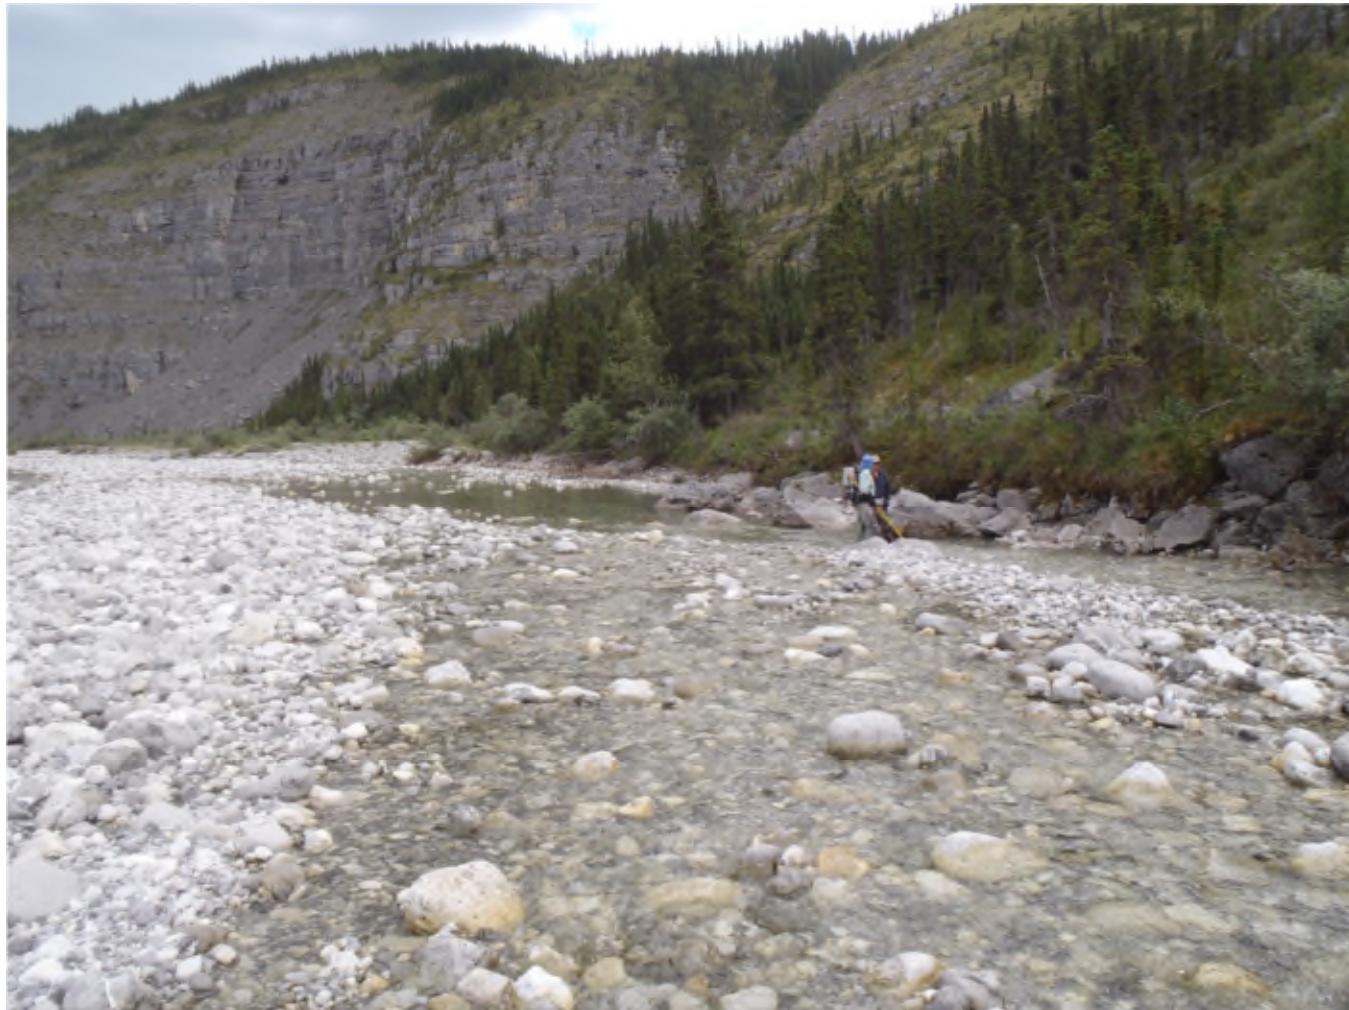
**Figure 5a: Sundog Creek View Downstream Near Road KP 37**

Figures 5a and 5b are photos taken during fish habitat surveys on Sundog Creek in the study area vicinity. The substrate consists of coarse gravels, cobbles and boulders, with cobbles dominating.

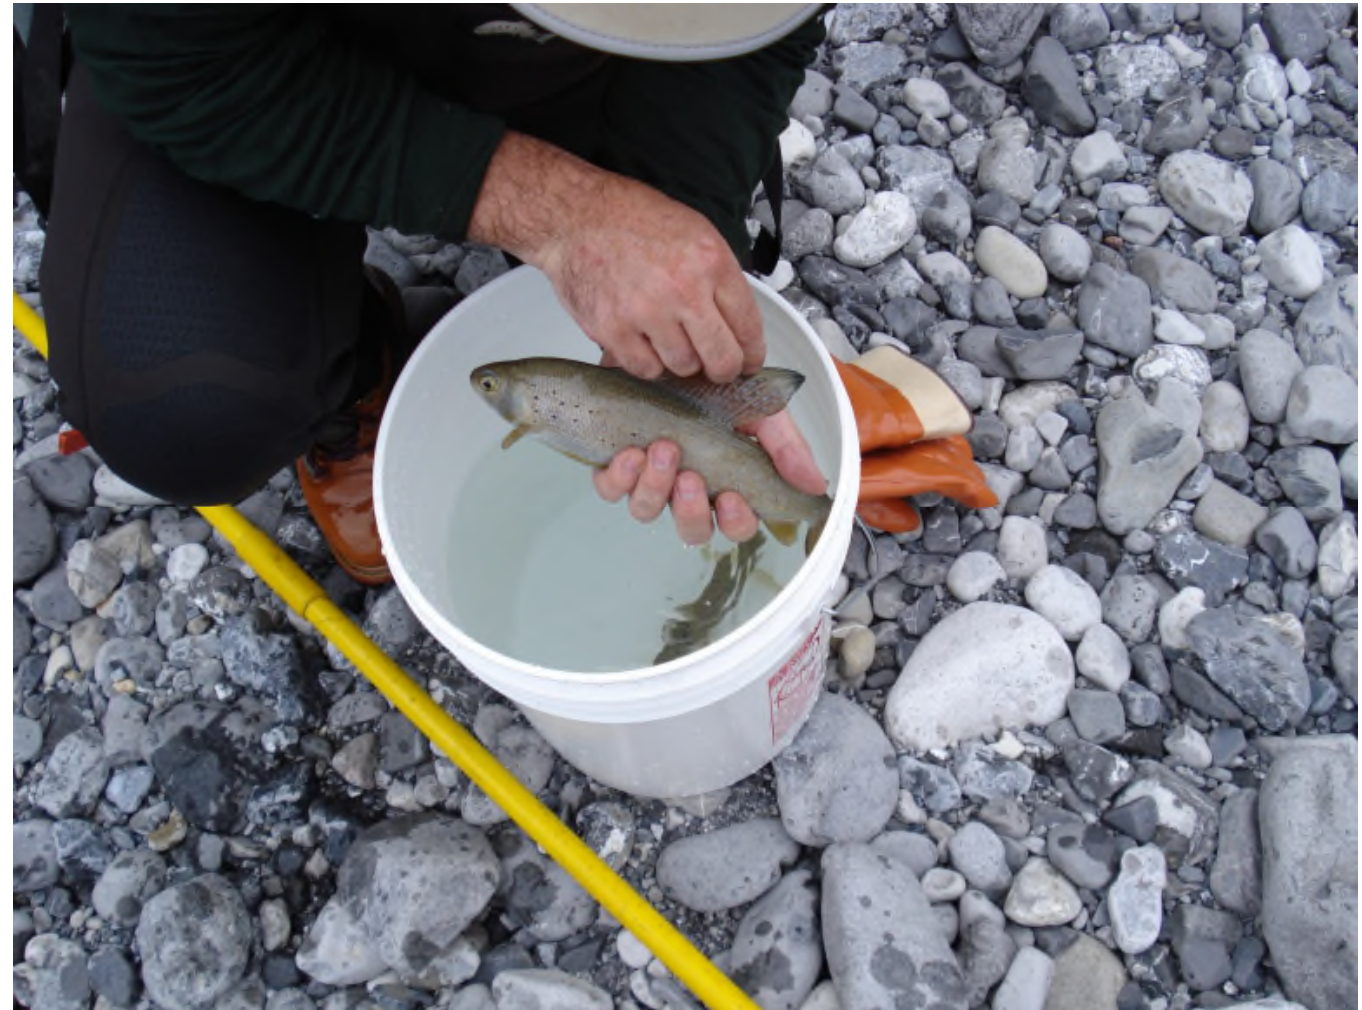
**Figure 5b: Sundog Creek Gravel Bar near Pool Downstream of Road KP 40, Not on Alignment**

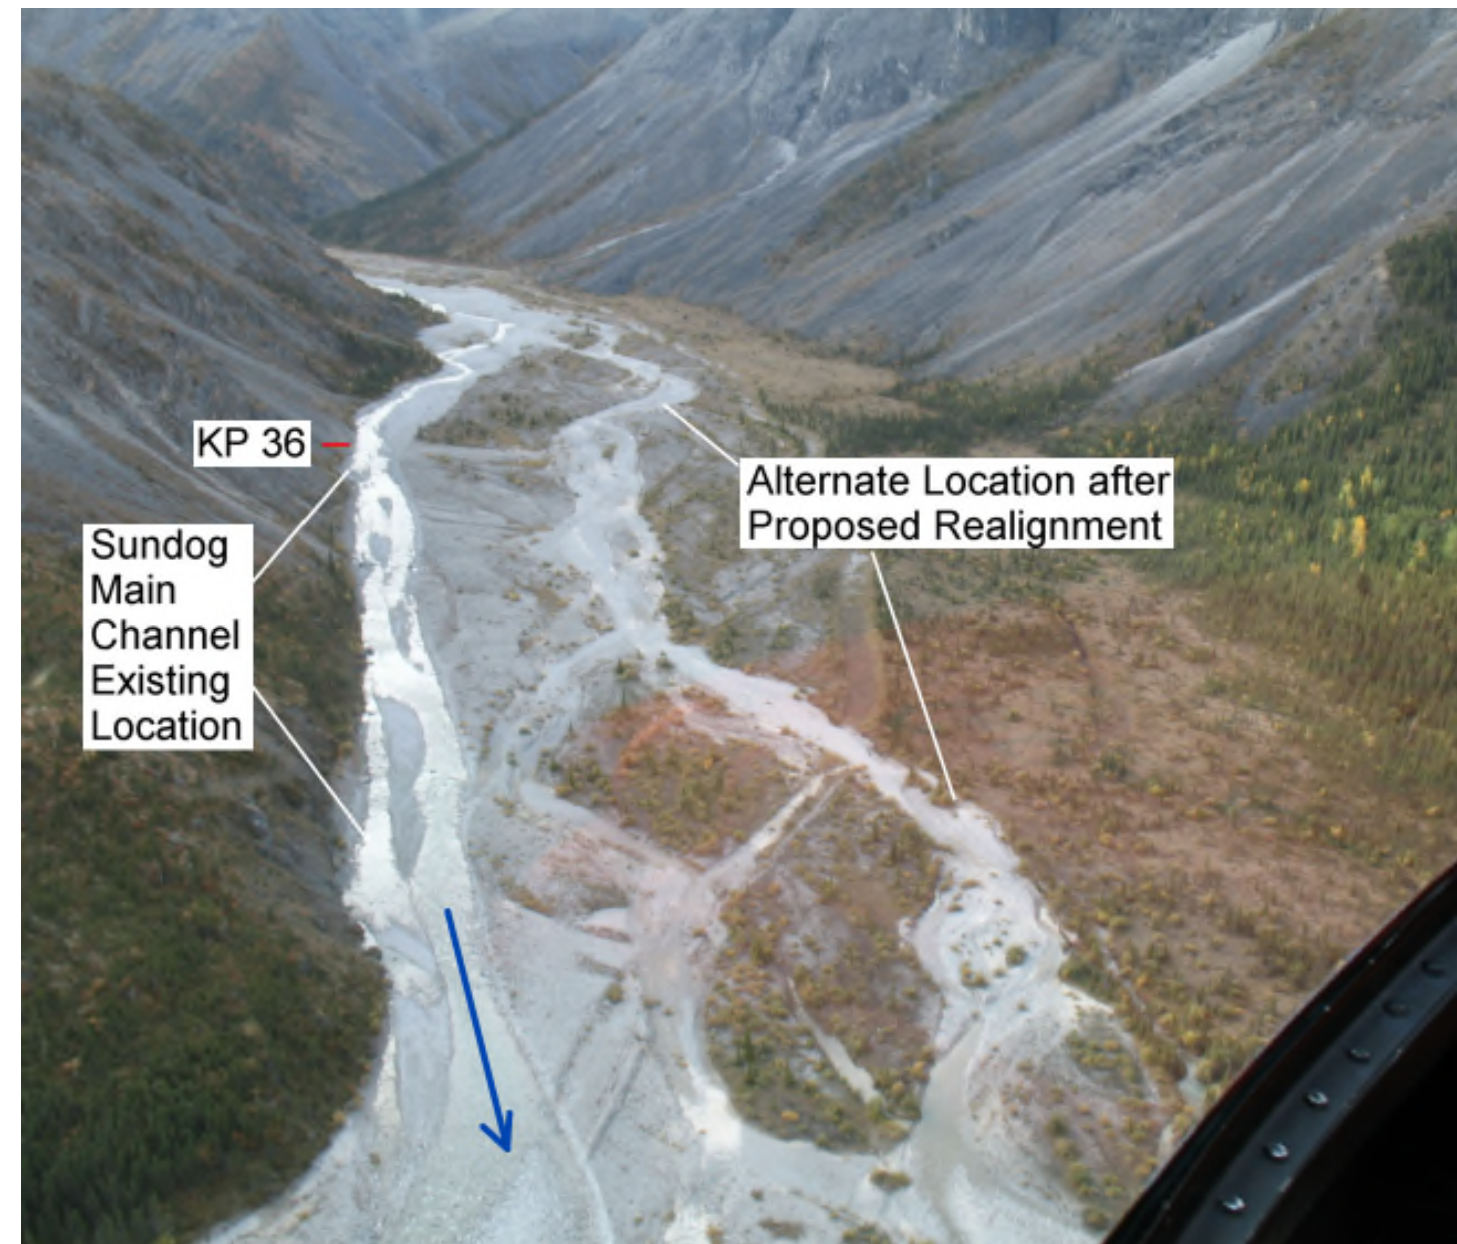
**Figure 10b: Sundog Creek Viewing Upstream at Realignment Reach**  
Photo date September 15, 2009

Figures 10a and 10b present oblique aerial views of the reach where the realignment is proposed.

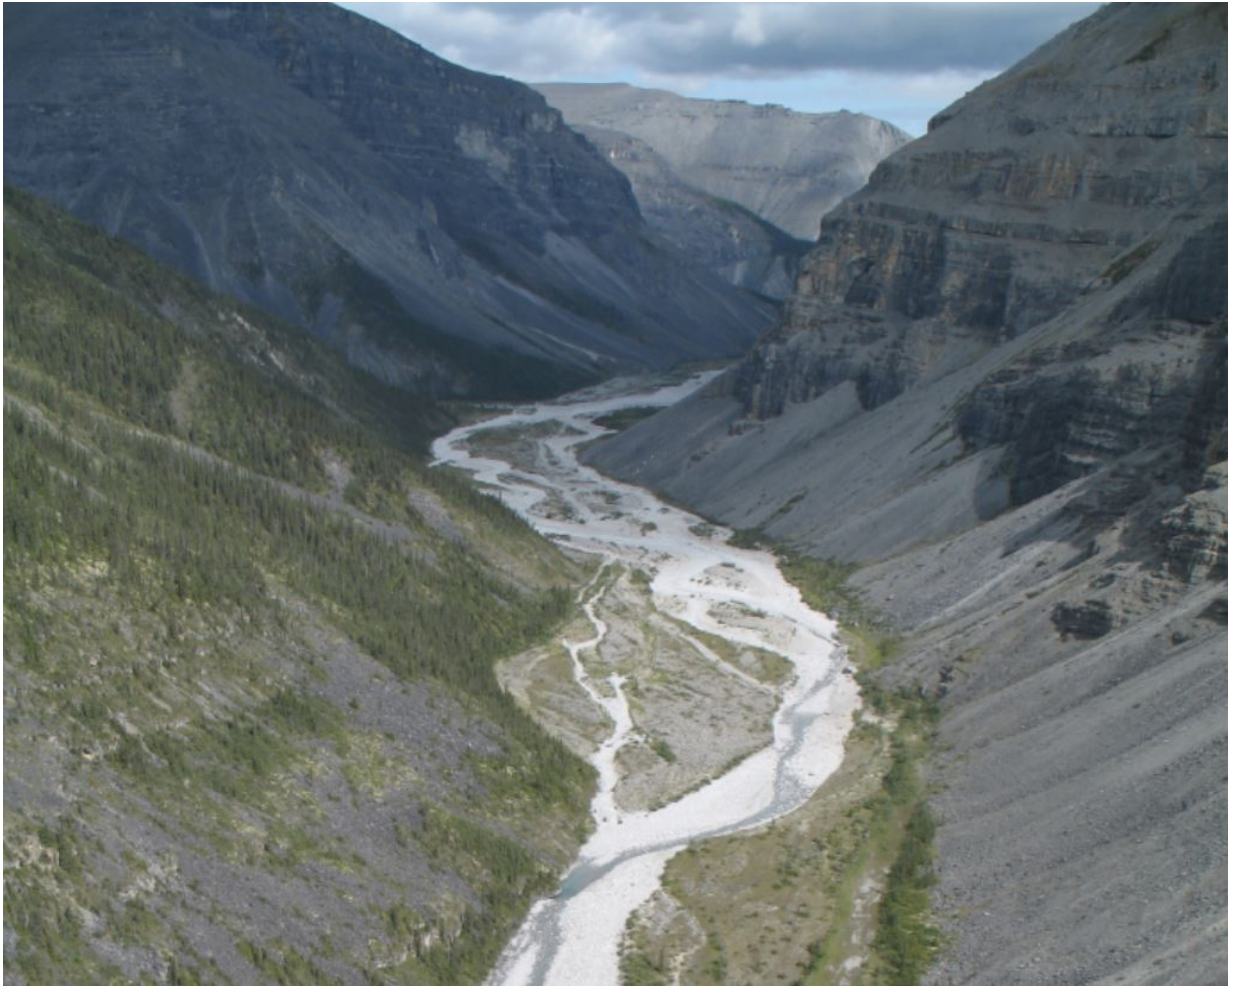
**Photo 1: A view of the Sundog valley floodplain looking north (downstream) near KP 33.**

As might be expected from viewing Photo 1 above, the natural materials within this confined valley are primarily clean gravels, cobbles, large fragmented, talus rock, and exposed bedrock. These natural, clean gravels (above the currently active floodplain) and rocks will provide ideal road building material and pose minimal risk related to sediment release during construction or road operations.

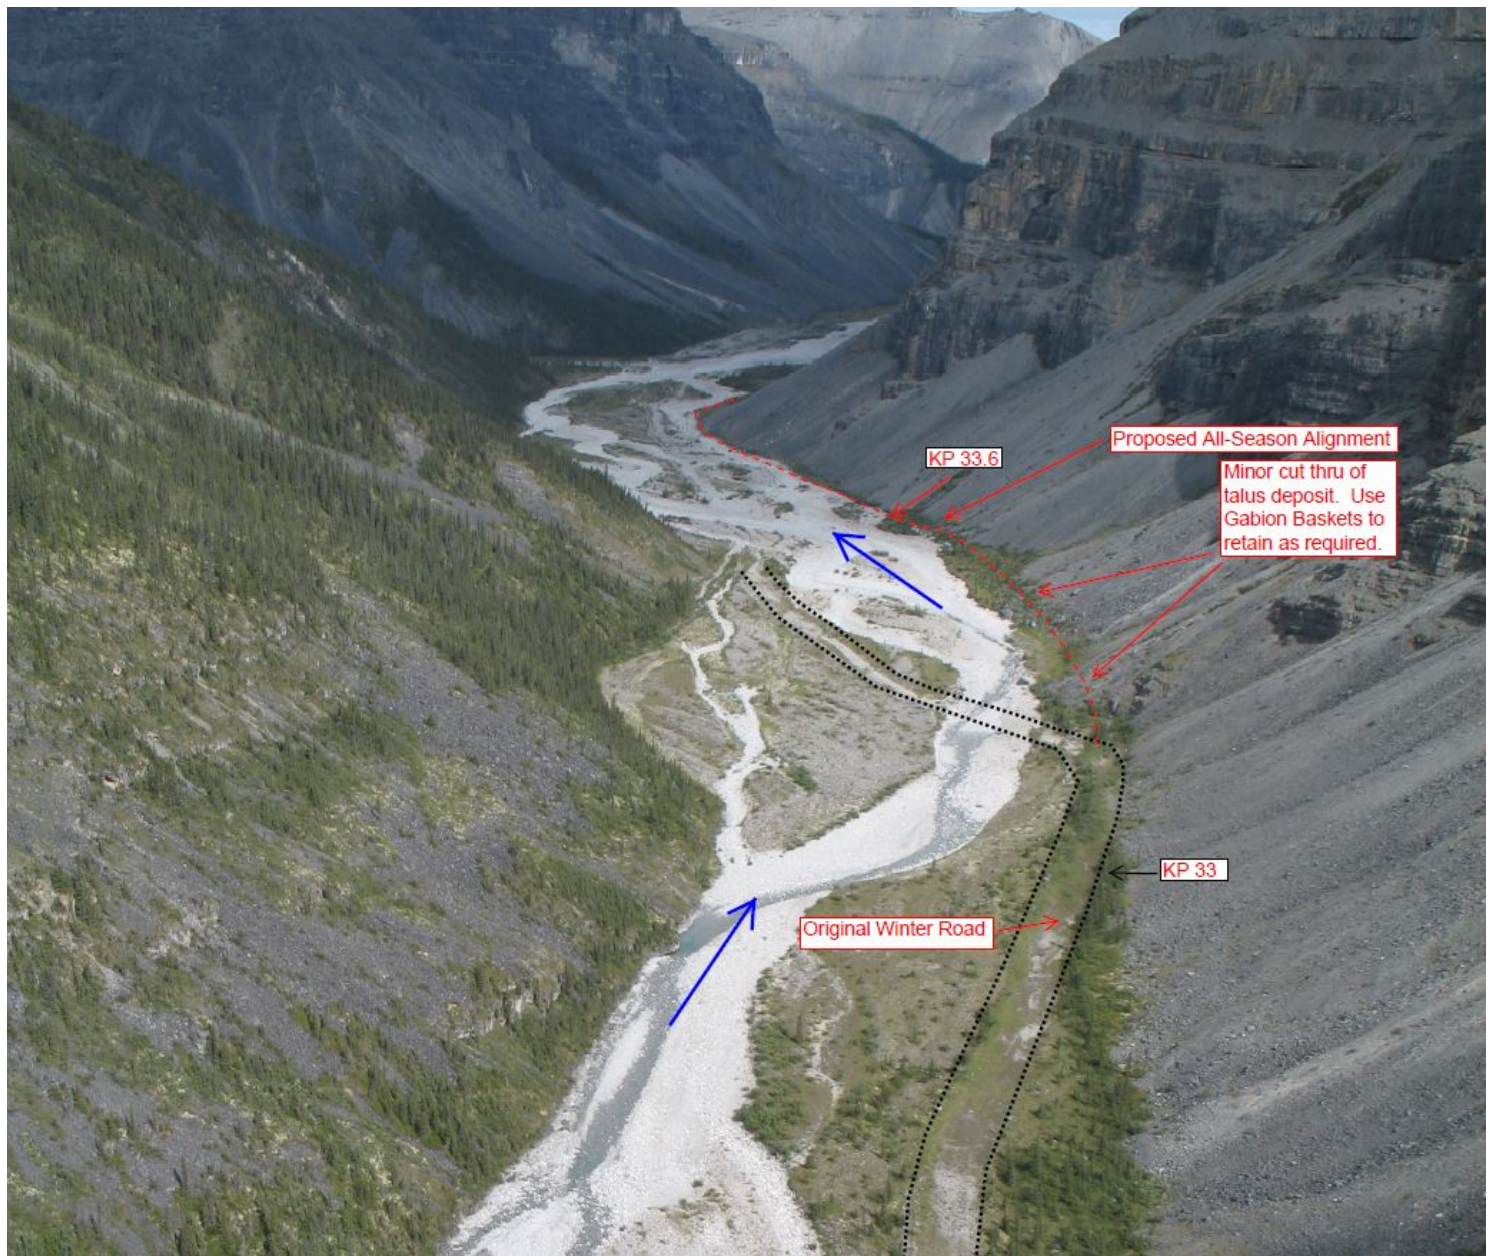
**Photo 4: View at KP 33 looking north (downstream).**

**KP 34.05 to 34.8.** Road prism will be located entirely outside the active floodplain.

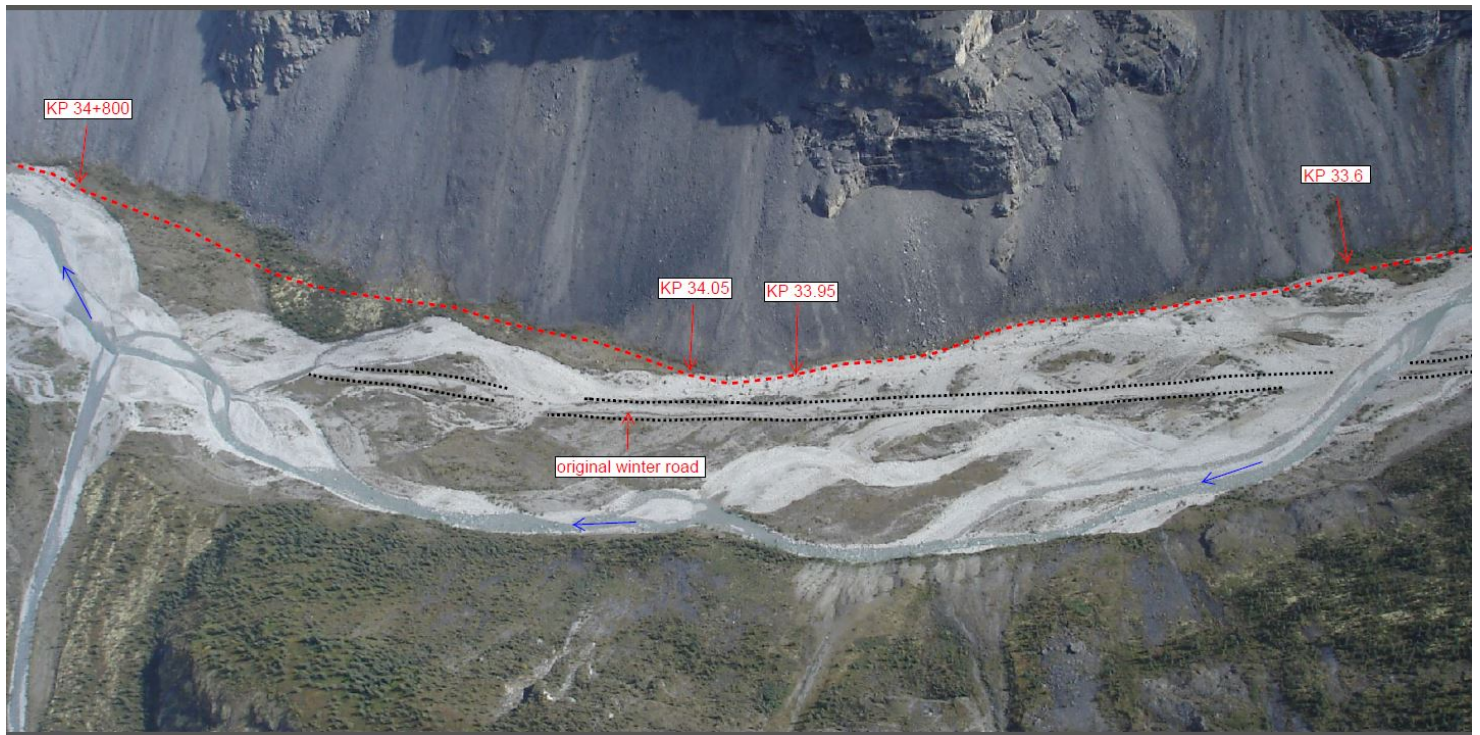
**Photo 5: Aerial view of KP 34 to 34.8 looking from the west side of the valley to the east (downstream to left)**

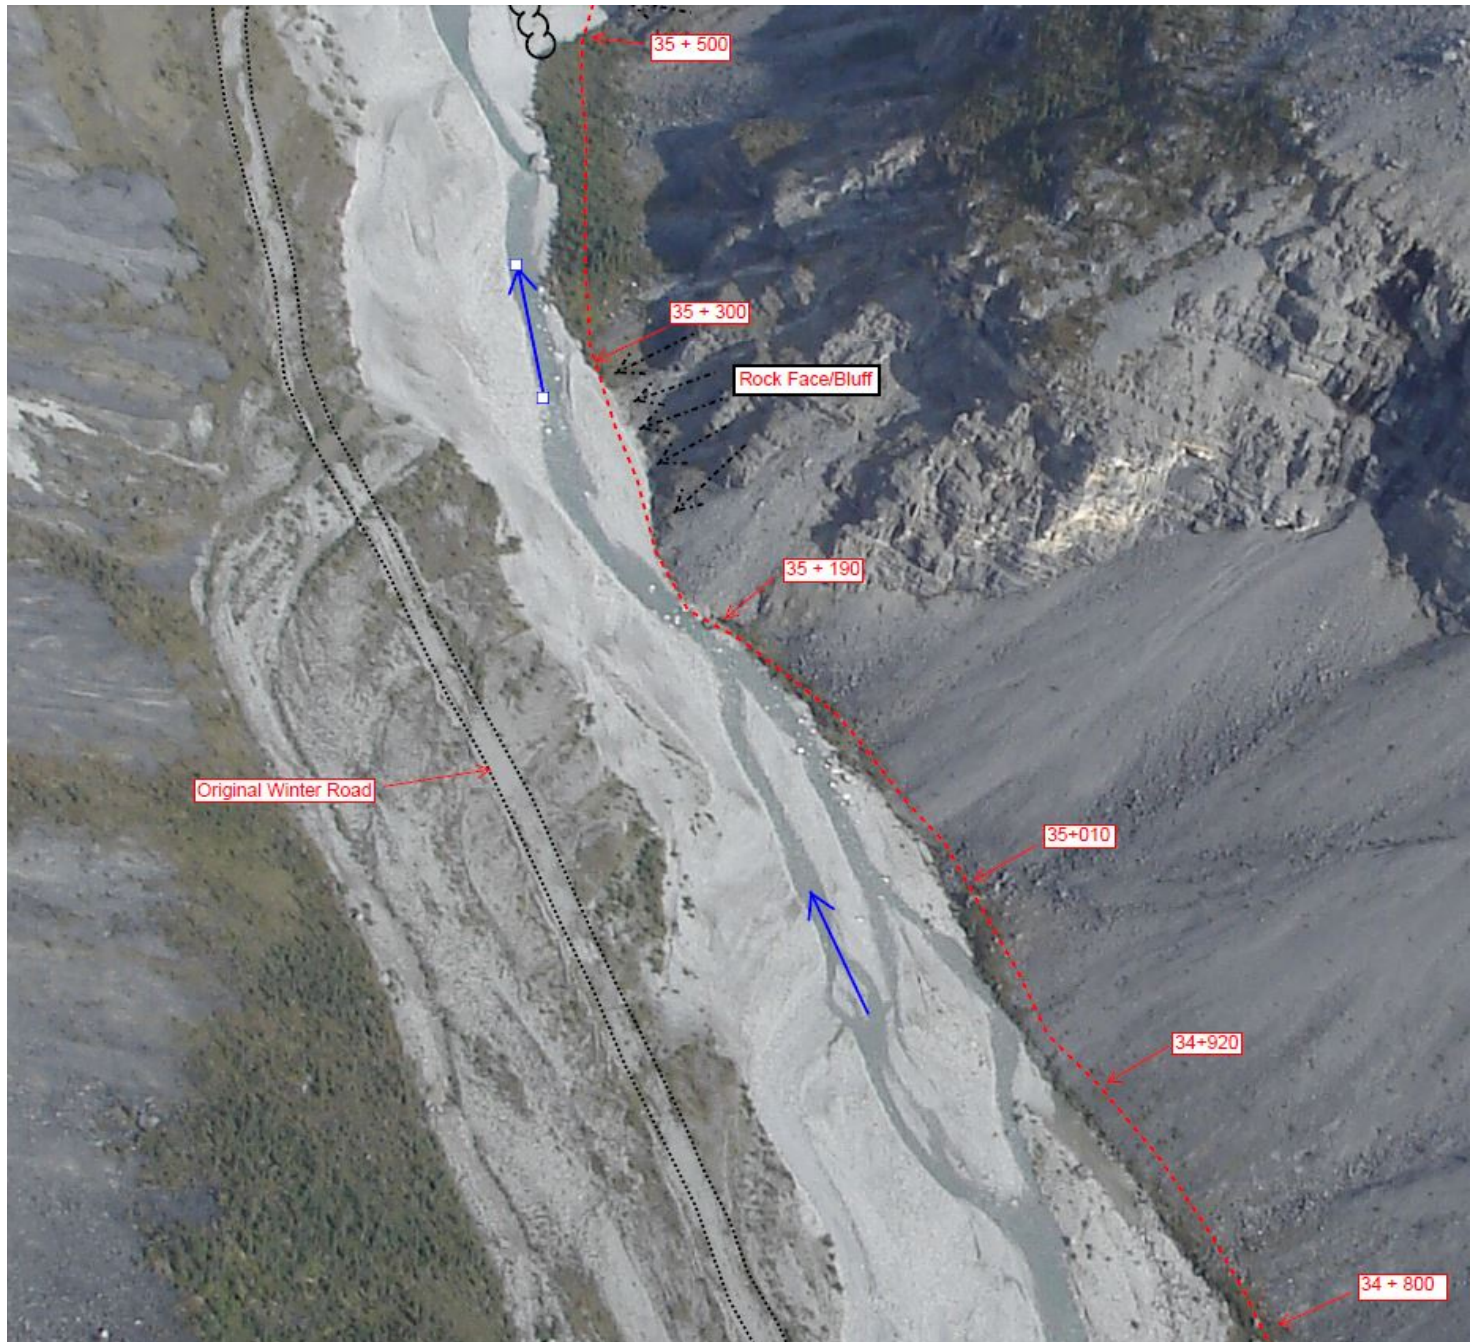
**Photo 6. Aerial view looking north from KP 34+800 to 35 + 500.**

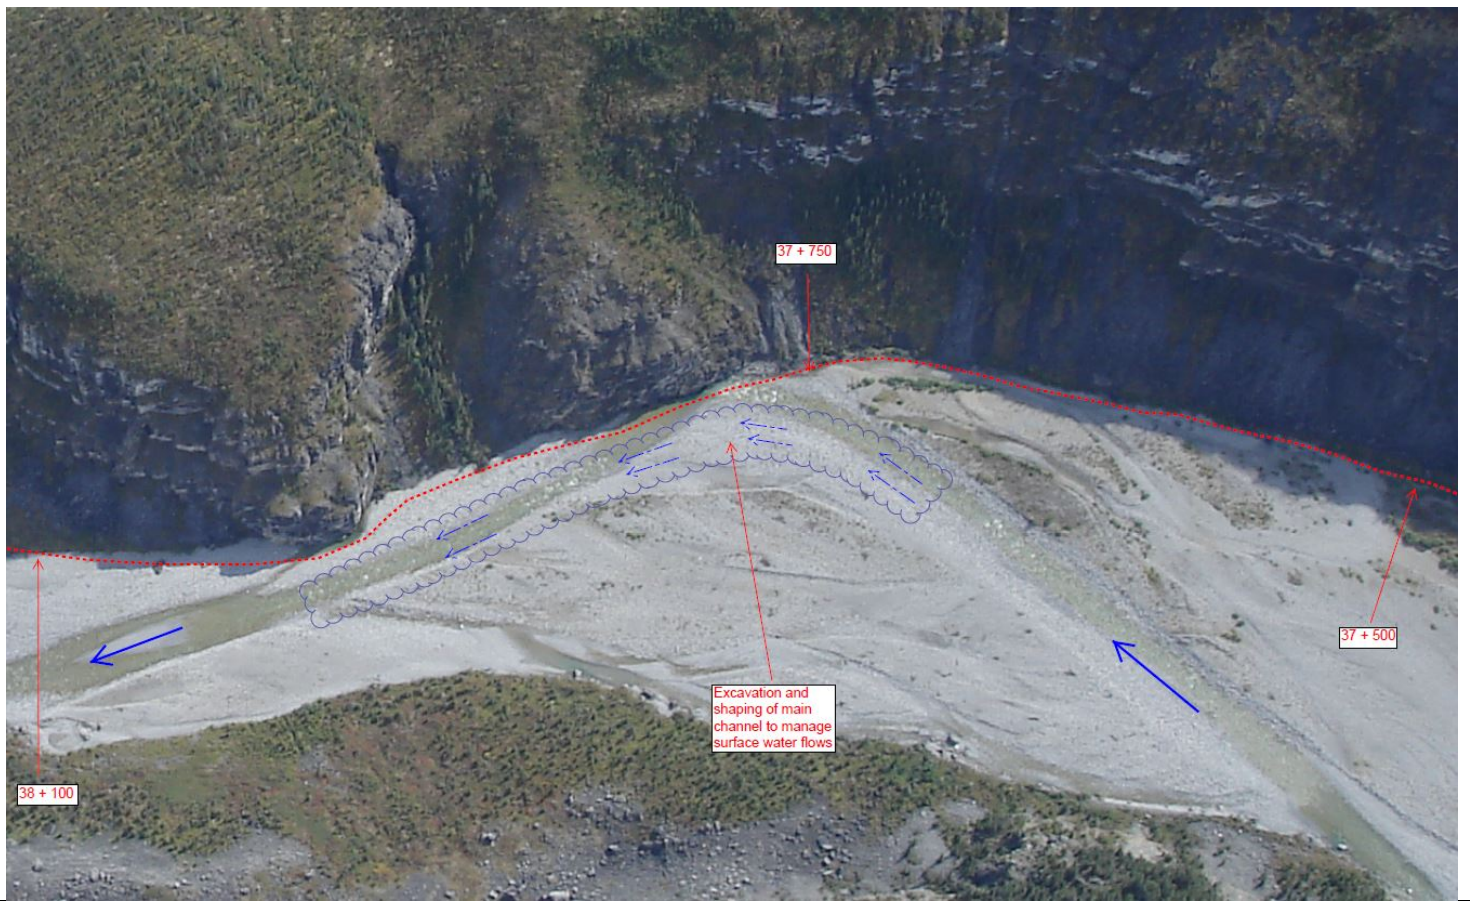
**Photo 11. Aerial view looking southeast from KP 37.5 to 38.1.**

**37+750 to 38+100.** The road structure will be constructed and anchored along the rock face with 80 to 100 % of the road prism occupying the main active stream channel. The hydrological force is expected to be significant. The road structure will be constructed to a height 1 m greater than the defined high water level with large coarse rock and extensive armoring of the exposed slope. The channel thalweg will be relocated (shifted) to the west to accommodate the road prism (see photo 11 below).

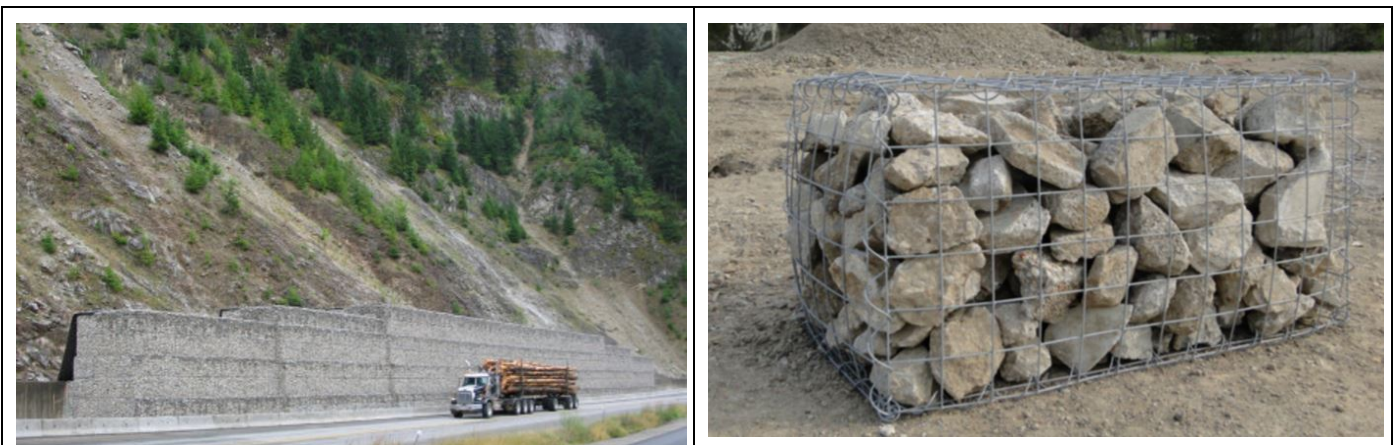
**Photo 12 is an example of the extreme capability of gabion baskets utilized on a highway structure (would not be necessary for the road standard prescribed for the Prairie Creek mine). Photo 13 is typical gabion basket.**

Photo 2 below shows a typical highway application for gabion baskets. Photo 3 shows a typical basket. Figure 1 is an example of a typical cross section with gabion baskets utilized. The detailed road design, based on final field evaluation and survey, will define where and how gabion baskets will be utilized.

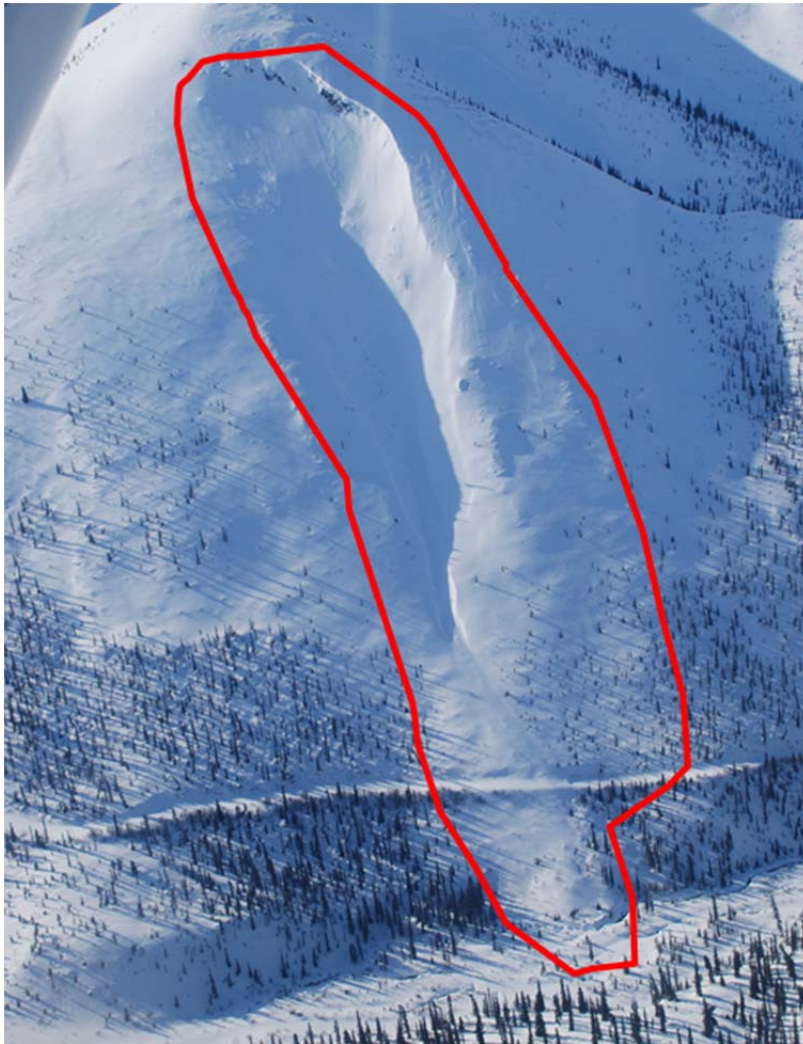
**Photograph 6-1 – Path 12 with cornices above start zone**

During the overview flight, several avalanche paths were confirmed along the mountain segment of the road (example in Photograph 6-1). In addition, recent avalanche debris was noted in several places along the access road (example in Photograph 6-2). And numerous wind ‘pillows’ were observed indicating wind slab avalanche conditions (example in Photograph 6-3).

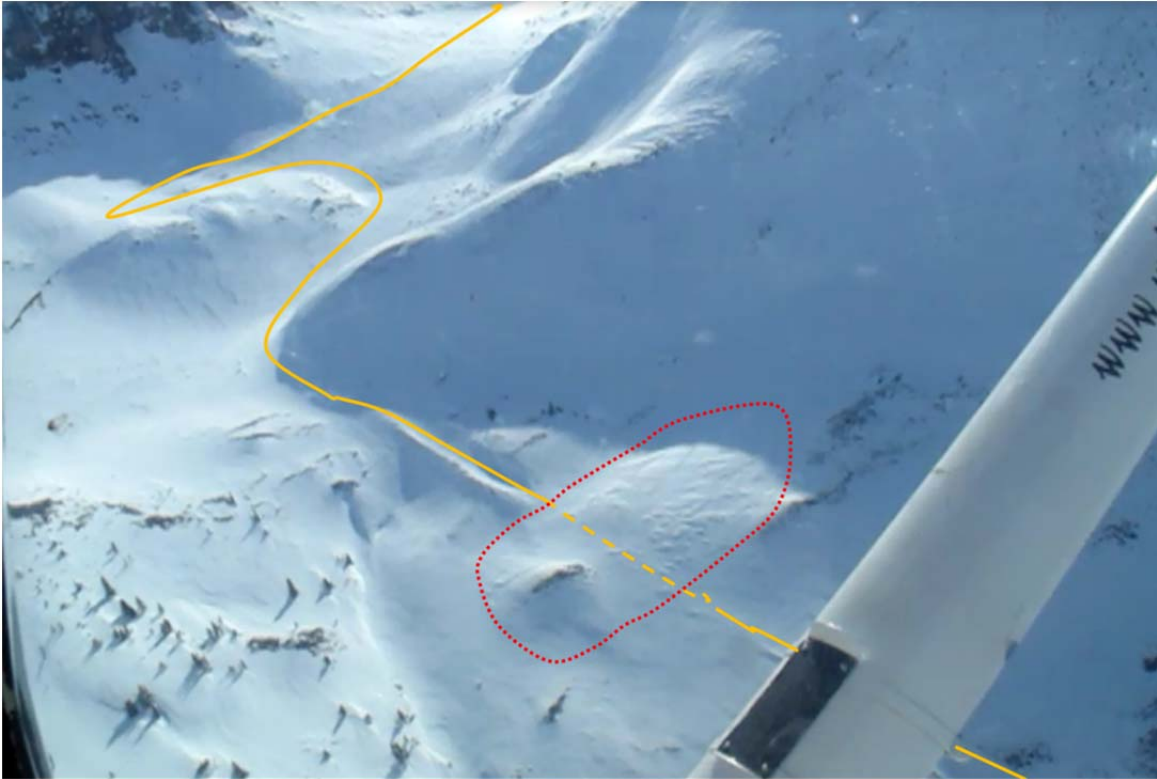
Photograph 6-2 – Path 15 - Recent avalanche deposit (red) on road (yellow) from winter 2011/2012

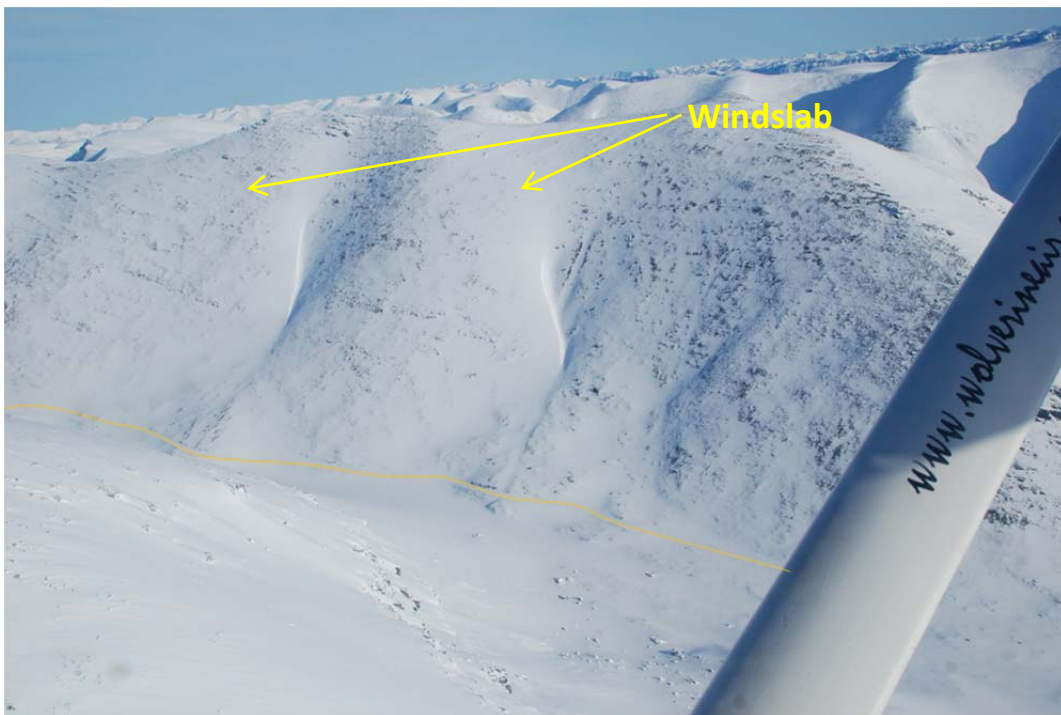
Photograph 6-3 – Example of wind slab avalanche conditions above road (orange line)
